VEHICLE INSPECTION REPORT

VK61NLU

Nissan Micra 1.2 DiG-S Acenta 5dr

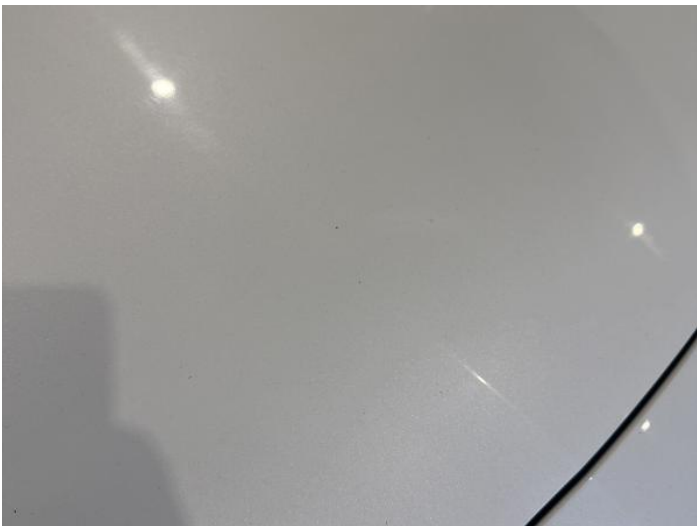
1: Bonnet
Chipped
Multiple Chips

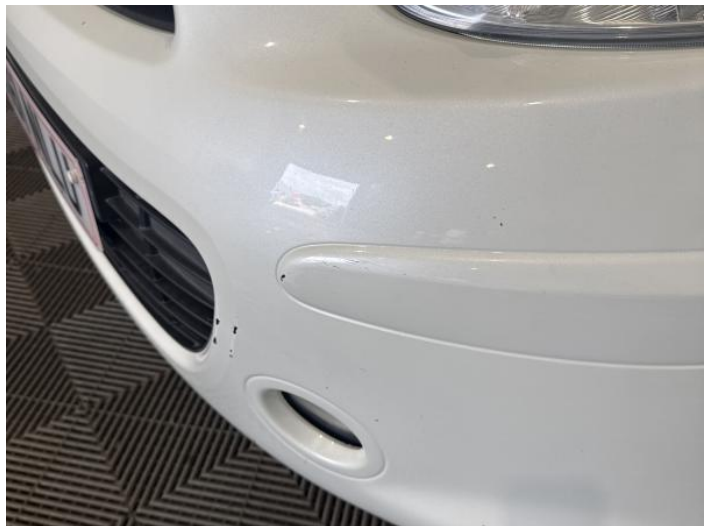
2: Bumper Front
Scratched
25 to 100mm Thru Paint

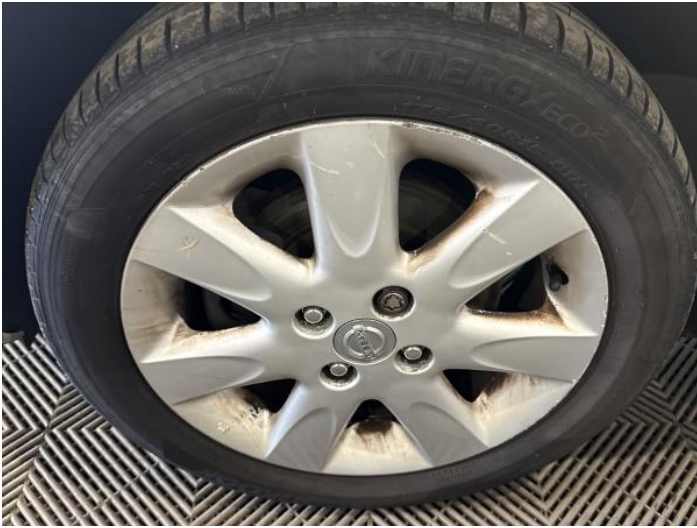
3: Wheel nsf
Scratched
Over 50mm

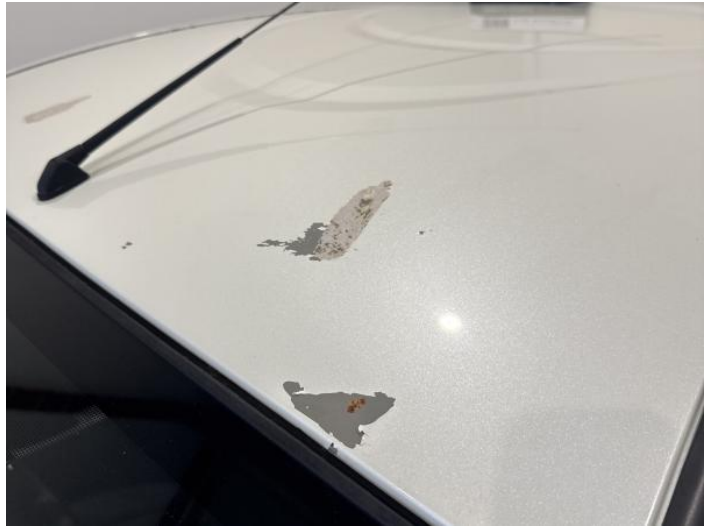
4: Roof
Poor Previous Repair
Paint Flake

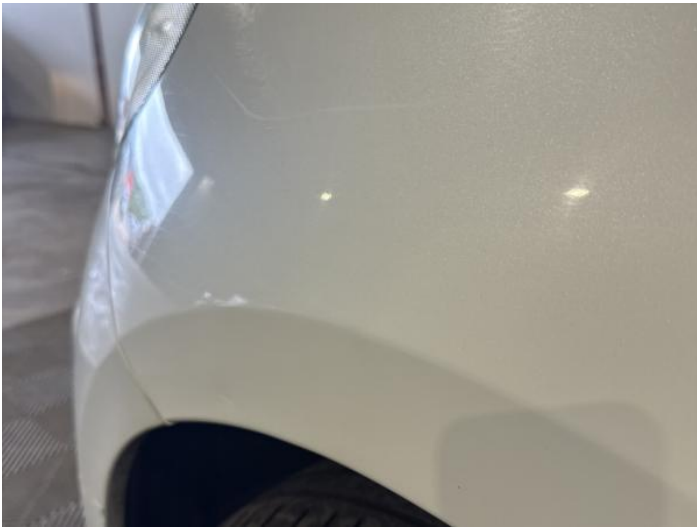
5: Wing nsf
Dented
Between 10mm + 30mm

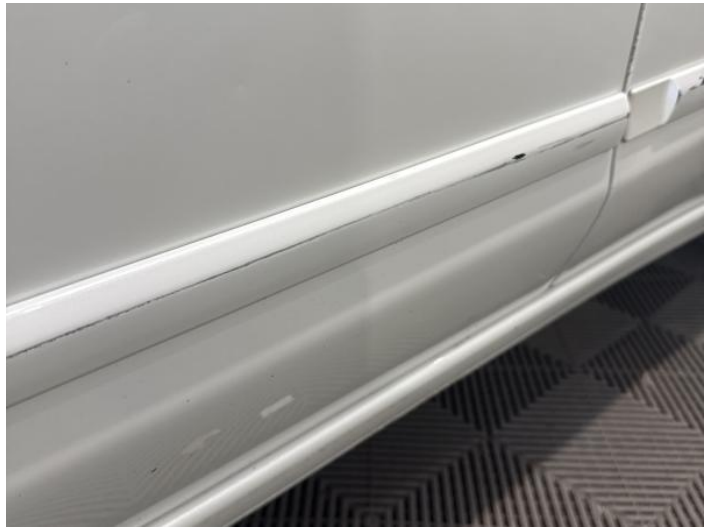
6: Door Moulding nsf
Scratched (Painted)
Over 25mm Thru Paint

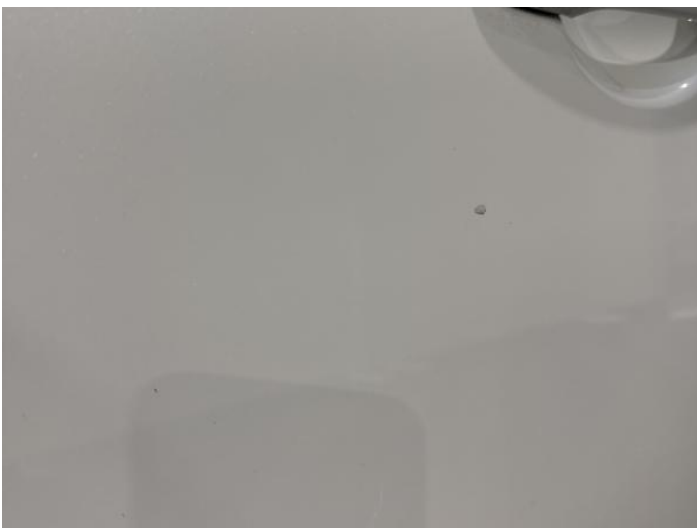
7: Door nsf
Chipped
1 To 5

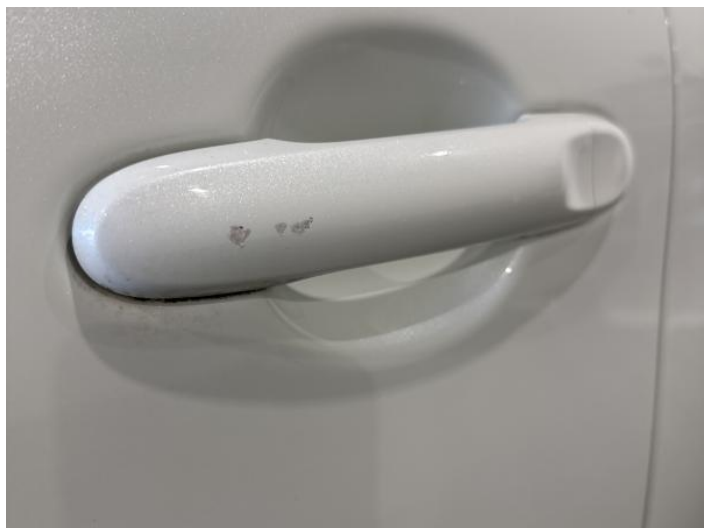
8: Handle Outer nsf
Scratched (Painted)
Over 25mm Thru Paint

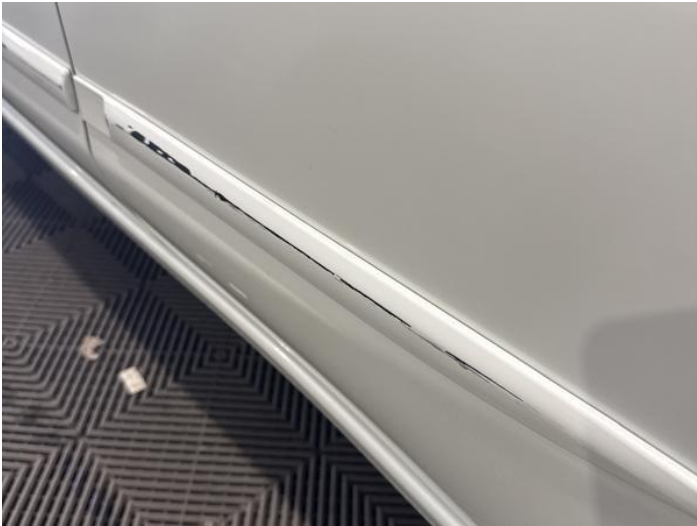
9: Door Moulding nsr
Scratched (Painted)
Over 25mm Thru Paint

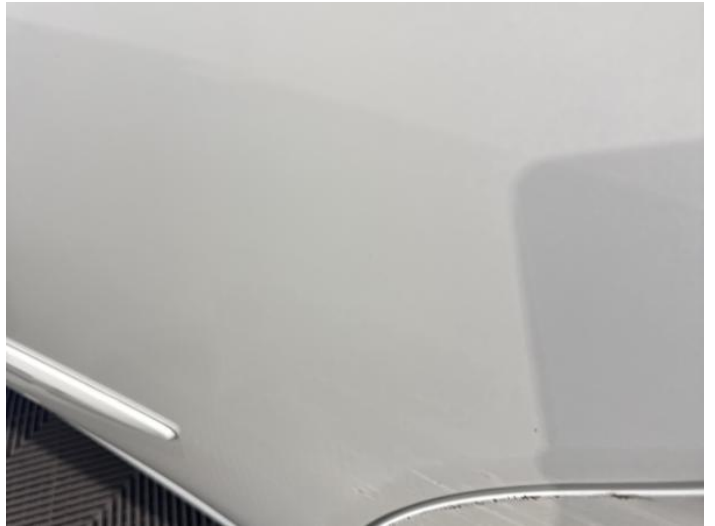
10: Door nsr
Scratched
Over 25mm Thru Paint

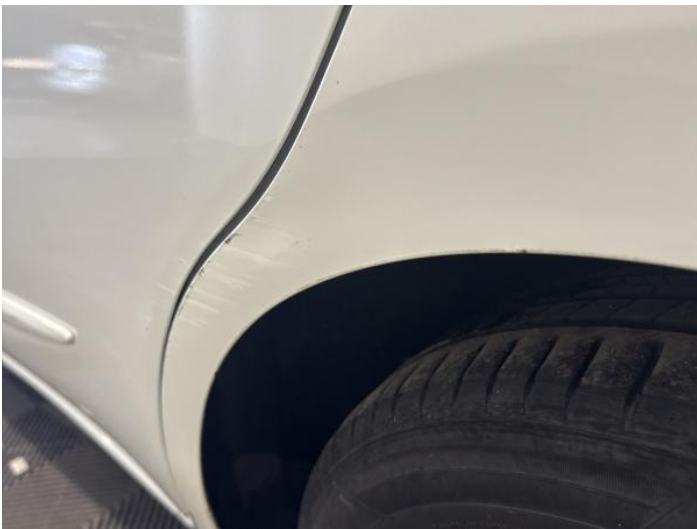
11: Qtr Panel nsr
Dented
With Paint Damage

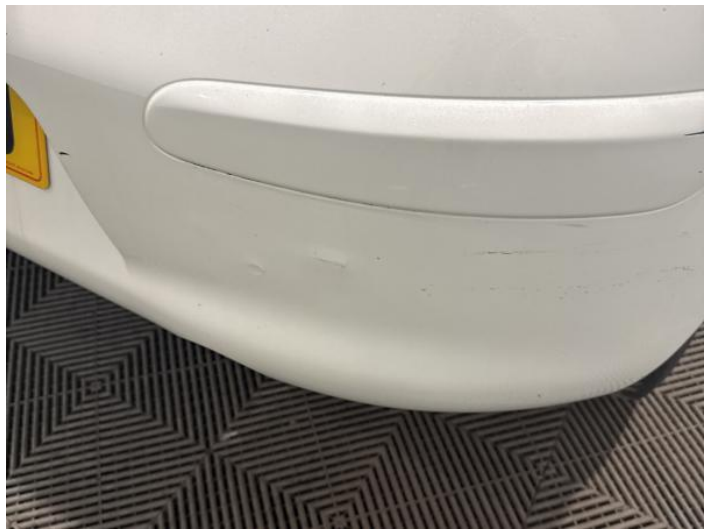
12: Bumper Rear
Dented
With Paint Damage

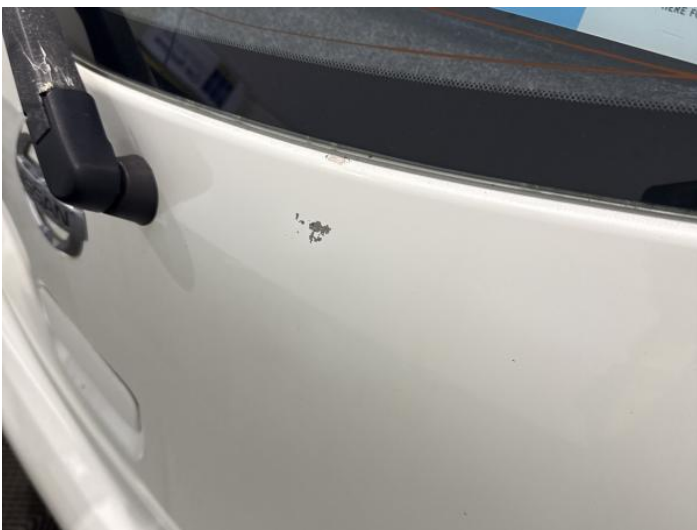
13: Tailgate
Scratched
Over 25mm Thru Paint

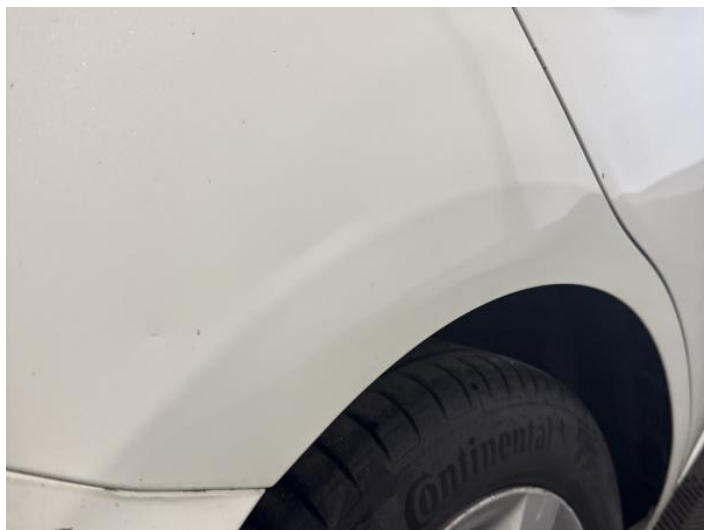
14: Qtr Panel osr
Dented
Over 30mm

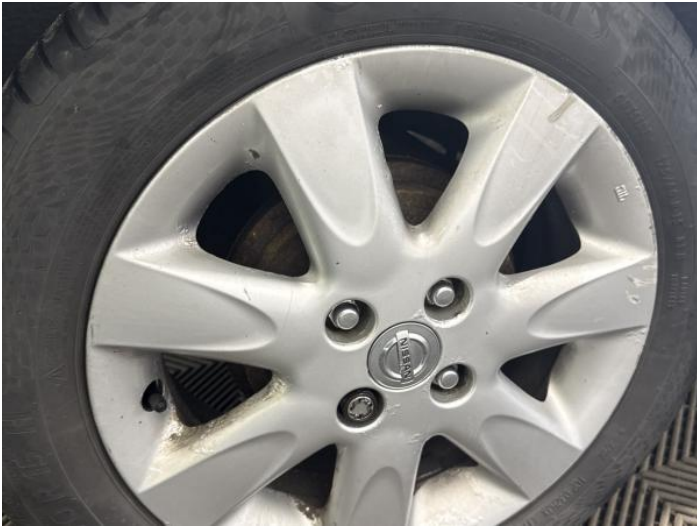
15: Wheel osr
Scratched
Over 50mm

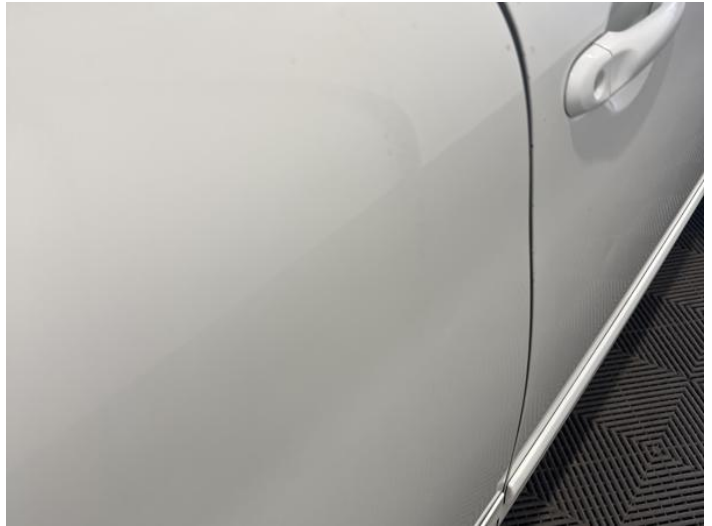
16: Door osr
Dented
Over 30mm

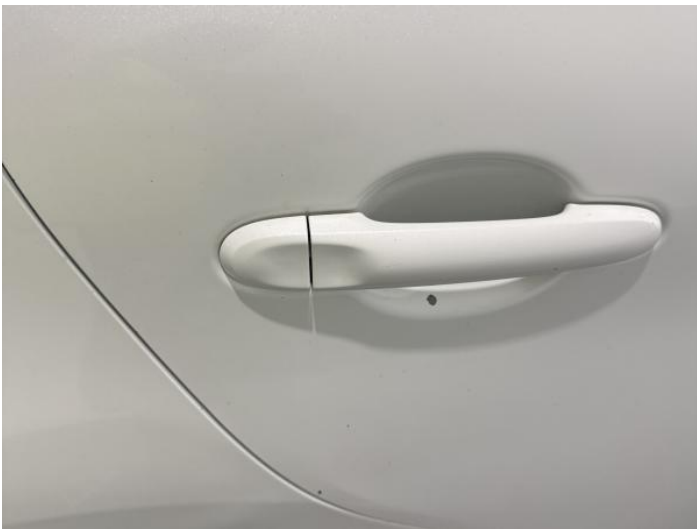
17: Door osr
Scratched
Over 25mm Thru Paint

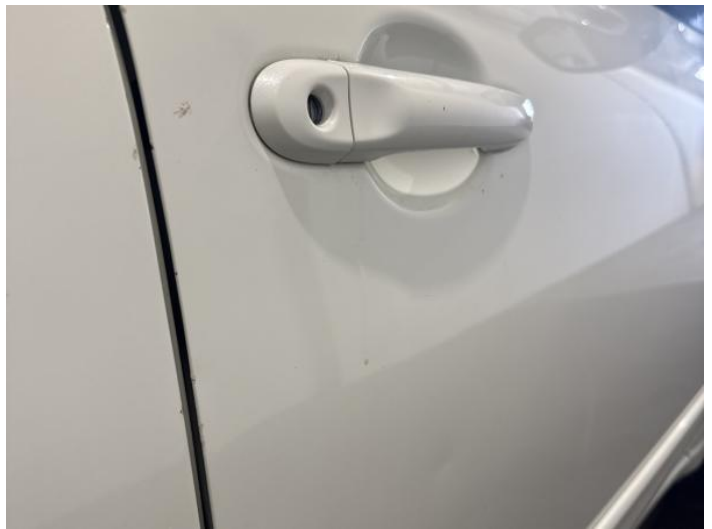
18: Door osf
Dented
Over 30mm

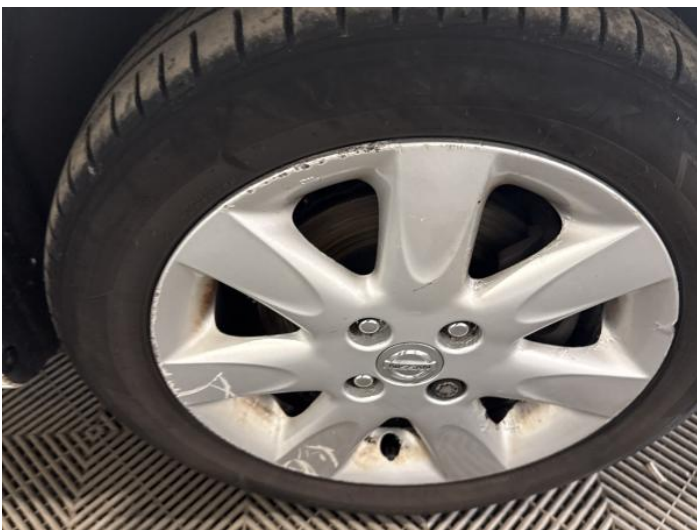
19: Wheel osf
Scratched
Over 50mm

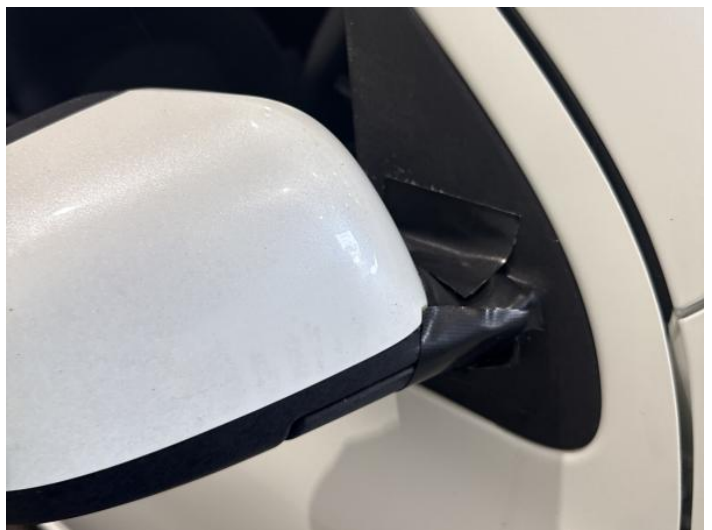
20: Door Mirror Assy osf
Broken
Replace

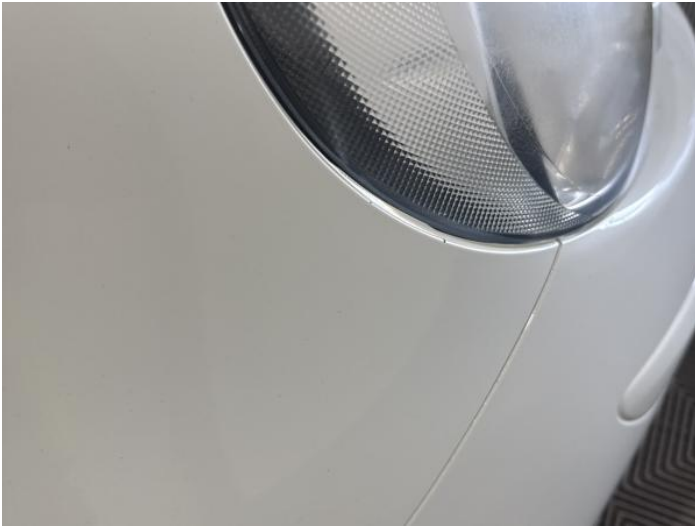
21: Wing osf
Chipped
1 To 5
