VEHICLE INSPECTION REPORT

VO20SYJ

Vauxhall Grandland X 1.6 Hybrid4 300 Ultimate Nav 5dr Auto

nama
GRADE
4

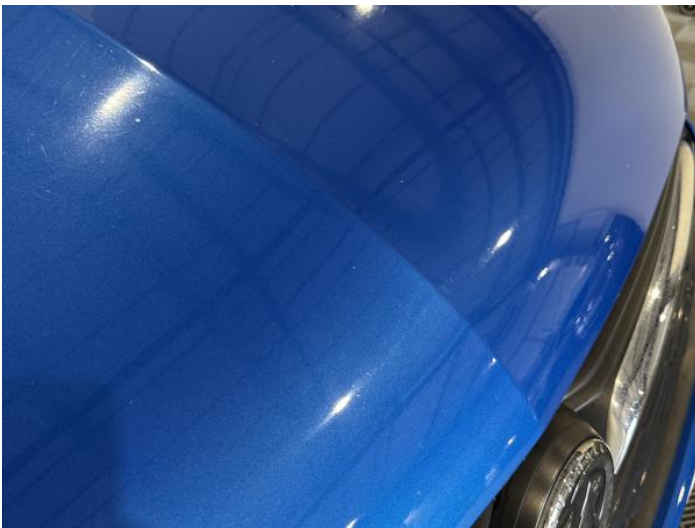
1: Bonnet
Chipped
Multiple Chips

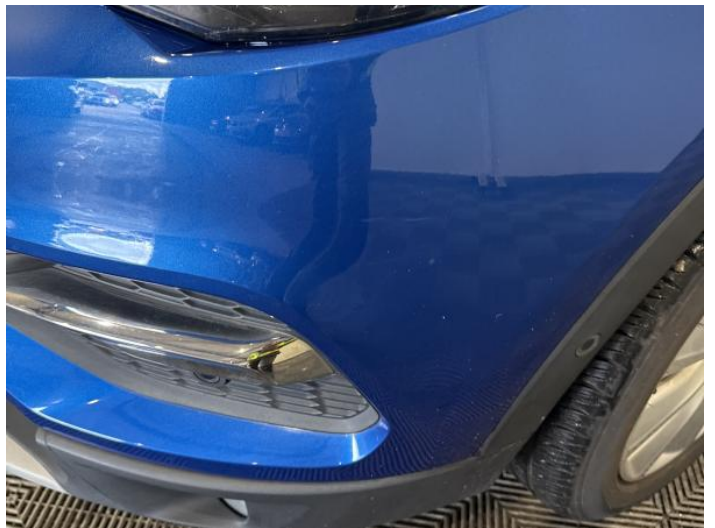
2: Bumper Front
Scratched
25 to 100mm Thru Paint

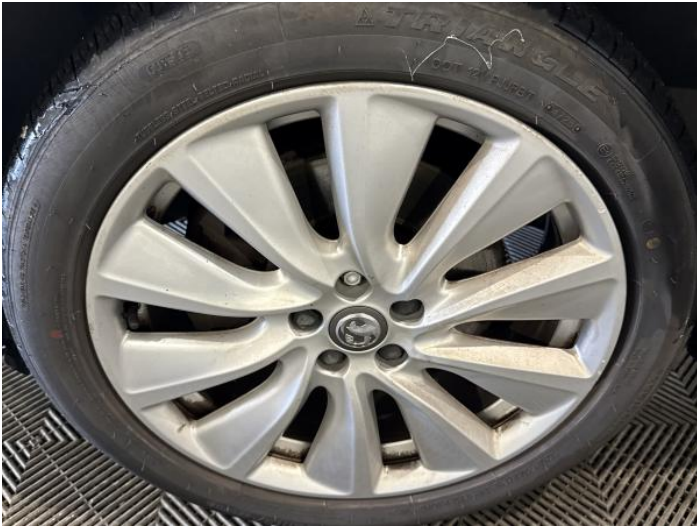
3: Wheel nsf
Scrapped
Over 50mm

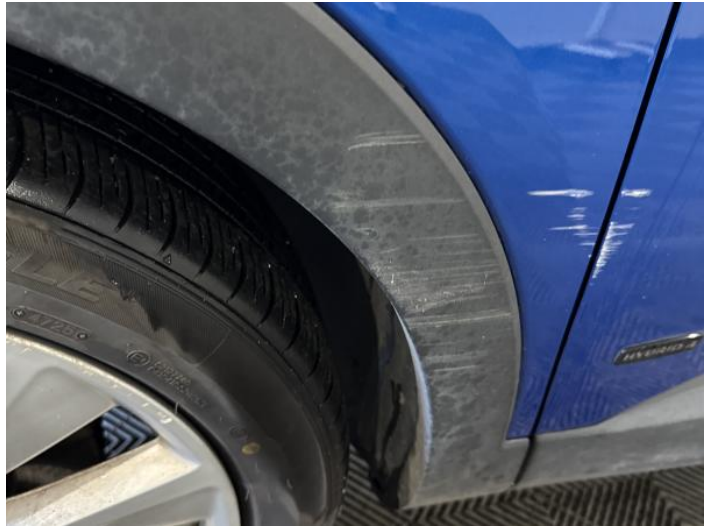
4: Wing Front Arch Extension ns
Scuffed (Unpainted)
Over 100mm

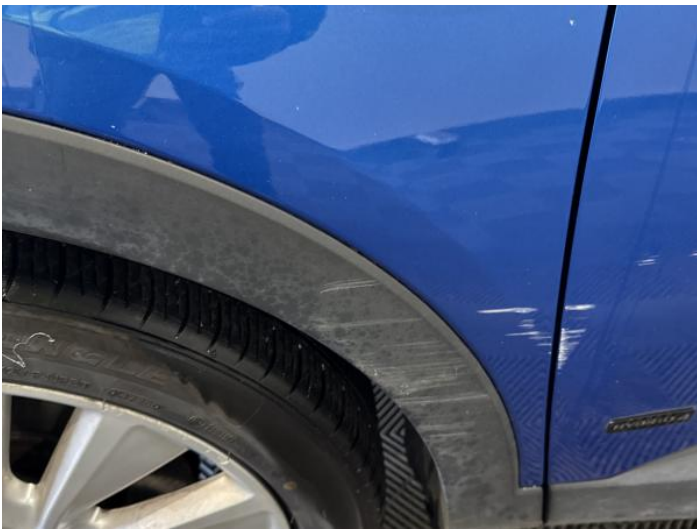
5: Wing nsf
Scrapped
Over 25mm Thru Paint

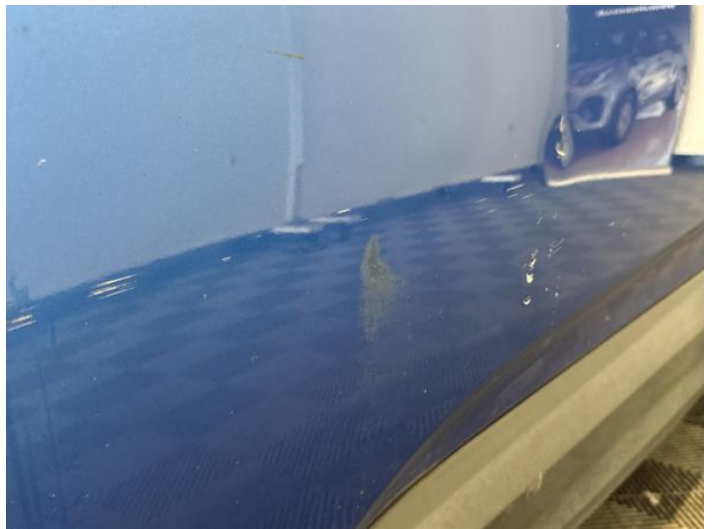
6: Door nsf
Dented
With Paint Damage

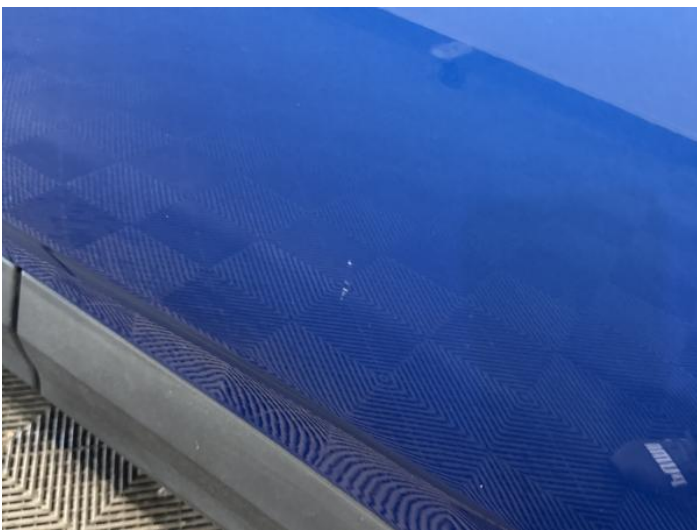
7: Door nsr
Scrapped
Up To 25mm Thru Paint

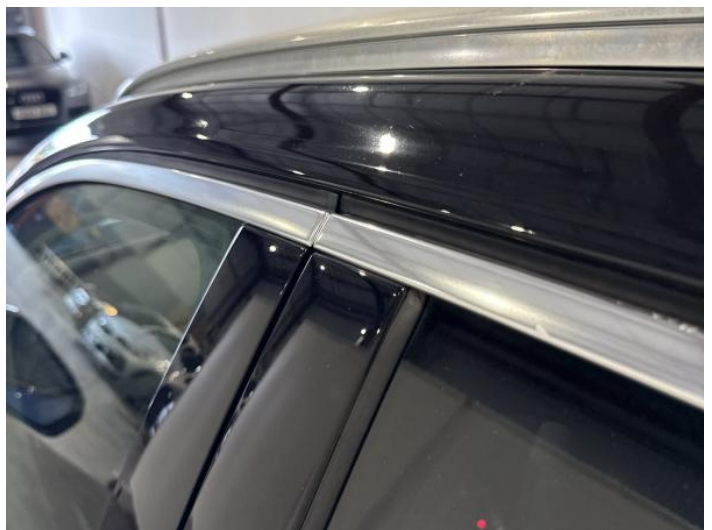
8: B Post ns
Dented
Between 10mm + 30mm

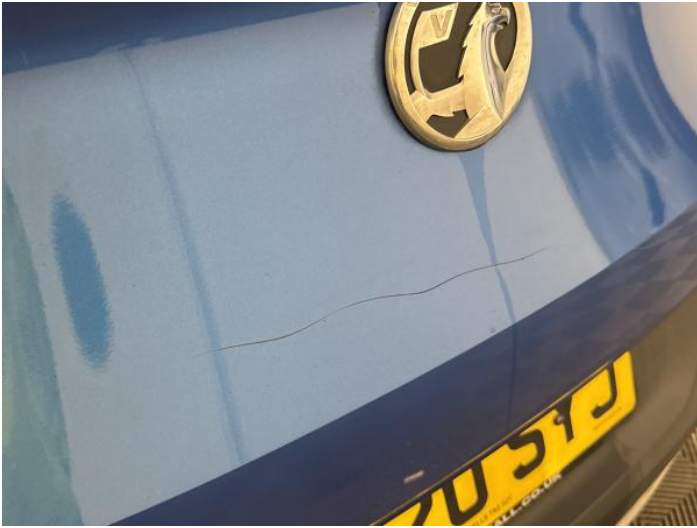
9: Tailgate
Scratched
Over 25mm Thru Paint

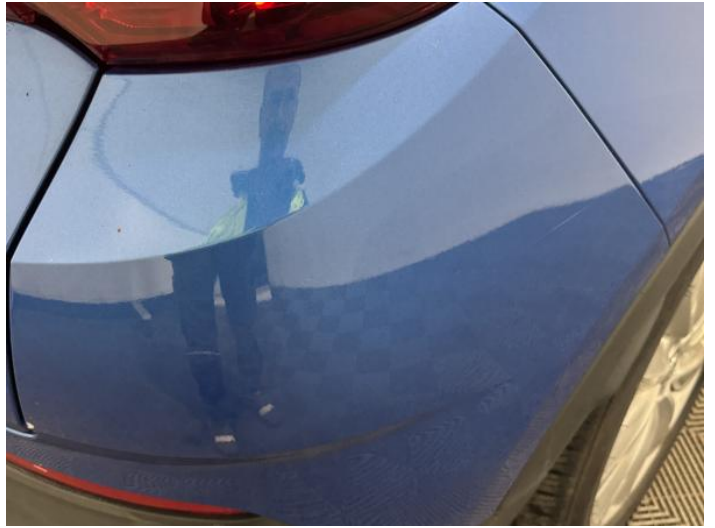
10: Bumper Rear
Scratched
25 to 100mm Thru Paint

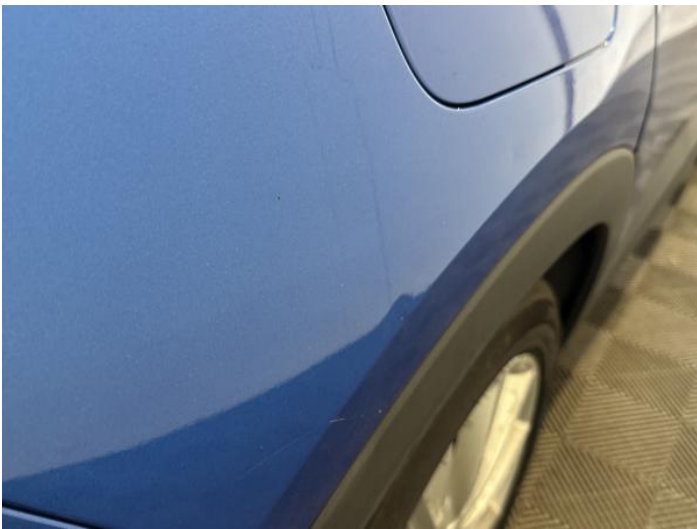
11: Qtr Panel osr
Dented
Between 10mm + 30mm

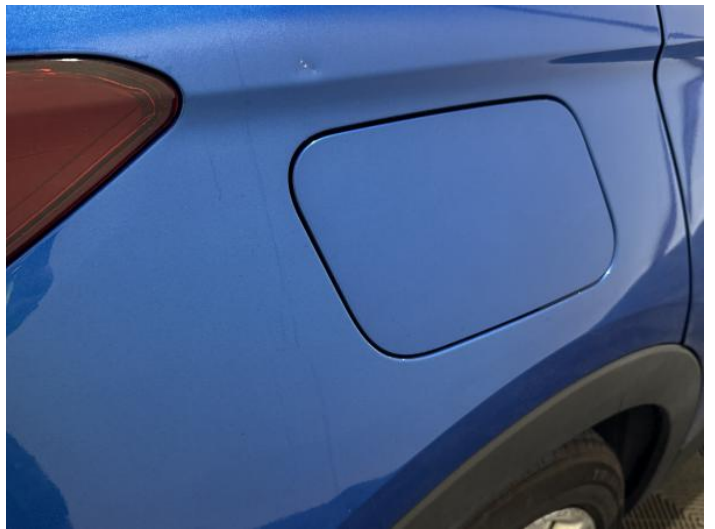
12: Qtr Panel nsr
Scratched
Over 25mm Thru Paint

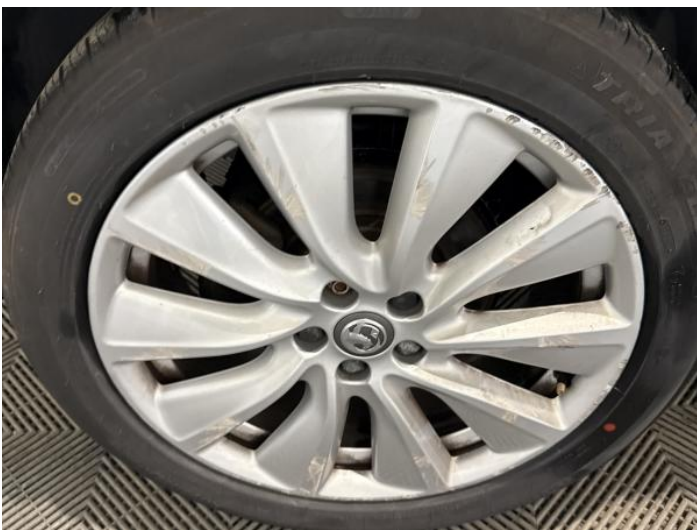
13: Wheel osr
Scratched
Over 50mm

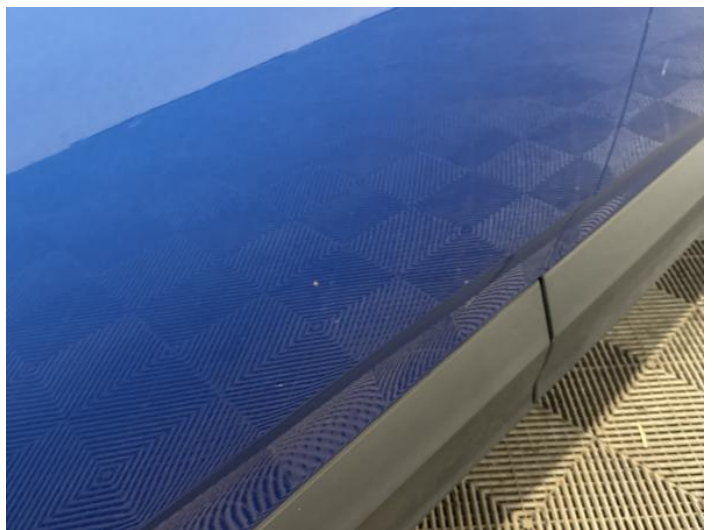
14: Door osr
Chipped
1 To 5

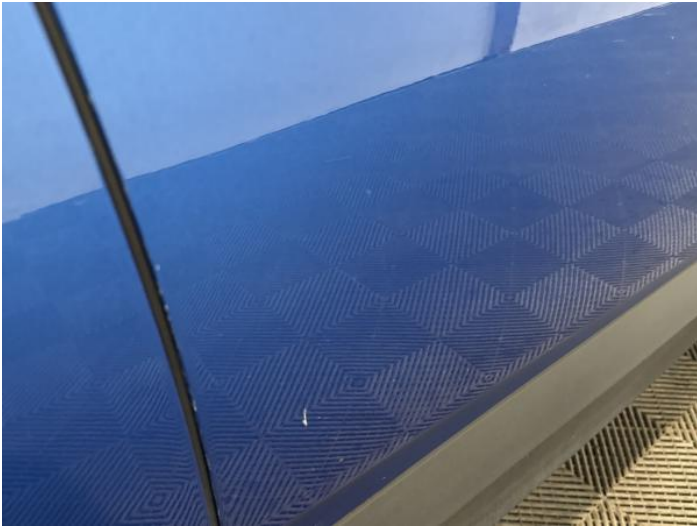
15: Door osf
Scratched
UpTo 25mm Thru Paint

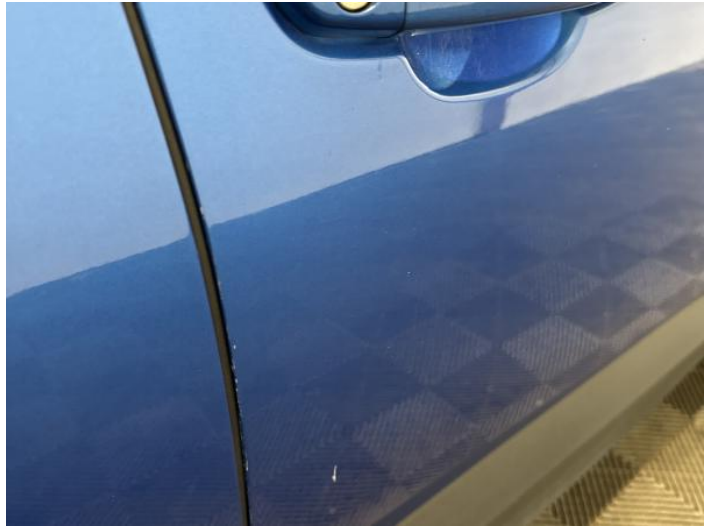
16: Door osf
Chipped
Edge Chip

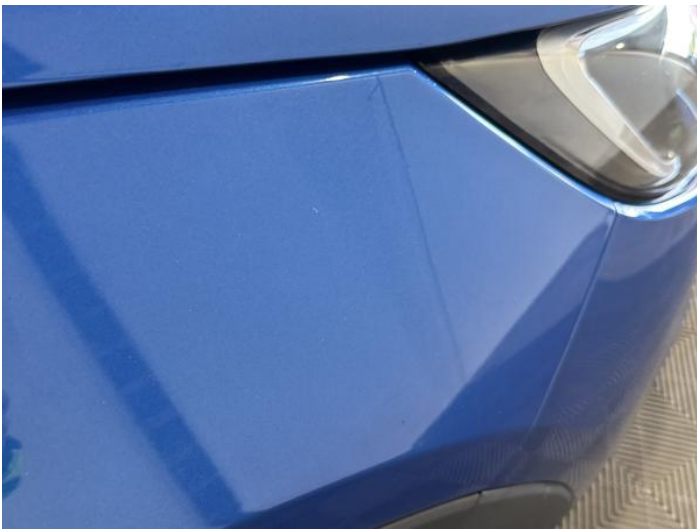
17: Wing osf
Chipped
1 To 5

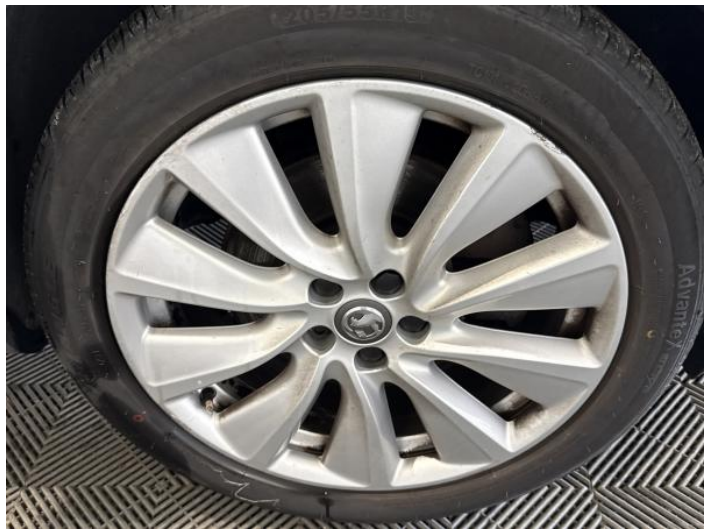
18: Wheel osf
Scratched
Up To 50mm

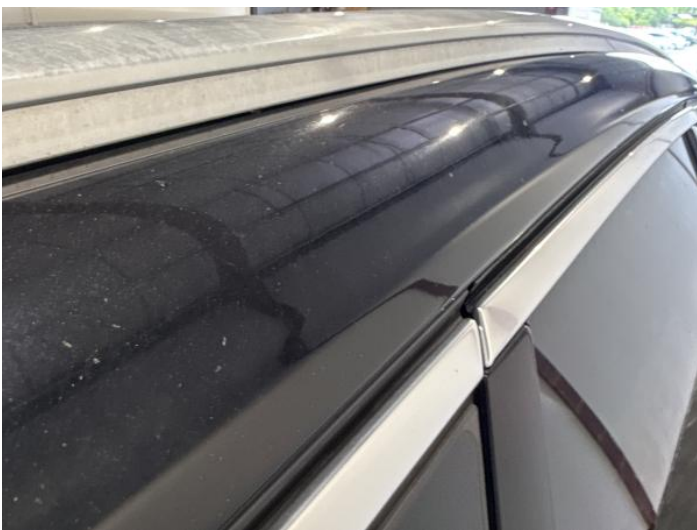
19: B Post os
Dented
Between 10mm + 30mm
