VEHICLE INSPECTION REPORT

DX16ZRG

Vauxhall Insignia 2.0 CDTi [170] ecoFLEX SRi Nav 5dr [Start Stop]

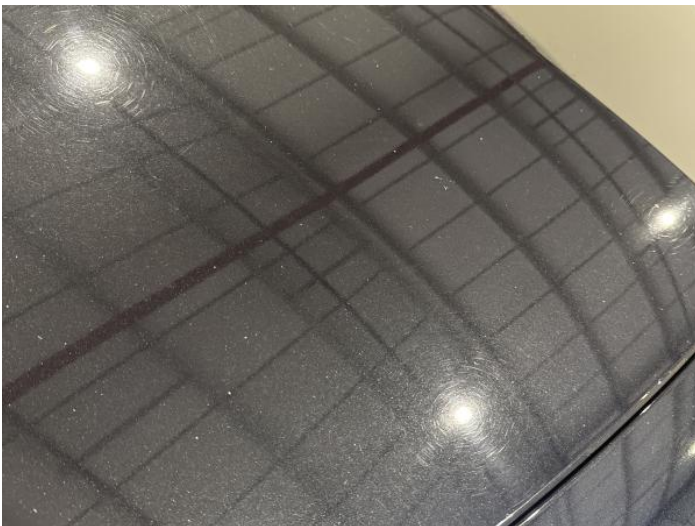
1: Bonnet
Chipped
Multiple Chips

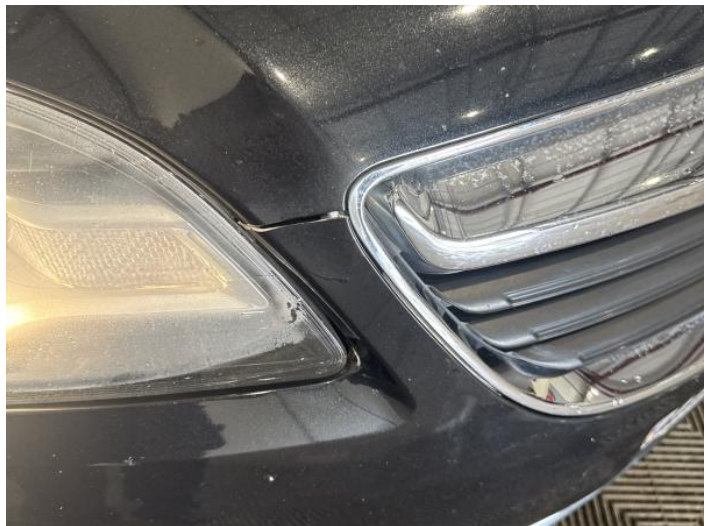
2: Bumper Front
Cracked
Over 25mm

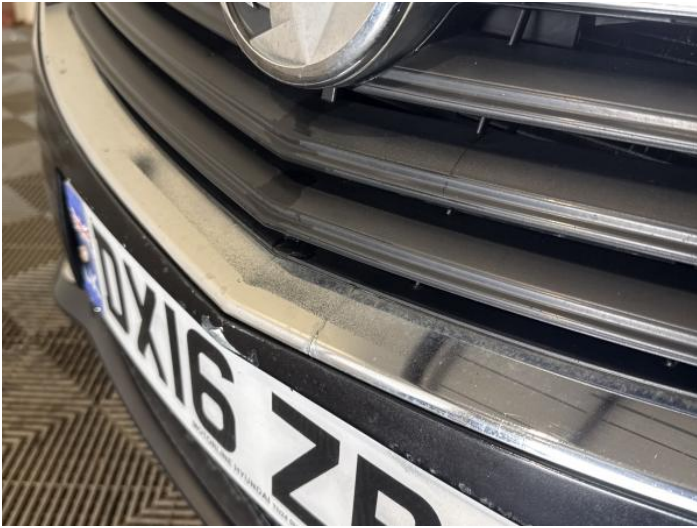
3: Bumper Front Grill
Broken
Replace

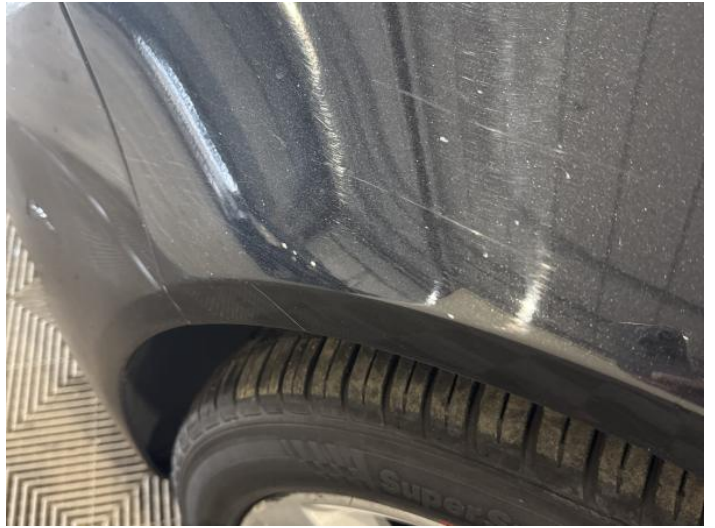
4: Wing nsf
Scratched
Over 25mm Thru Paint

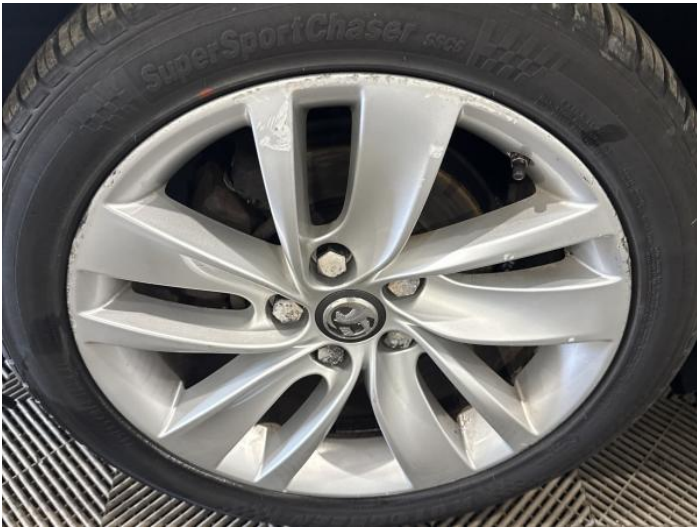
5: Wheel nsf
Scratched
Over 50mm

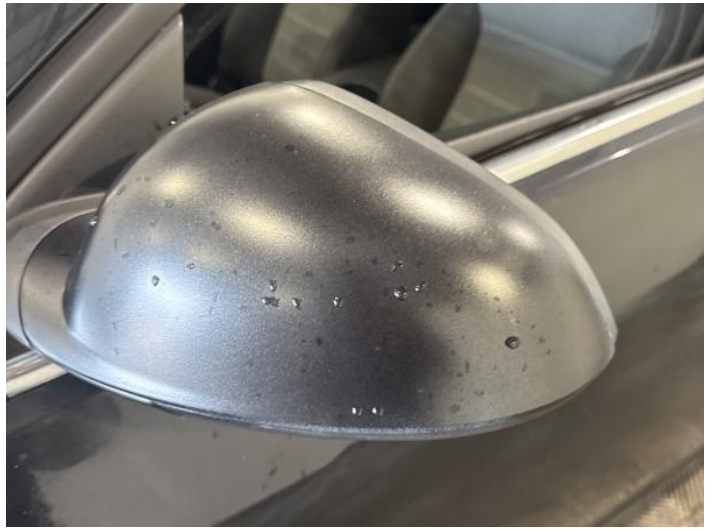
6: Door Mirror Assy nsf
Scratched (Painted)
Over 25mm Thru Paint

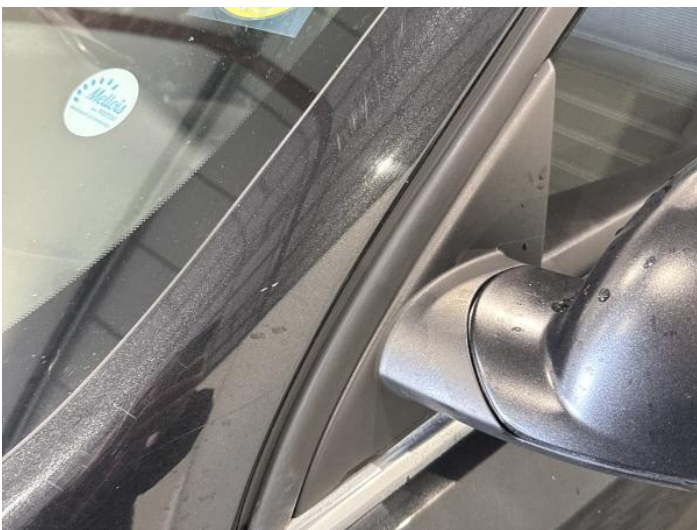
7: A Post ns
Scratched
Over 25mm Thru Paint

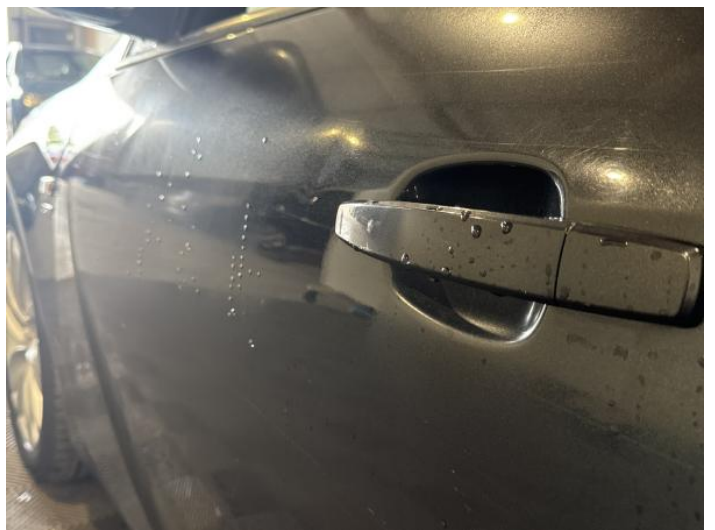
8: Door nsf
Poor Previous Repair
Rippled Up To 30%

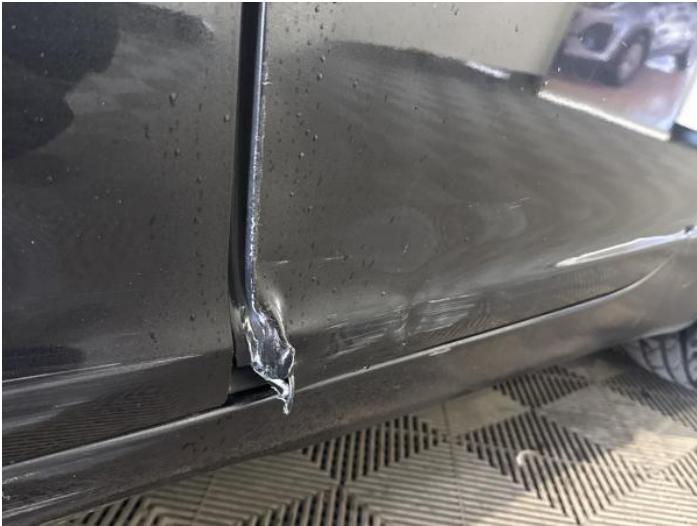
9: Door nsr
Dented
With Paint Damage

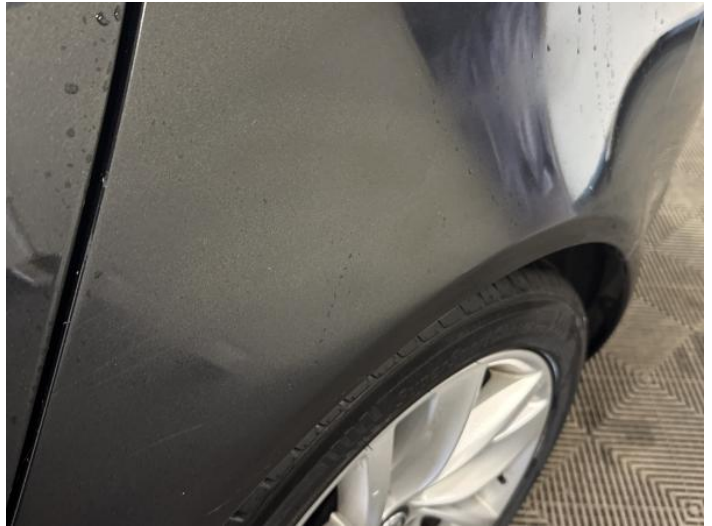
10: Qtr Panel nsr
Poor Previous Repair
Poor Paint

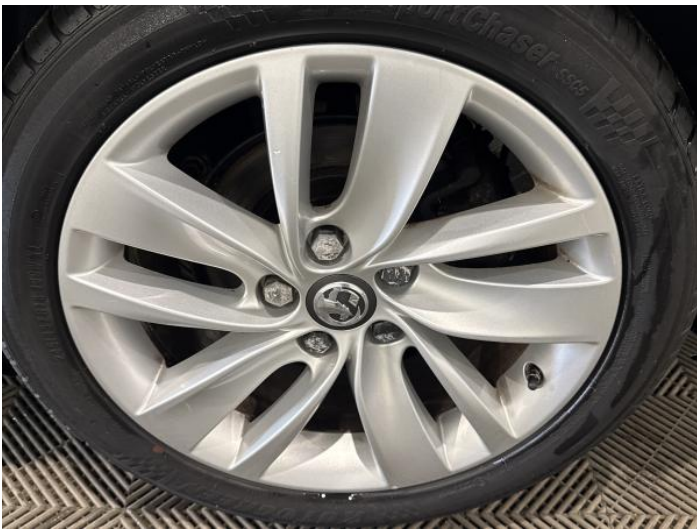
11: Wheel nsr
Scratched
Up To 50mm

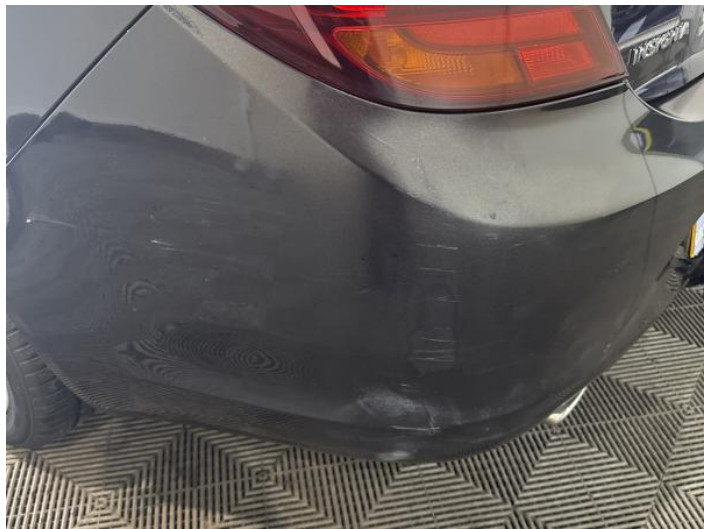
12: Bumper Rear
Poor Previous Repair
Poor Paint

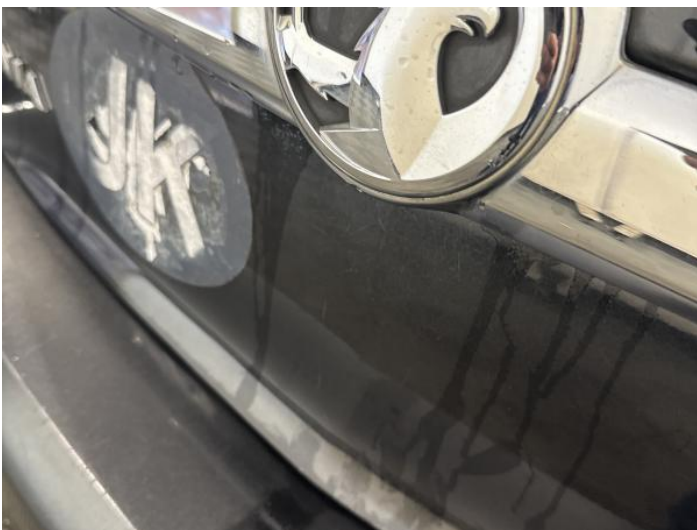
13: Tailgate
Scratched
Up To 25mm Thru Paint

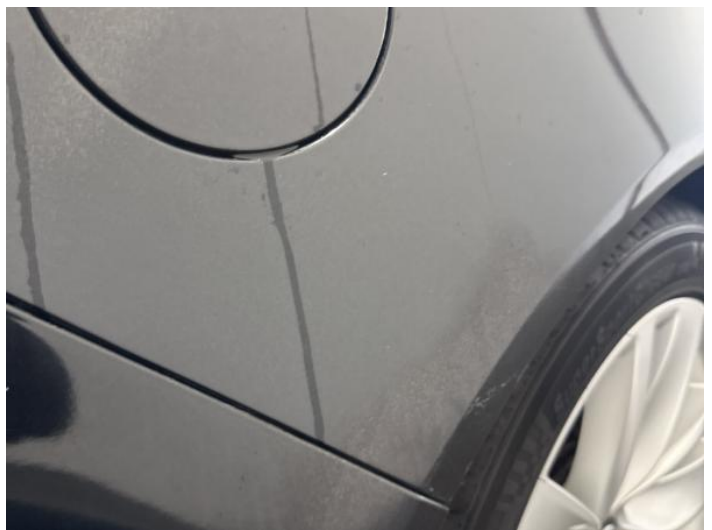
14: Qtr Panel osr
Poor Previous Repair
Poor Paint

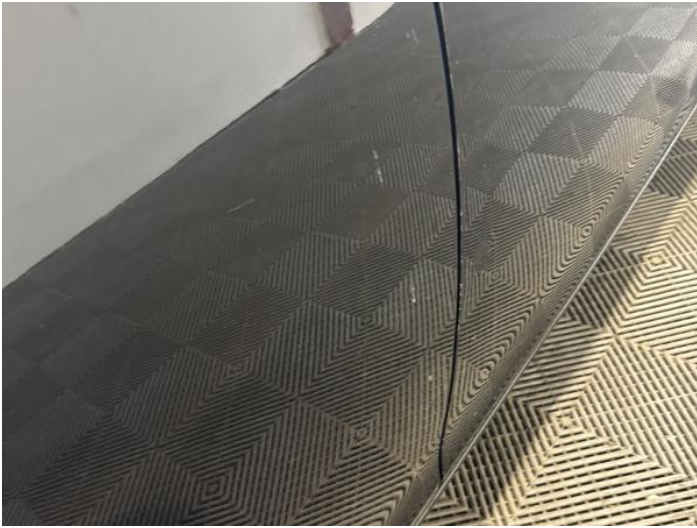
15: Door osr
Scratched
Over 25mm Thru Paint

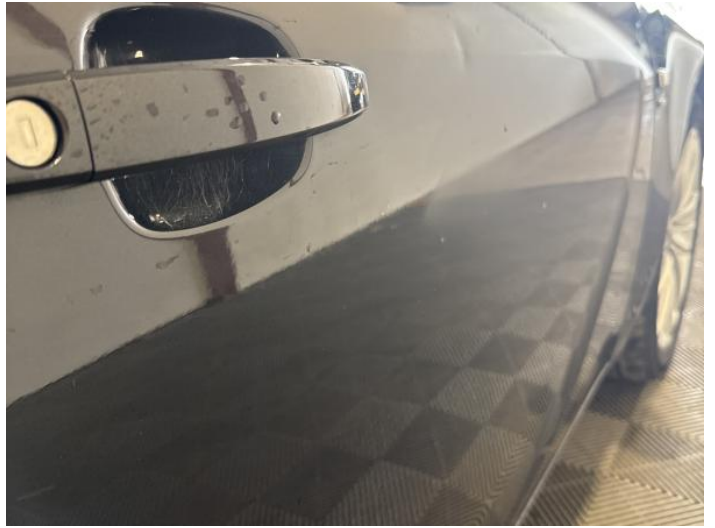
16: Door osf
Dented
With Paint Damage

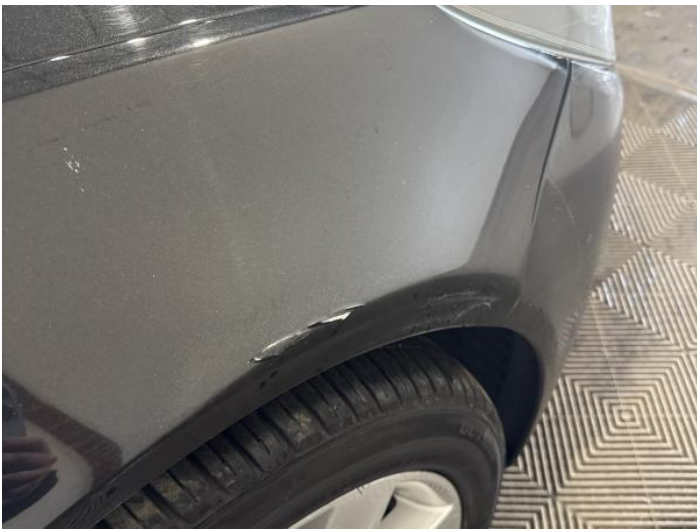
17: Wing osf
Dented
With Paint Damage

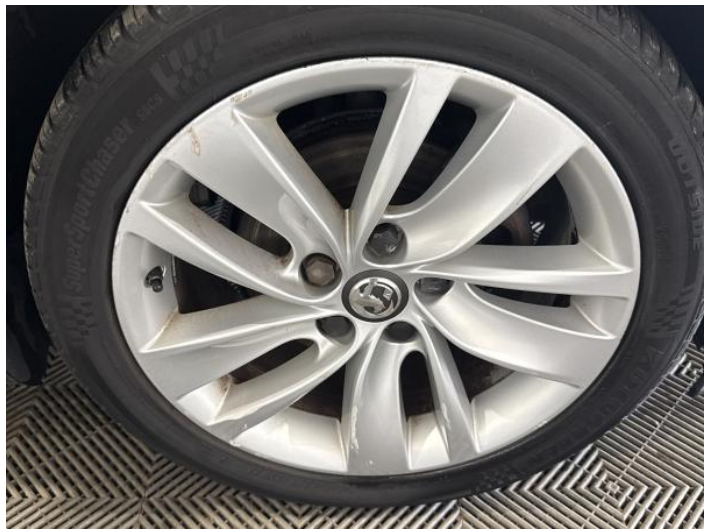
18: Wheel osf
Scratched
Over 50mm

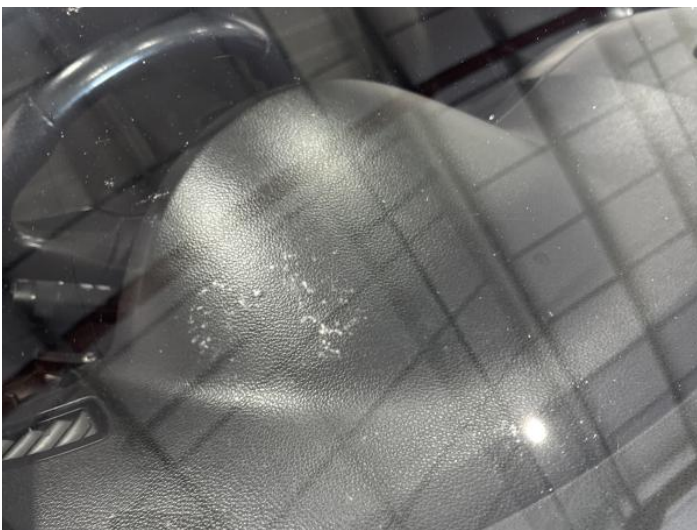
19: Screen Front
Chipped
UpTo 10mm

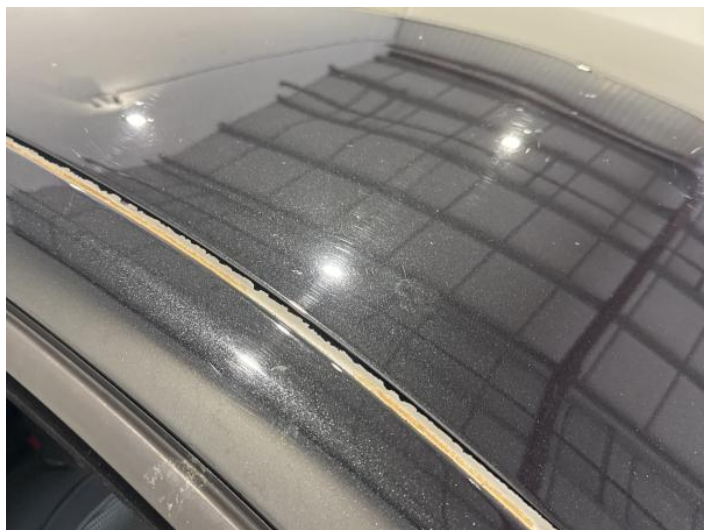
20: Roof
Scratched
Rusted
