VEHICLE INSPECTION REPORT

LG12WLB

Hyundai Santa Fe 2.2 CRDi Premium 5dr [7 Seats]

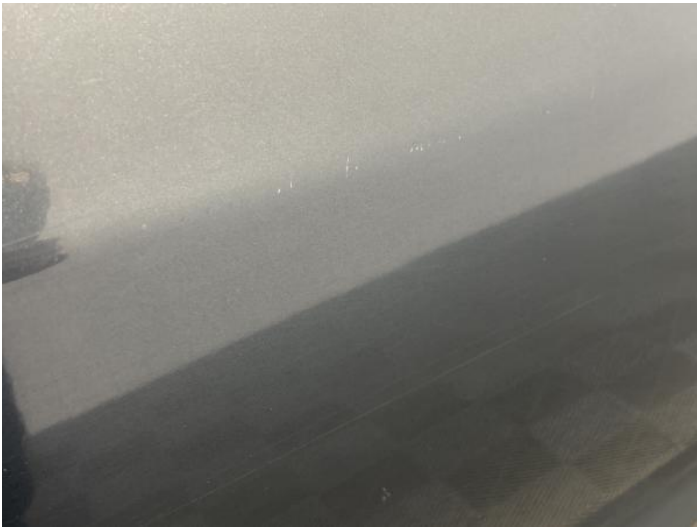
5: Door osr
Chipped
Multiple Chips

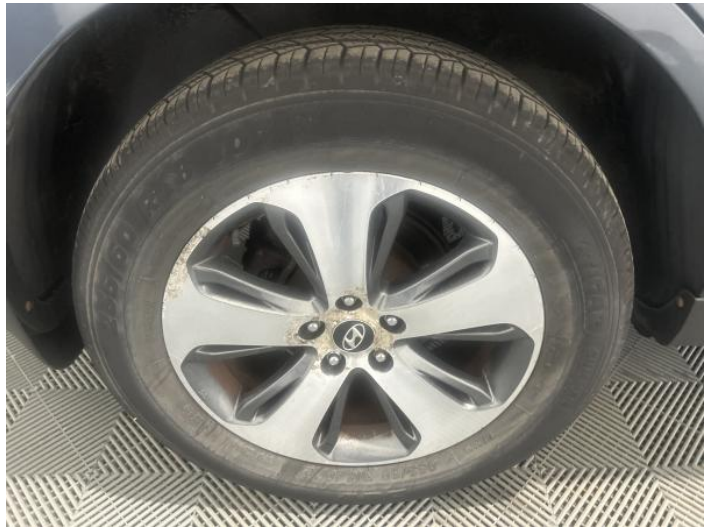
6: Wheel osr
Corroded
Light

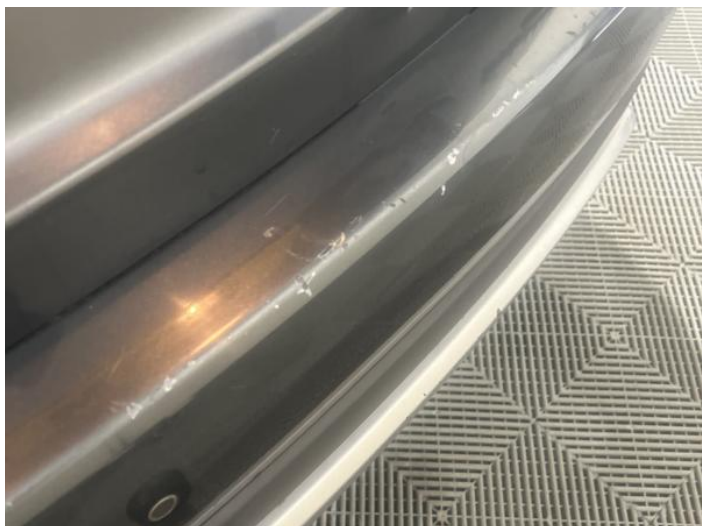
9: Bumper Rear
Scratched
Over 100mm Thru Paint

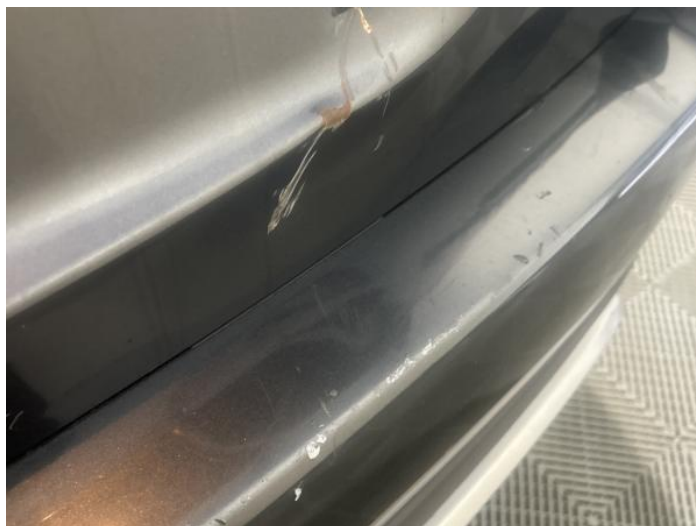
10: Tailgate
Dented
With Paint Damage

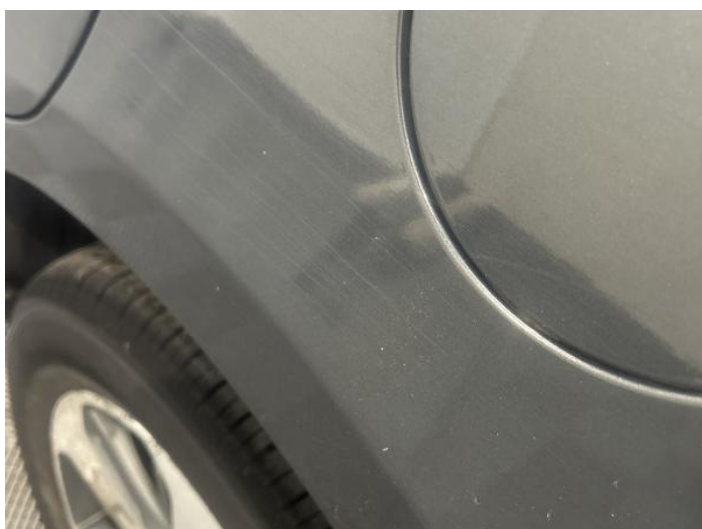
11: Qtr Panel nsr
Scratched
Over 25mm Not Thru Paint

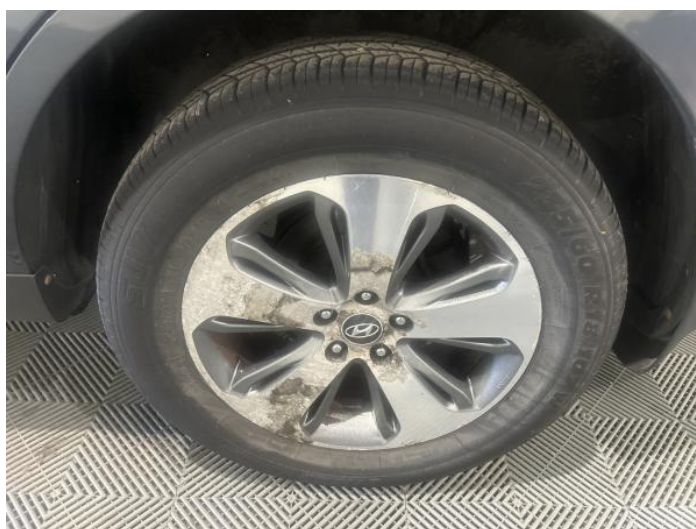
12: Wheel nsr
Corroded
Light

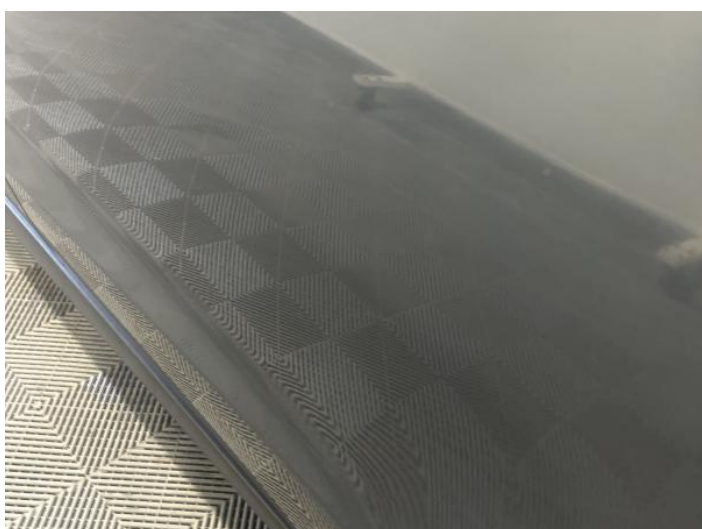
13: Door nsr
Scratched
Over 25mm Not Thru Paint

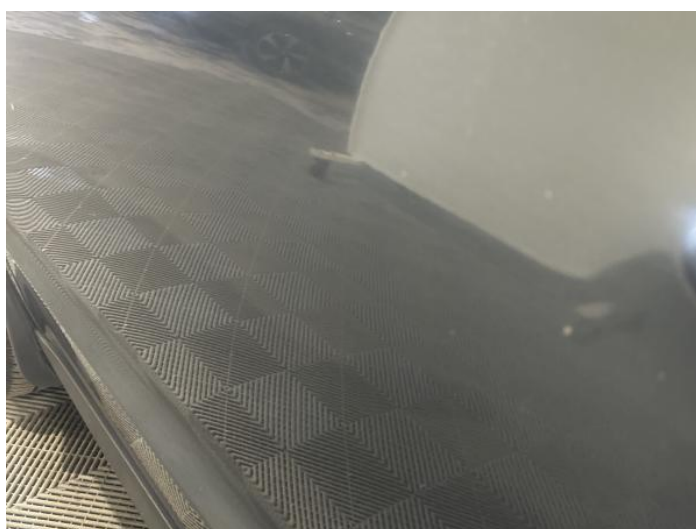
14: Door nsf
Scratched
Over 25mm Not Thru Paint

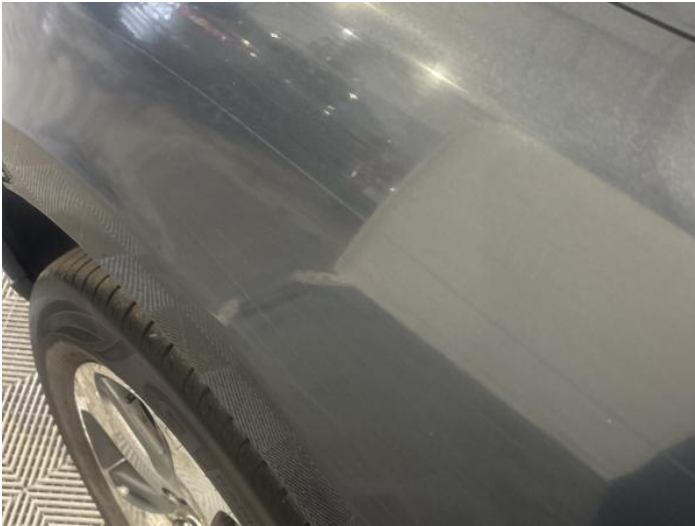
15: Wing nsf
Scratched
Over 25mm Not Thru Paint

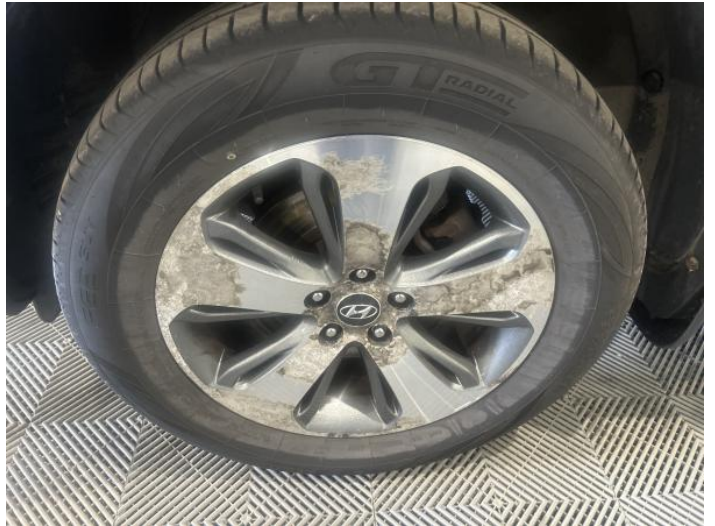
16: Wheel nsf
Corroded
Light

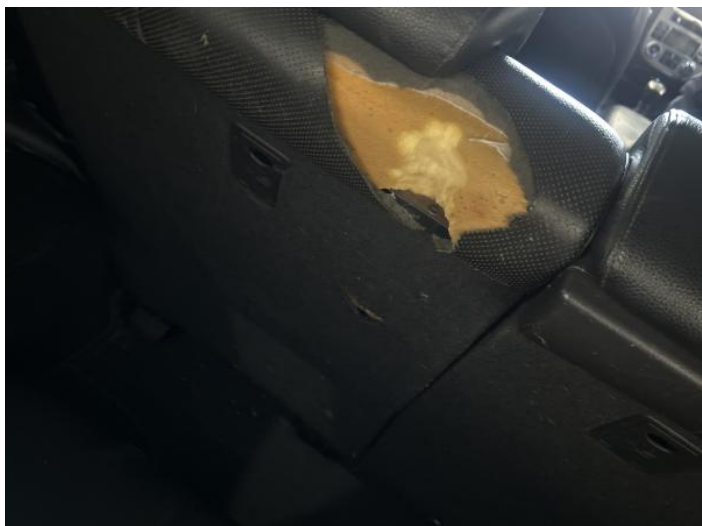
21: Seat Back Cover nsr
Holed
Over 3mm
