# VEHICLE INSPECTION REPORT

**SC64UYG**

## Dacia Duster 1.6 Access 5dr

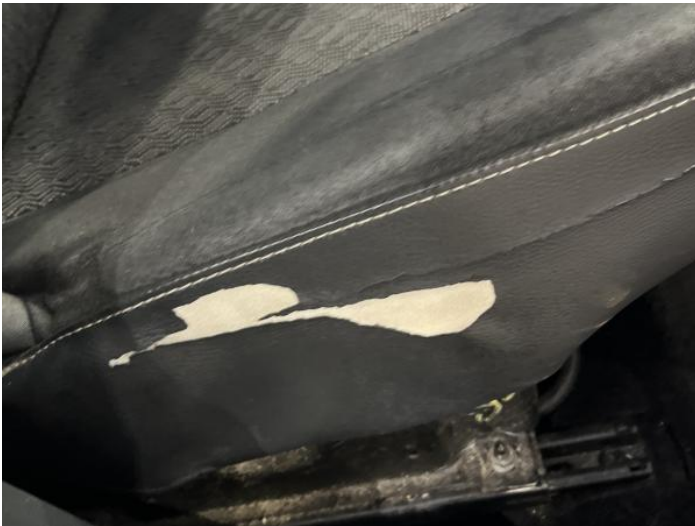
1: Seat Base Cover osf  
Scuffed  
Over 25mm

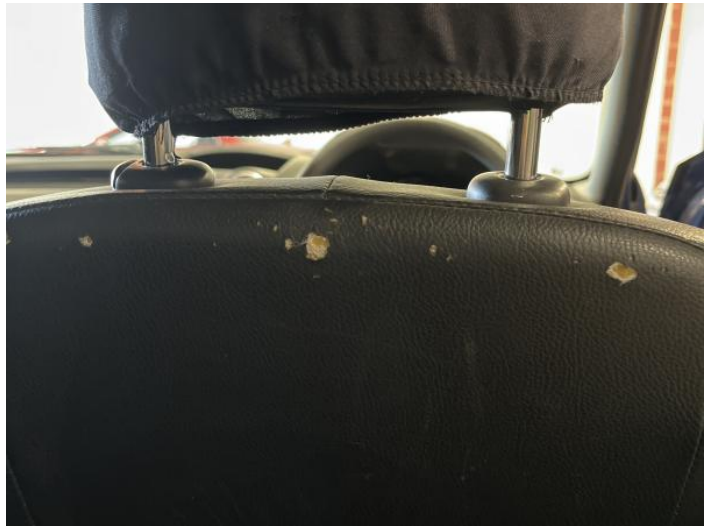
2: Seat Back Cover osf  
Scuffed  
UpTo 25mm

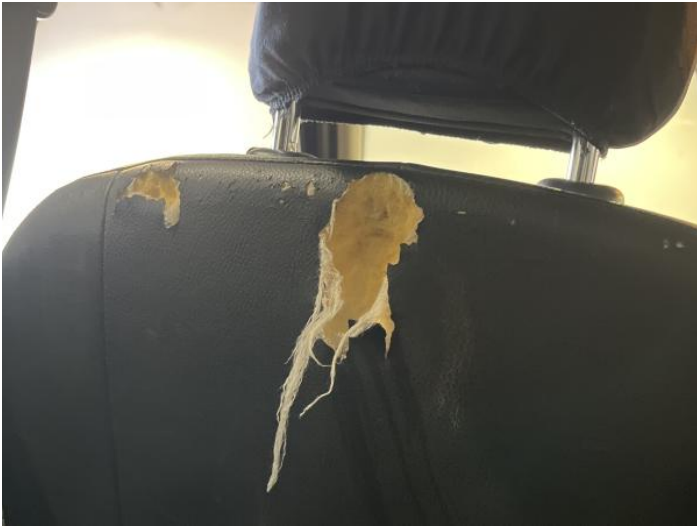
3: Seat Back Cover nsf  
Torn  
Over 3mm

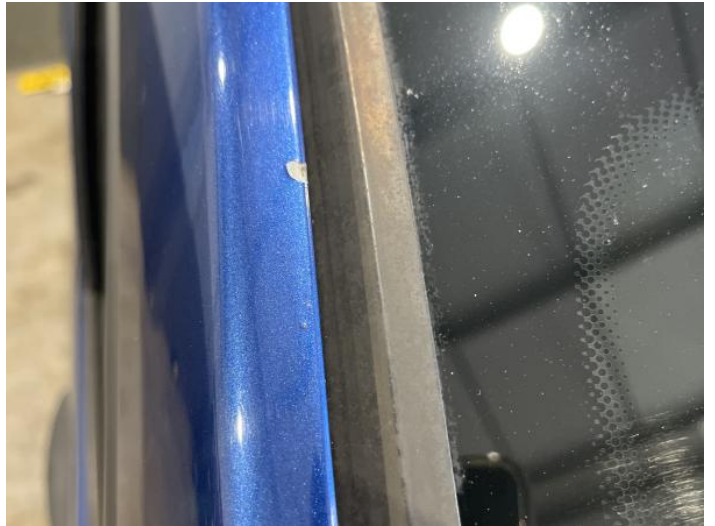
4: A Post os  
Chipped  
1 To 5

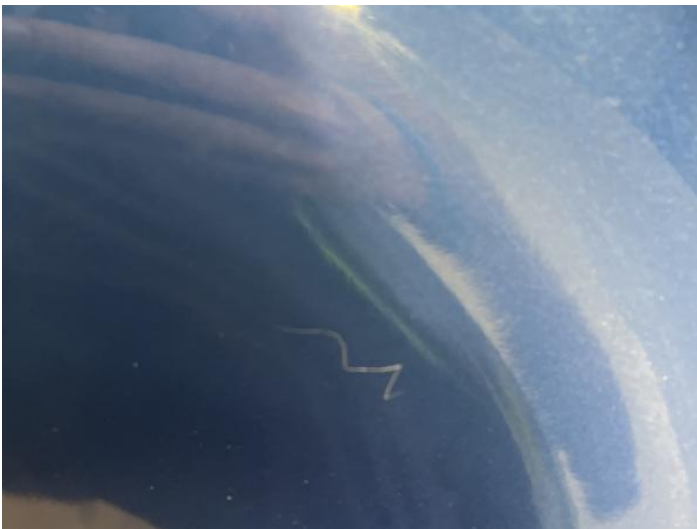
5: Wing osf  
Scratched  
Over 25mm Thru Paint

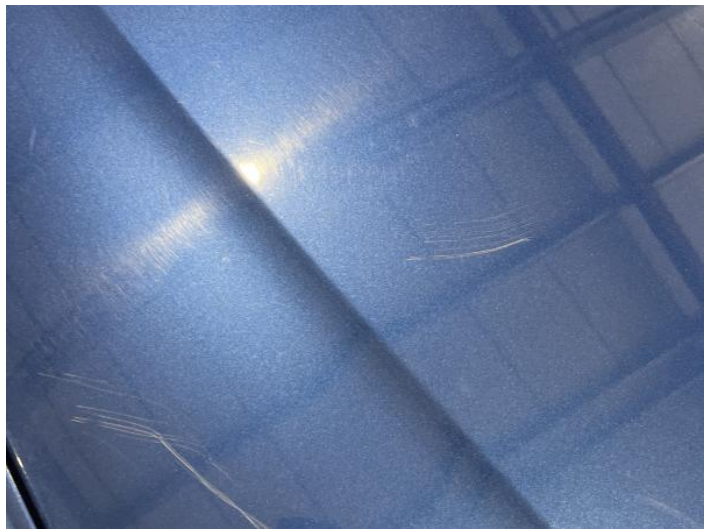
6: Bonnet  
Scratched  
Over 25mm Thru Paint

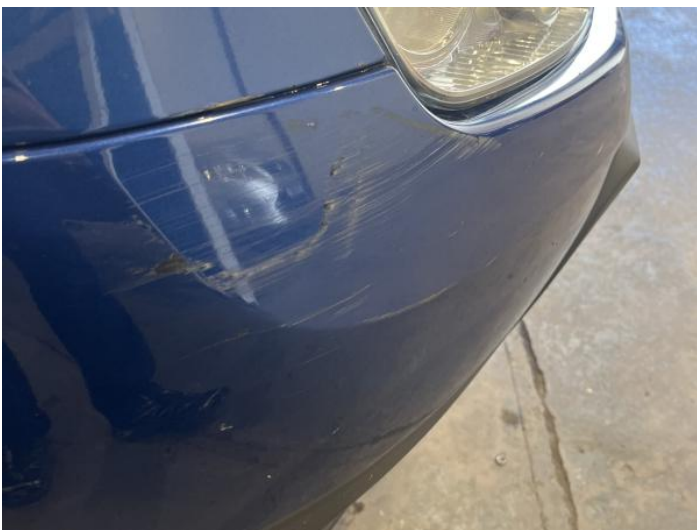
7: Bumper Front  
Scratched  
Over 100mm Thru Paint

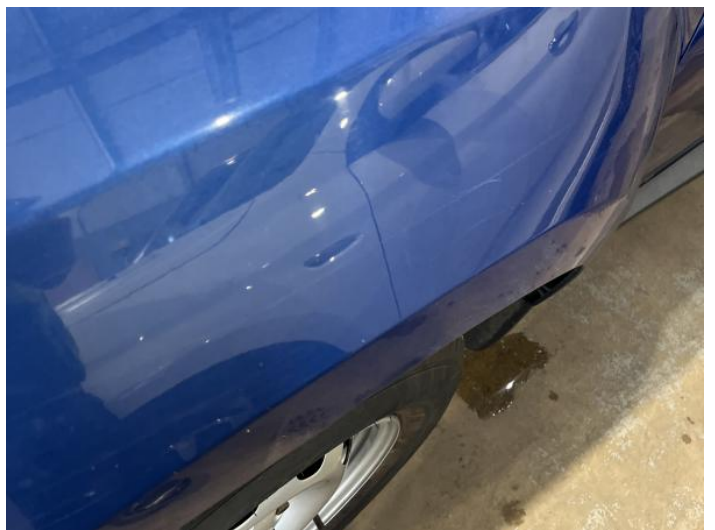
8: Wing nsf  
Scratched  
Over 25mm Thru Paint

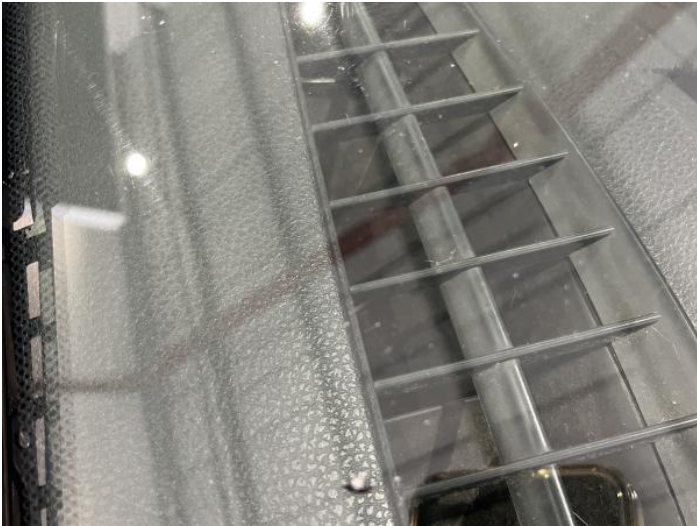
9: Screen Front  
Chipped  
Over 10mm

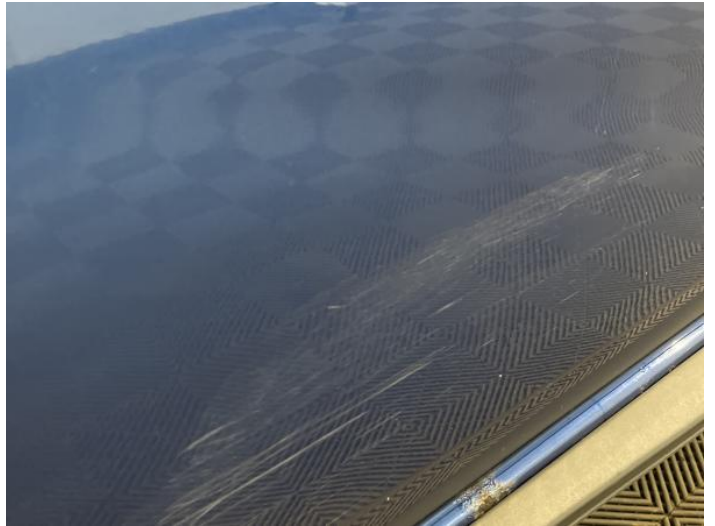
10: Door nsf  
Scratched  
Over 25mm Thru Paint

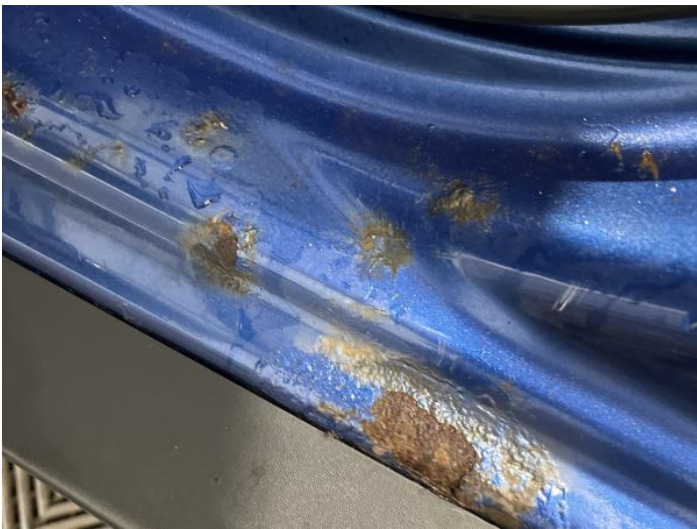
11: Sill ns  
Rusted  
Over 5mm

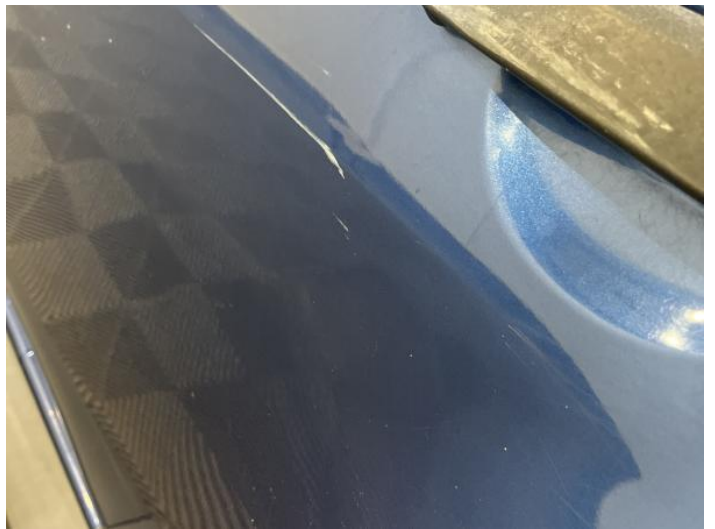
12: Door nsr  
Scratched  
Over 25mm Thru Paint

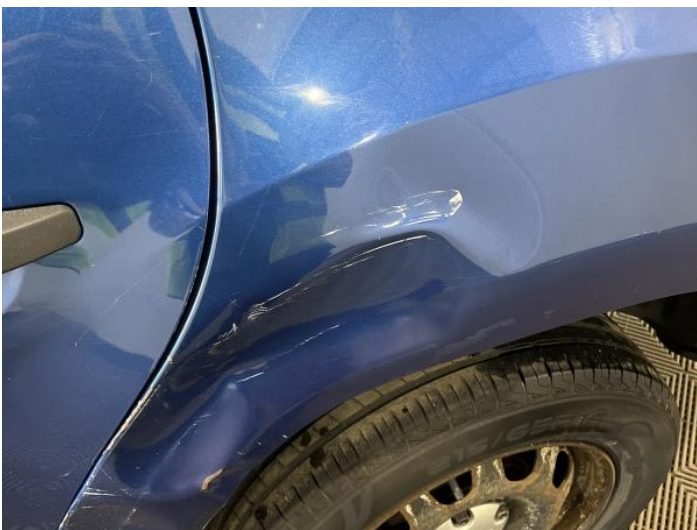
13: Qtr Panel nsr  
Dented  
With Paint Damage

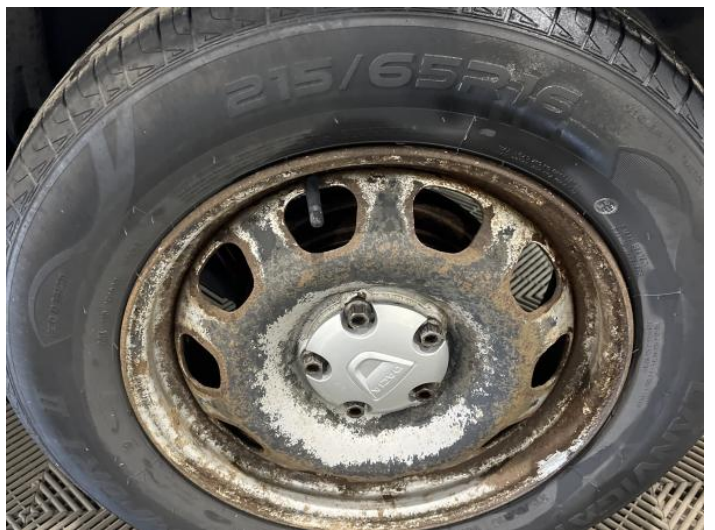
14: Wheel nsr  
Corroded  
Light

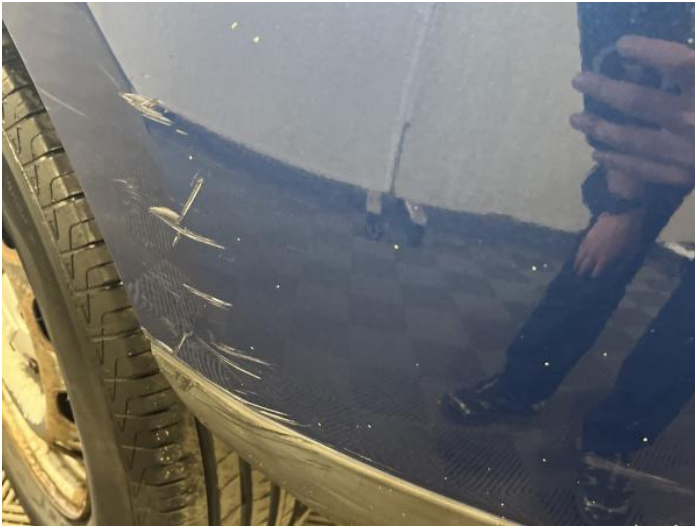
15: Bumper Rear  
Scratched  
Over 100mm Thru Paint

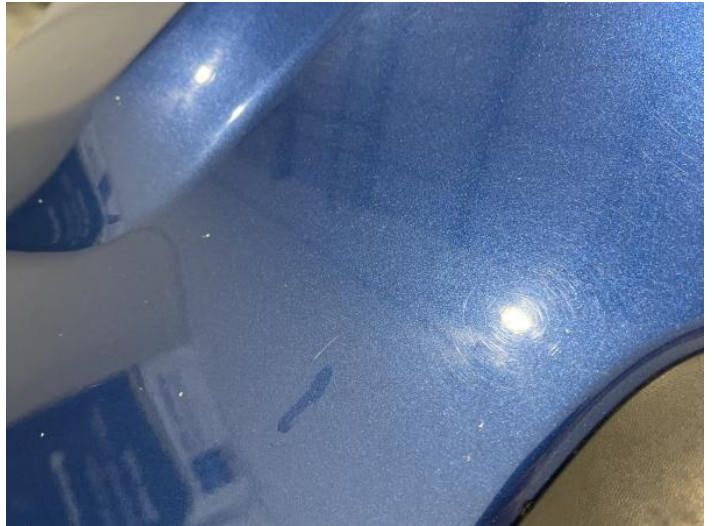
16: Tailgate  
Scratched  
UpTo 25mm Thru Paint

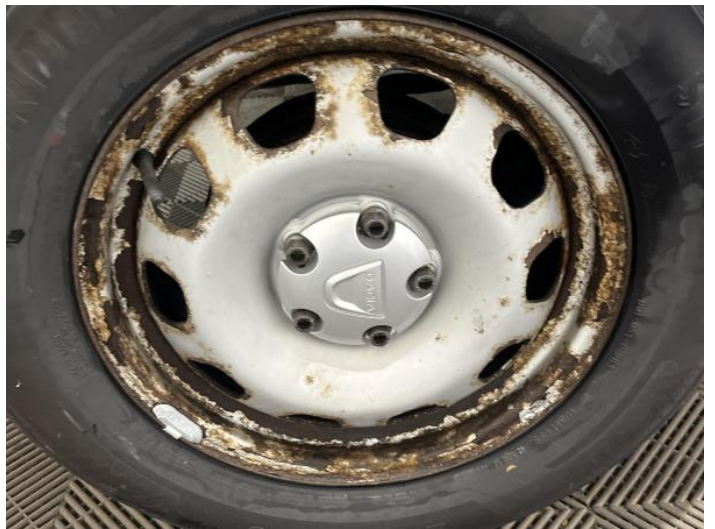
18: Wheel osr  
Corroded  
Light

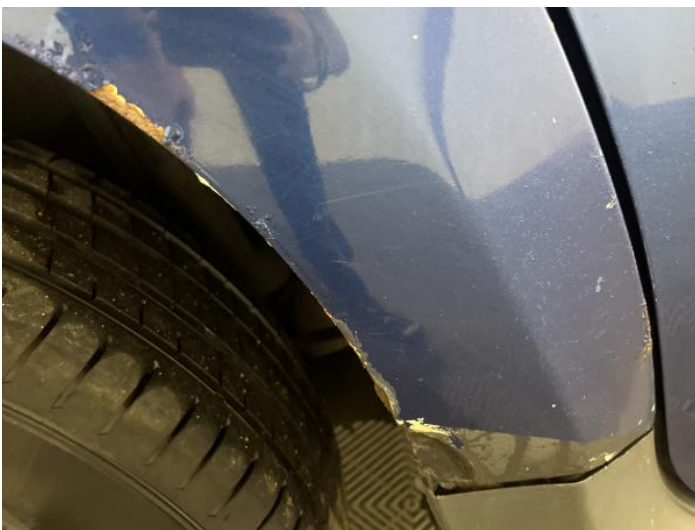
19: Qtr Panel osr  
Rusted  
Holed

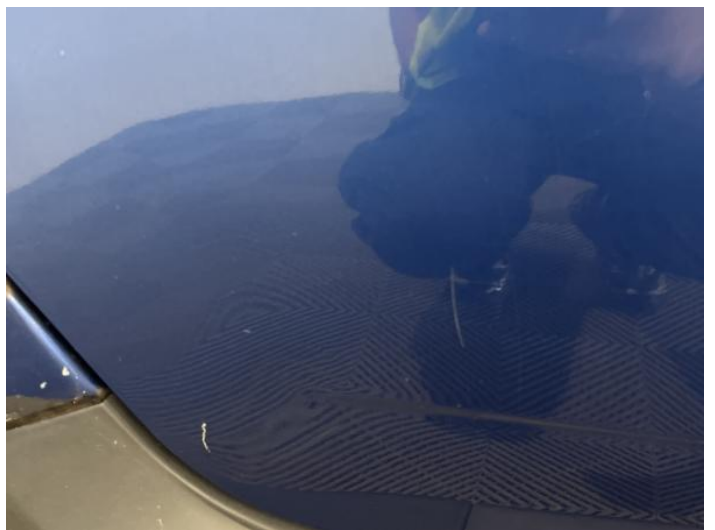
20: Door osr  
Scratched  
Over 25mm Thru Paint

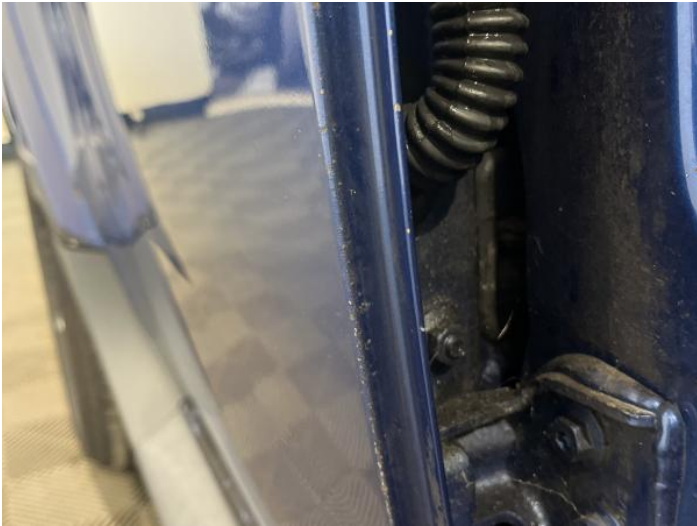
21: Door osr  
Rusted  
Over 5mm

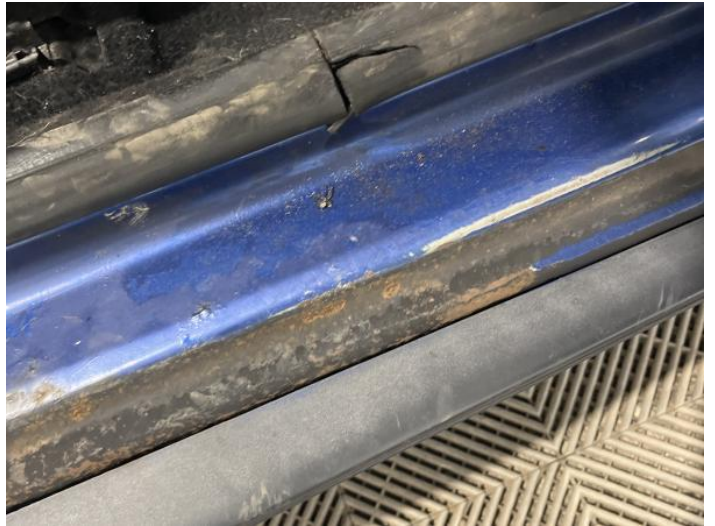
22: Sill os  
Rusted  
Over 5mm

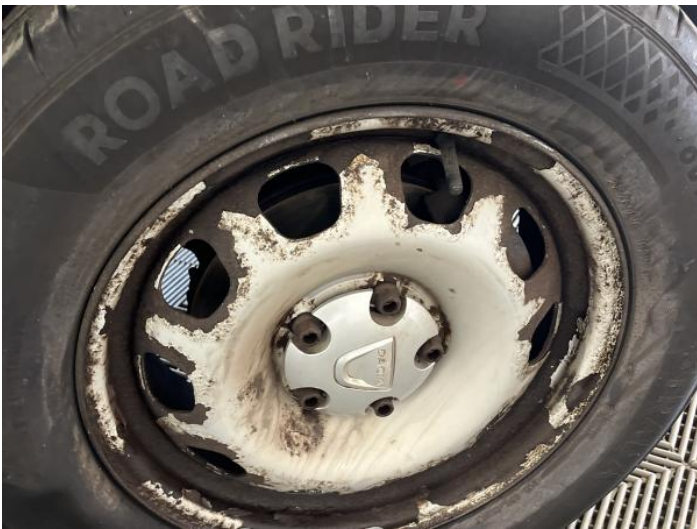
23: Wheel osf  
Corroded  
Light

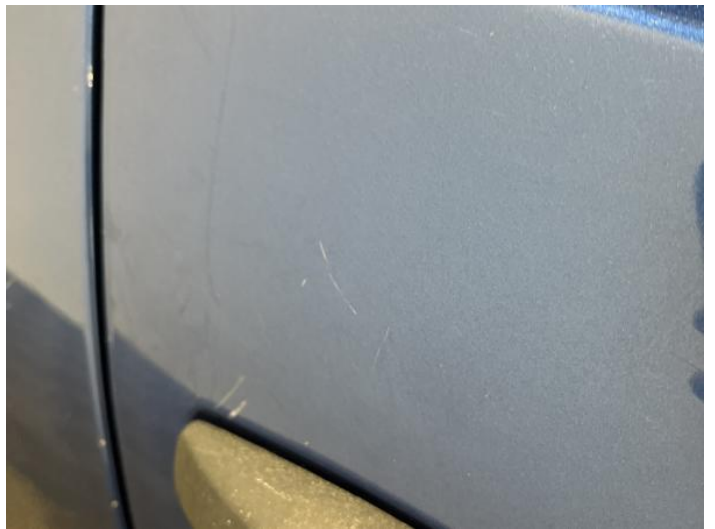
24: Door osf  
Scratched  
Over 25mm Thru Paint

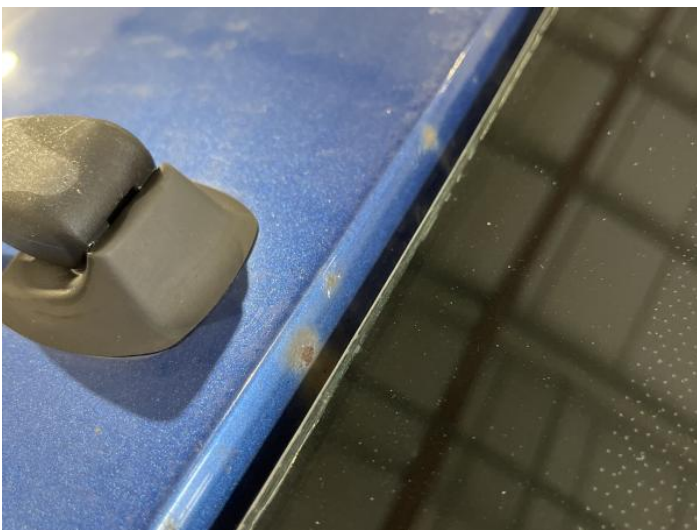
25: Roof  
Rusted  
Over 5mm

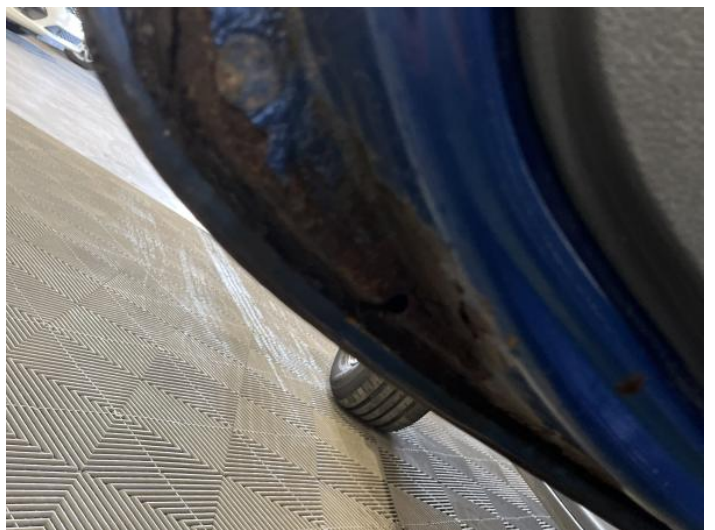
26: Door nsr  
Rusted  
Over 5mm

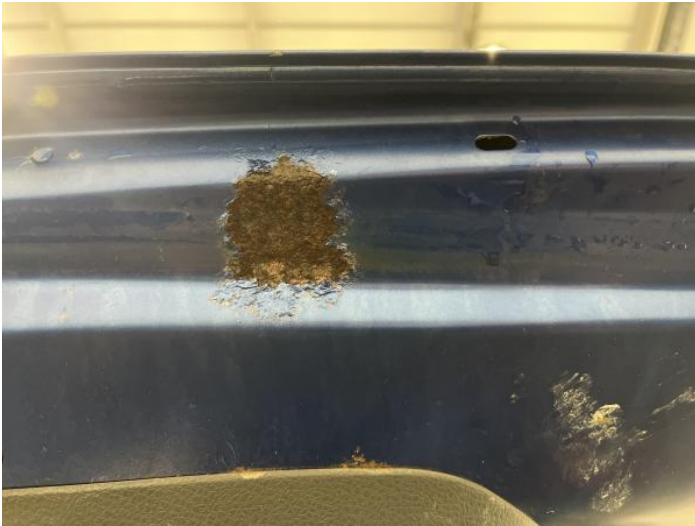
27: Tailgate  
Rusted  
Over 5mm
