# VEHICLE INSPECTION REPORT

**GV67PUF**

## Suzuki Sx4 S-Cross 1.4 Boosterjet SZ5 ALLGRIP 5dr Auto

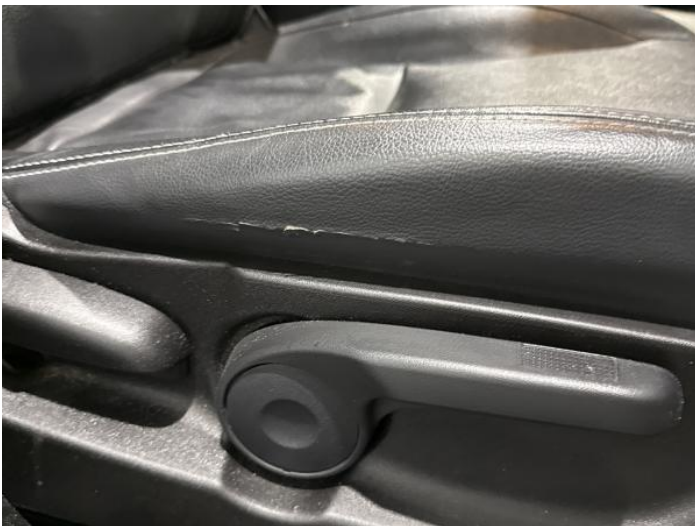
1: Seat Base Cover osf  
Scuffed  
Over 25mm

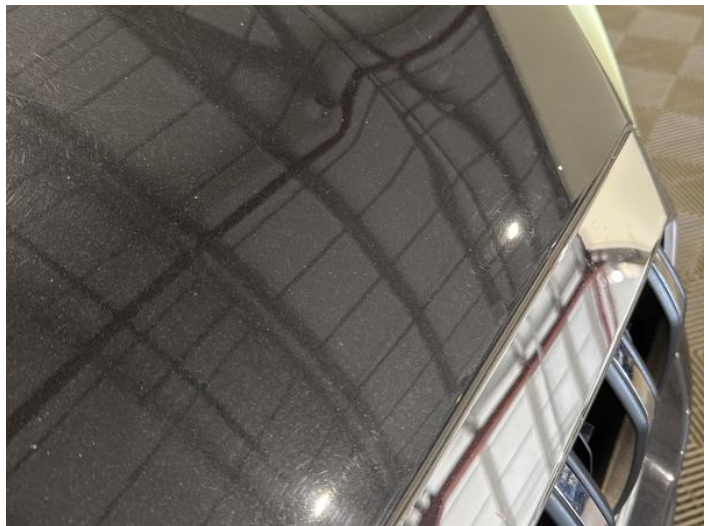
2: Bonnet  
Chipped  
Multiple Chips

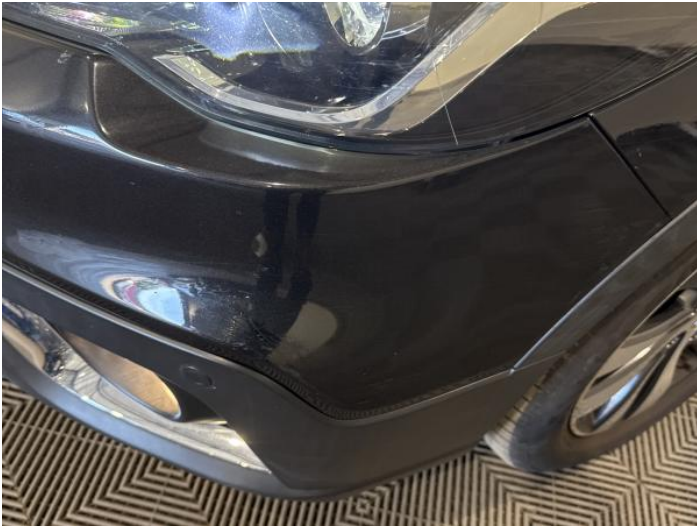
3: Bumper Front  
Scratched  
Over 100mm Thru Paint

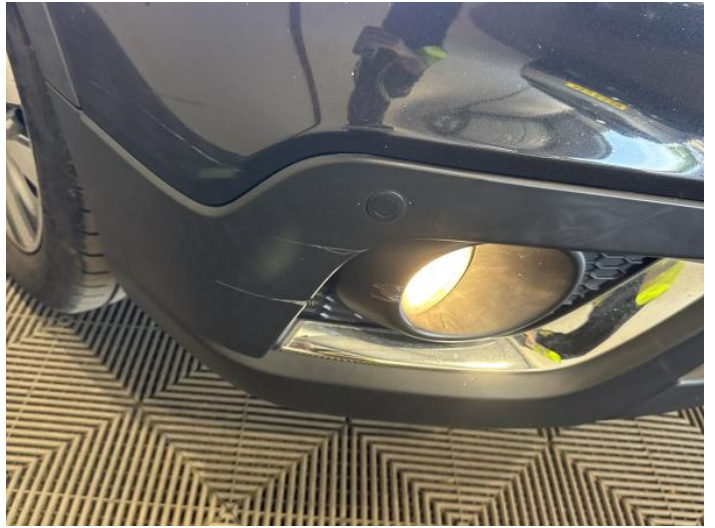
4: Bumper Front Moulding  
Scuffed (Unpainted)  
Over 100mm

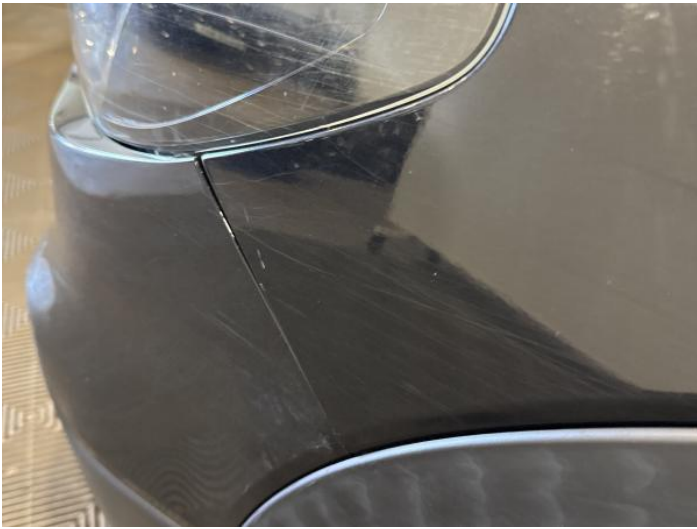
5: Wing nsf  
Scratched  
Up To 25mm Thru Paint

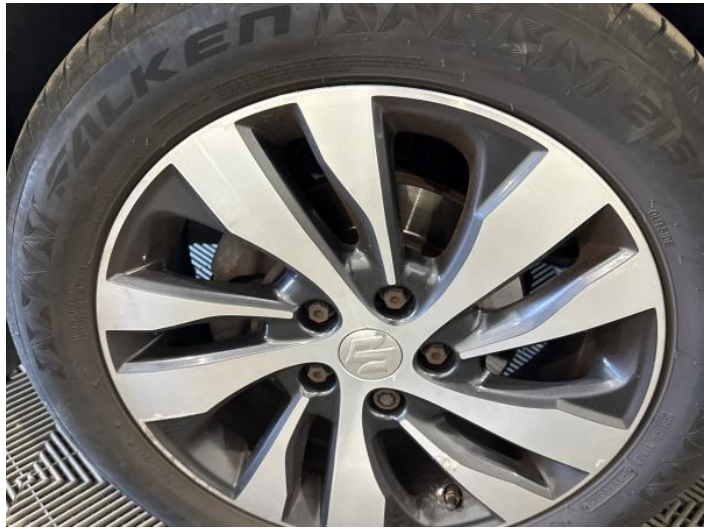
6: Wheel nsf  
Scratched  
Up To 50mm

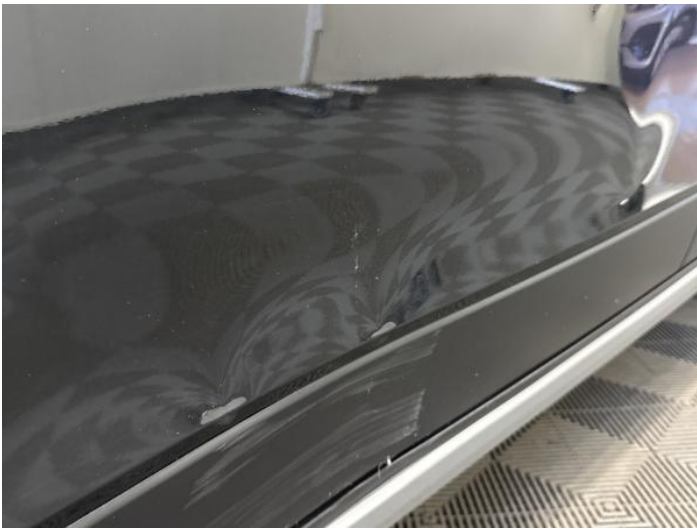
7: Door nsf  
Dented  
Over 30mm

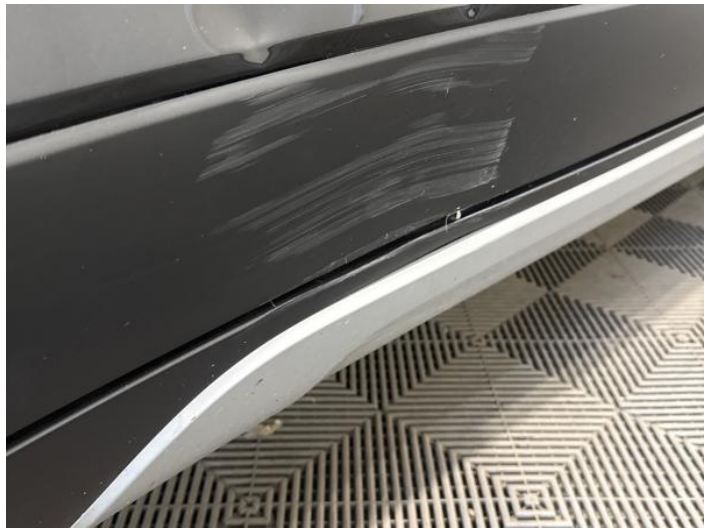
8: Door Moulding nsf  
Scuffed (Unpainted)  
Over 100mm

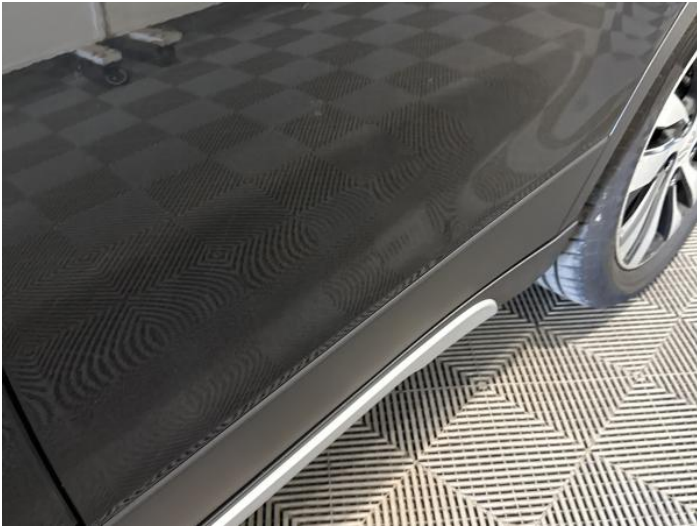
9: Door nsr  
Dented  
With Paint Damage

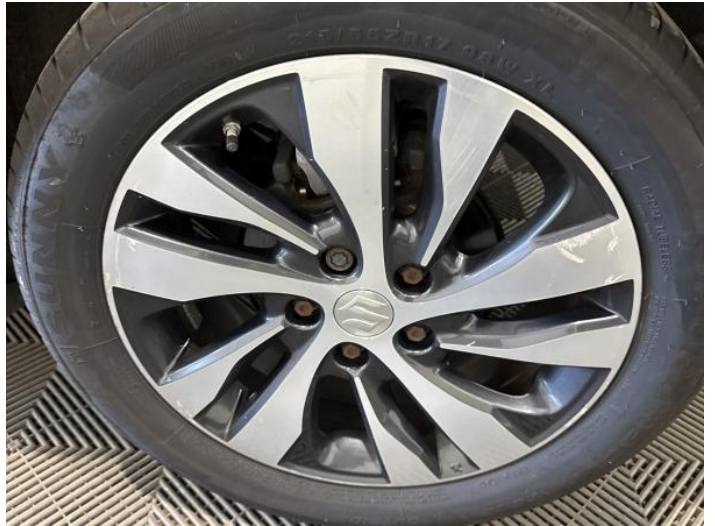
10: Wheel nsr  
Scratched  
Over 50mm

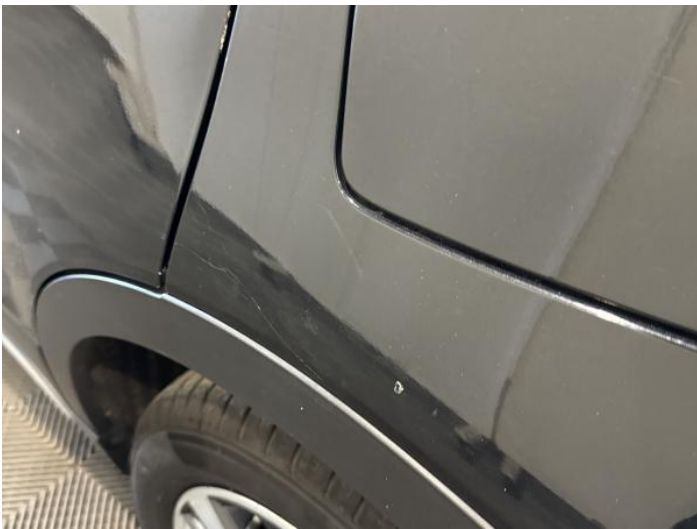
11: Qtr Panel nsr  
Dented  
With Paint Damage

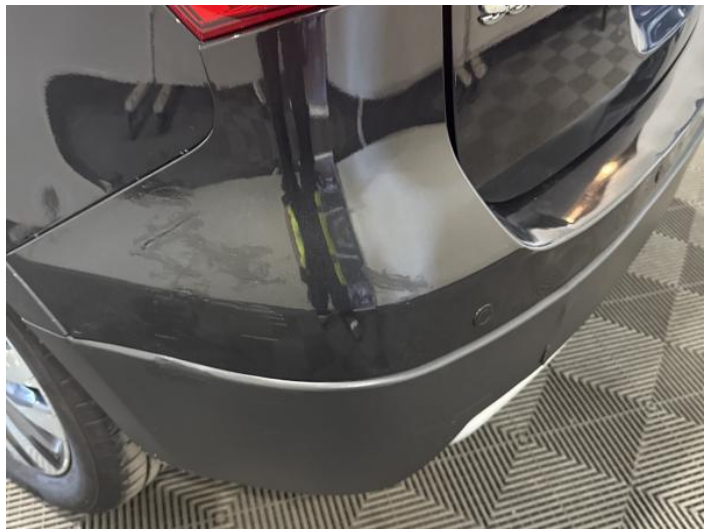
12: Bumper Rear  
Dented  
With Paint Damage

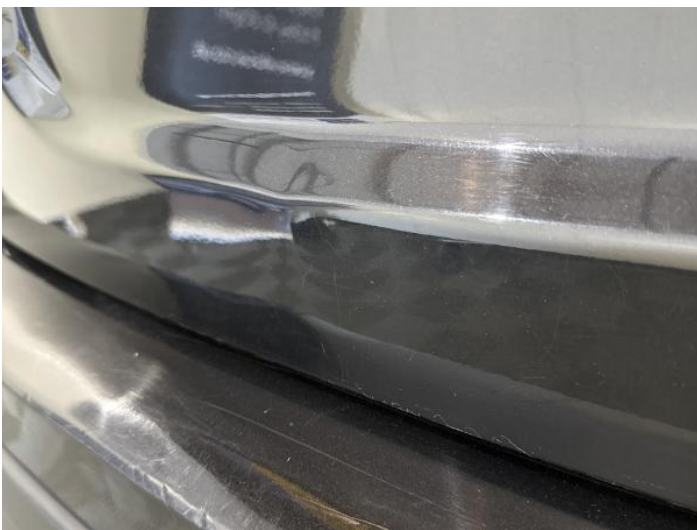
13: Tailgate  
Dented  
Over 30mm

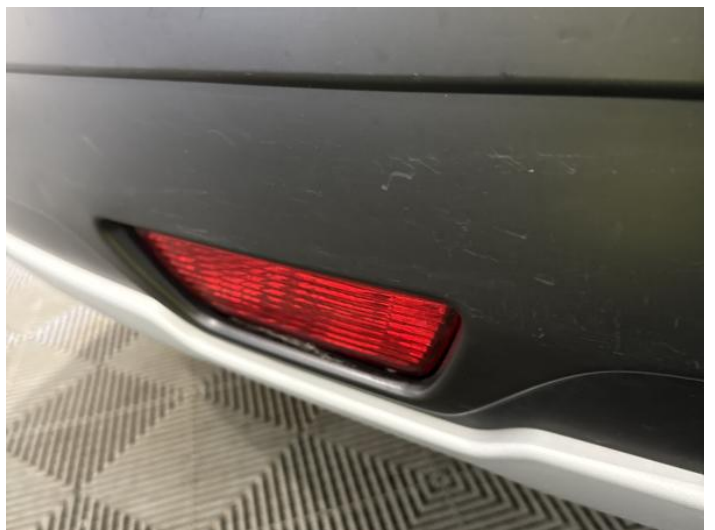
14: Bumper Rear Moulding  
Scuffed (Unpainted)  
Over 100mm

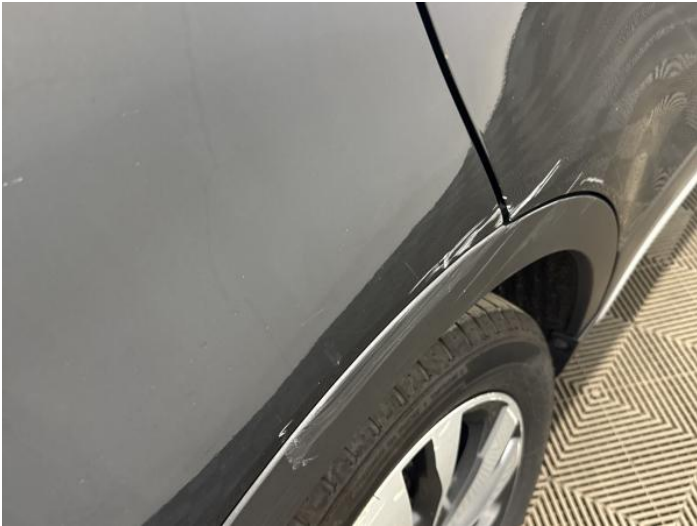
15: Qtr Panel osr  
Dented  
With Paint Damage

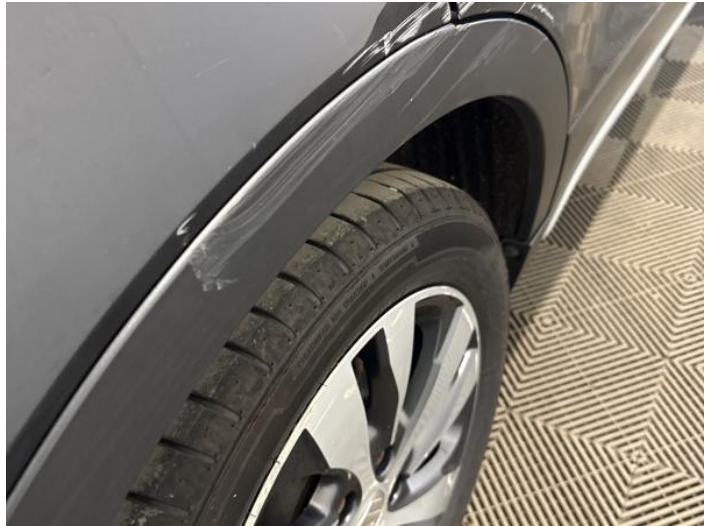
16: Qtr Panel Arch Extension os  
Scuffed (Unpainted)  
Over 100mm

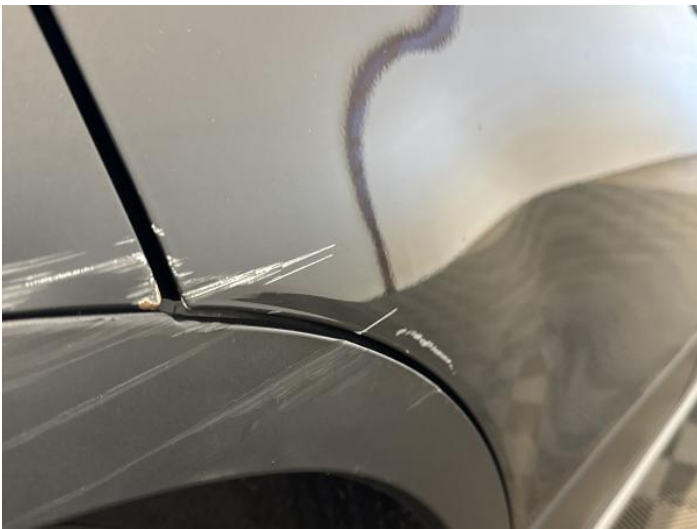
17: Door osr  
Dented  
With Paint Damage

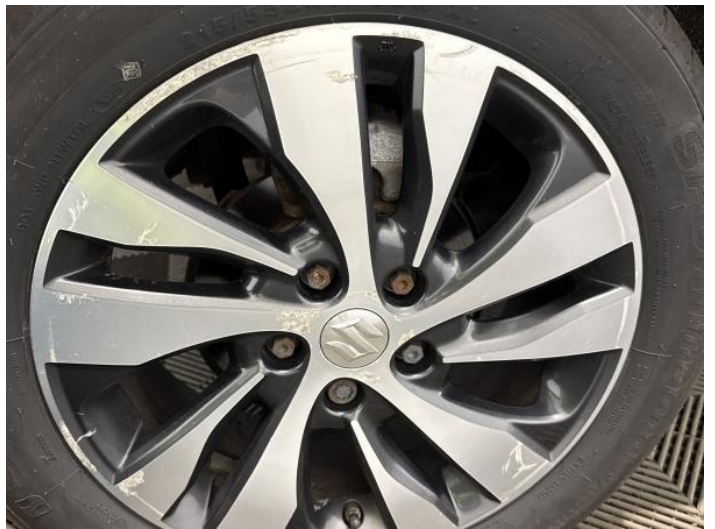
18: Wheel osr  
Scratched  
Over 50mm

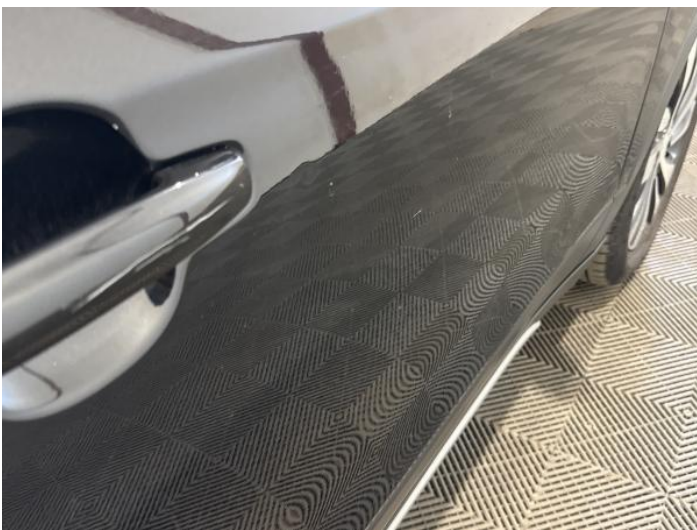
19: Door osf  
Dented  
Over 30mm

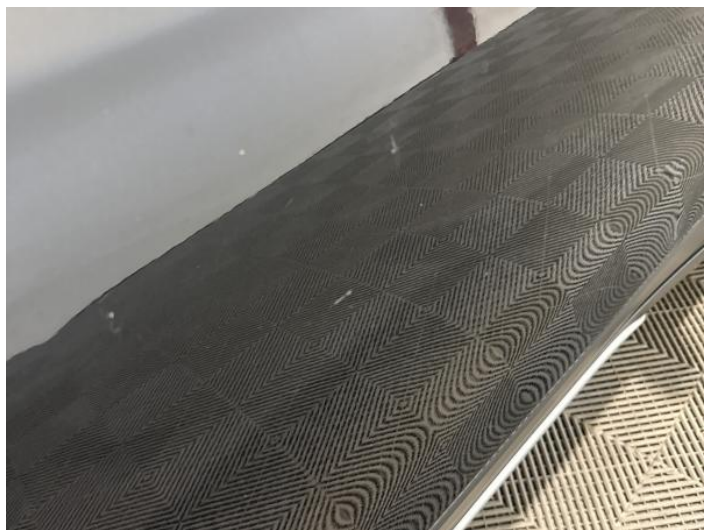
20: Door osf  
Scratched  
UpTo 25mm Thru Paint

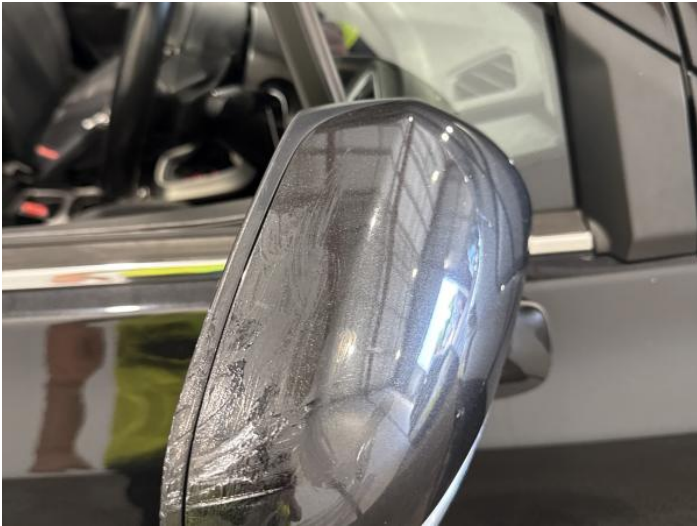
21: Door Mirror Assy osf  
Scratched (Painted)  
Over 25mm Thru Paint

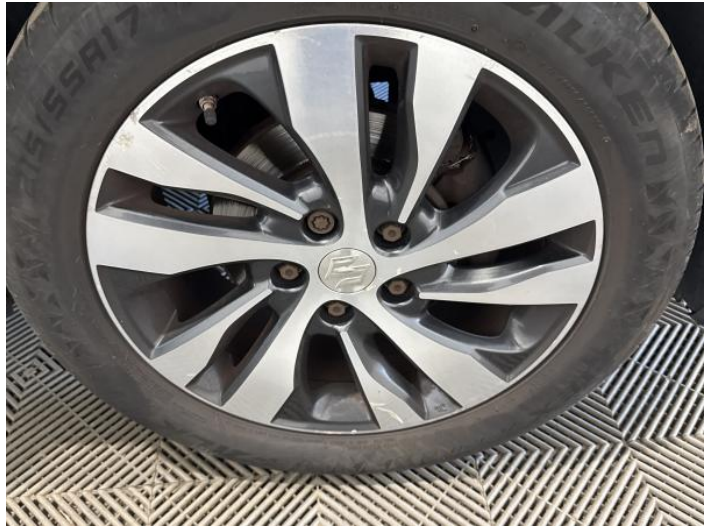
22: Wheel osf  
Scratched  
Over 50mm

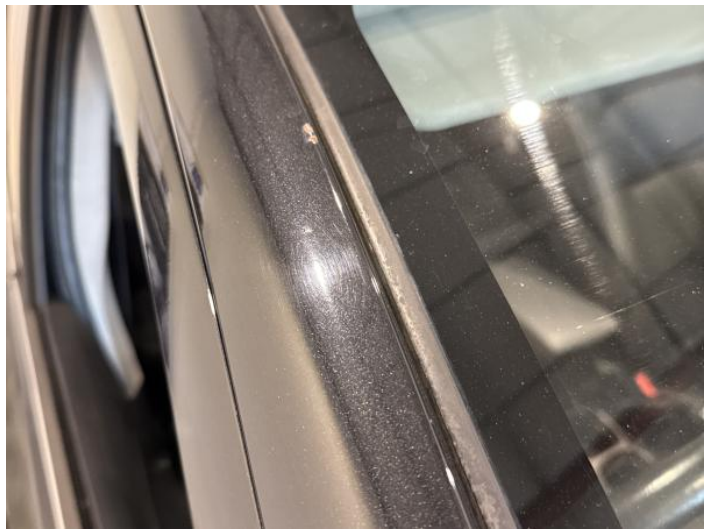
24: A Post os  
Chipped  
1 To 5

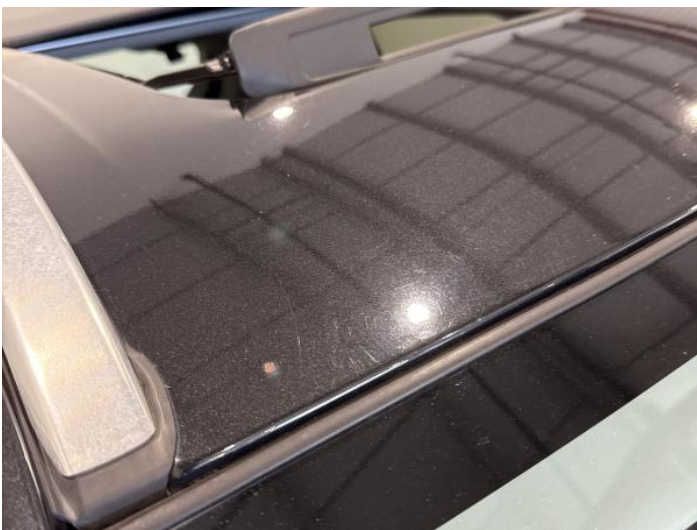
25: Roof  
Chipped  
1 To 5
