VEHICLE INSPECTION REPORT

LB18SYR

Peugeot 208 1.6 THP GTi Prestige 3dr

nama
GRADE
4

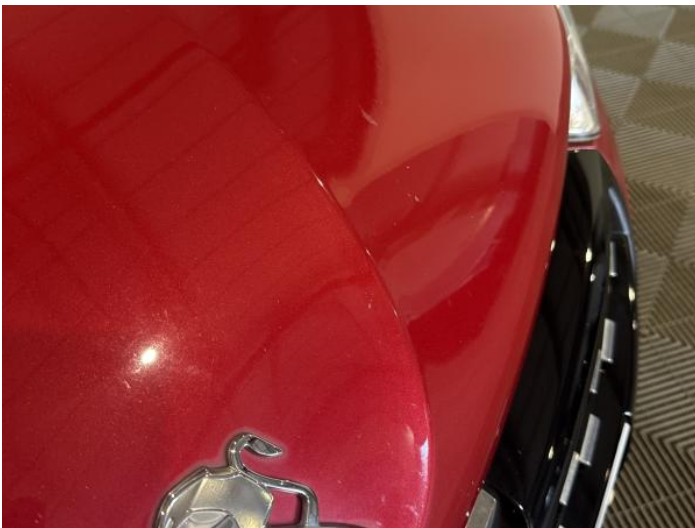
1: Bonnet
Chipped
Multiple Chips

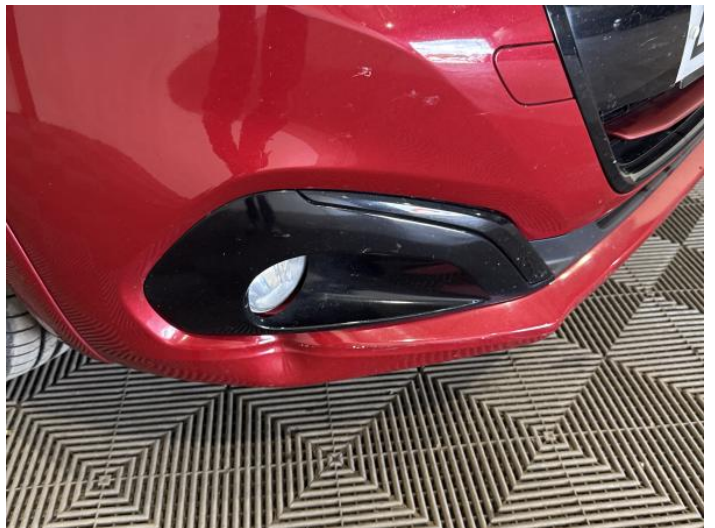
2: Bumper Front
Dented
With Paint Damage

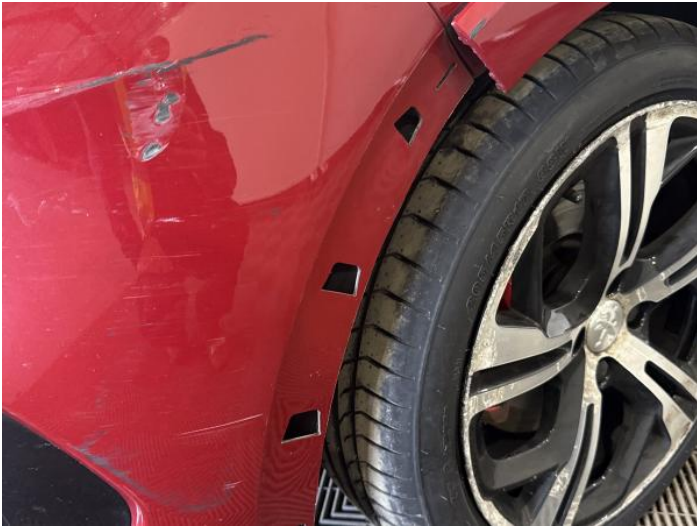
3: Bumper Front Moulding
Missing
Replace

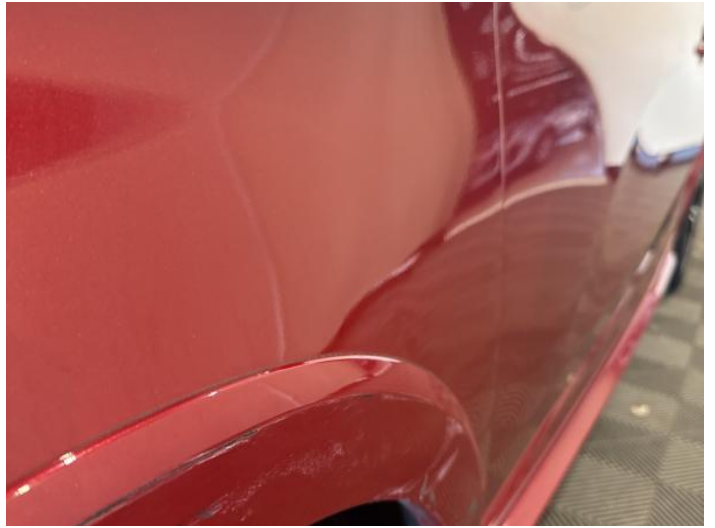
4: Wing nsf
Dented
Over 30mm

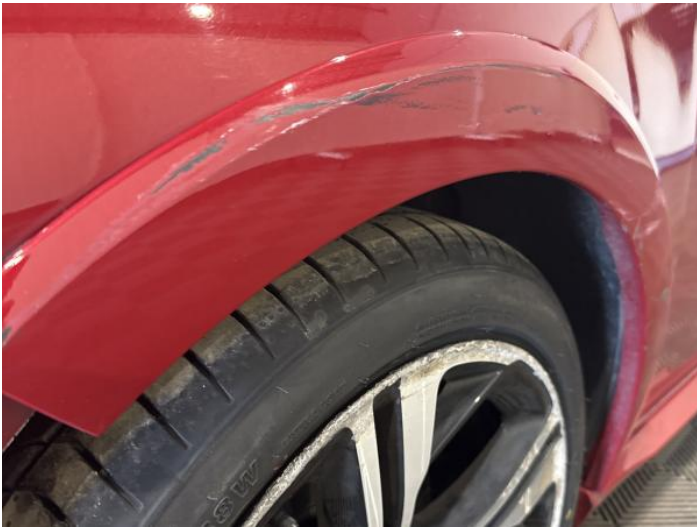
5: Wing Front Arch Extension ns
Scratched (Painted)
Over 25mm Thru Paint

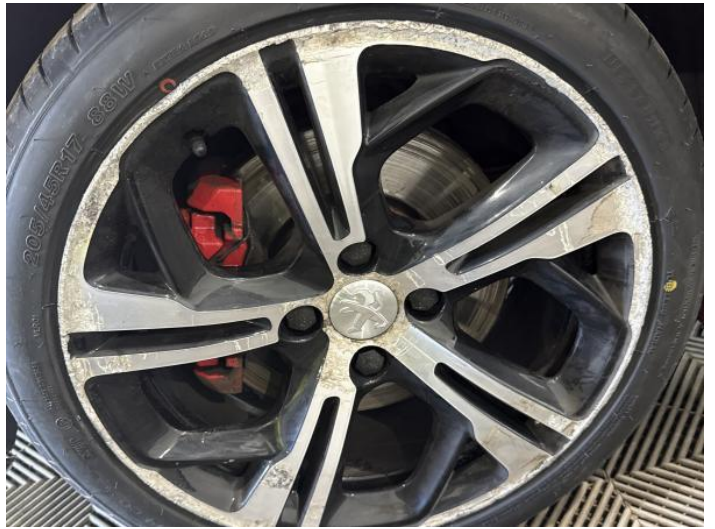
6: Wheel nsf
Scratched
Over 50mm

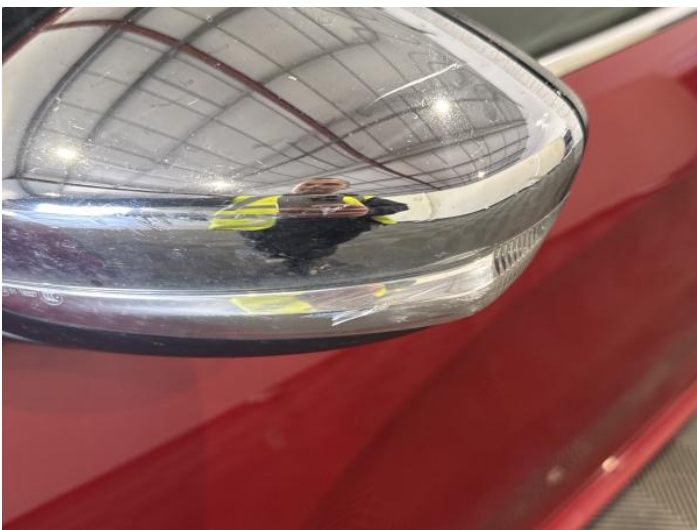
7: Flasher Side Repeater ns
Broken
Replace

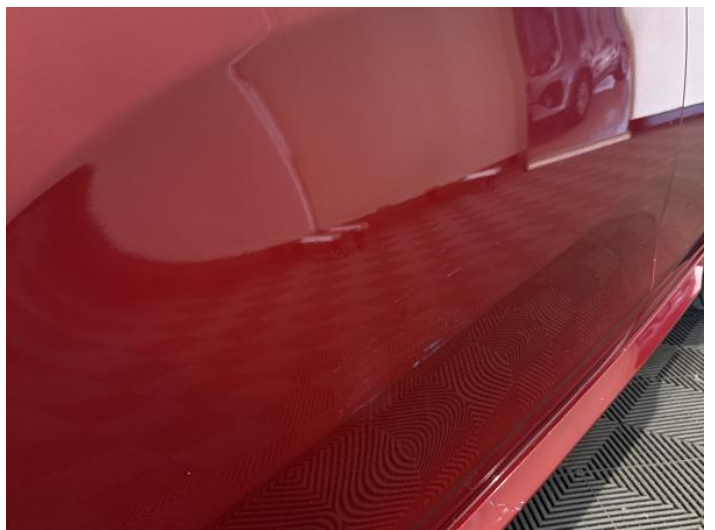
8: Door nsf
Dented
With Paint Damage

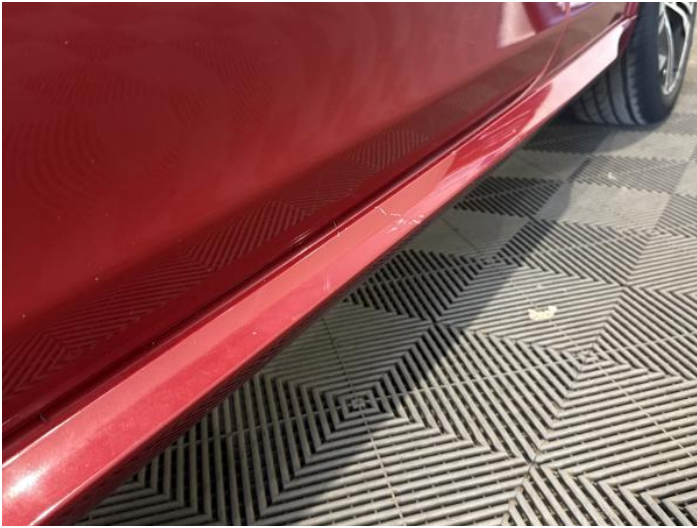
9: Sill Panel Trim ns
Scratched (Painted)
Over 25mm Thru Paint

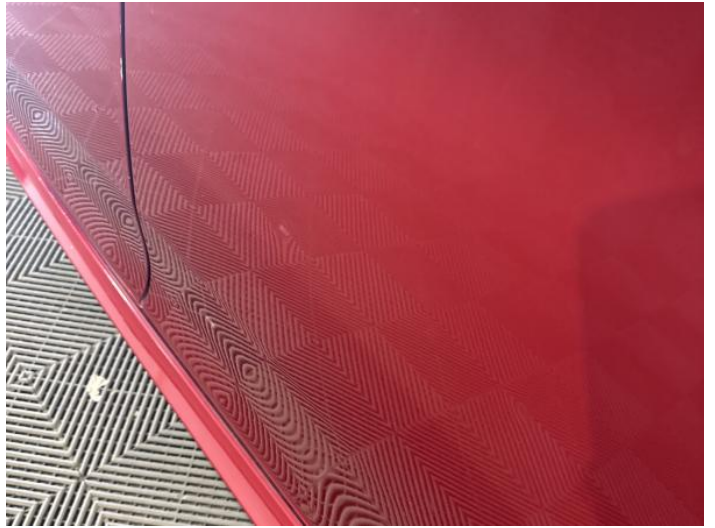
10: Qtr Panel nsr
Dented
Between 10mm + 30mm

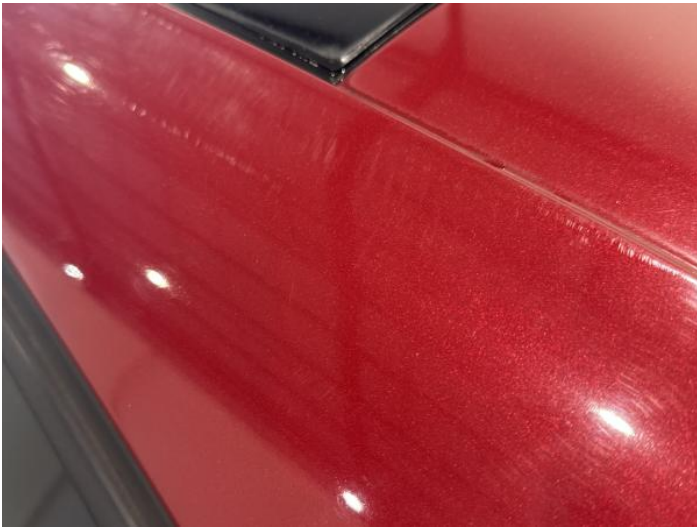
11: Qtr Panel nsr
Scratched
Over 25mm Thru Paint

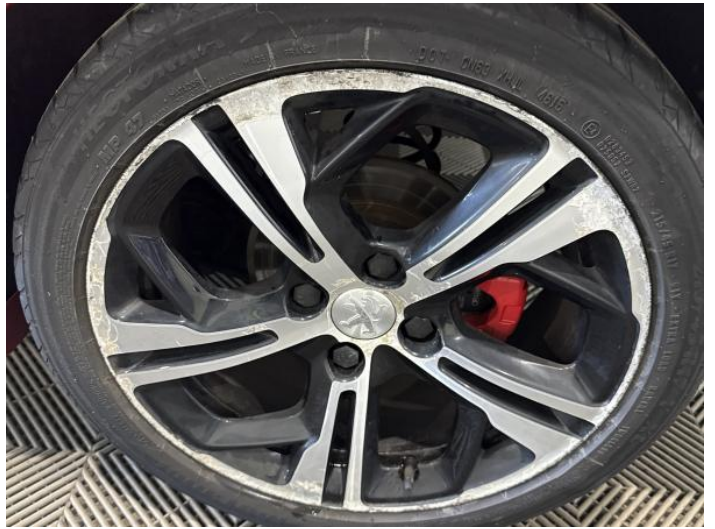
12: Wheel nsr
Scratched
Over 50mm

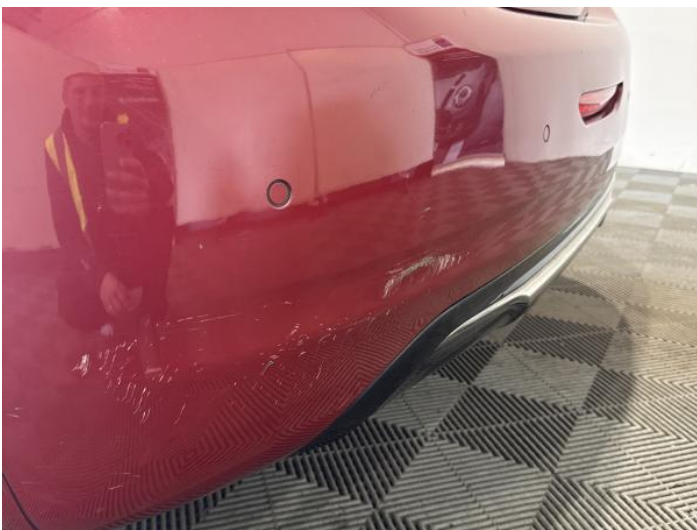
13: Bumper Rear
Scratched
Over 100mm Thru Paint

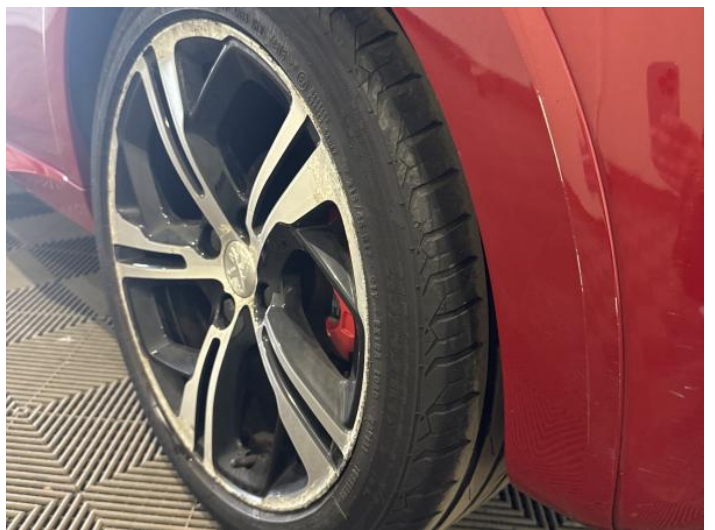
14: Bumper Rear Moulding
Scratched (Painted)
Over 25mm Thru Paint

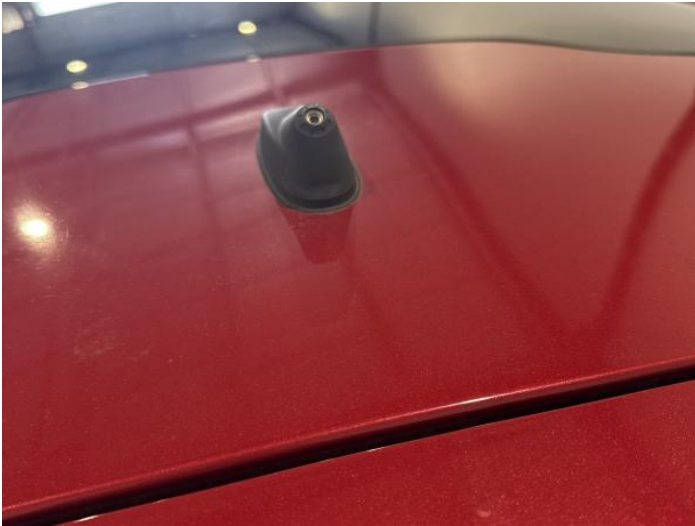
15: Aerial
Missing
Replace

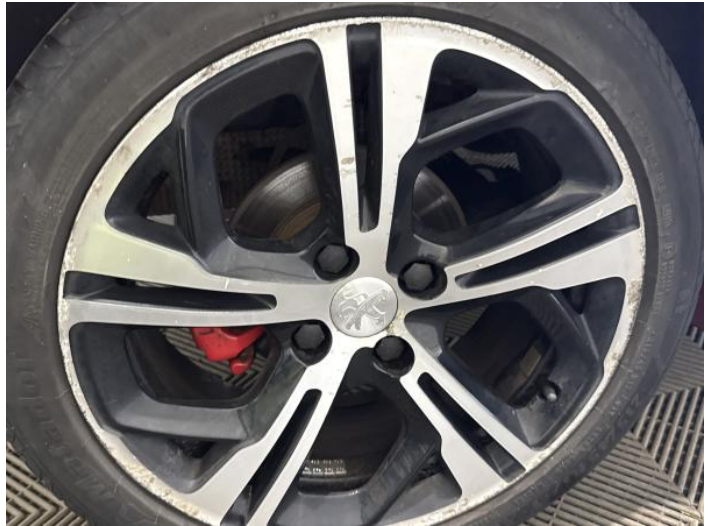
16: Wheel osr
Scratched
Over 50mm

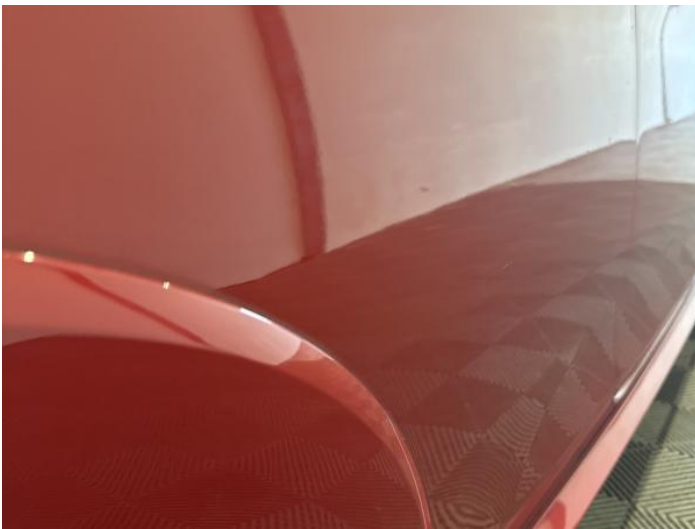
17: Qtr Panel osr
Dented
Between 10mm + 30mm

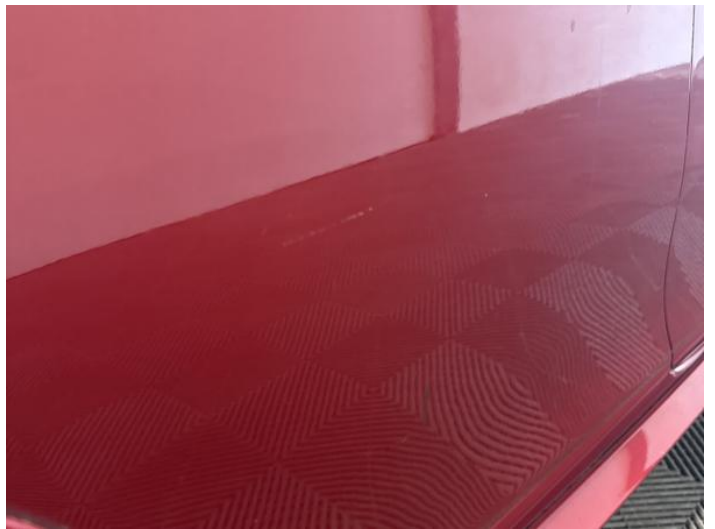
18: Qtr Panel osr
Scratched
Over 25mm Thru Paint

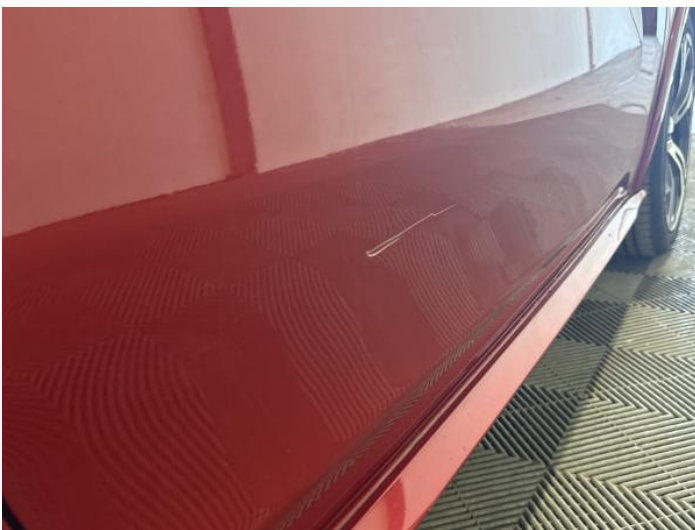
19: Door osf
Dented
With Paint Damage

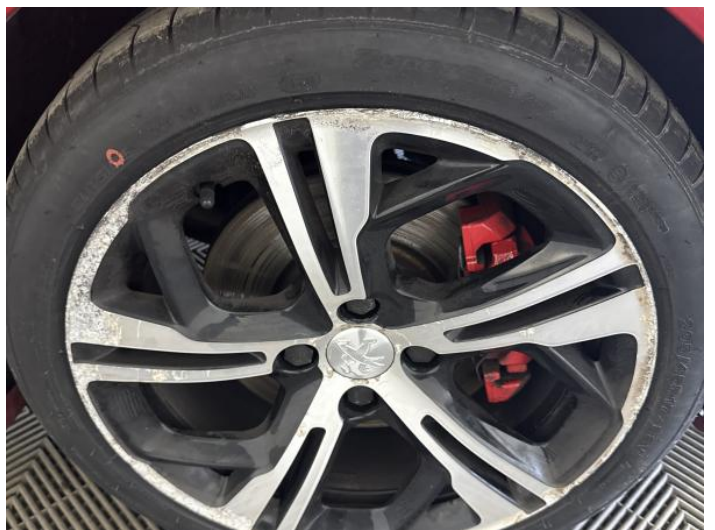
20: Wheel osf
Scratched
Over 50mm

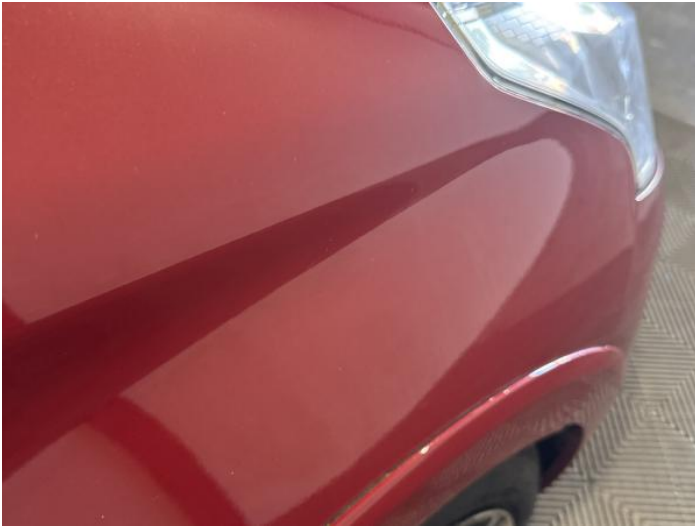
21: Wing osf
Dented
2 Or Less UpTo 10mm
