VEHICLE INSPECTION REPORT

LD65MLY

Ford C-Max 1.5 TDCi Titanium X 5dr

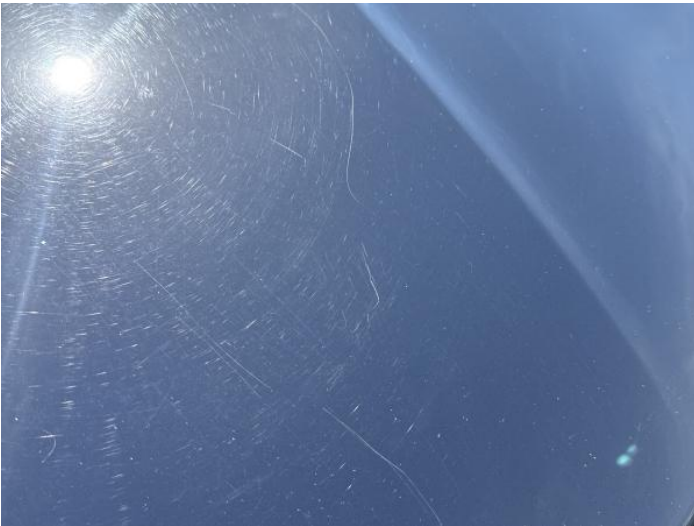
1: Bonnet
Chipped
Multiple Chips

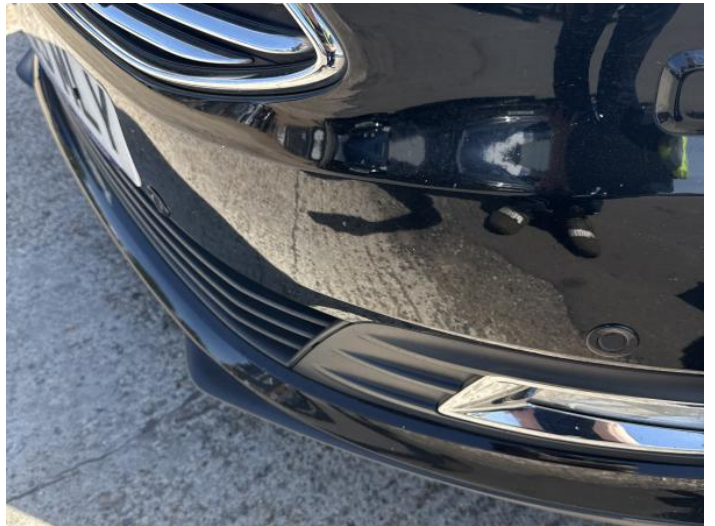
2: Bumper Front
Scratched
25 to 100mm Thru Paint

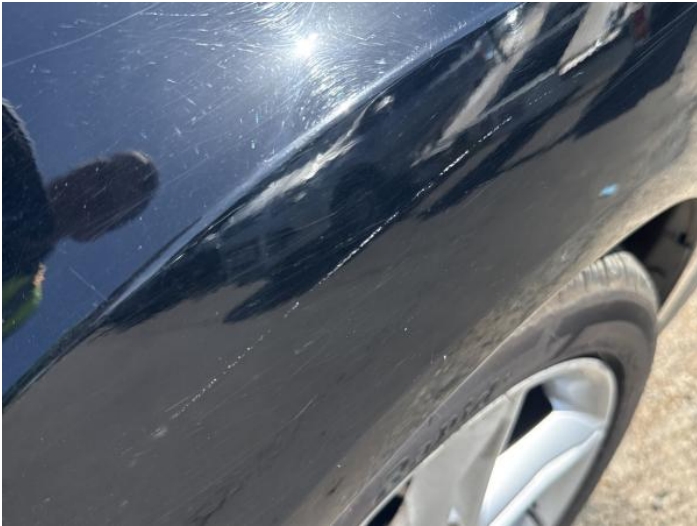
3: Wing nsf
Scratched
Over 25mm Thru Paint

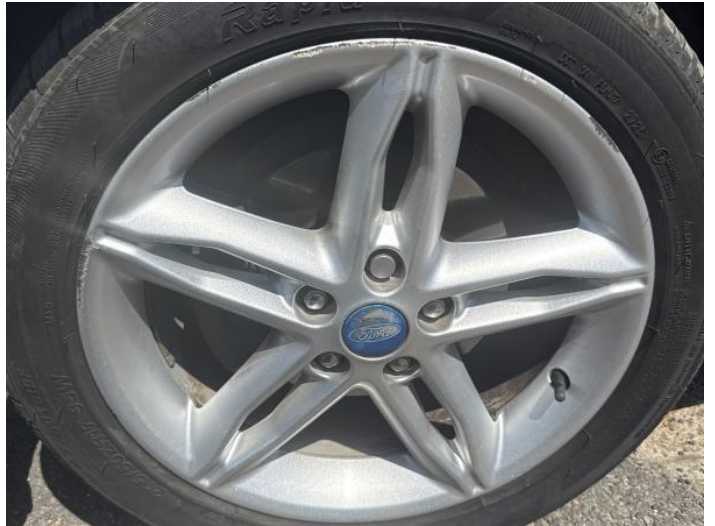
4: Wheel nsf
Scratched
Over 50mm

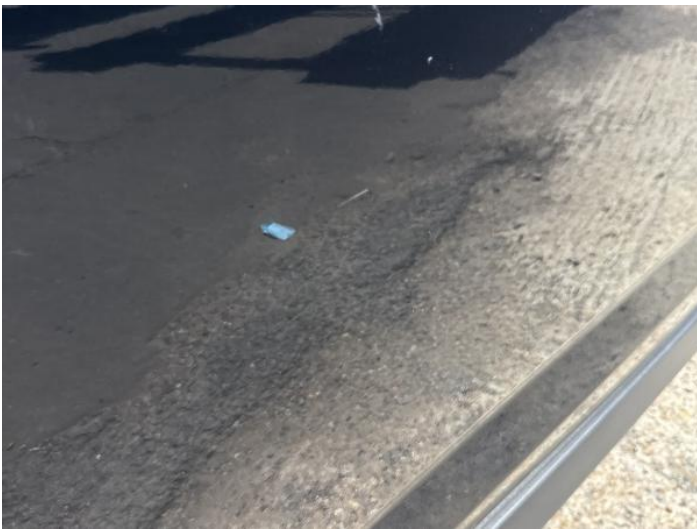
5: Door nsf
Scratched
Up To 25mm Thru Paint

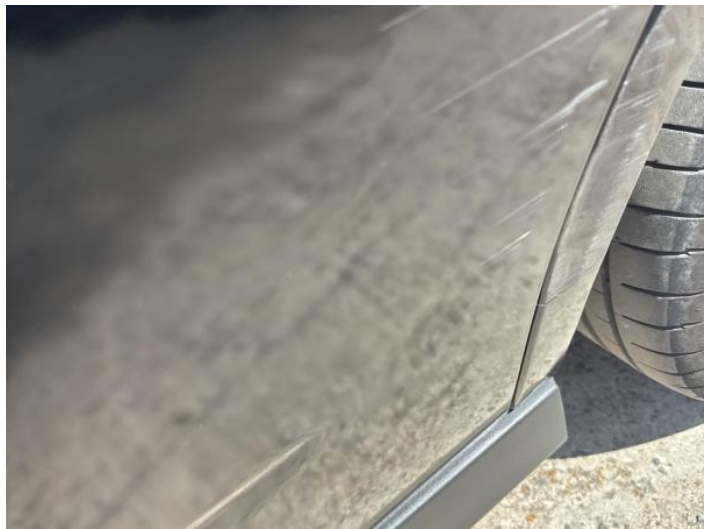
6: Door nsr
Scratched
Over 25mm Thru Paint

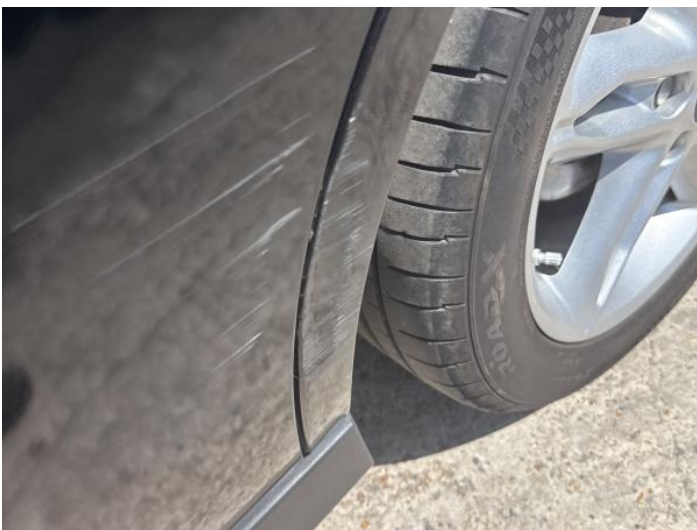
7: Qtr Panel nsr
Dented
With Paint Damage

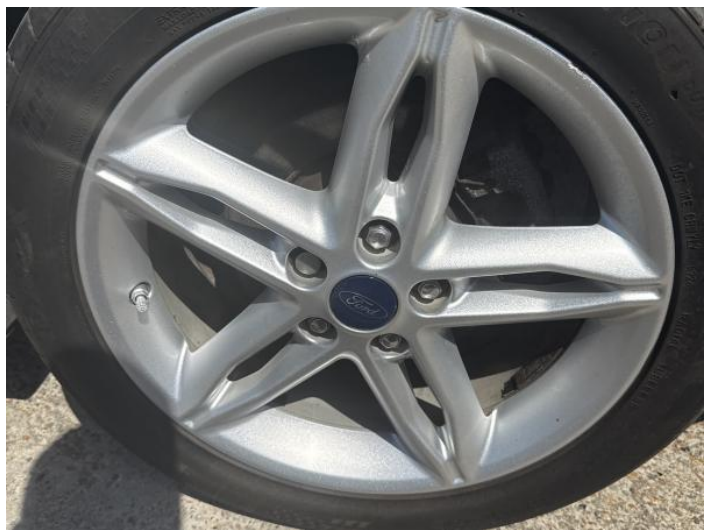
8: Wheel nsr
Scratched
Up To 50mm

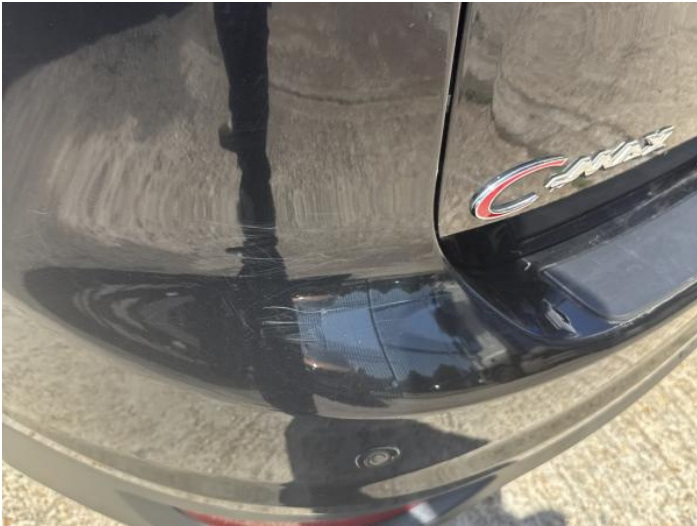
9: Bumper Rear
Scratched
25 to 100mm Thru Paint

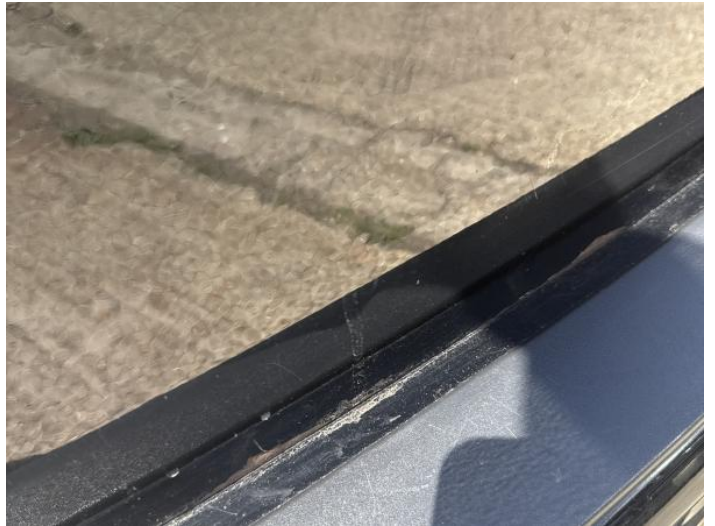
10: Tailgate
Scratched
Rusted

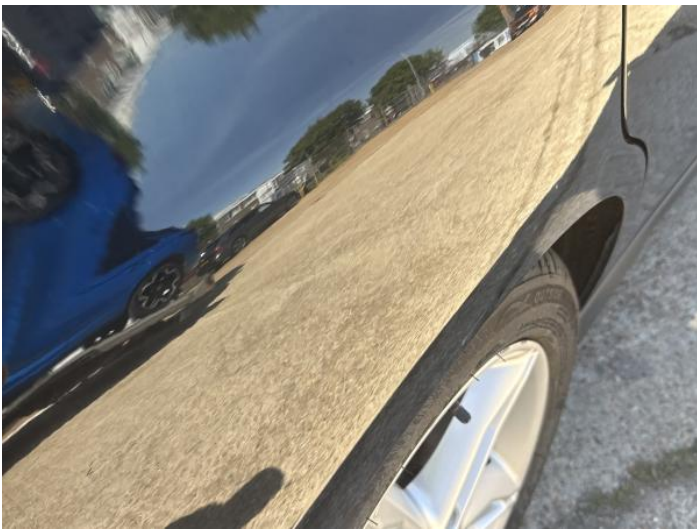
11: Qtr Panel osr
Dented
2 Or Less UpTo 10mm

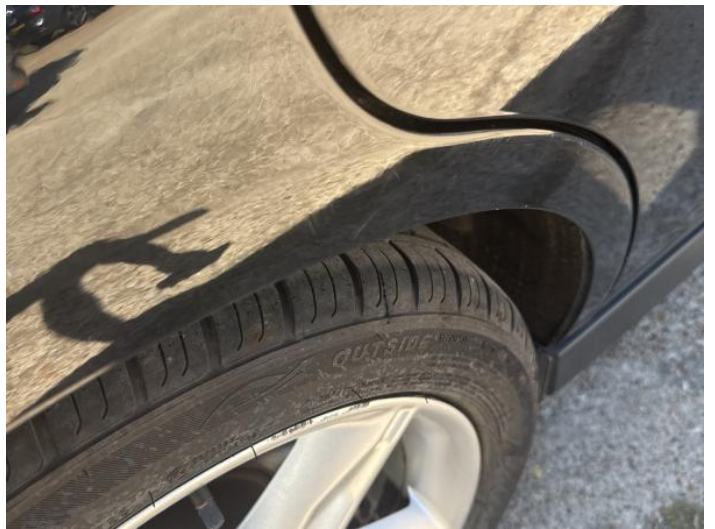
12: Qtr Panel osr
Scratched
Over 25mm Thru Paint

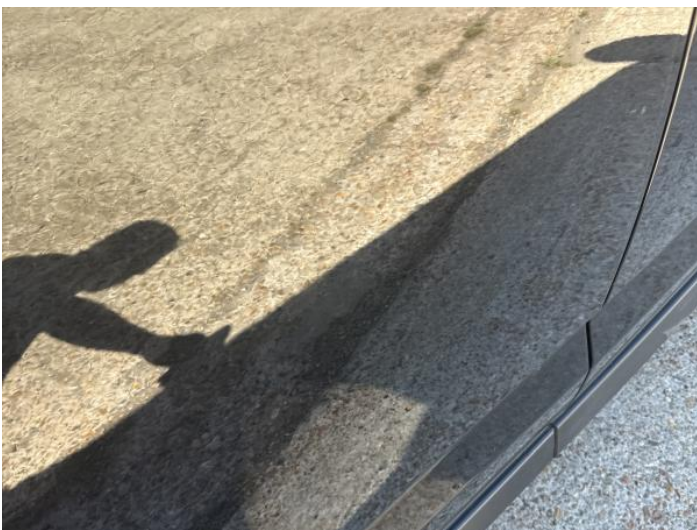
13: Door osr
Scratched
Over 25mm Thru Paint

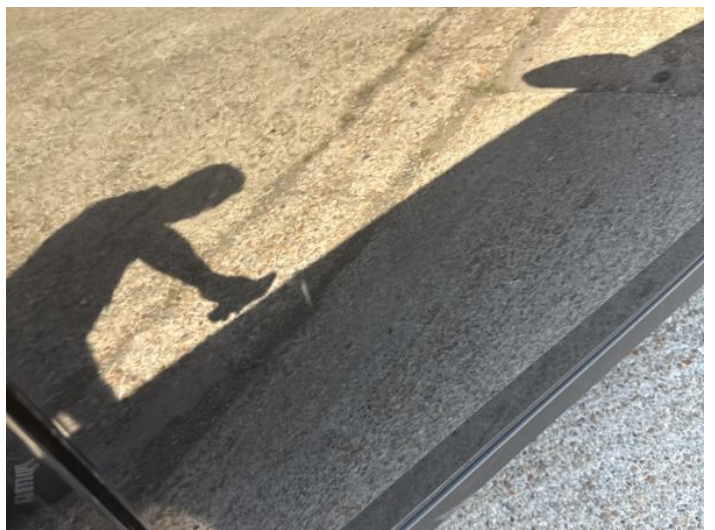
14: Door osf
Scratched
UpTo 25mm Thru Paint

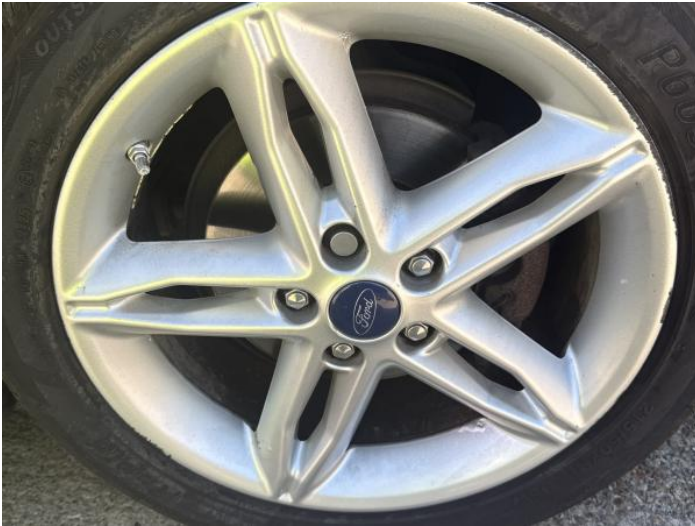
15: Wheel of
Scratched
Over 50mm

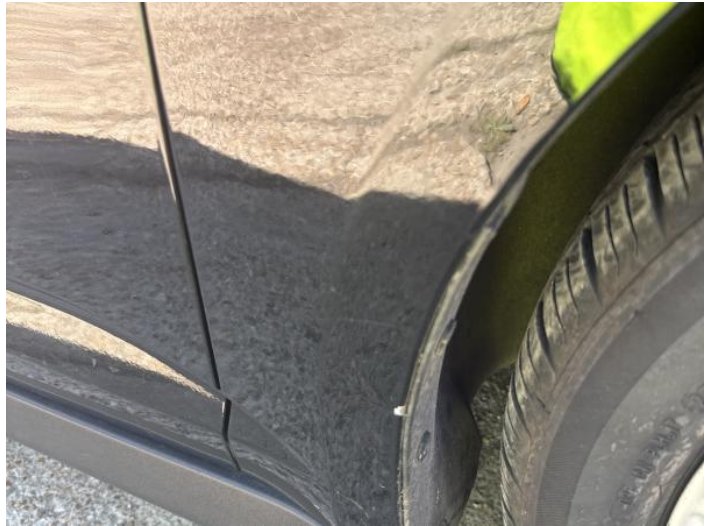
16: Wing of
Scratched
Up To 25mm Thru Paint

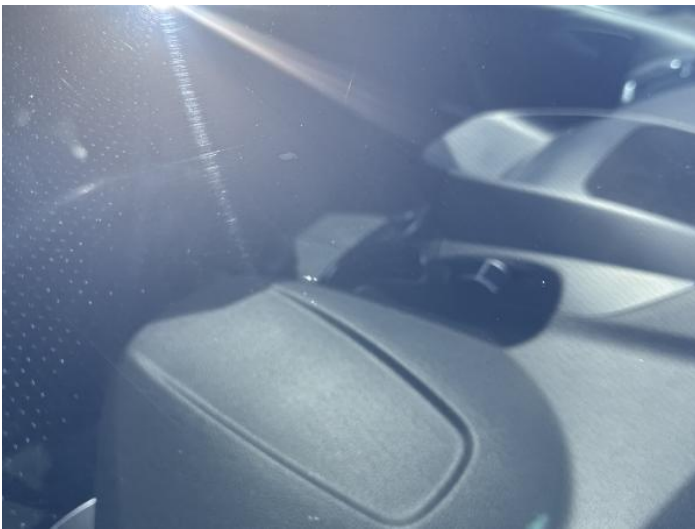
17: Screen Front
Chipped
Up To 10mm

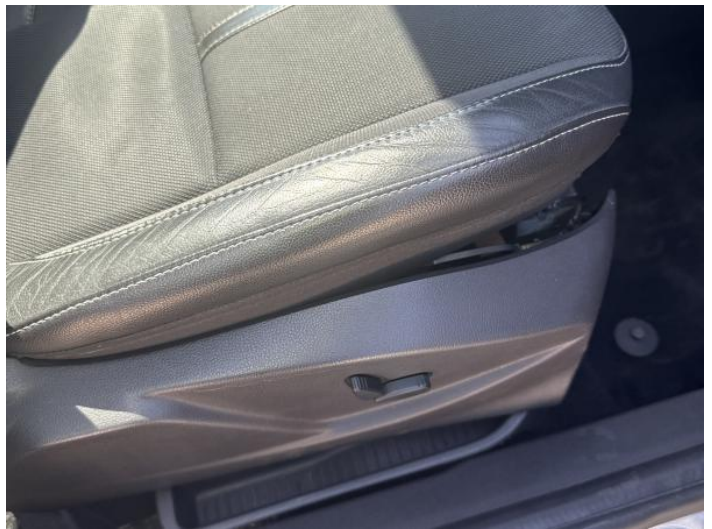
18: Fascia Trim
Damaged
Replace
