# VEHICLE INSPECTION REPORT

**YV19TOJ**

## Kia Sportage 1.6 CRDi ISG GT-Line 5dr

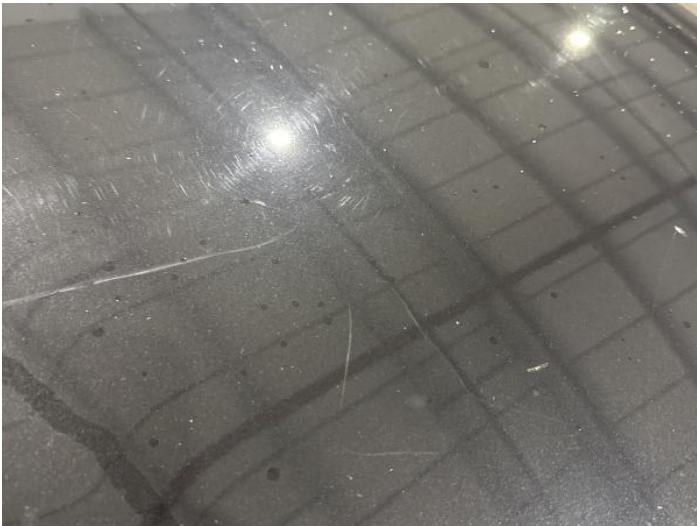
1: Bonnet  
Scratched  
Over 25mm Thru Paint

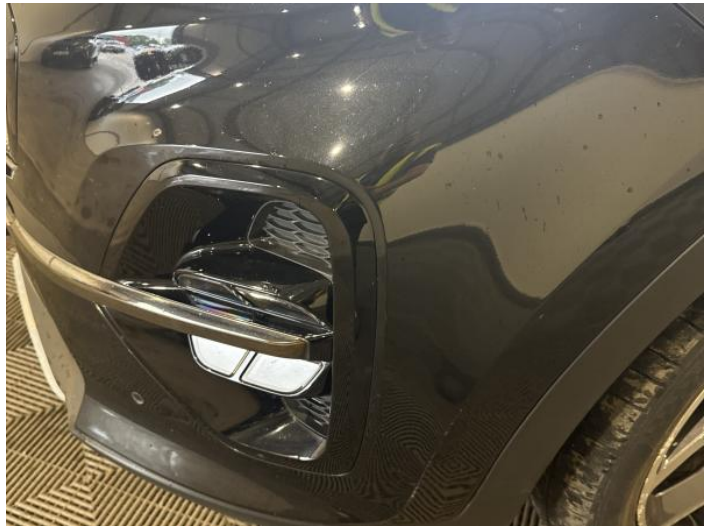
2: Bumper Front  
Scratched  
25 to 100mm Thru Paint

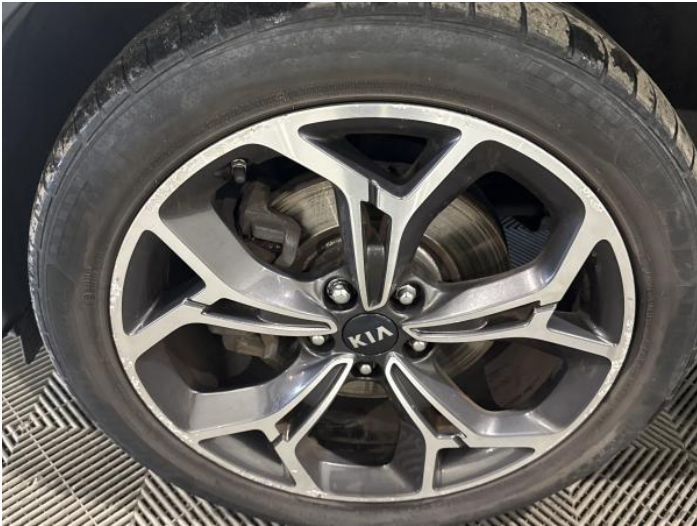
3: Wheel nsf  
Scratched  
Over 50mm

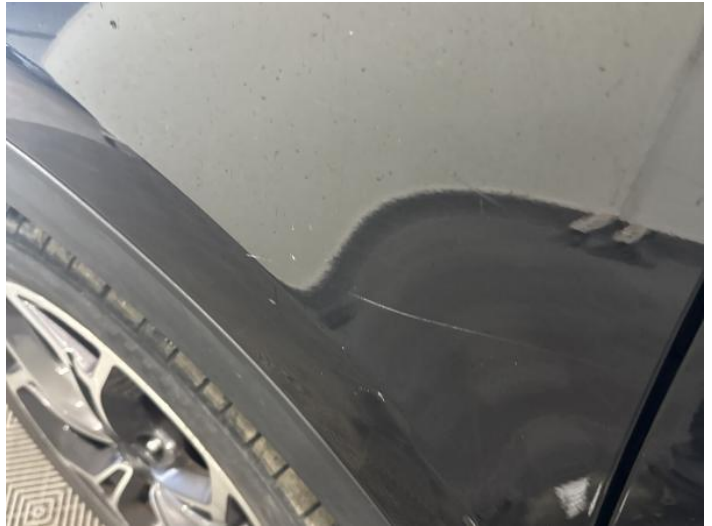
4: Wing nsf  
Scratched  
Over 25mm Thru Paint

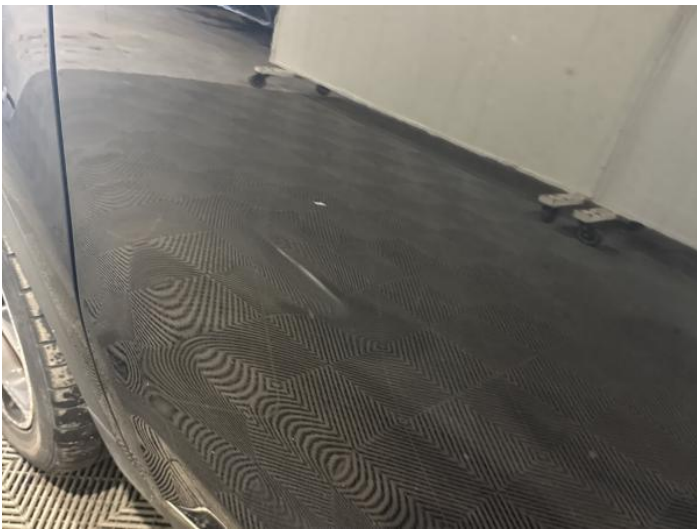
5: Door nsf  
Dented  
With Paint Damage

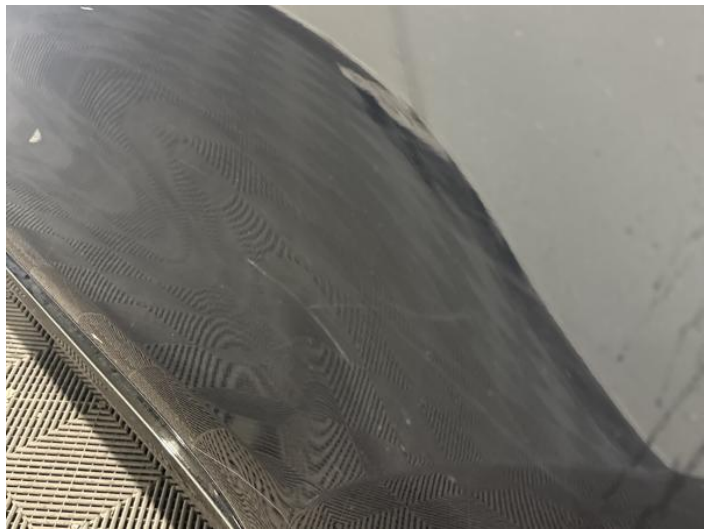
6: Door nsr  
Scratched  
Over 25mm Thru Paint

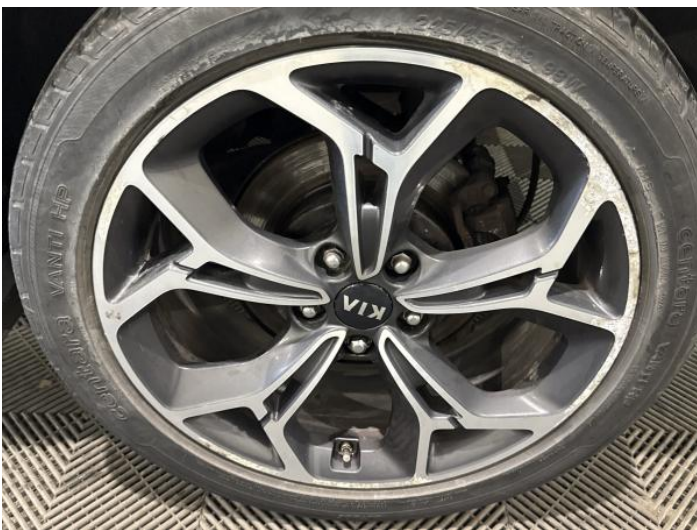
7: Wheel nsr  
Scratched  
Over 50mm

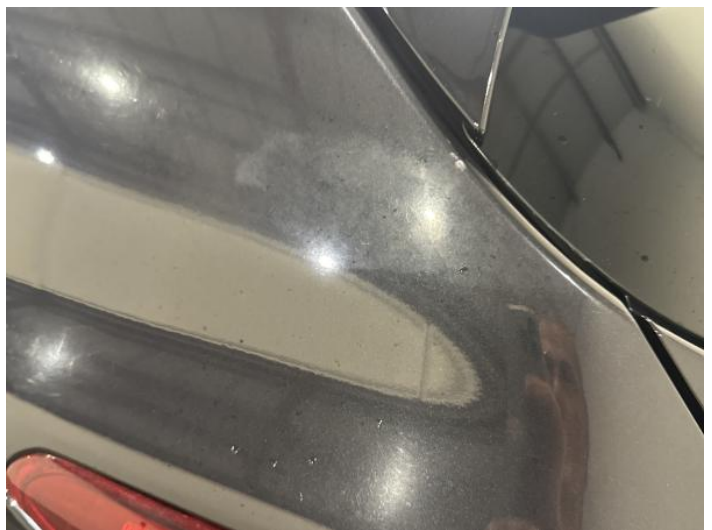
8: Qtr Panel nsr  
Poor Previous Repair  
Poor Paint

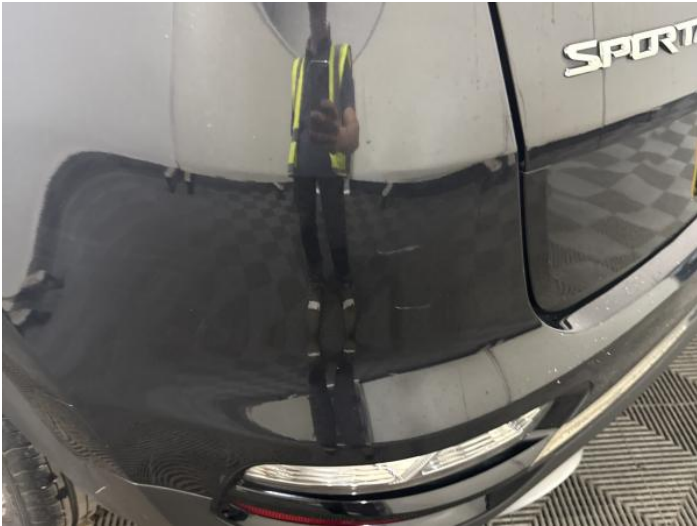
9: Bumper Rear  
Scratched  
25 to 100mm Thru Paint

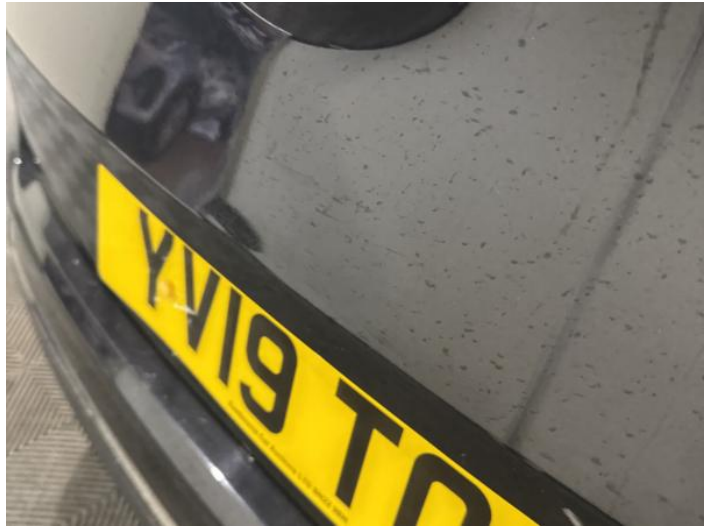
10: Tailgate  
Scratched  
Over 25mm Thru Paint

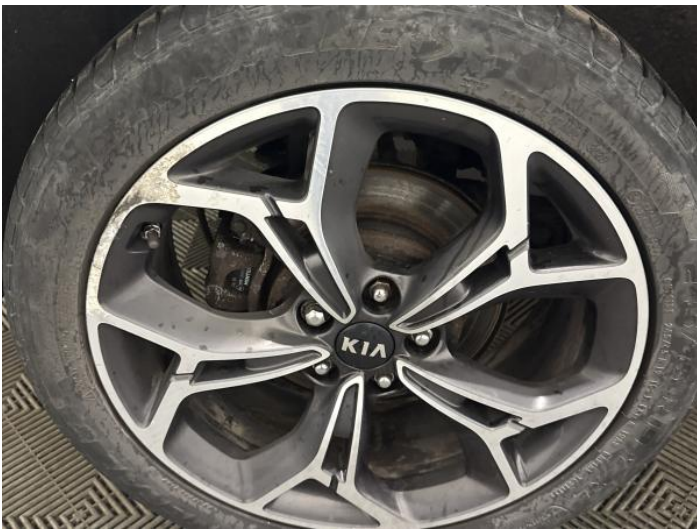
11: Wheel osr  
Scratched  
Over 50mm

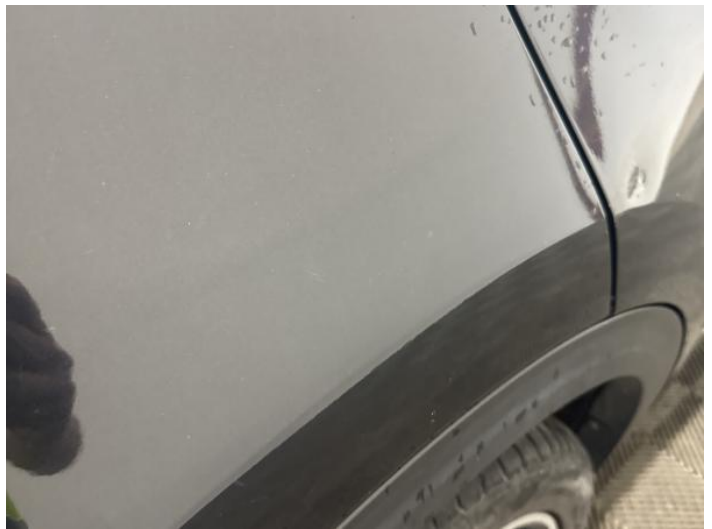
12: Qtr Panel osr  
Scratched  
Over 25mm Thru Paint

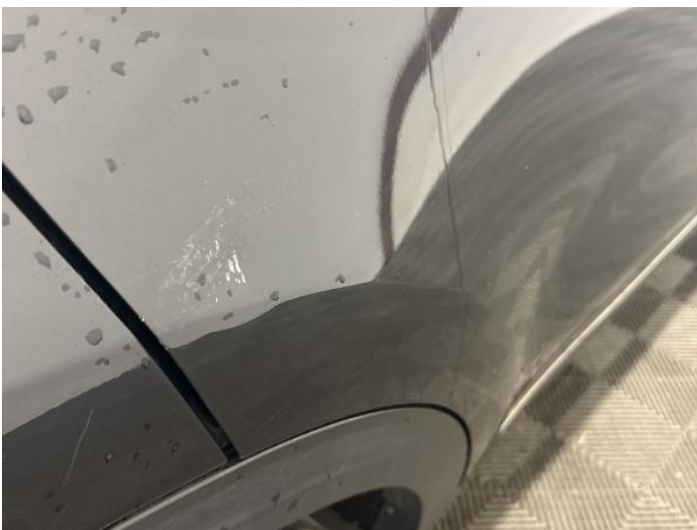
13: Door osr  
Dented  
With Paint Damage

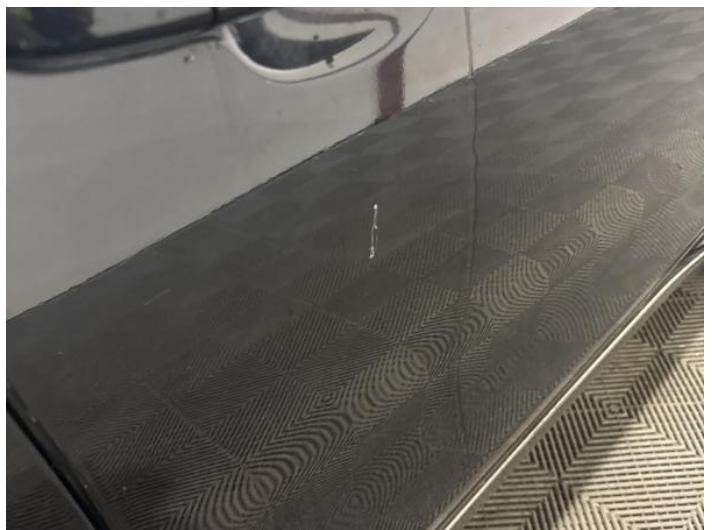
14: Door osf  
Scratched  
Over 25mm Thru Paint

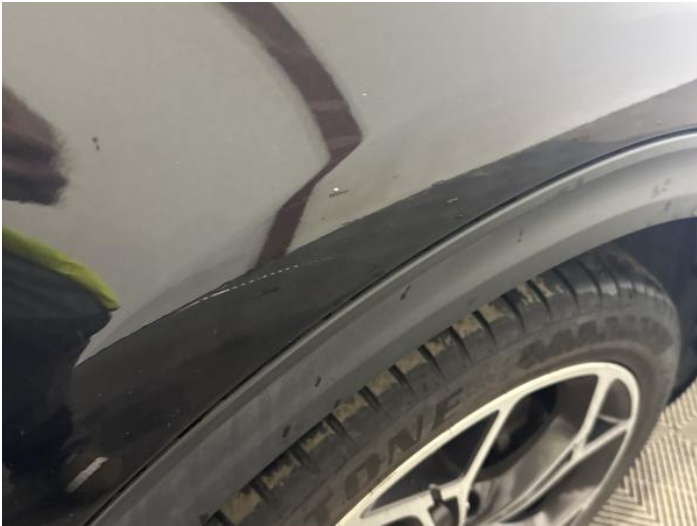
15: Wing osf  
 Scratched  
 Over 25mm Thru Paint

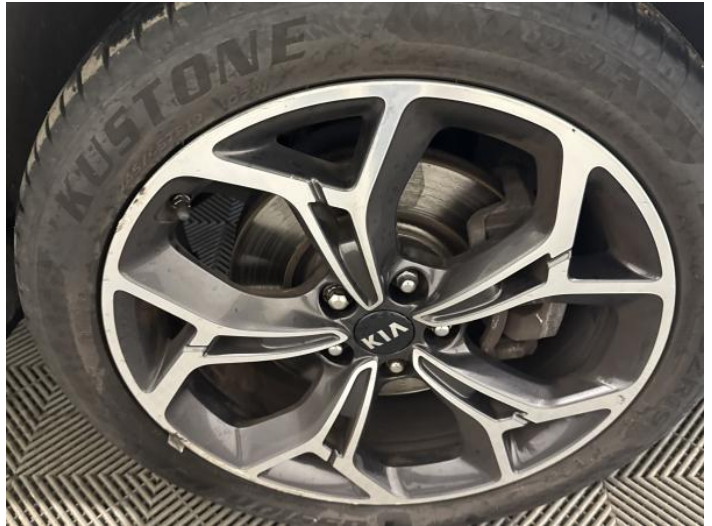
16: Wheel osf  
 Scratched  
 Over 50mm

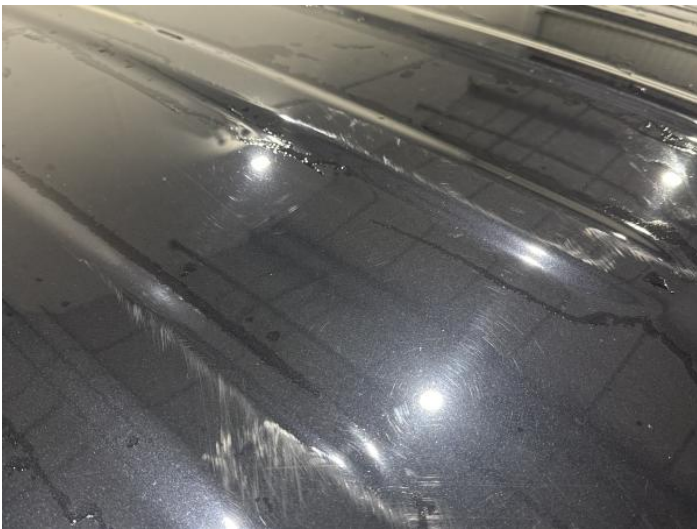
17: Roof  
 Scratched  
 Over 25mm Thru Paint
