VEHICLE INSPECTION REPORT

DP22TUJ

Cupra Formentor 1.5 TSI 150 V1 5dr DSG

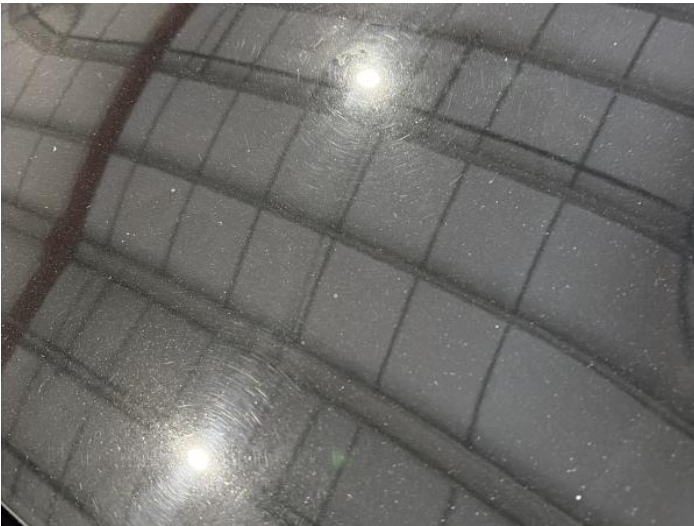
1: Bonnet
Chipped
1 To 5

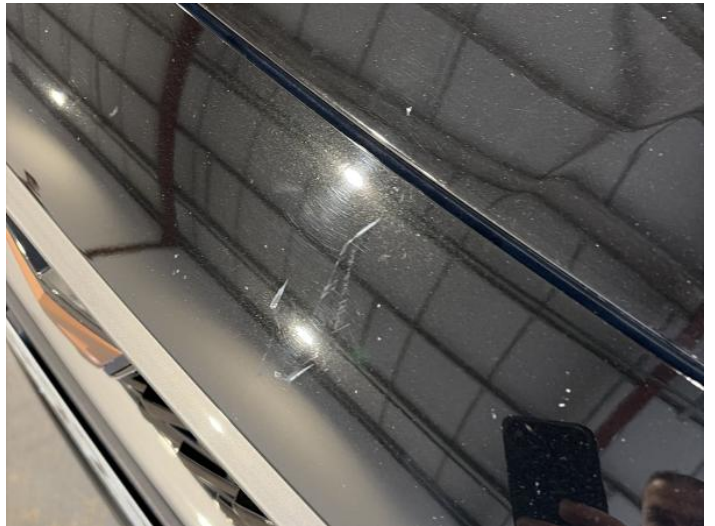
2: Bumper Front
Scratched
25 to 100mm Thru Paint

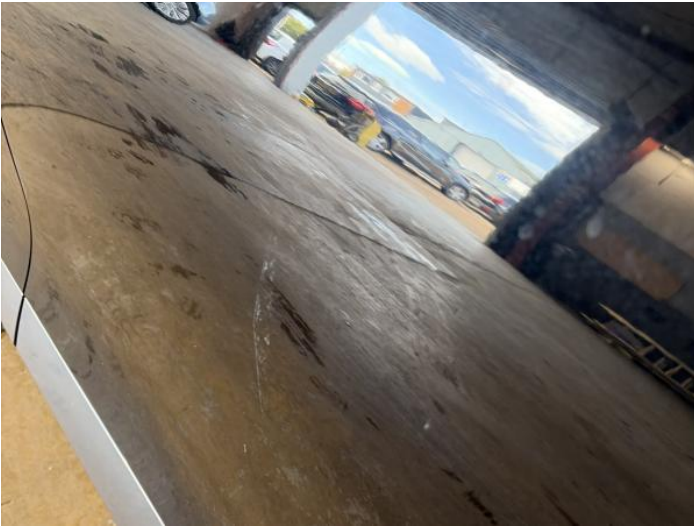
3: Door nsr
Scratched
Over 25mm Thru Paint

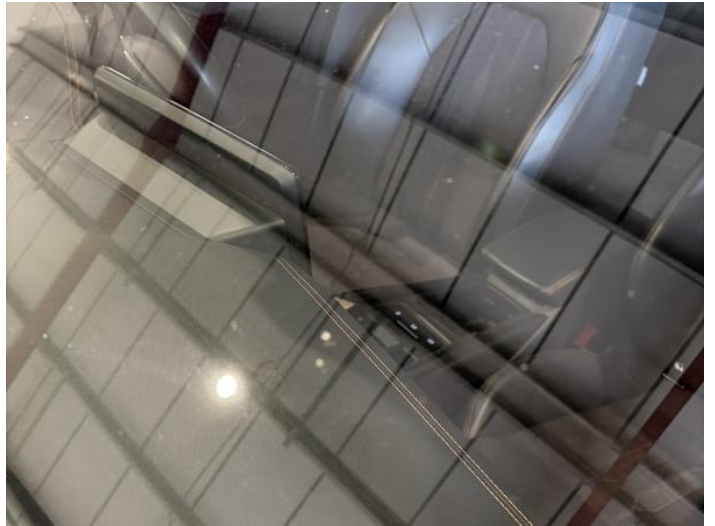
4: Screen Front
Chipped
UpTo 10mm

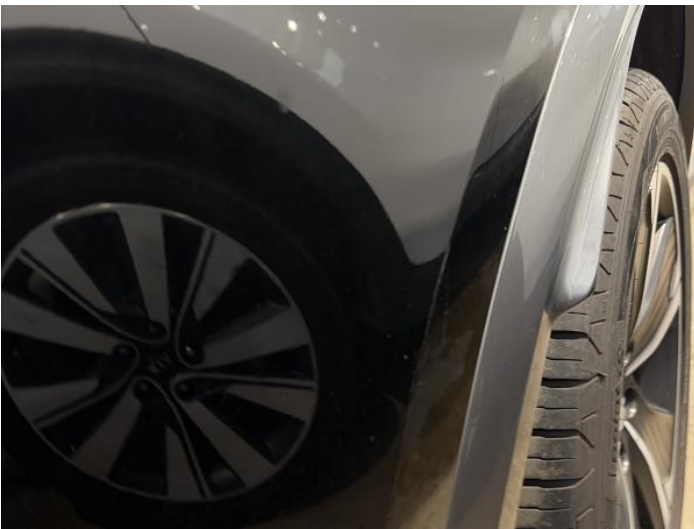
5: Bumper Rear
Scratched
25 to 100mm Thru Paint

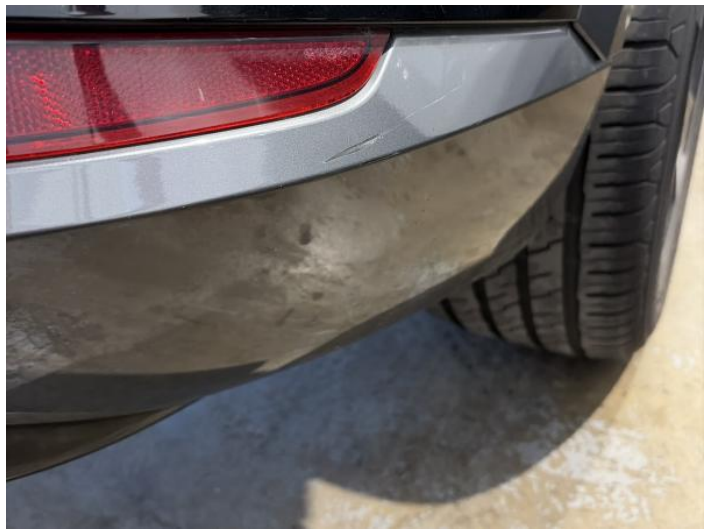
6: Bumper Rear Moulding
Scratched (Painted)
Over 25mm Thru Paint

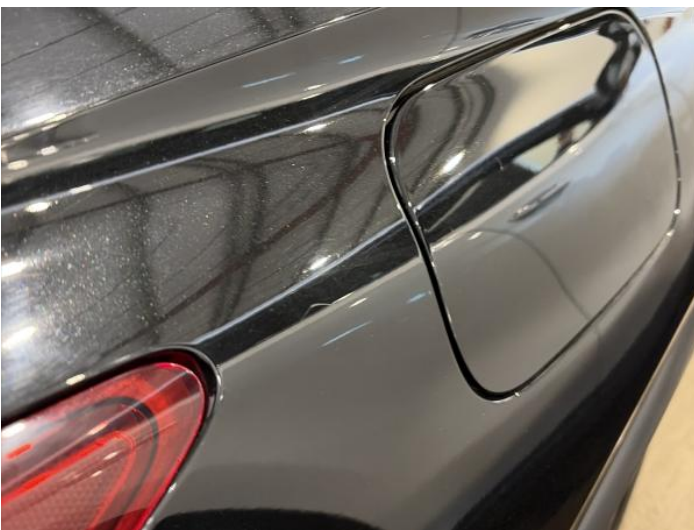
7: Qtr Panel osr
Scratched
UpTo 25mm Thru Paint

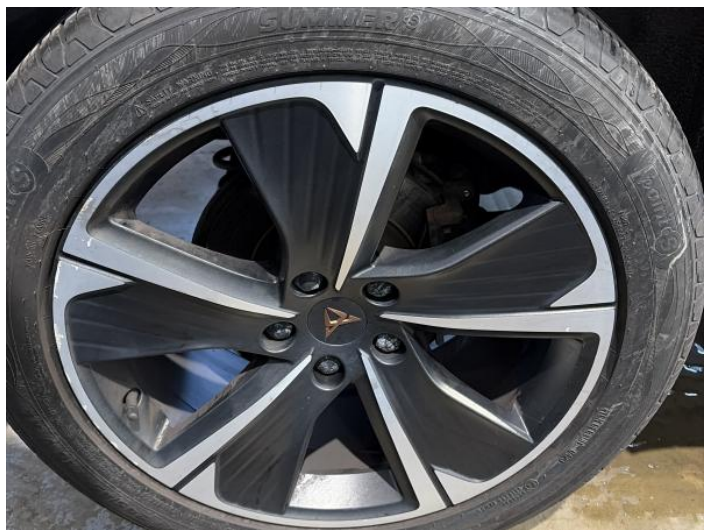
8: Wheel osr
Scratched
Over 50mm

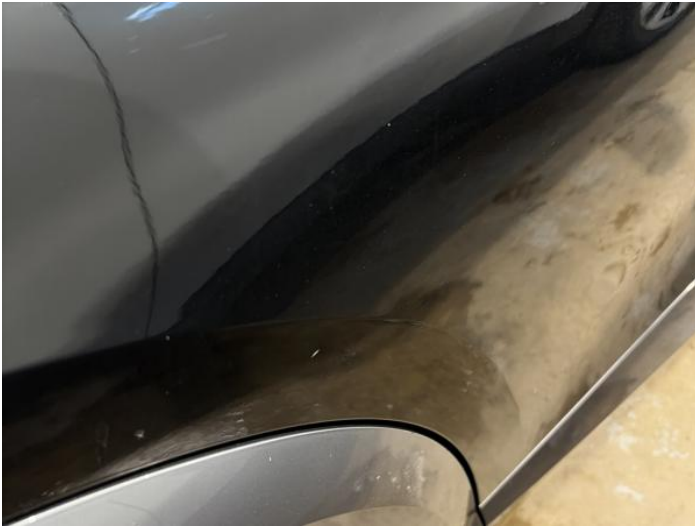
9: Door osr
Chipped
1 To 5

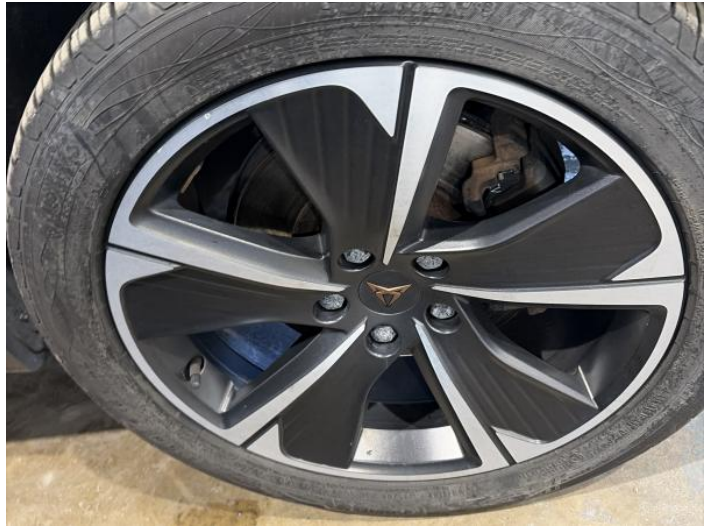
10: Wheel osf
Scratched
Up To 50mm
