VEHICLE INSPECTION REPORT

HV14GZT

Mazda CX-5 2.2d [175] Sport Nav 5dr AWD

nama
GRADE
4

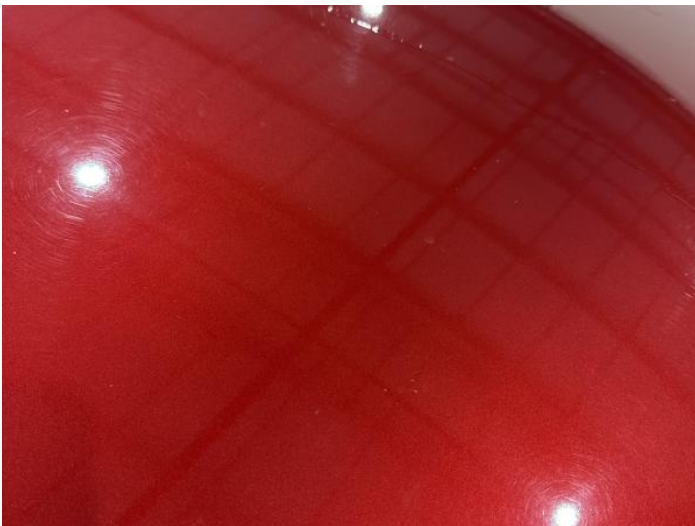
1: Bonnet
Chipped
1 To 5

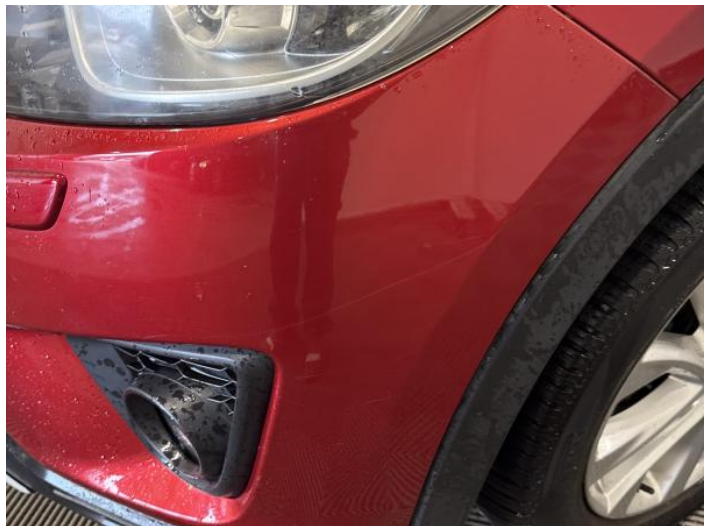
2: Bumper Front
Scratched
25 to 100mm Thru Paint

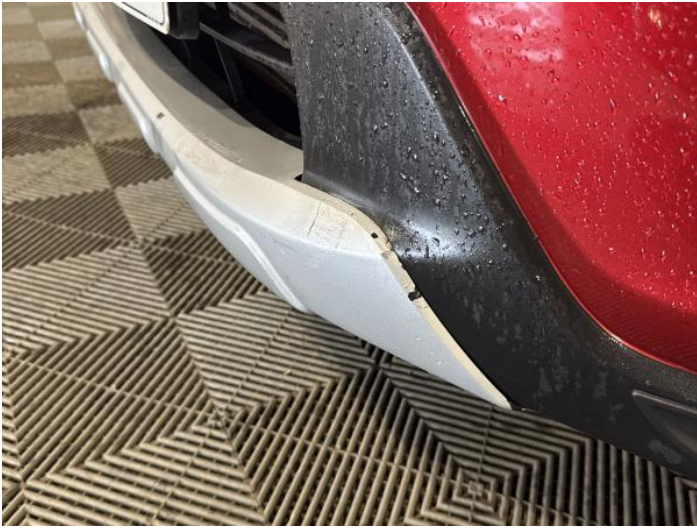
3: Bumper Front Moulding
Scratched (Painted)
Over 25mm Thru Paint

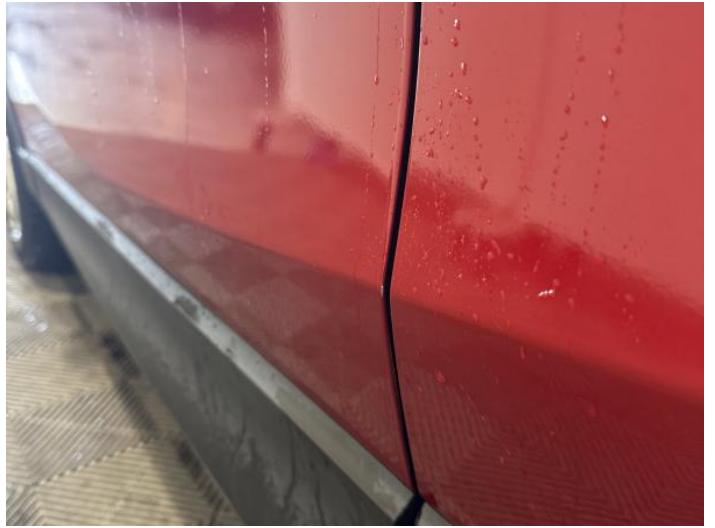
4: Door nsf
Chipped
Edge Chip

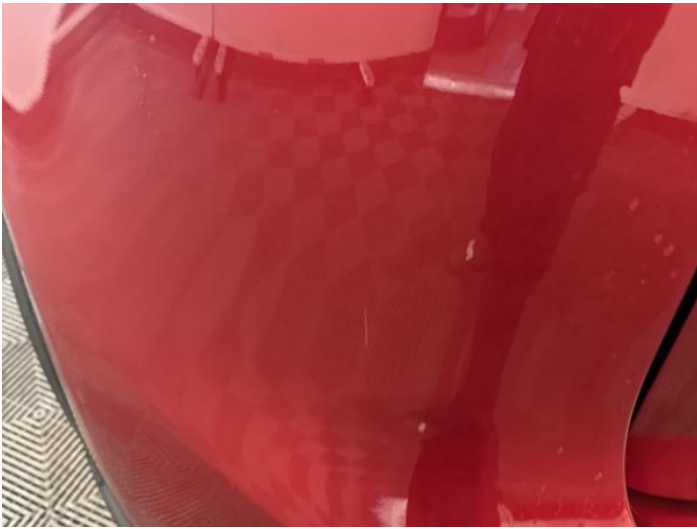
5: Bumper Rear
Scratched
Up To 25mm Thru Paint

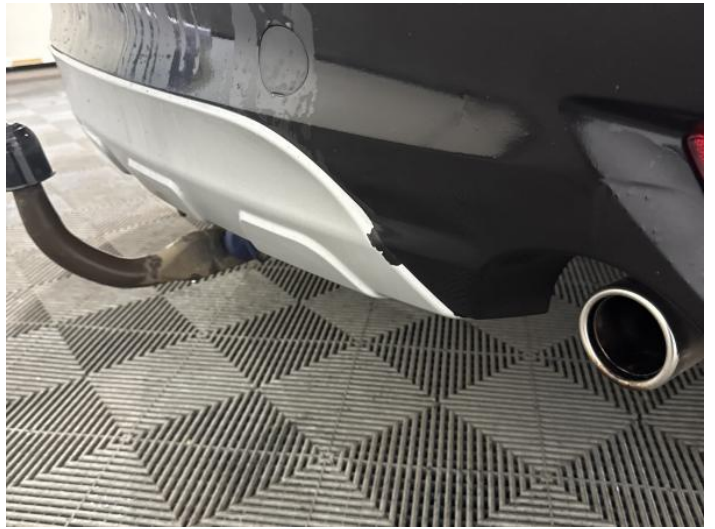
6: Bumper Rear Moulding
Scratched (Painted)
Over 25mm Thru Paint

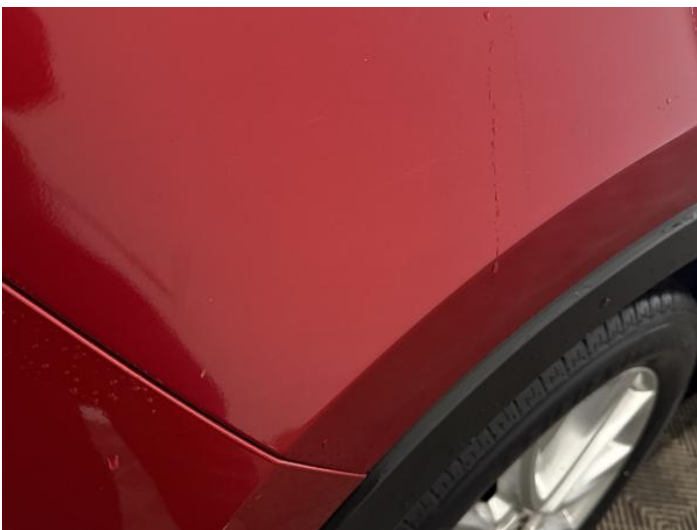
7: Qtr Panel osr
Poor Previous Repair
Poor Paint

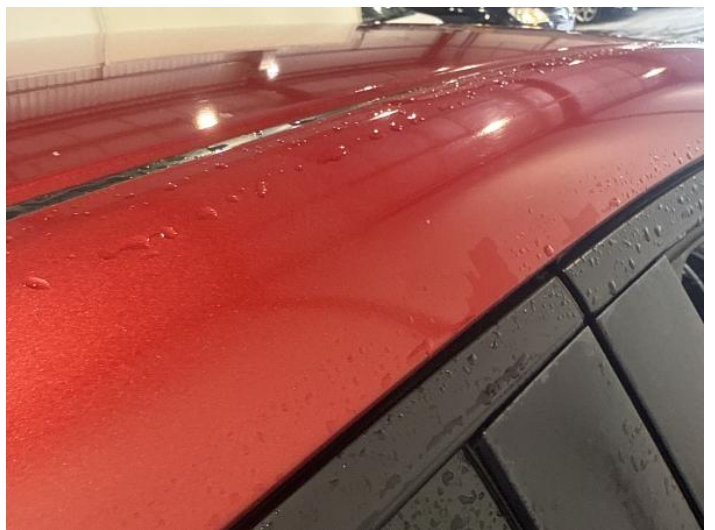
8: B Post os
Poor Previous Repair
Poor Paint

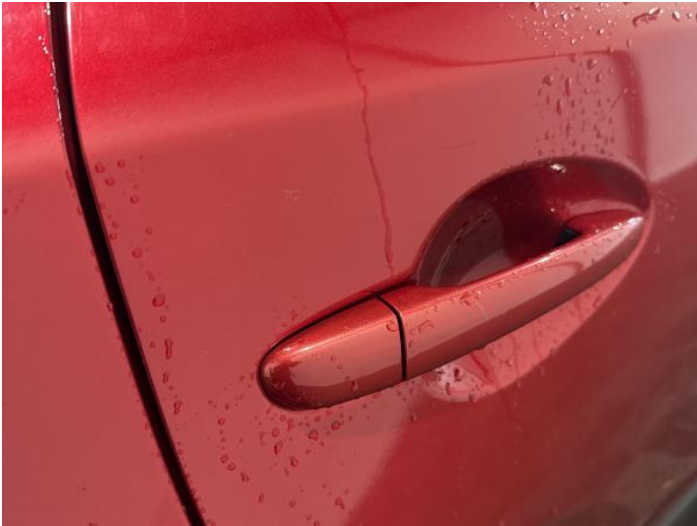
9: Door osr
Poor Previous Repair
Poor Paint

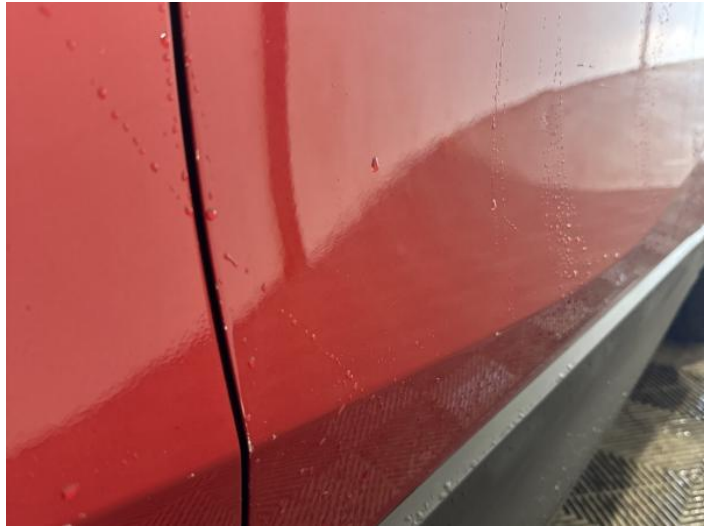
10: Door osf
Scratched
Over 25mm Thru Paint

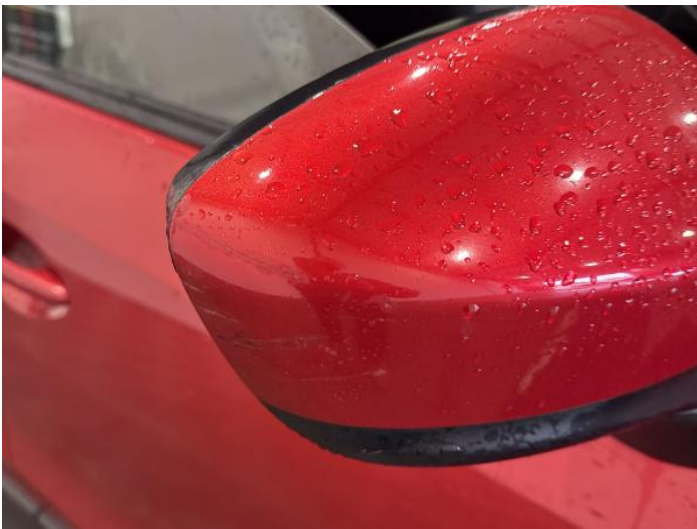
11: Door Mirror Assy osf
Scratched (Painted)
Over 25mm Thru Paint

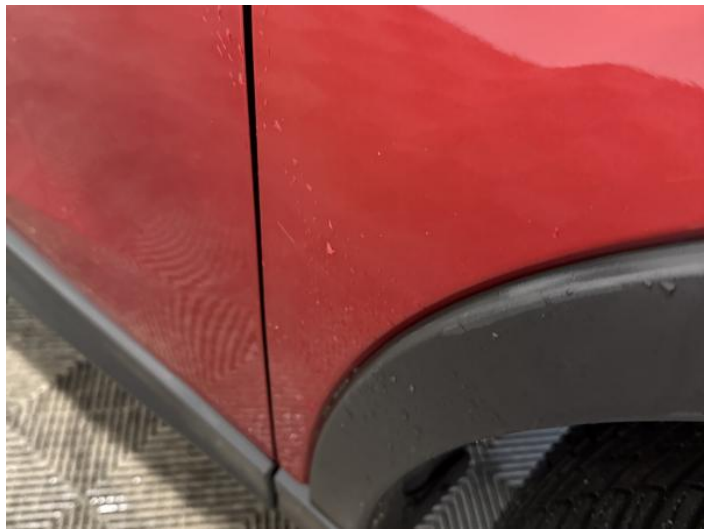
12: Wing osf
Scratched
Over 25mm Thru Paint

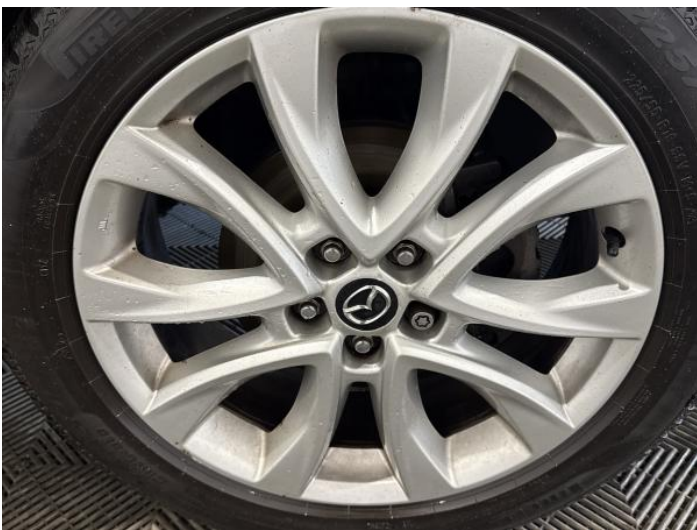
13: Wheel osf
Scratched
Over 50mm

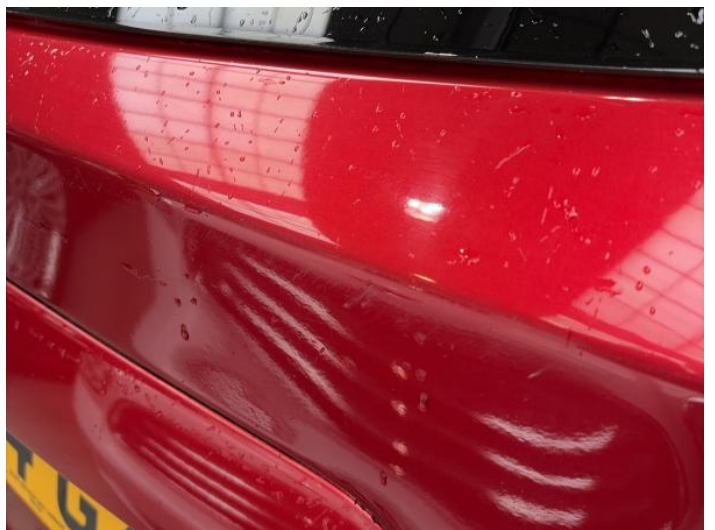
14: Tailgate
Scratched
Over 25mm Thru Paint
