VEHICLE INSPECTION REPORT

FY18NOF

Ford Fiesta 1.0 EcoBoost 140 ST-Line X 3dr

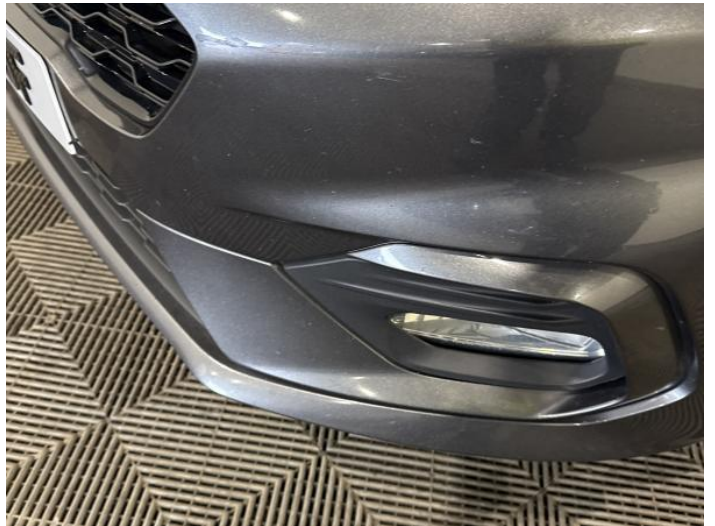
2: Bumper Front
Poor Previous Repair
Poor Paint

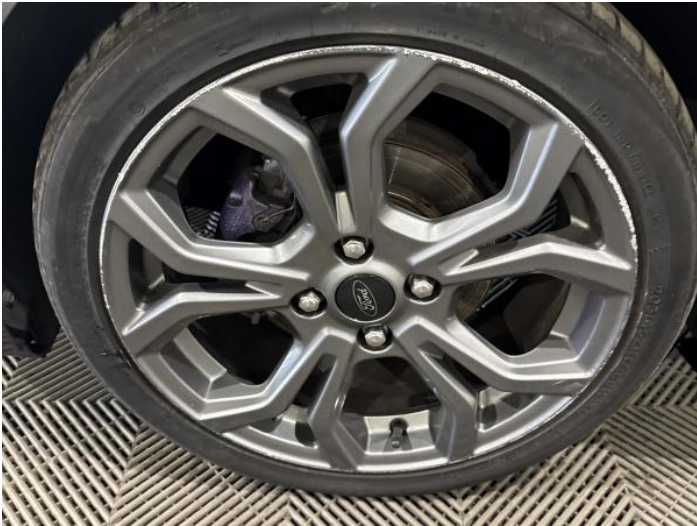
3: Wheel nsr
Scratched
Over 50mm

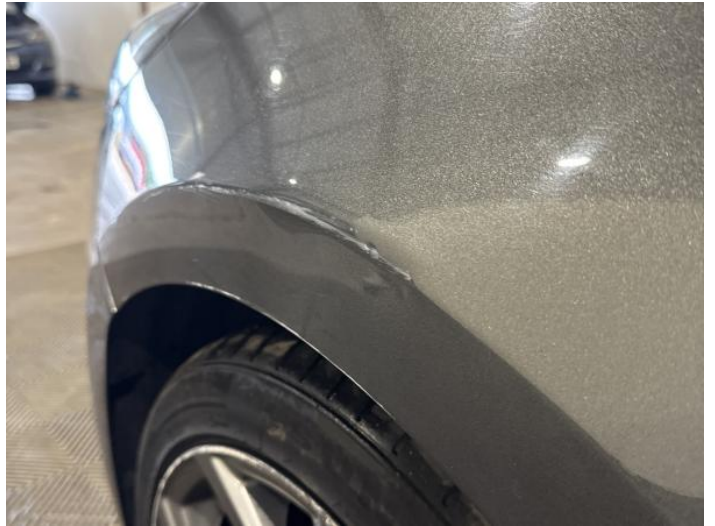
4: Wing nsf
Dented
With Paint Damage

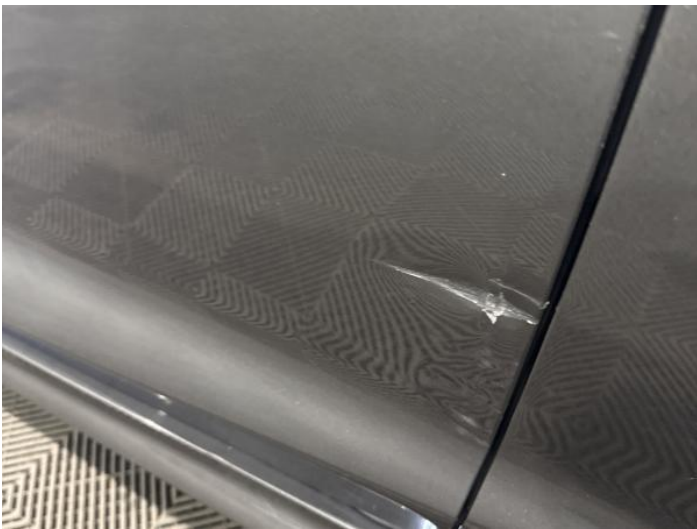
5: Door nsr
Dented
With Paint Damage

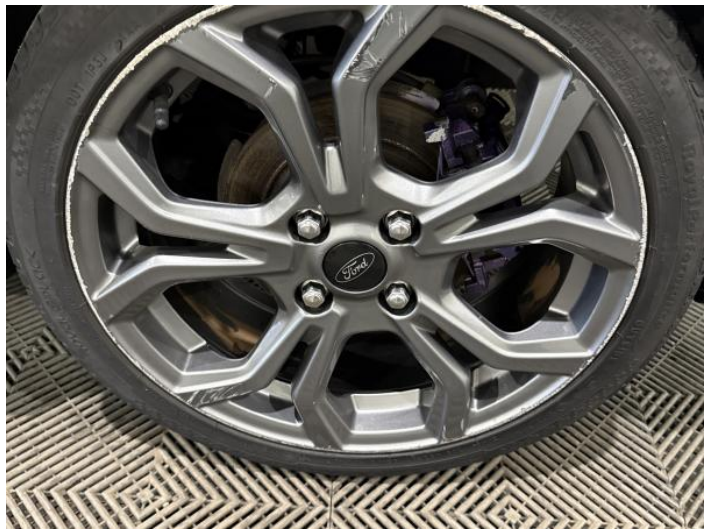
6: Wheel nsr
Scratched
Over 50mm

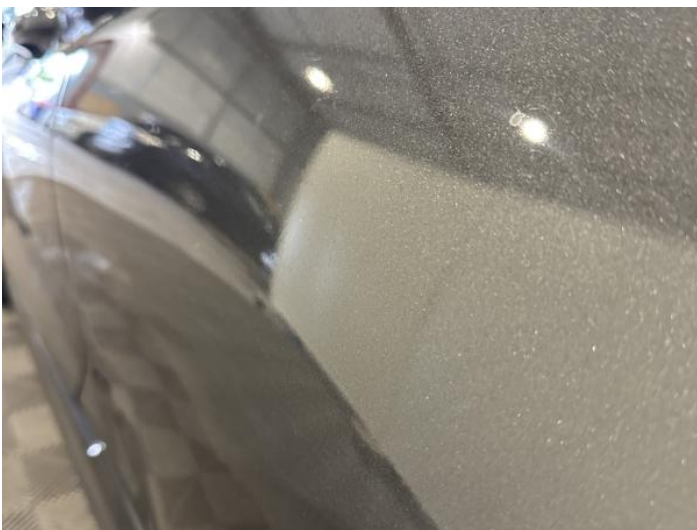
7: Qtr Panel nsr
Dented
Between 10mm + 30mm

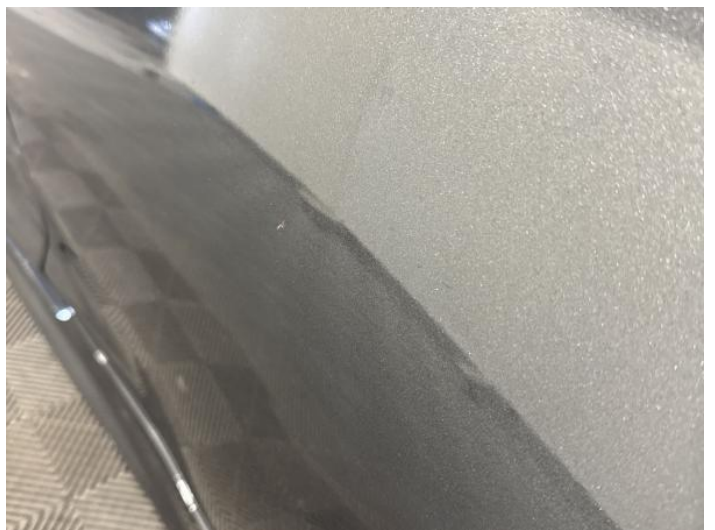
8: Qtr Panel nsr
Chipped
1 To 5

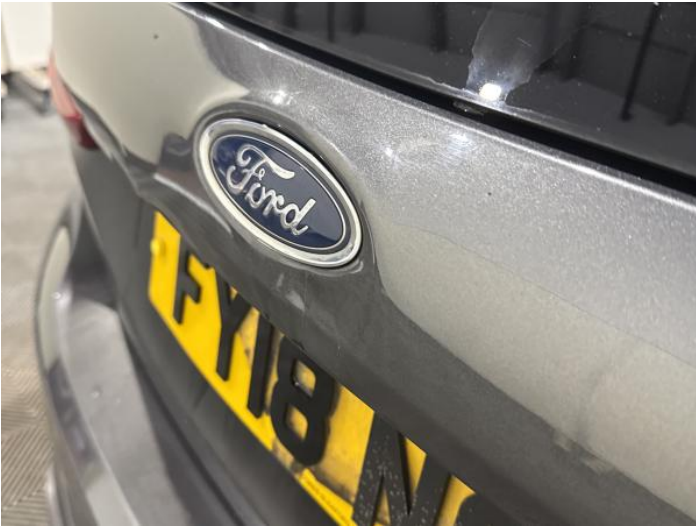
9: Tailgate
Dented
Over 30mm

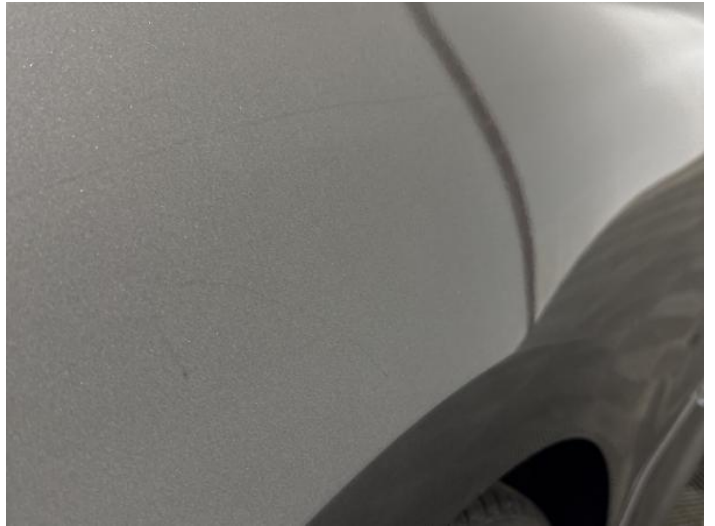
10: Qtr Panel osr
Dented
Between 10mm + 30mm

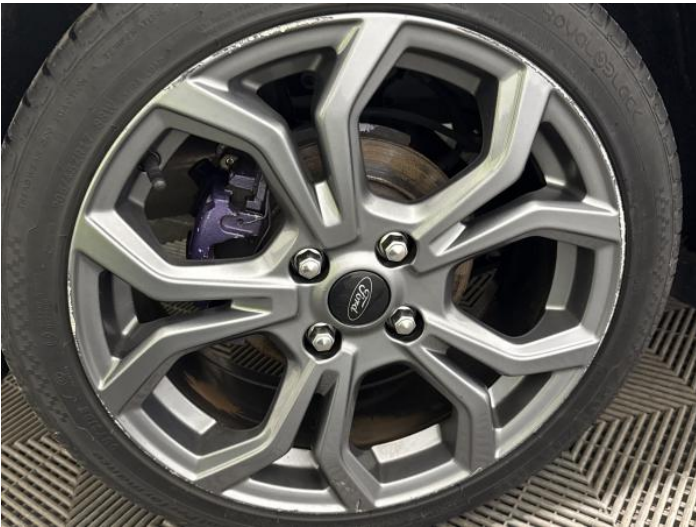
11: Wheel osr
Scratched
Over 50mm

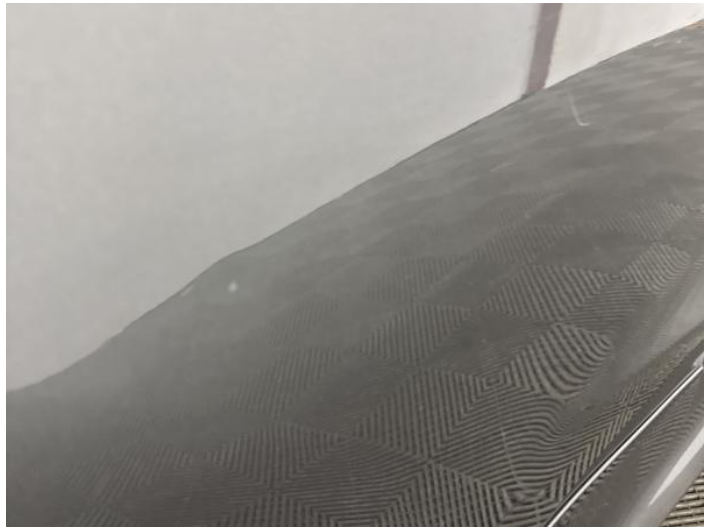
12: Qtr Panel osr
Scratched
Over 25mm Thru Paint

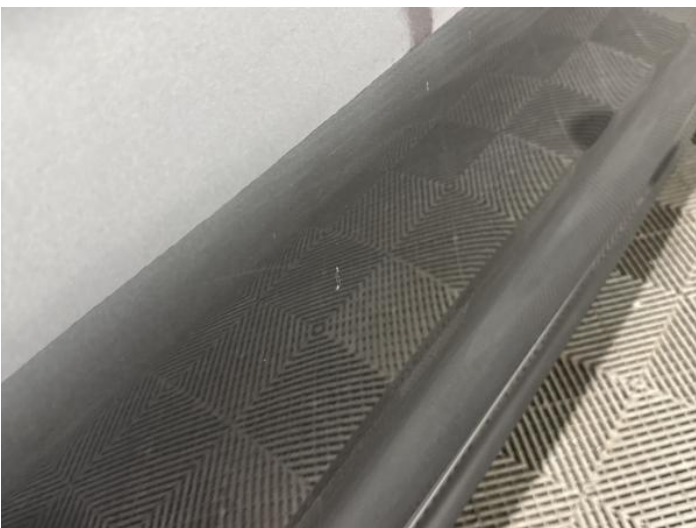
13: Door osf
Scratched
Up To 25mm Thru Paint

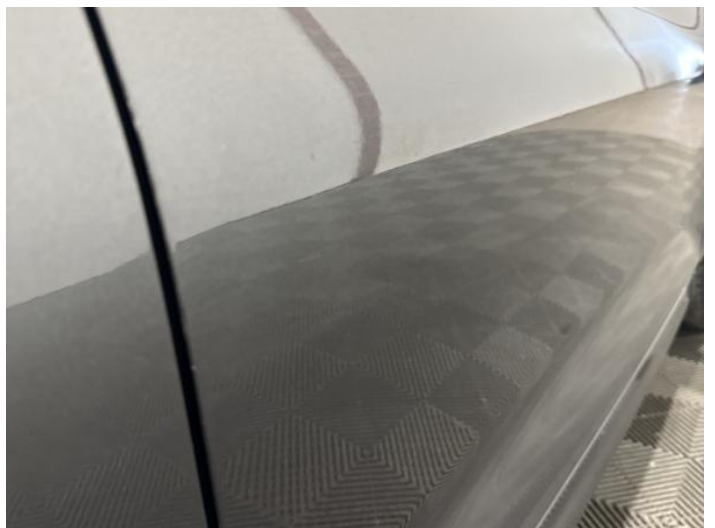
14: Door osf
Dented
Between 10mm + 30mm

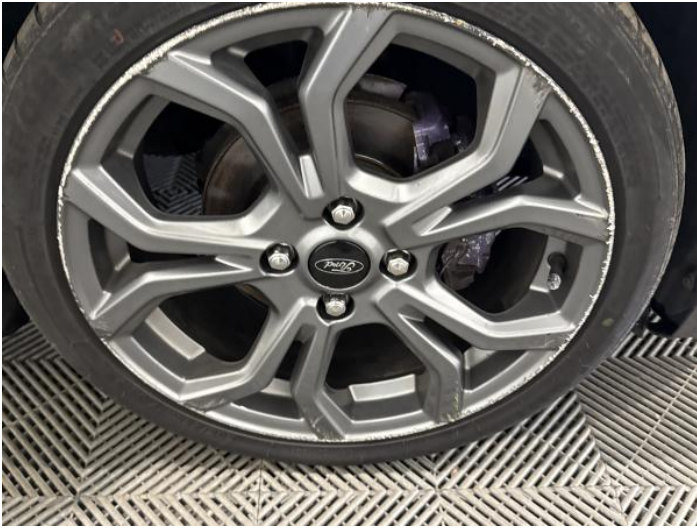
15: Wheel osf
Scratched
Over 50mm

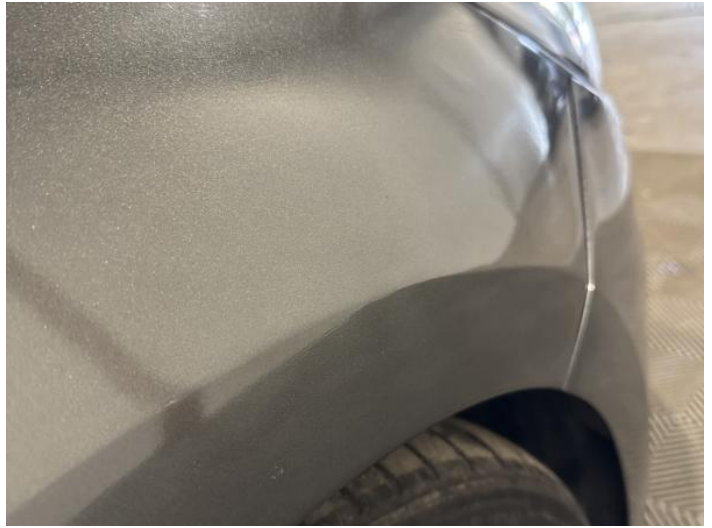
16: Wing nsf
Poor Previous Repair
Poor Paint

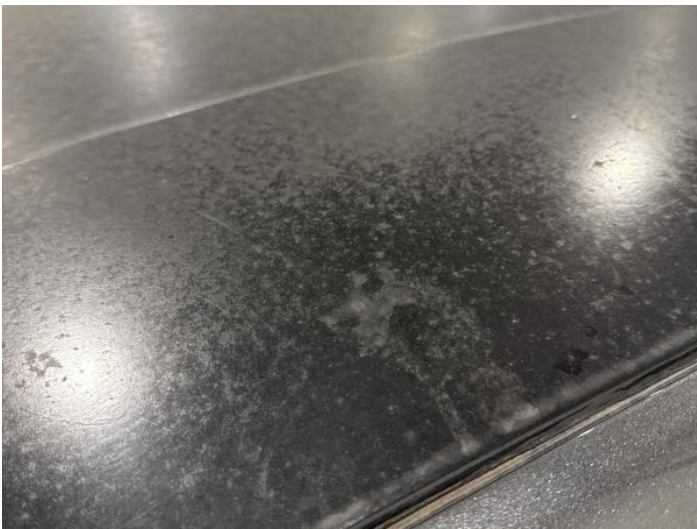
17: Roof
Scratched
Over 25mm Thru Paint
