# VEHICLE INSPECTION REPORT

**MK64YAV**

## Ford Focus 1.6 TDCi 115 Zetec Navigator 5dr

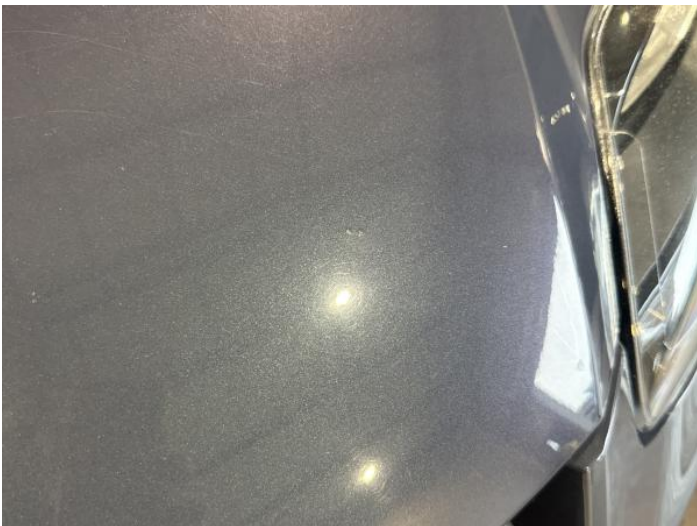
1: Bonnet  
Chipped  
1 To 5

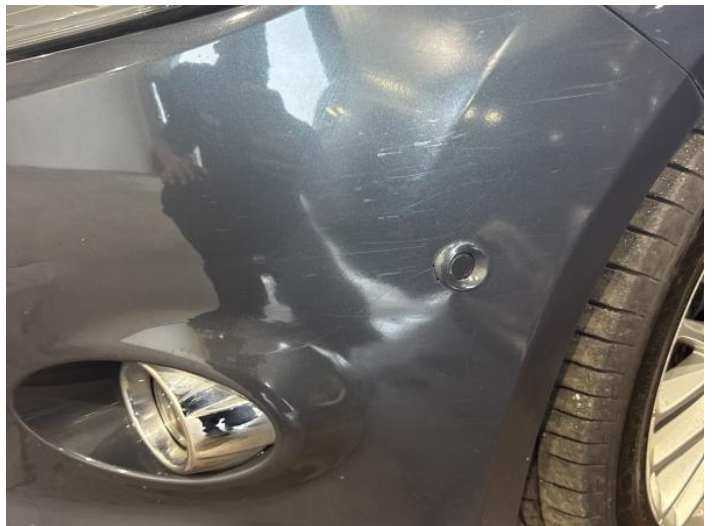
2: Bumper Front  
Poor Previous Repair  
Poor Paint

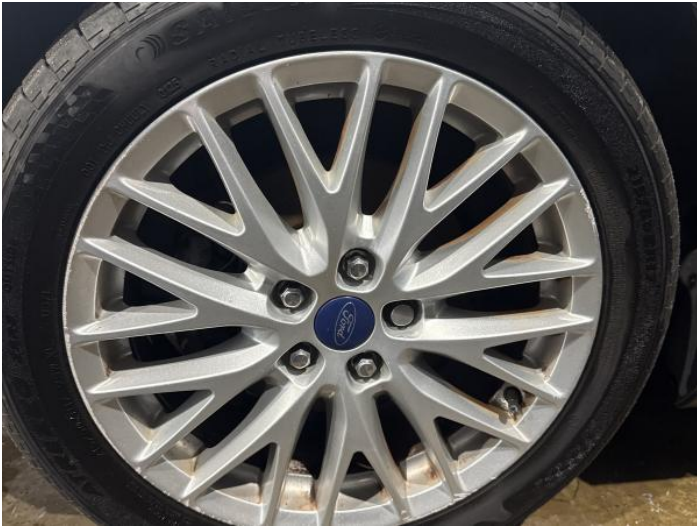
3: Wheel nsf  
Scratched  
Over 50mm

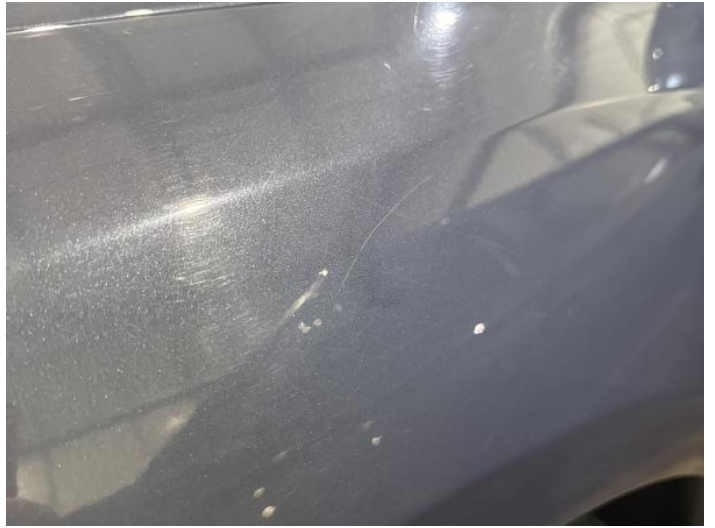
4: Wing nsf  
Scratched  
Over 25mm Thru Paint

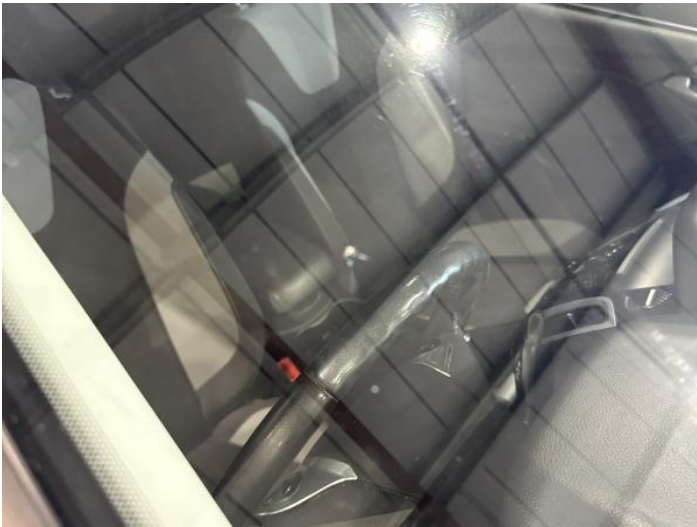
5: Screen Front  
Cracked  
Replace

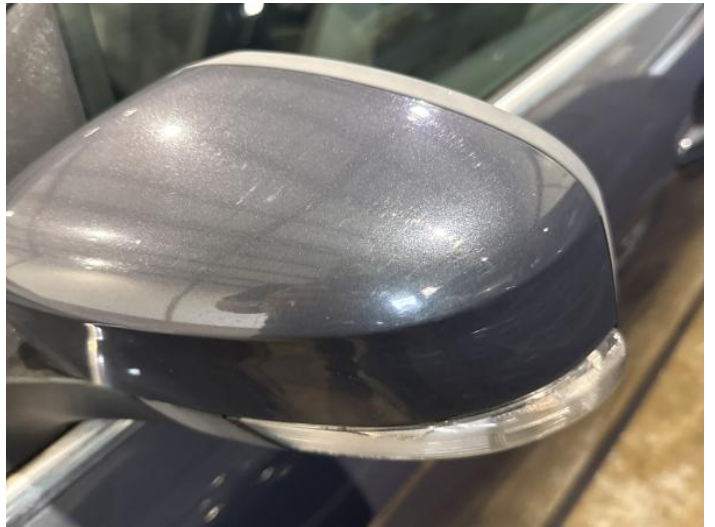
6: Door Mirror Assy nsf  
Scratched (Painted)  
UpTo 25mm Thru Paint

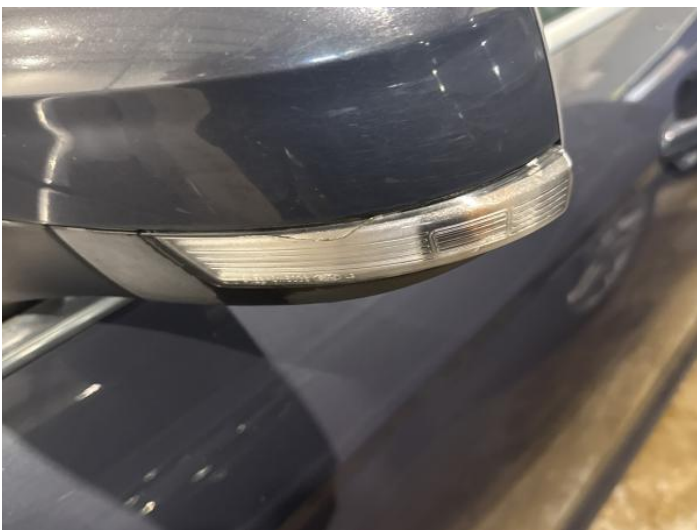
7: Flasher Side Repeater ns  
Broken  
Replace

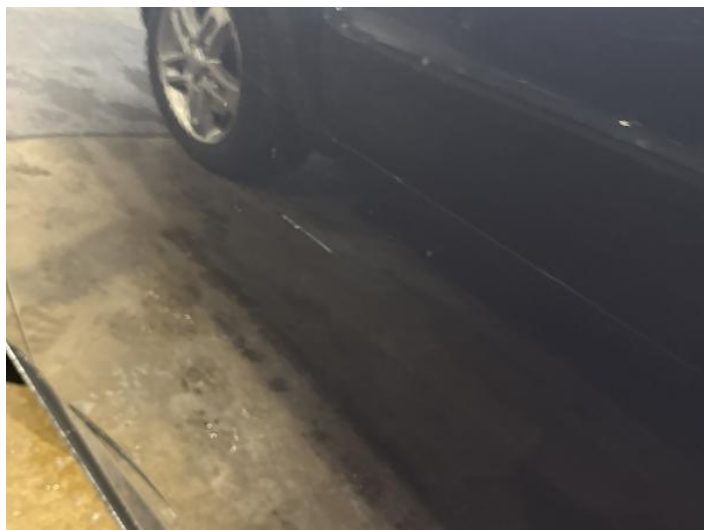
8: Door nsf  
Scratched  
UpTo 25mm Thru Paint

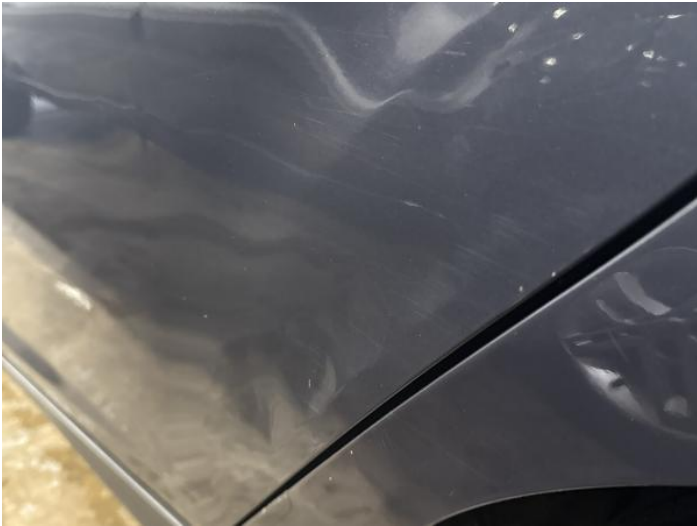
9: Door nsr  
Dented  
With Paint Damage

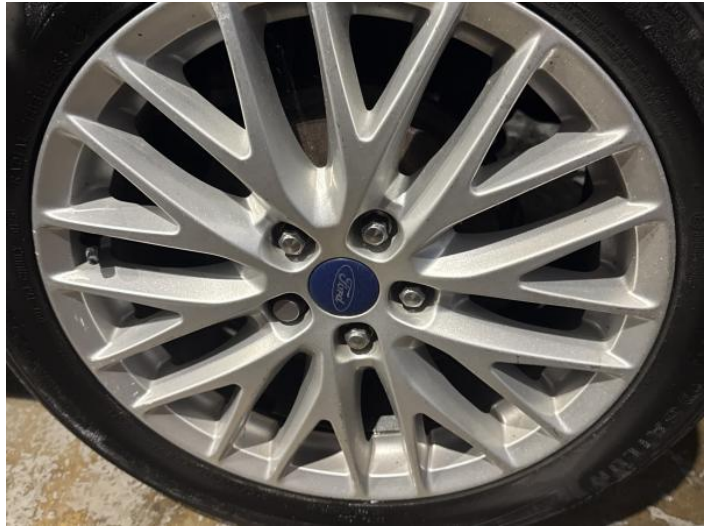
10: Wheel nsr  
Scratched  
Over 50mm

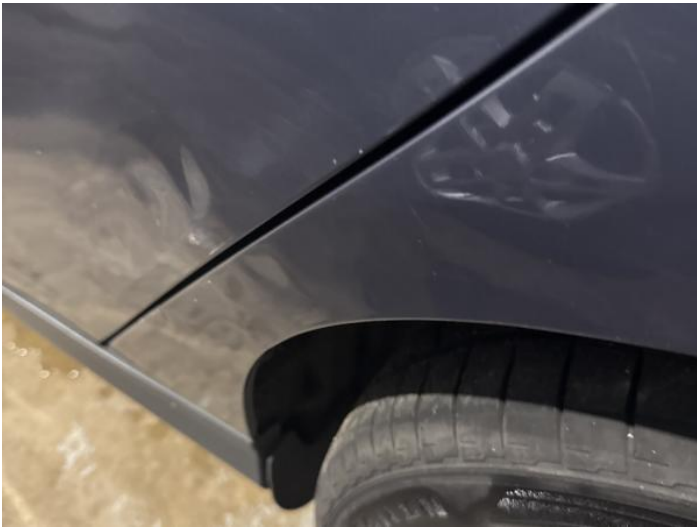
11: Qtr Panel nsr  
Dented  
Over 30mm

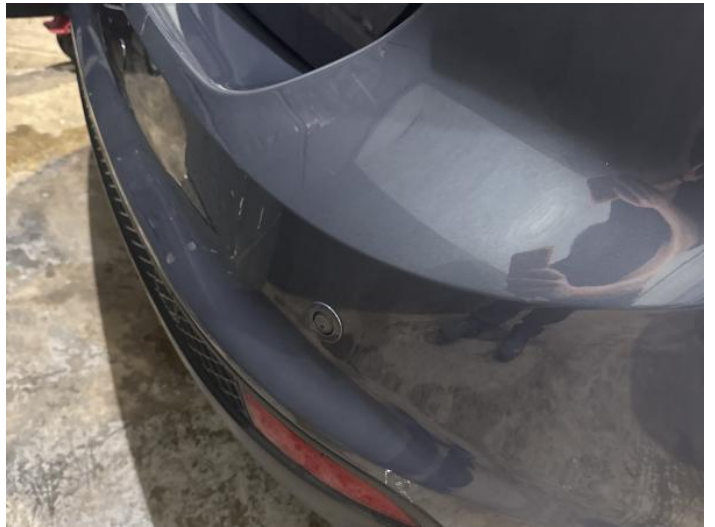
12: Bumper Rear  
Poor Previous Repair  
Poor Paint

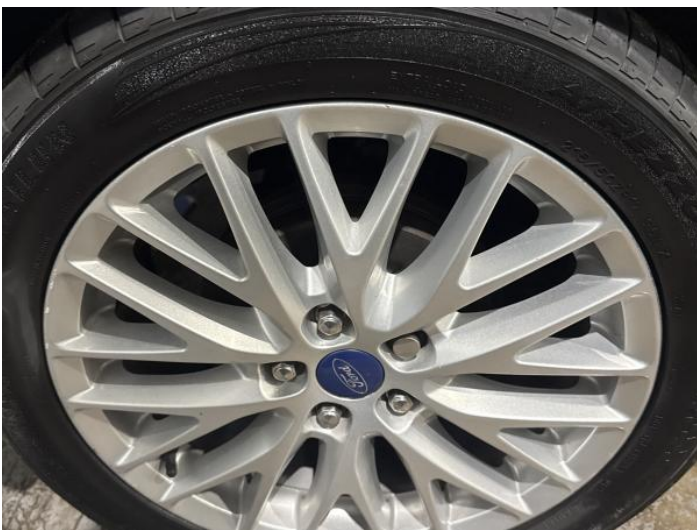
13: Wheel osr  
Scratched  
Up To 50mm

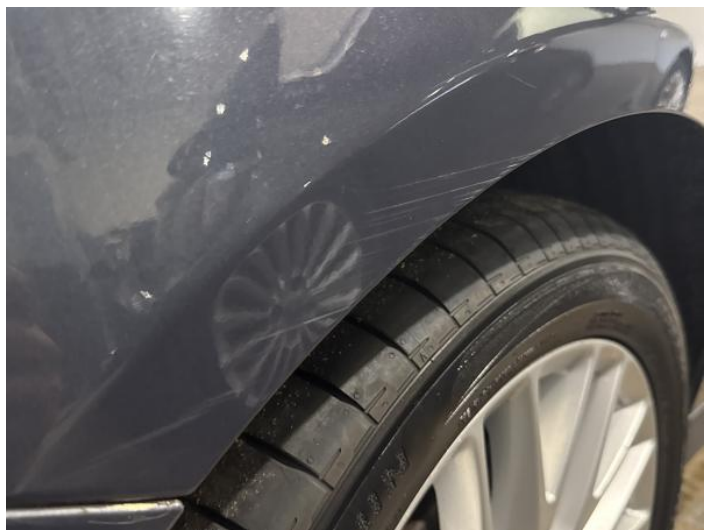
14: Qtr Panel osr  
Scratched  
Over 25mm Thru Paint

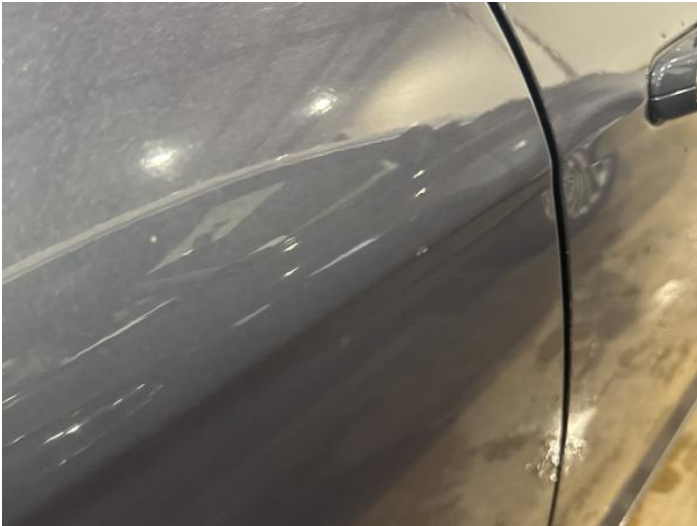
15: Door osr  
Chipped  
1 To 5

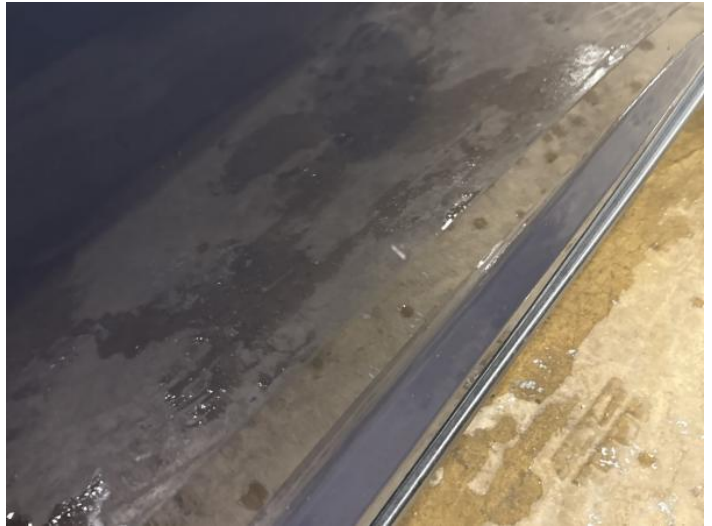
16: Door osf  
Scratched  
UpTo 25mm Thru Paint

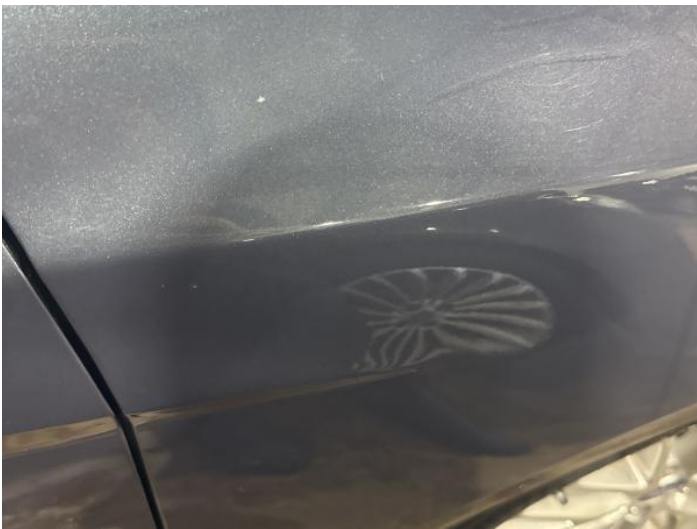
17: Wing osf  
Chipped  
1 To 5

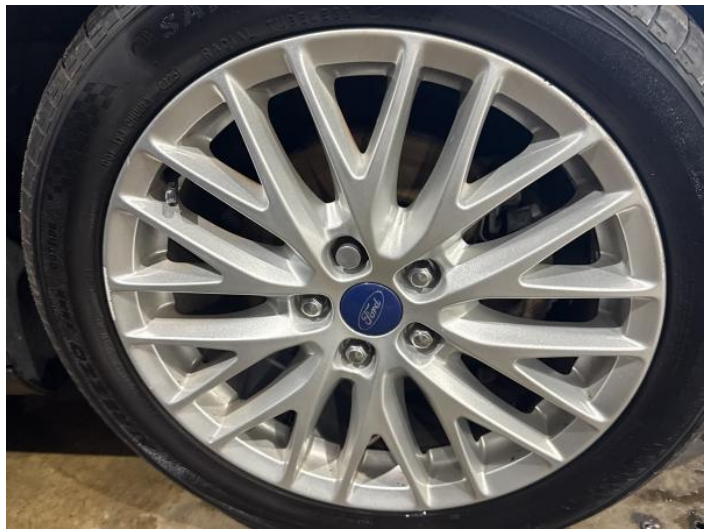
18: Wheel osf  
Scratched  
Over 50mm
