VEHICLE INSPECTION REPORT

KY11OBF

Mazda 6 2.0 Takuya 5dr

nama
GRADE
4

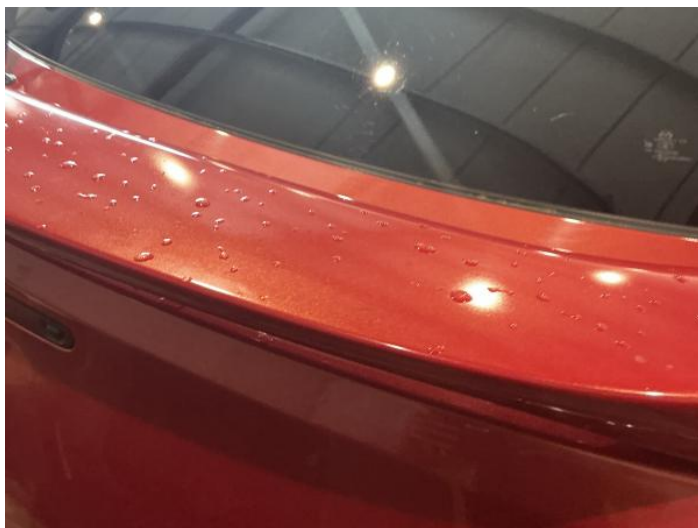
1: Boot Lid
Scratched
Over 25mm Not Thru Paint

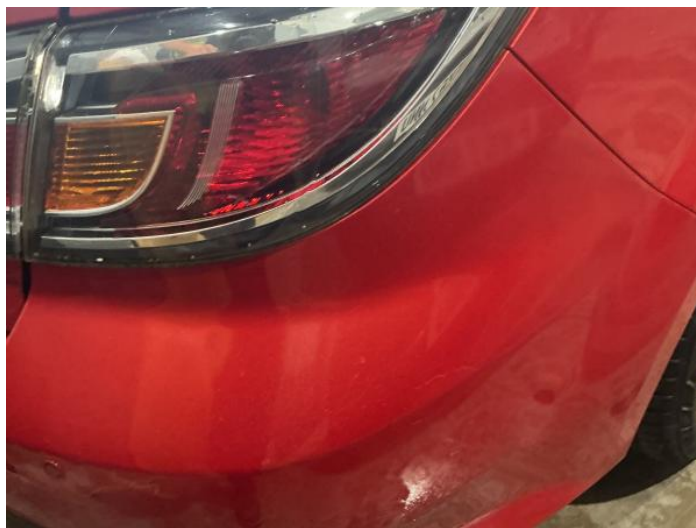
2: Bumper Rear
Scratched
Over 100mm Thru Paint

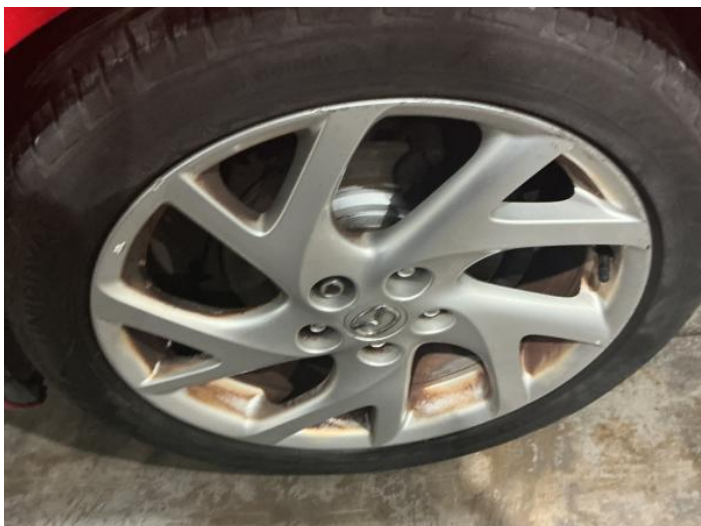
3: Wheel osr
Scratched
Over 50mm

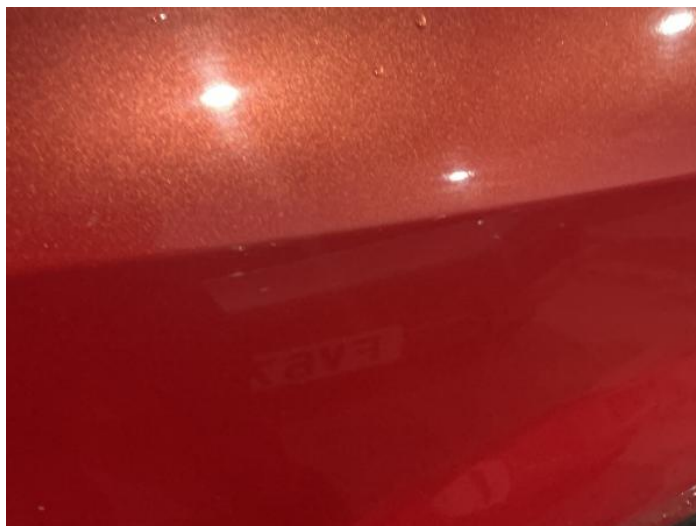
4: Qtr Panel osr
Chipped
1 To 5

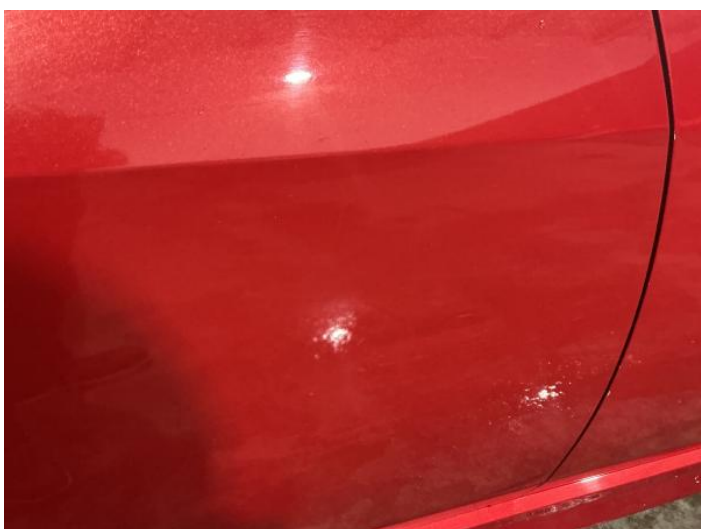
5: Door osr
Dented
Over 30mm

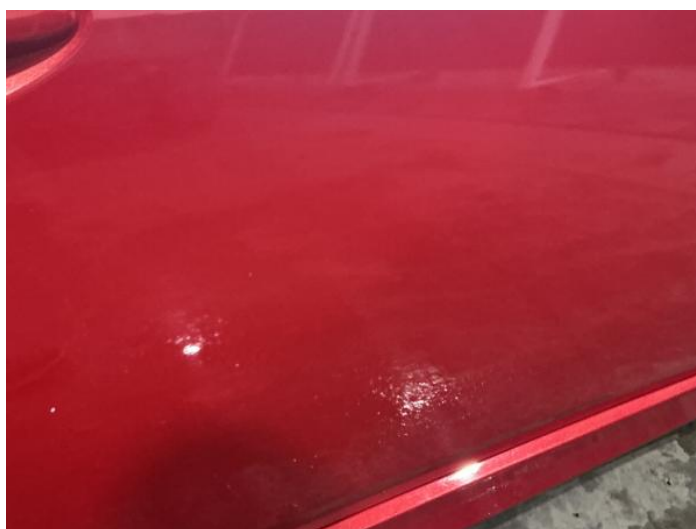
6: Door osf
Chipped
1 To 5

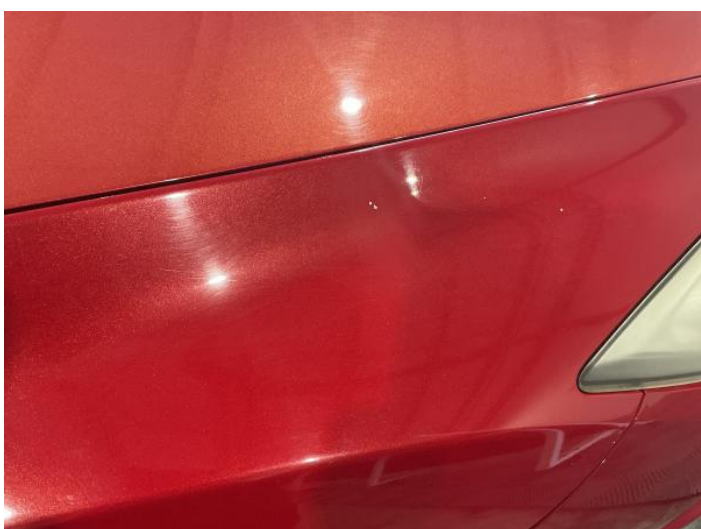
7: Wing osf
Chipped
Multiple Chips

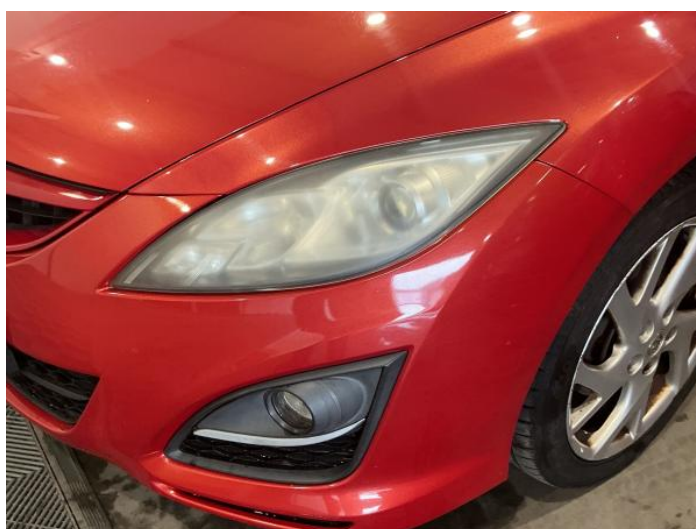
8: Bumper Front
Scratched
25 to 100mm Thru Paint

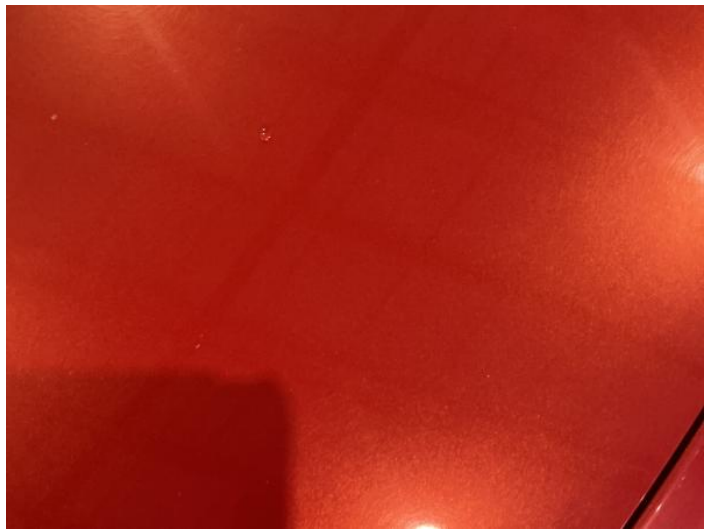
10: Bonnet
Chipped
1 To 5

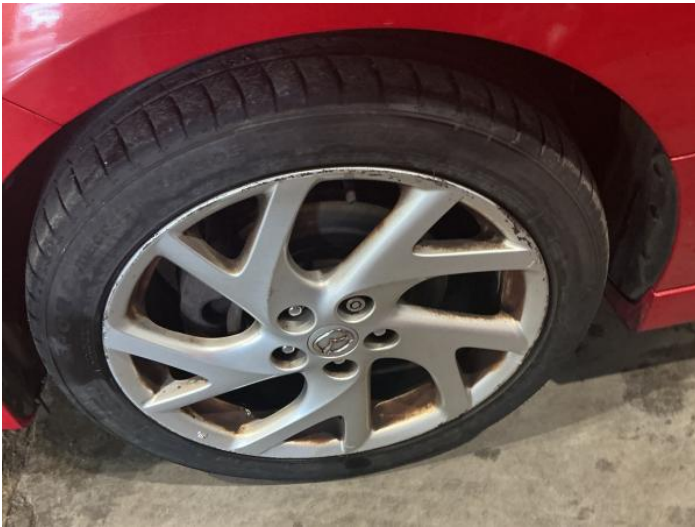
11: Wheel nsf
Scratched
Over 50mm

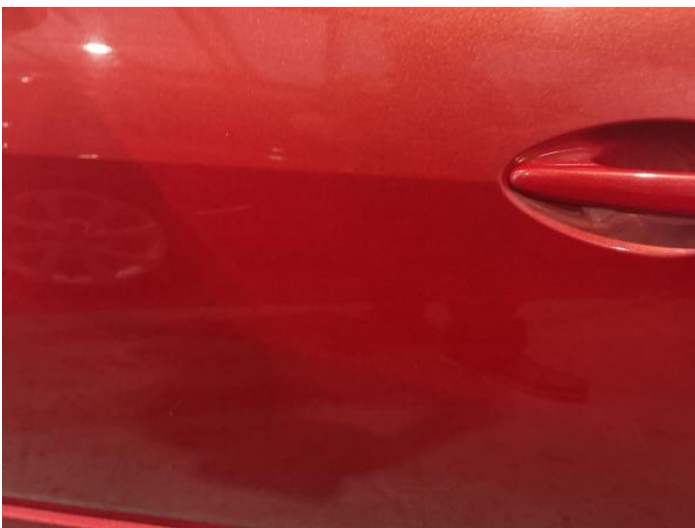
13: Door nsf
Dented
Over 2 UpTo 10mm

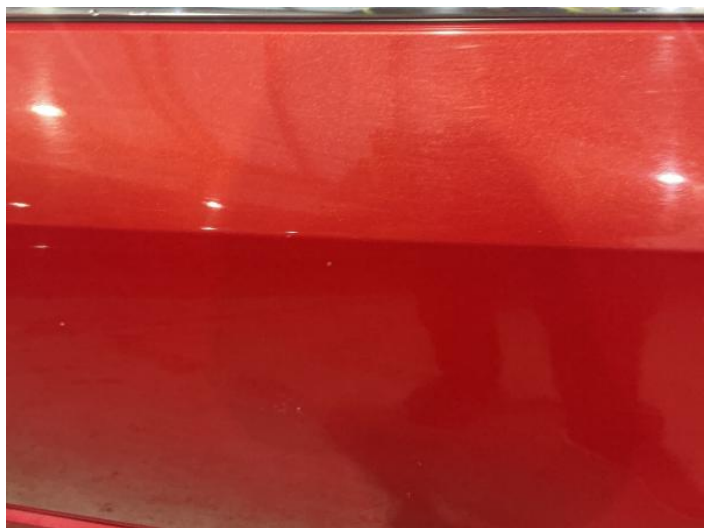
14: Door nsr
Chipped
1 To 5

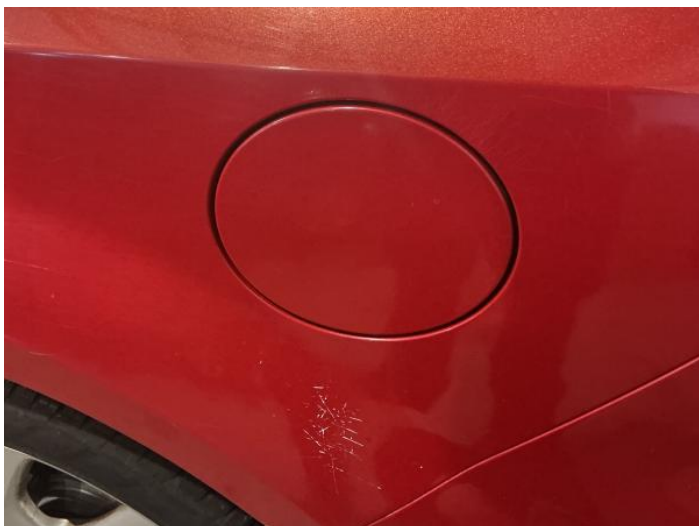
15: Qtr Panel nsr
Poor Previous Repair
Poor Paint

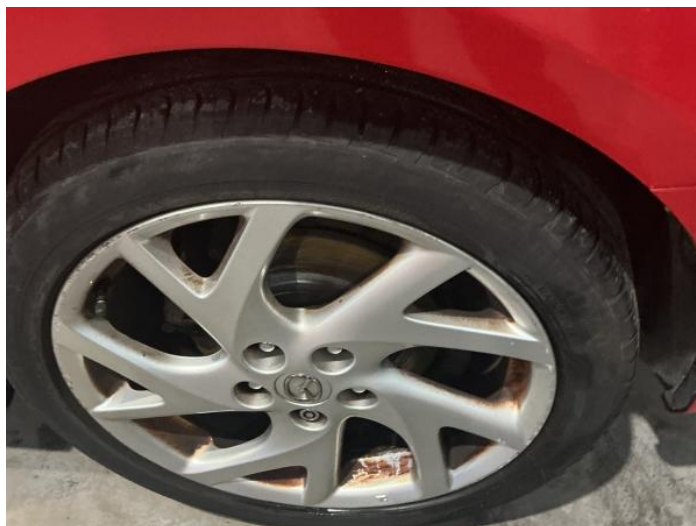
16: Wheel nsr
Scratched
Over 50mm

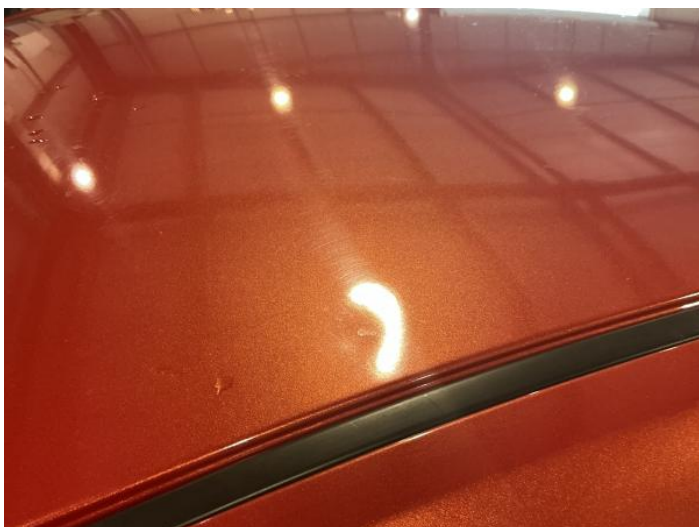
17: Roof
Dented
Between 10mm + 30mm

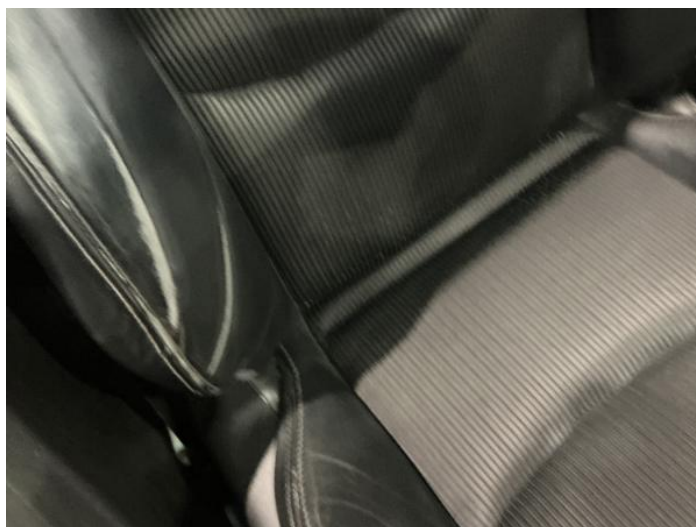
18: Seat Back Cover osf
Torn
Over 3mm
