# VEHICLE INSPECTION REPORT

**LD63AEK**

## Nissan Qashqai 1.6 [117] 360 5dr

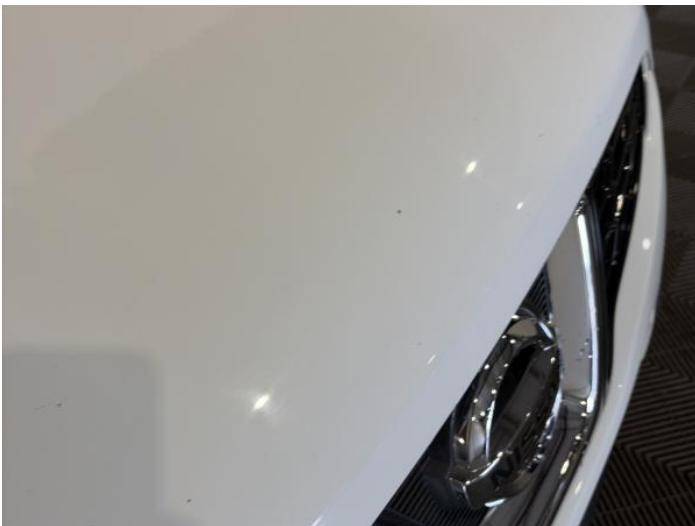
1: Bonnet  
Chipped  
Multiple Chips

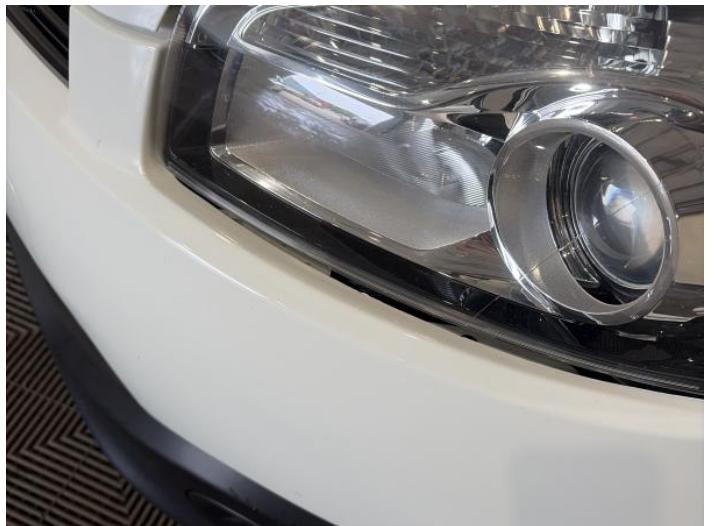
2: Bumper Front  
Insecure  
Action Required

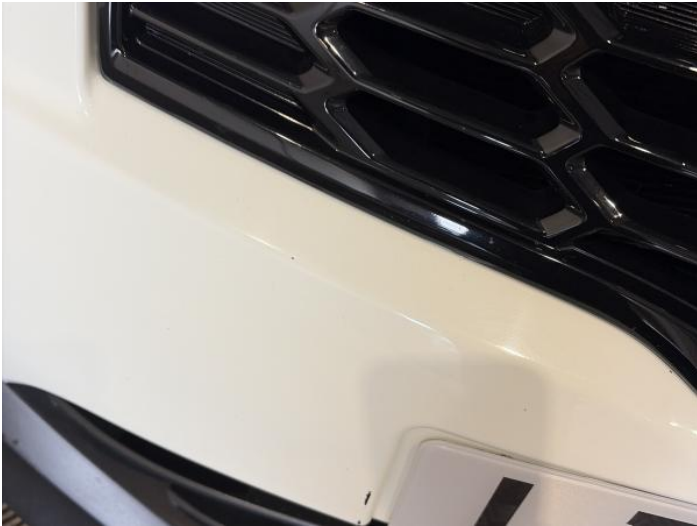
3: Bumper Front  
Poor Previous Repair  
Poor Paint

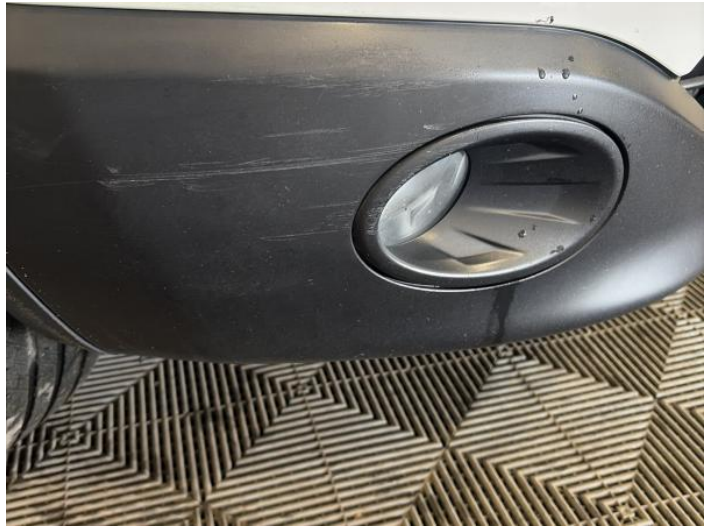
4: Bumper Front Moulding  
Scuffed (Unpainted)  
Over 100mm

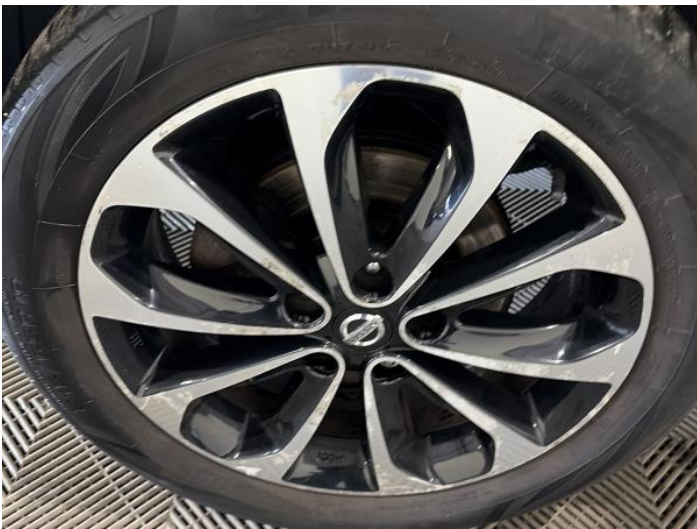
5: Wheel nsf  
Scratched  
Over 50mm

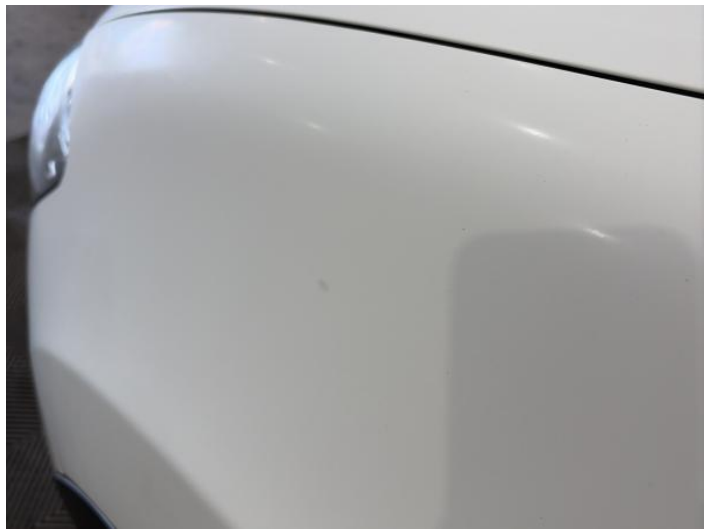
6: Wing nsf  
Scratched  
Up To 25mm Thru Paint

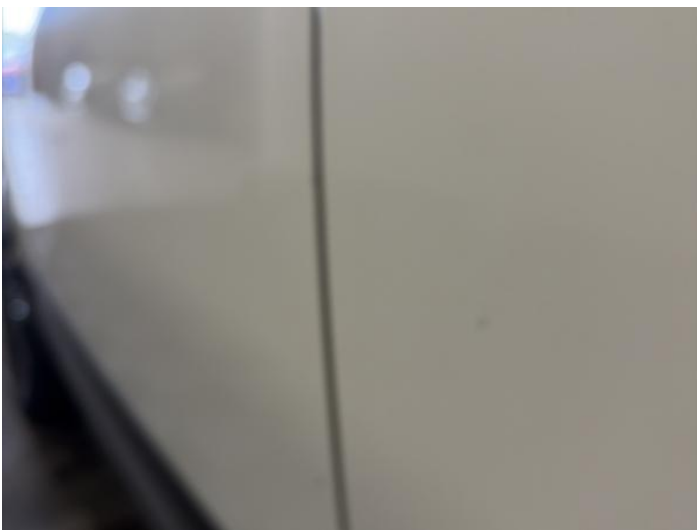
7: Door nsf  
Chipped  
Edge Chip

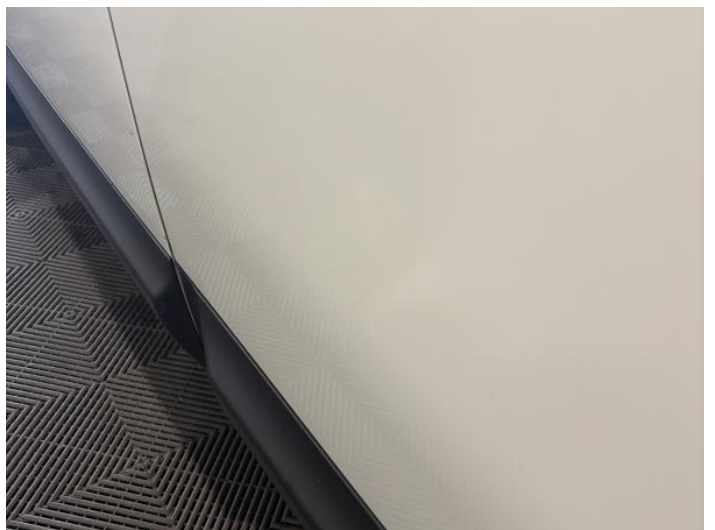
8: Door nsr  
Dented  
Between 10mm + 30mm

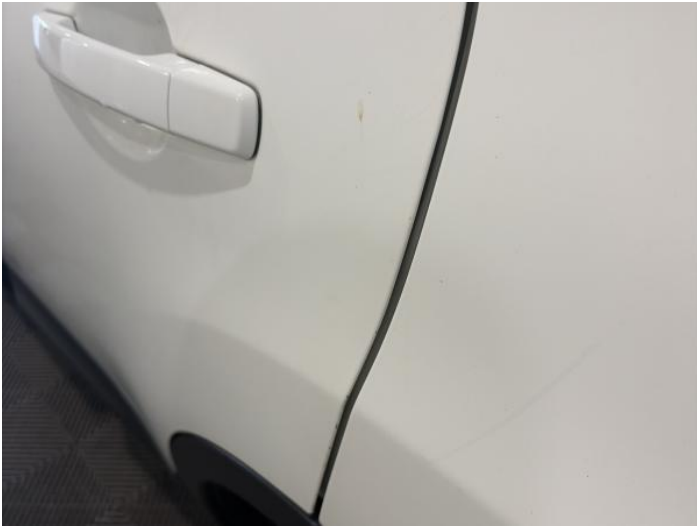
9: Door nsr  
Chipped  
Edge Chip

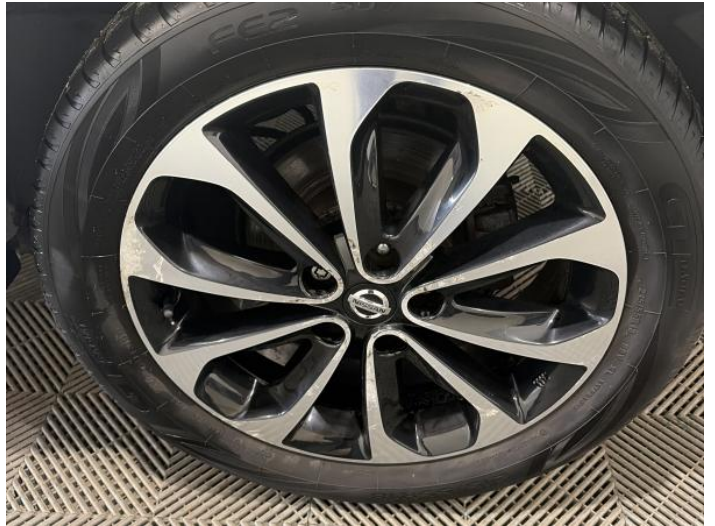
10: Wheel nsr  
Scratched  
Over 50mm

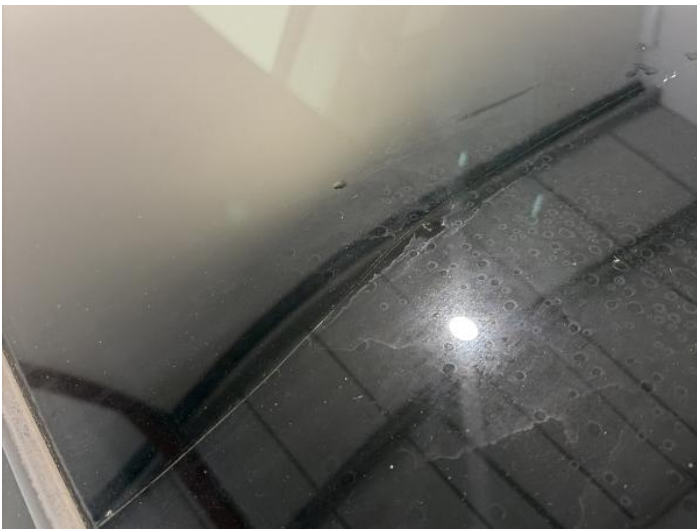
Last service 18/05/2026 at 127,142 miles- 1 service Glass roof cracked

11: Glass Roof  
Cracked  
Replace

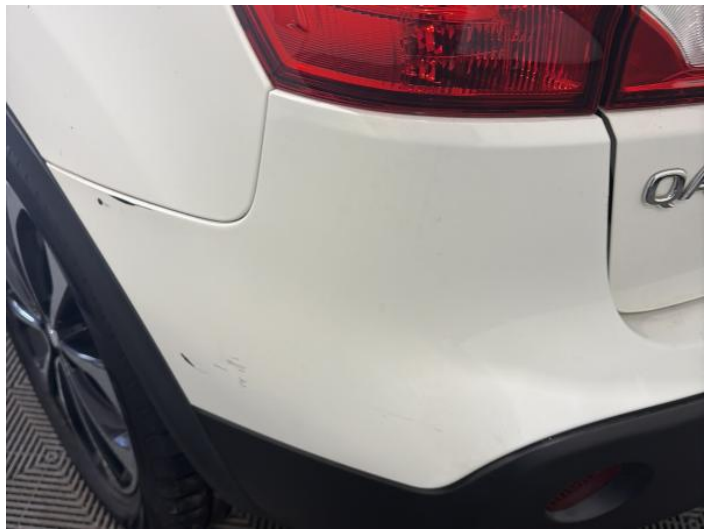
12: Bumper Rear  
Scratched  
25 to 100mm Thru Paint

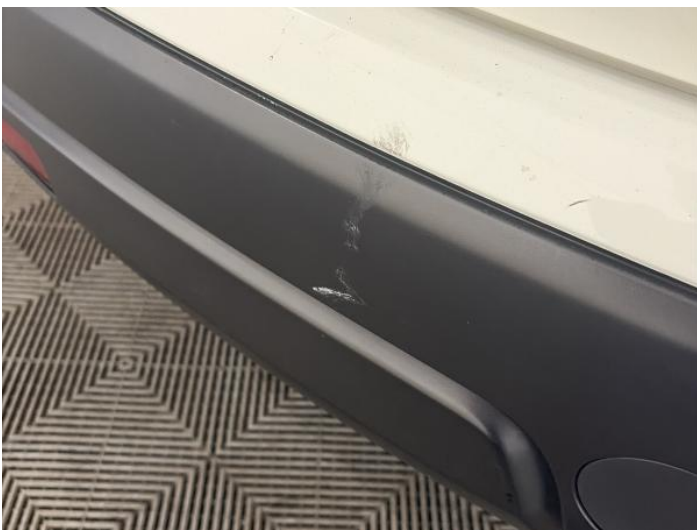
13: Bumper Rear Moulding  
Scuffed (Unpainted)  
UpTo 100mm

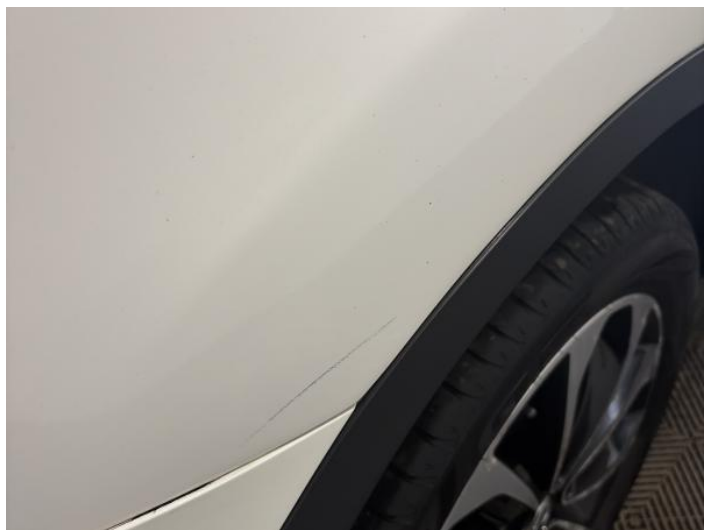
14: Qtr Panel osr  
Scratched  
Over 25mm Thru Paint

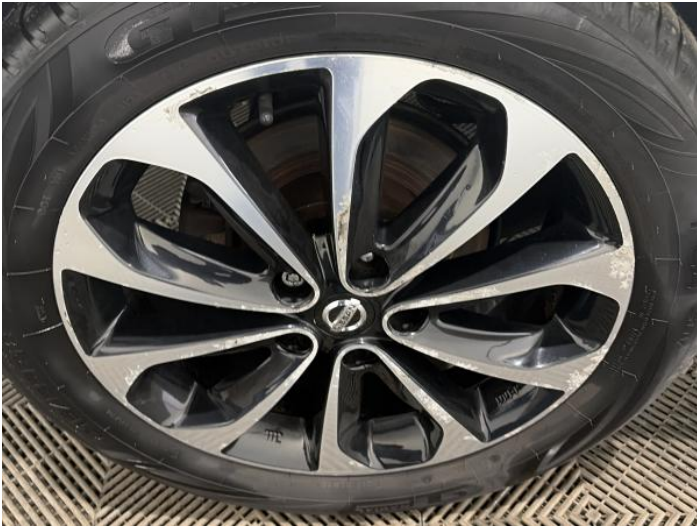
15: Wheel osr  
Scratched  
Over 50mm

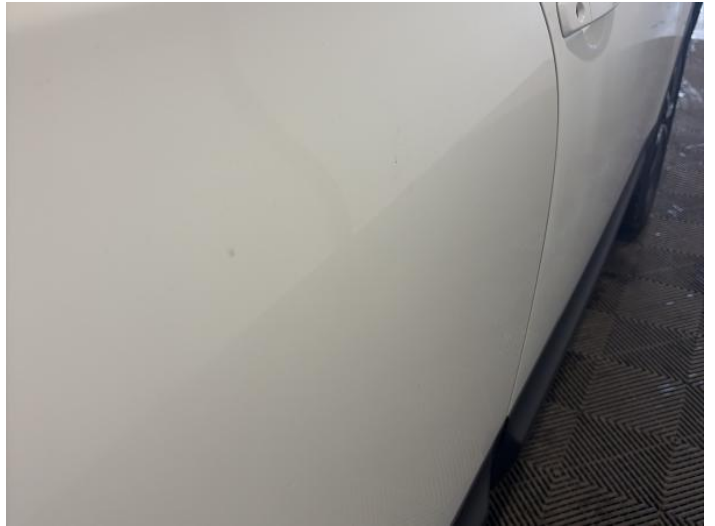
16: Door osr  
Dented  
Between 10mm + 30mm

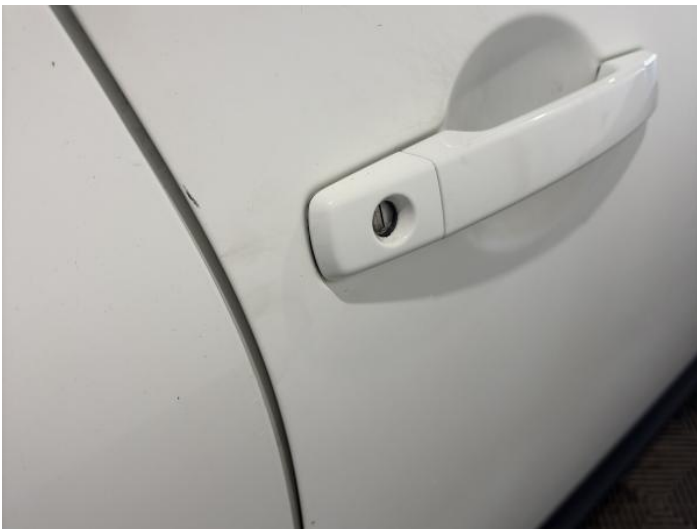
17: Door osf  
Scratched  
UpTo 25mm Thru Paint

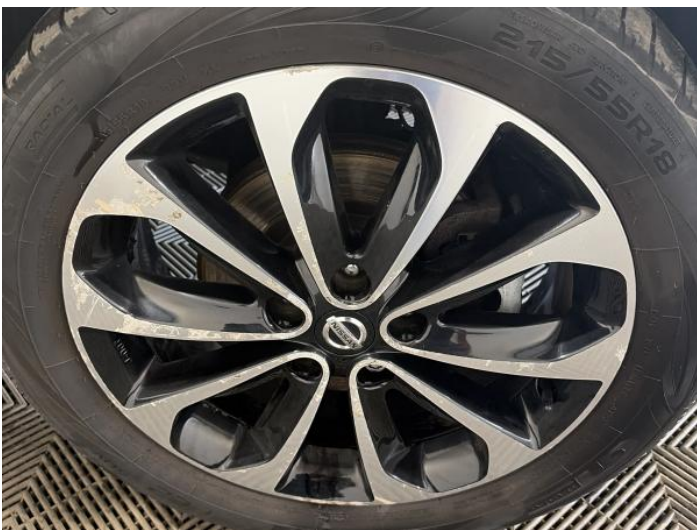
19: Wheel osf  
Scratched  
Over 50mm
