VEHICLE INSPECTION REPORT

GV14XBD

Volkswagen Golf 2.0 TDI GT 5dr

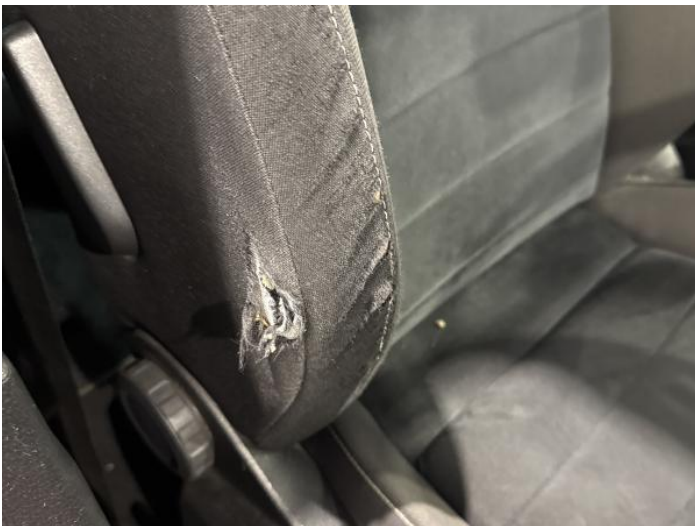
1: Seat Back Cover of
Torn
Over 3mm

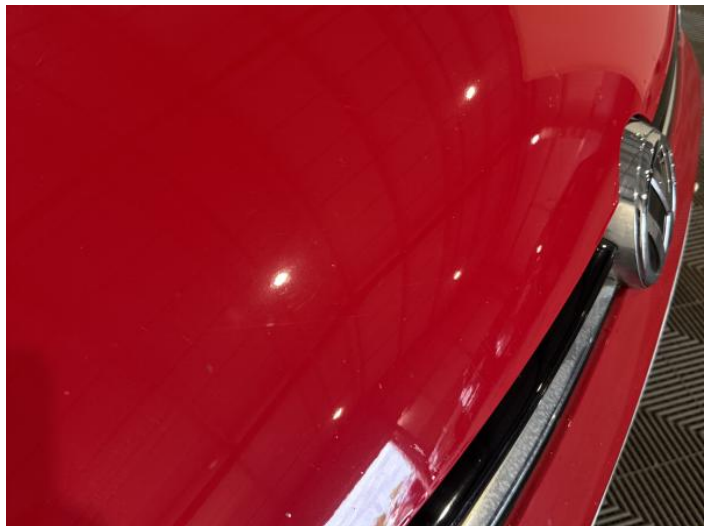
2: Bonnet
Chipped
Multiple Chips

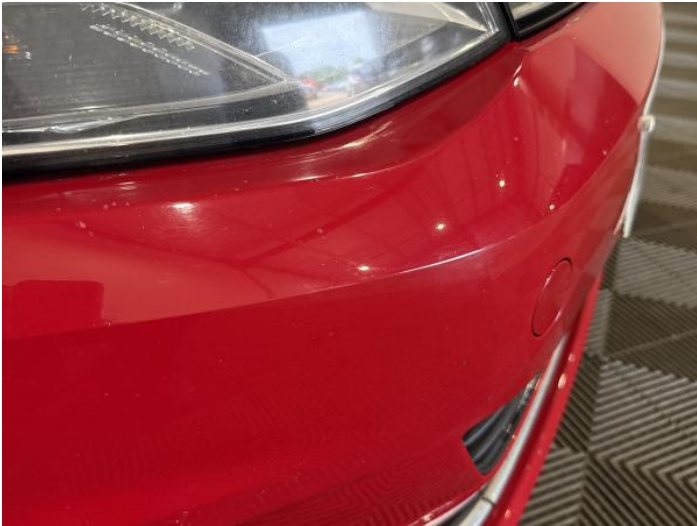
3: Bumper Front
Poor Previous Repair
Paint Flake

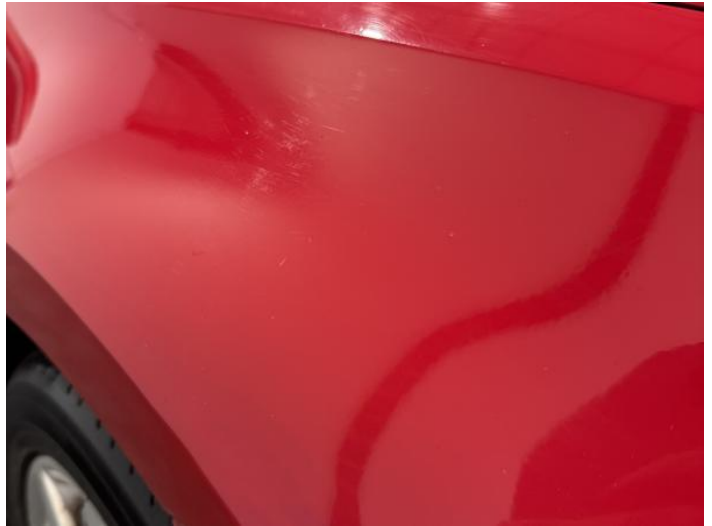
4: Wing osf
Poor Previous Repair
Poor Paint

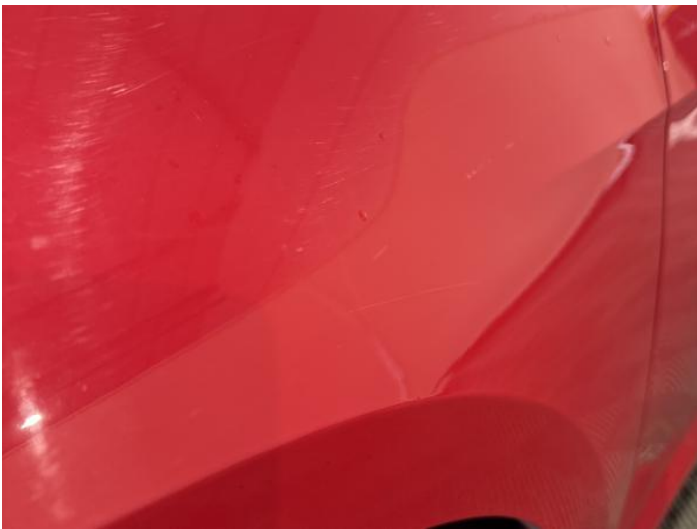
5: Wing nsf
Scratched
Over 25mm Thru Paint

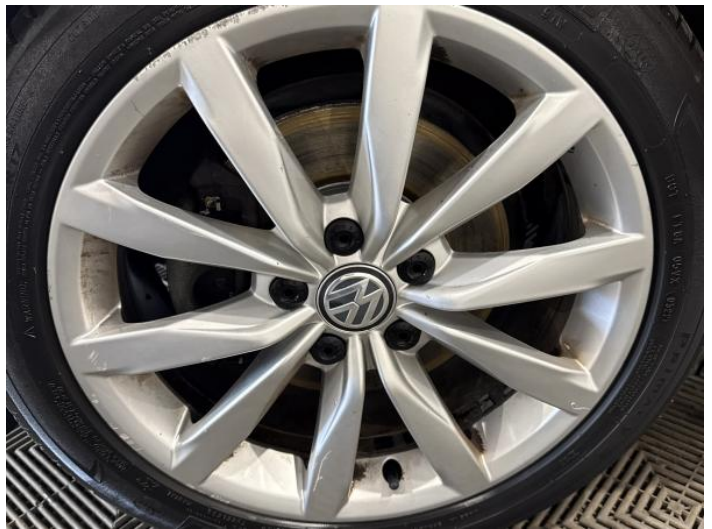
6: Wheel nsf
Scratched
Over 50mm

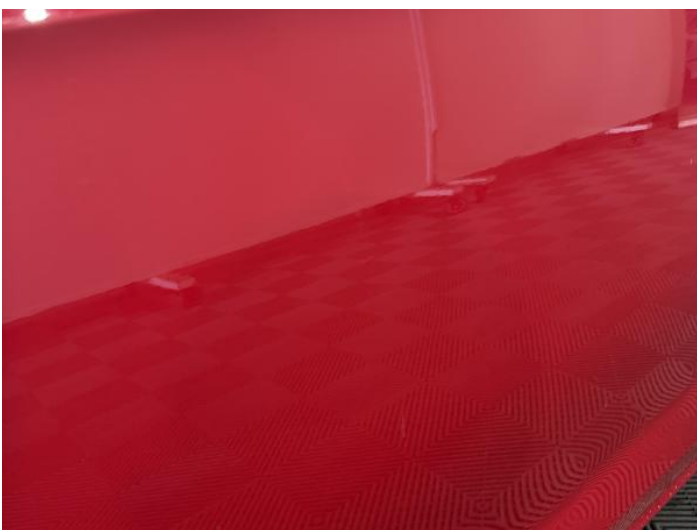
7: Door nsf
Scratched
Over 25mm Thru Paint

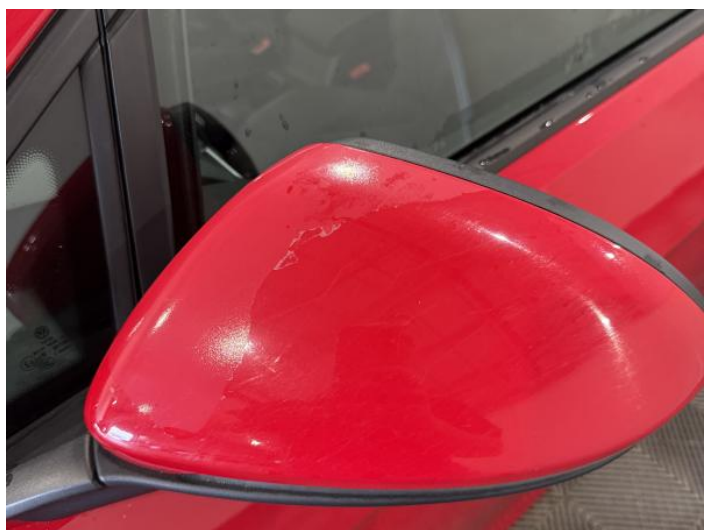
8: Door Mirror Assy nsf
Scratched (Painted)
Over 25mm Thru Paint

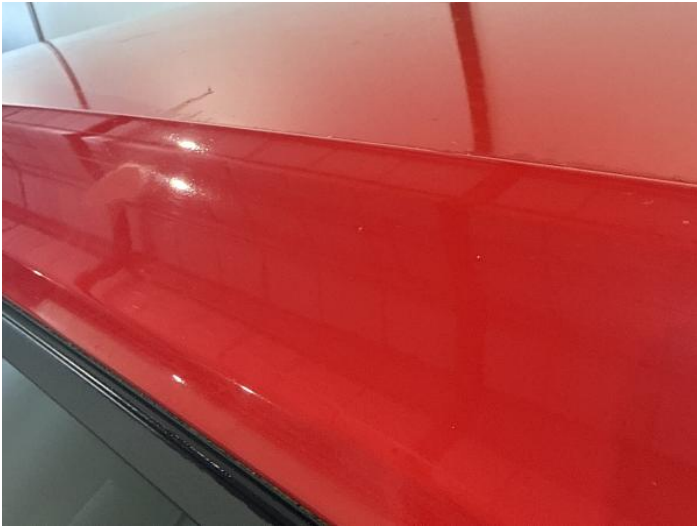
9: B Post ns
Scratched
Over 25mm Thru Paint

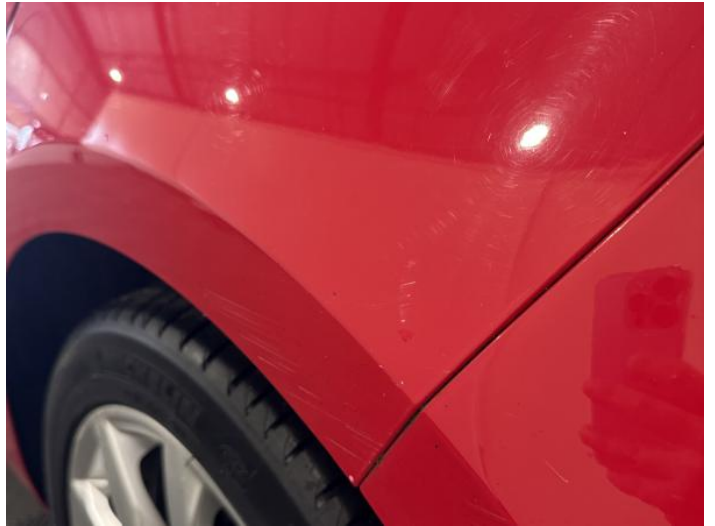
10: Qtr Panel nsr
Scratched
Over 25mm Thru Paint

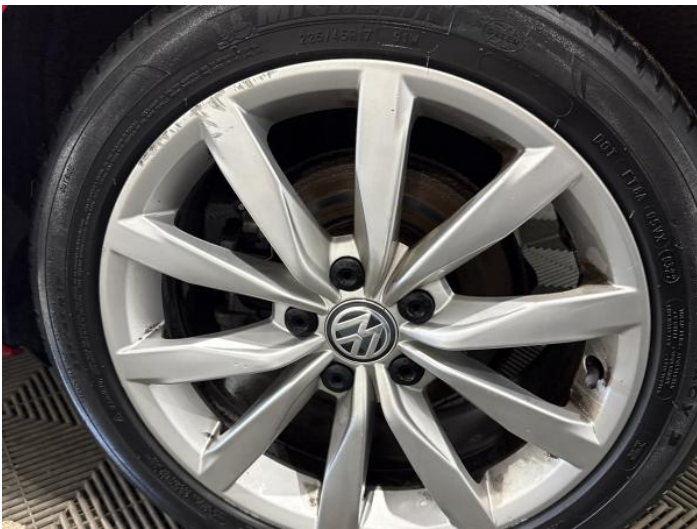
11: Wheel nsr
Scratched
Over 50mm

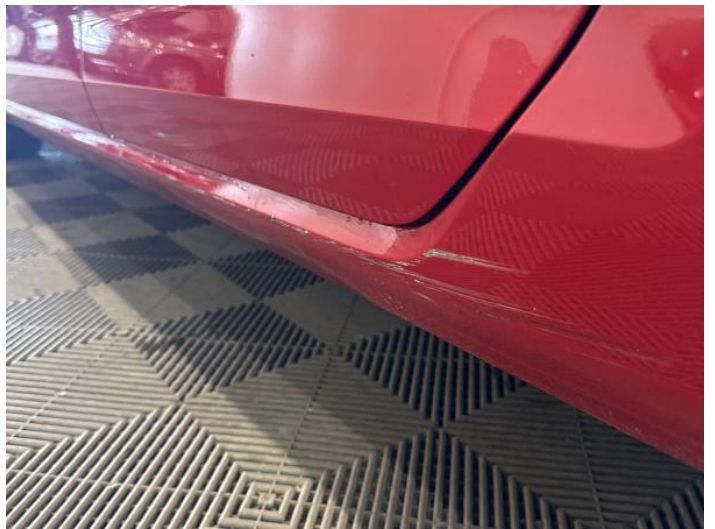
12: Sill ns
Scratched
Over 25mm Thru Paint

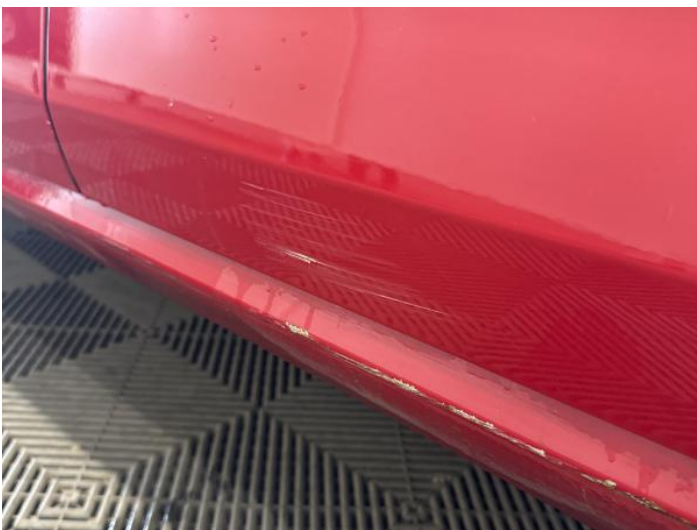
13: Door nsr
Scratched
Over 25mm Thru Paint

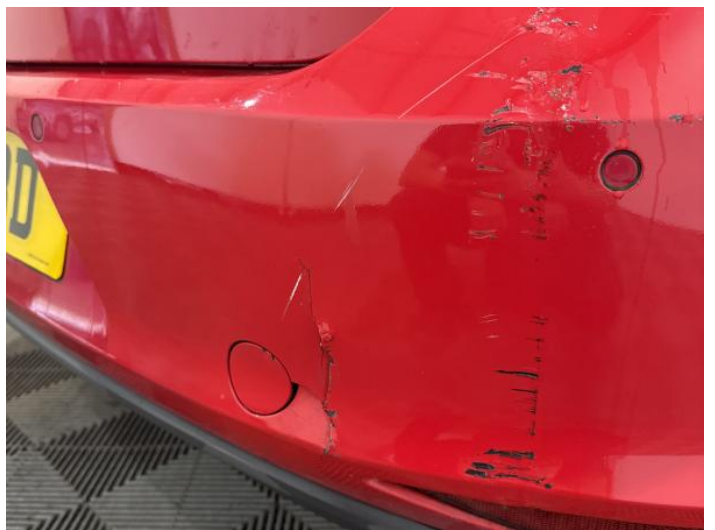
14: Bumper Rear
Cracked
Over 25mm

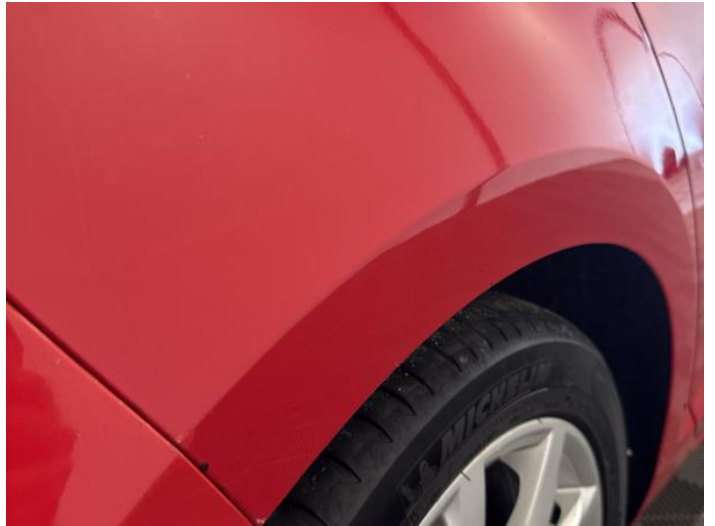
16: Qtr Panel osr
Scratched
Over 25mm Thru Paint

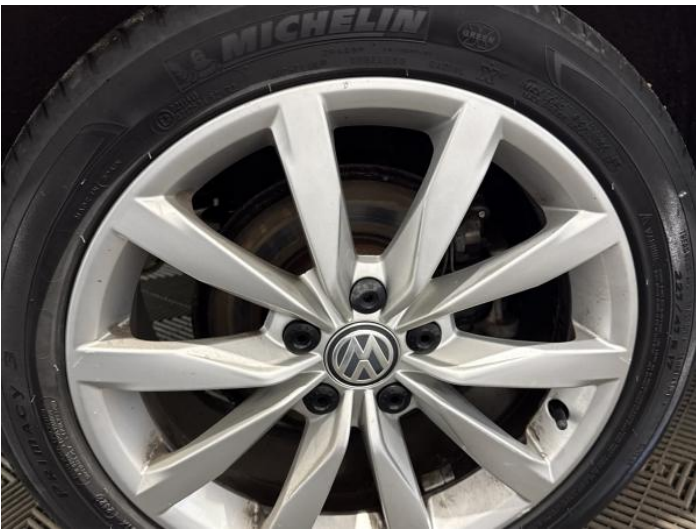
17: Wheel osr
Scratched
Over 50mm

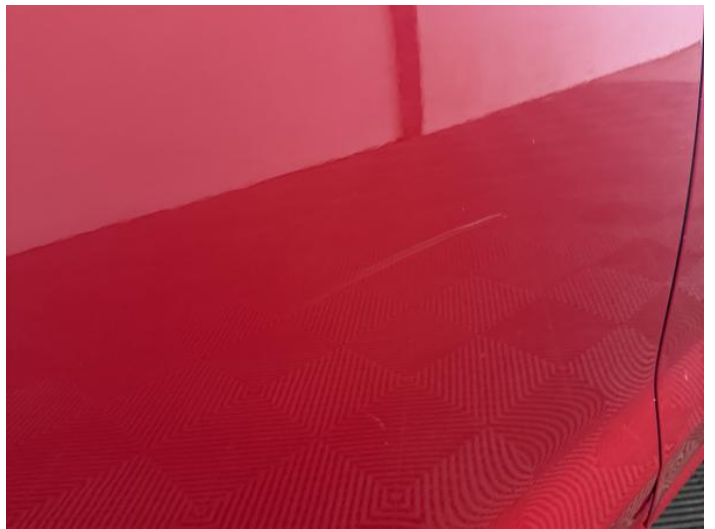
18: Door osr
Scratched
Over 25mm Thru Paint

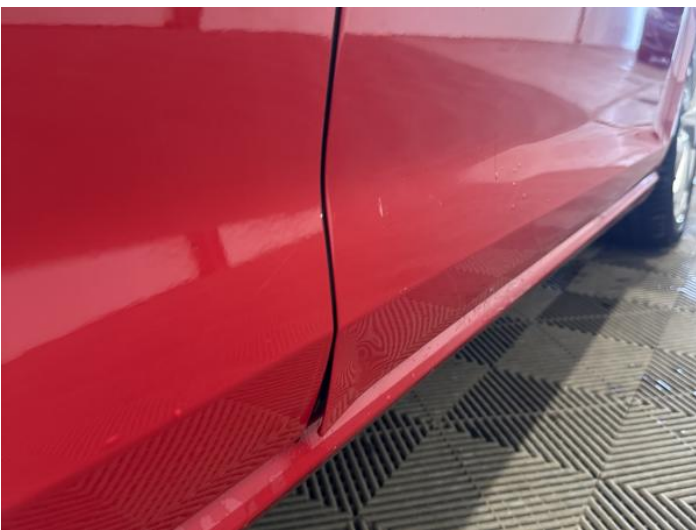
19: Door osf
Dented
Over 30mm

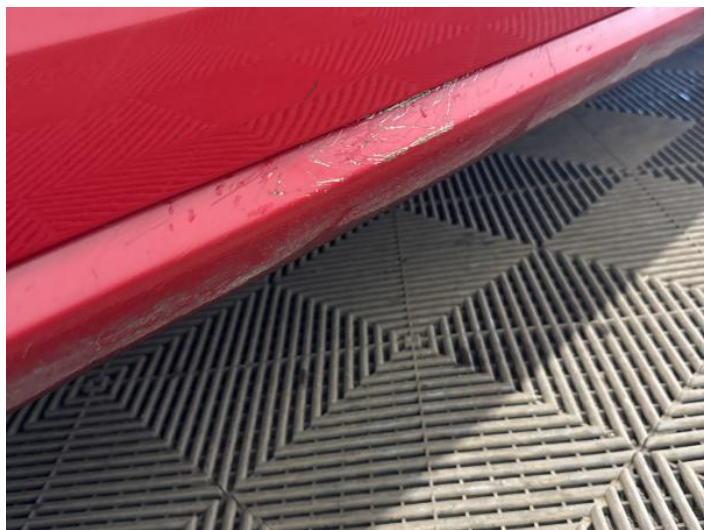
20: Sill os
Scratched
Over 25mm Thru Paint

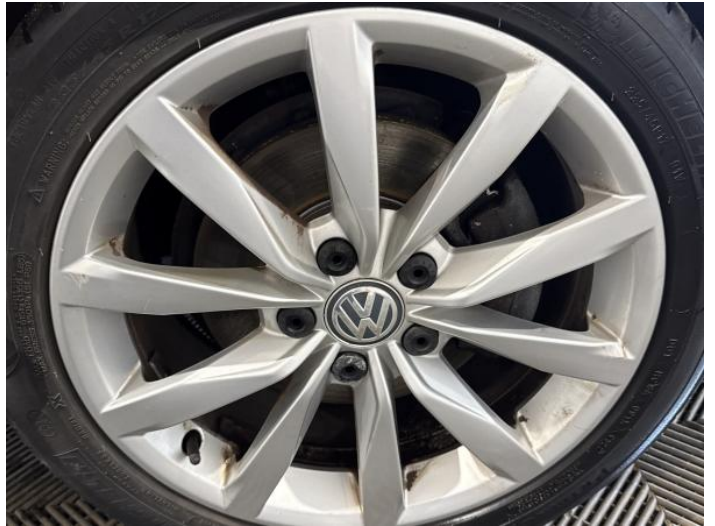
22: Wheel osf
Scratched
Up To 50mm

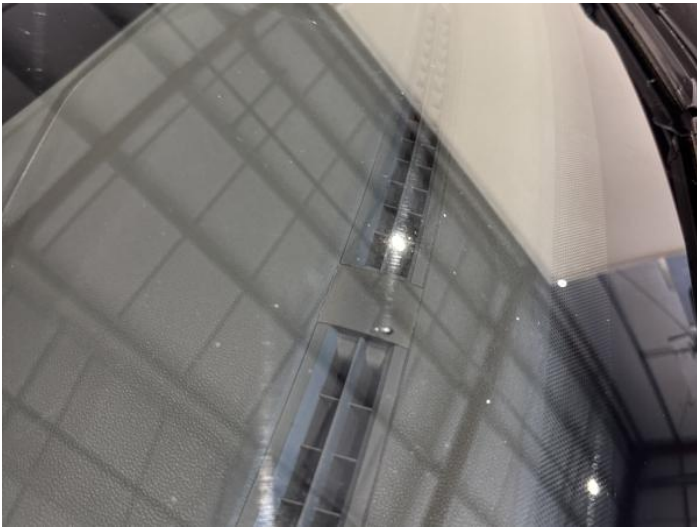
23: Screen Front
Chipped
Up To 10mm

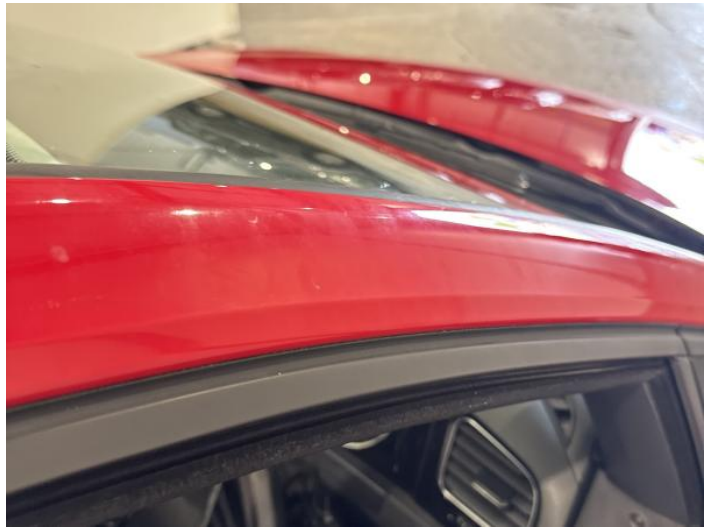
24: A Post os
Chipped
1 To 5

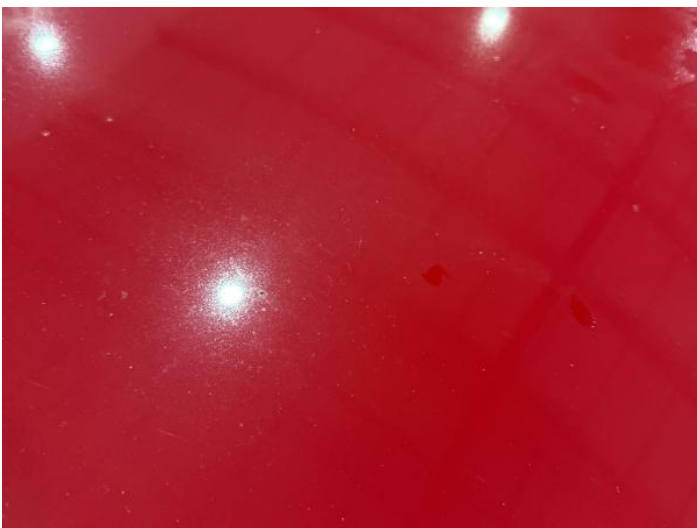
25: Roof
Chipped
1 To 5
