VEHICLE INSPECTION REPORT

NX59UMO

Ford Fusion 1.4 Zetec 5dr [Climate]

nama
 GRADE
5

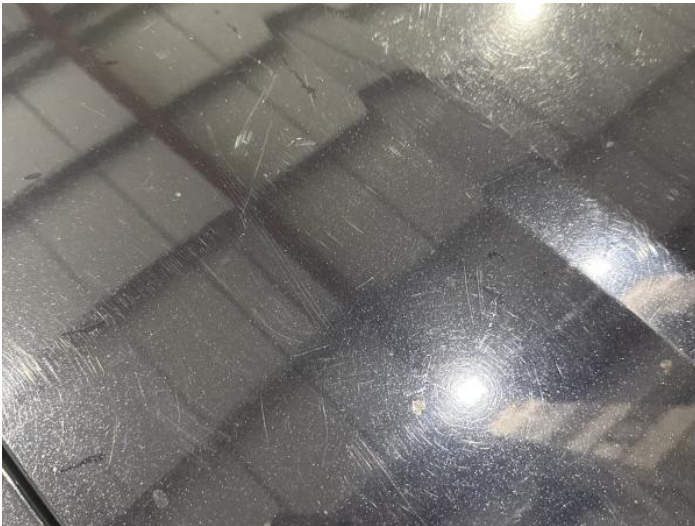
1: Bonnet
Scratched
Over 25mm Thru Paint

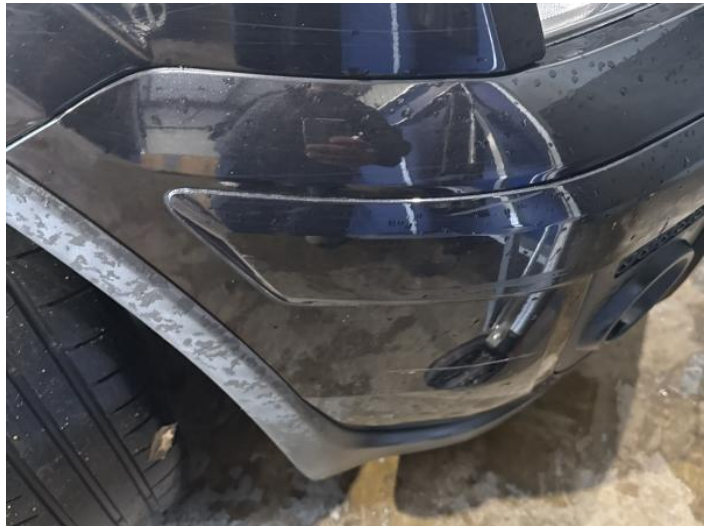
2: Bumper Front
Scratched
25 to 100mm Thru Paint

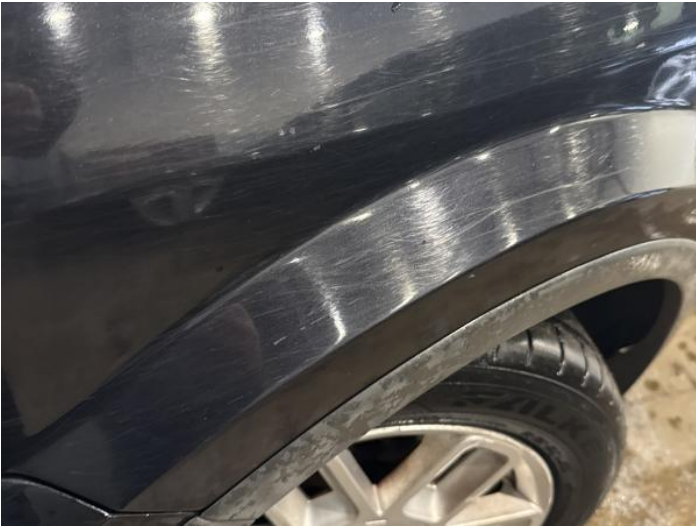
3: Wing nsf
Scratched
Over 25mm Thru Paint

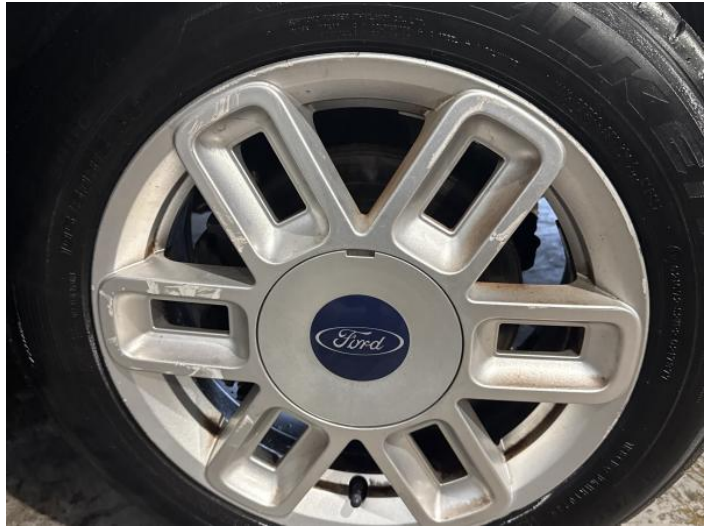
4: Wheel nsf
Scratched
Over 50mm

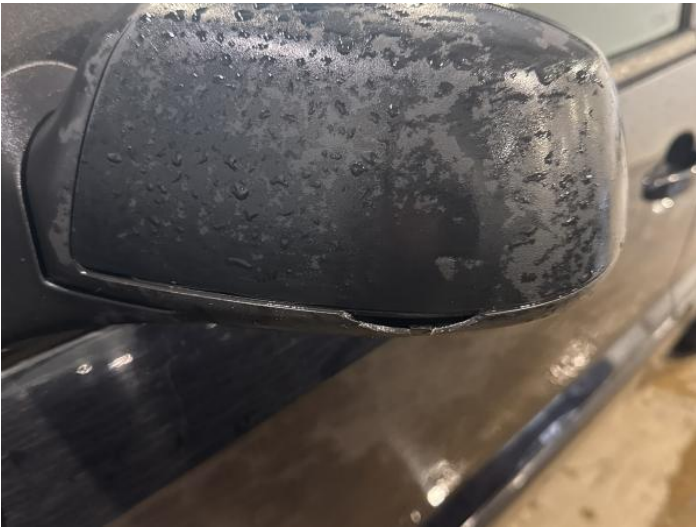
5: Door Mirror Assy nsf
Broken
Replace

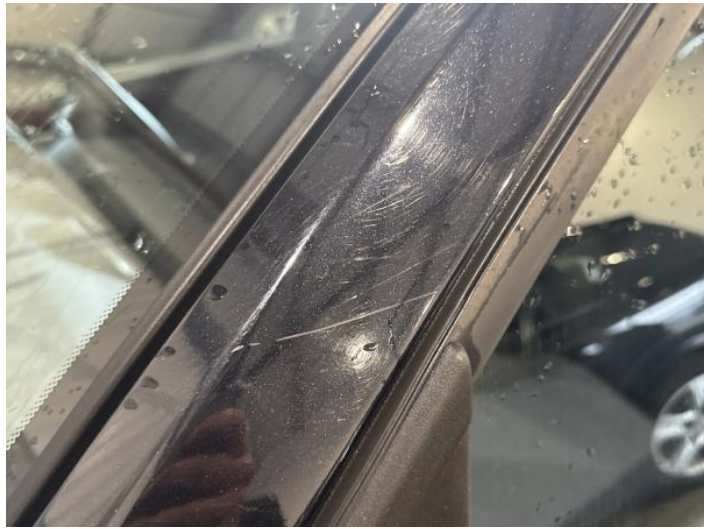
6: A Post ns
Scratched
Over 25mm Thru Paint

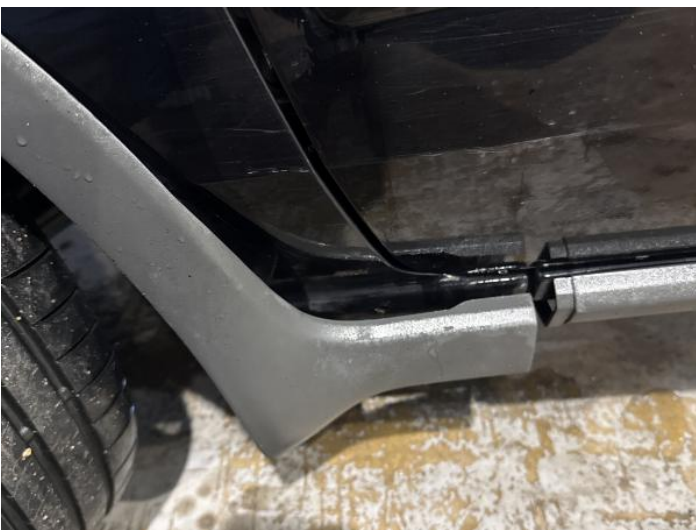
7: Wing Front Arch Extension ns
Broken
Replace

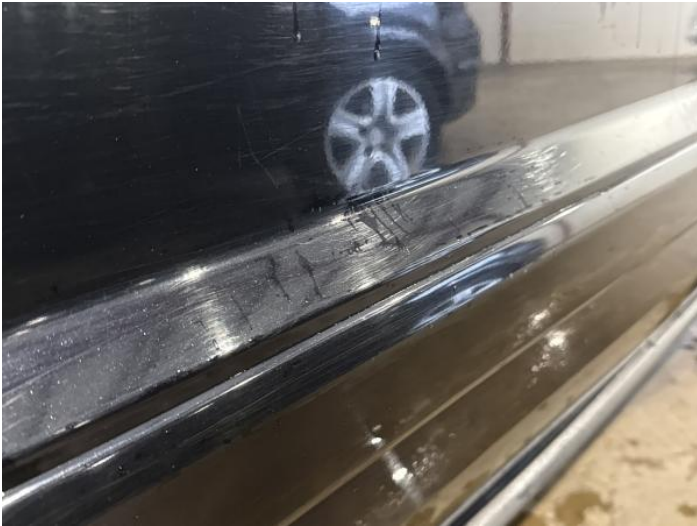
9: Door nsf
Scratched
Over 25mm Thru Paint

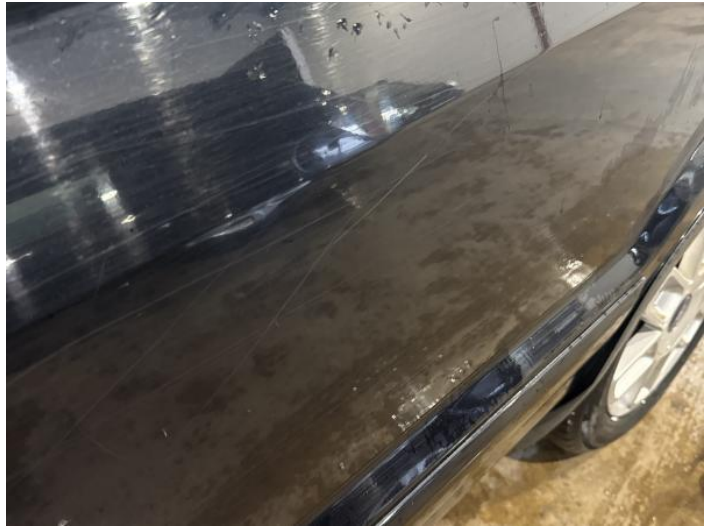
10: Door nsr
Scratched
Over 25mm Thru Paint

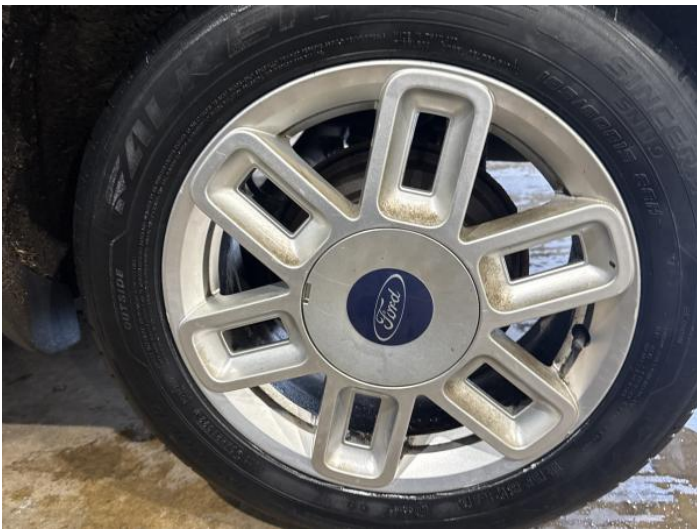
11: Wheel nsr
Scratched
Over 50mm

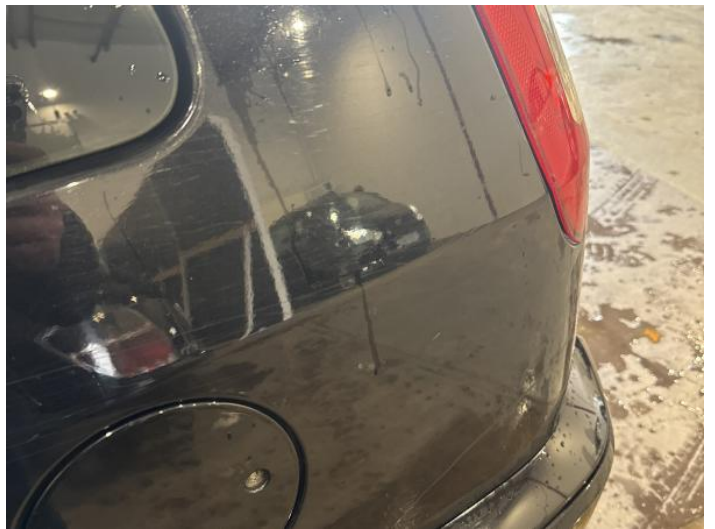
12: Qtr Panel nsr
Scratched
Over 25mm Thru Paint

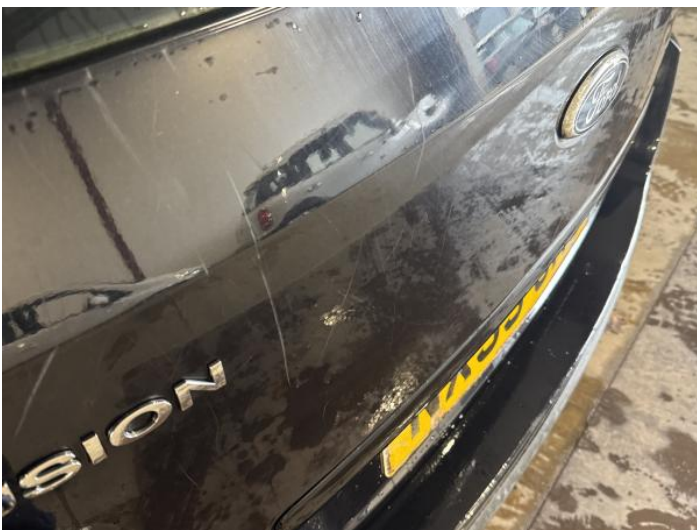
13: Tailgate
Dented
With Paint Damage

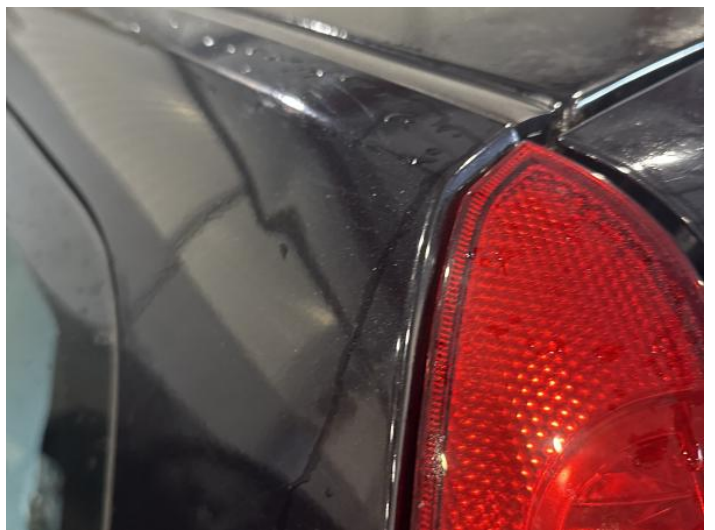
14: Qtr Panel osr
Dented
Between 10mm + 30mm

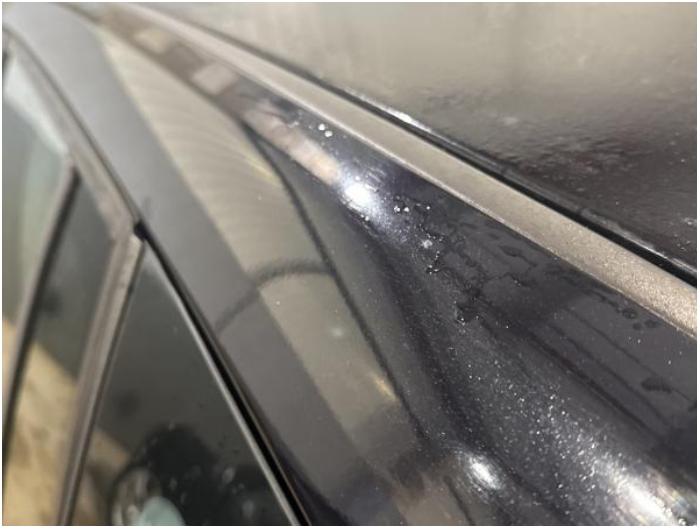
15: C Post ns
Dented
Between 10mm + 30mm

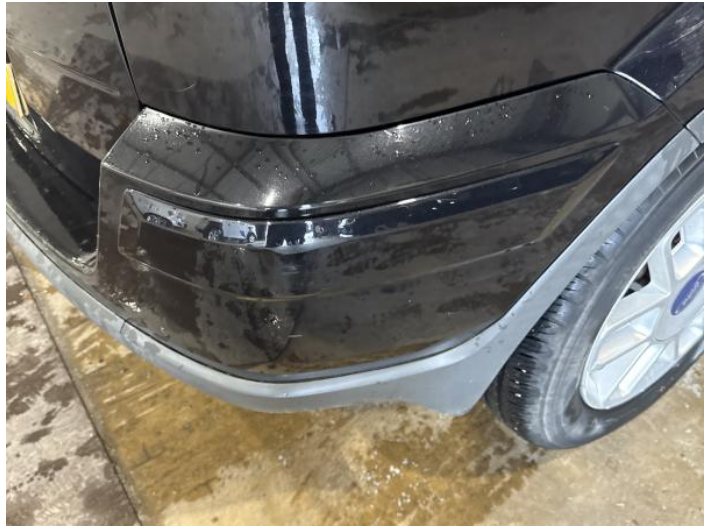
16: Bumper Rear
Scratched
Over 100mm Thru Paint

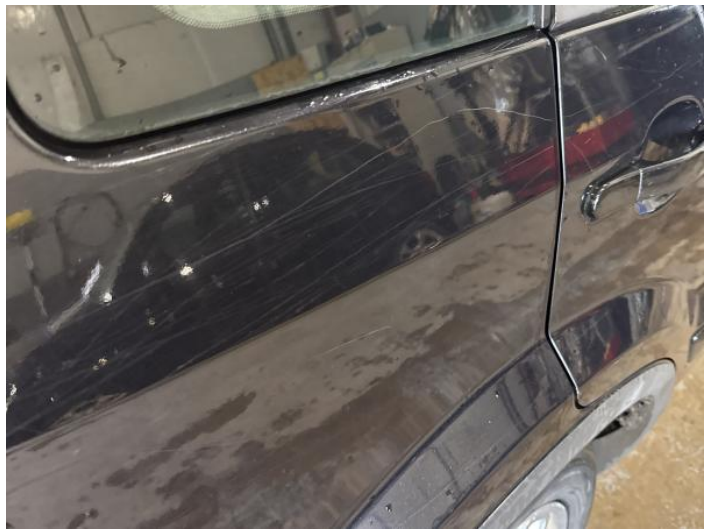
18: Qtr Panel osr
Scratched
Over 25mm Thru Paint

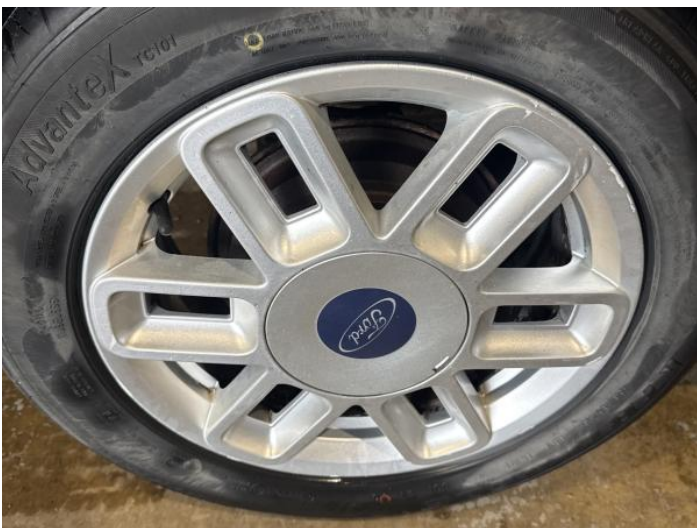
19: Wheel osr
Scratched
Over 50mm

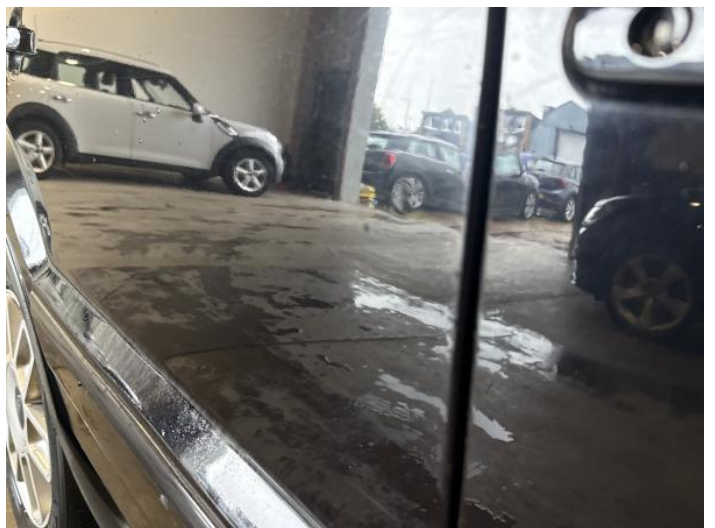
20: Door osr
Dented
Between 10mm + 30mm

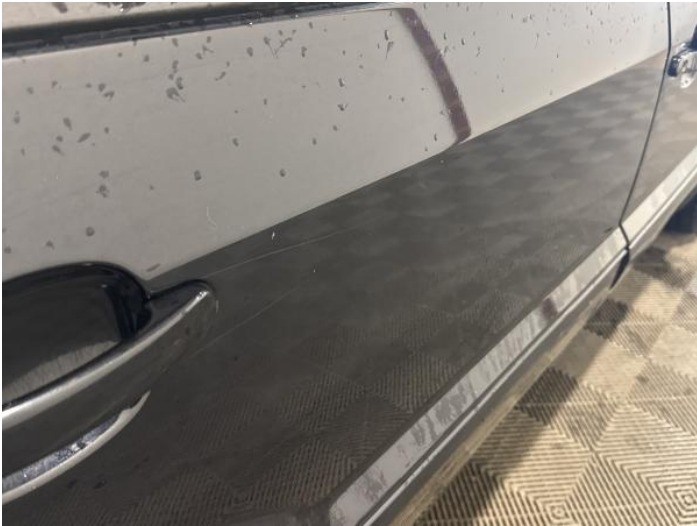
21: Door osr
Scratched
Over 25mm Thru Paint

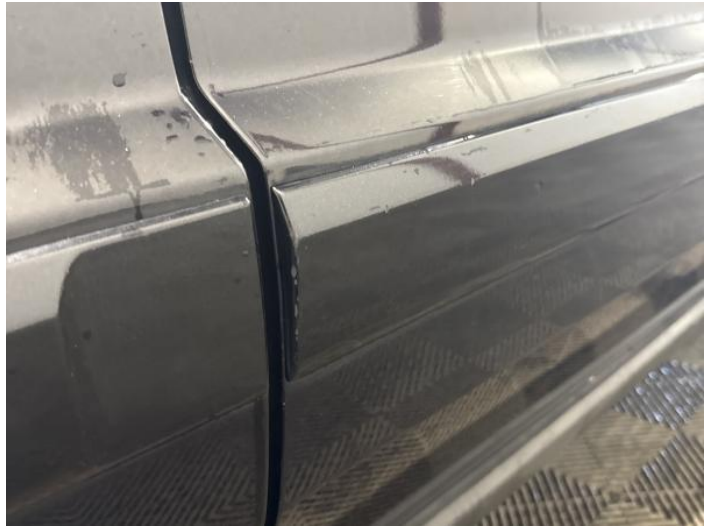
22: Door osf
Chipped
Edge Chip

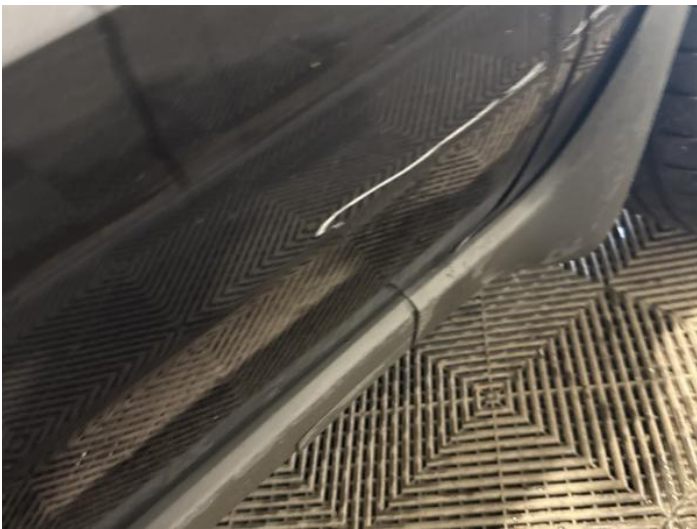
23: Door osf
Scratched
Over 25mm Thru Paint

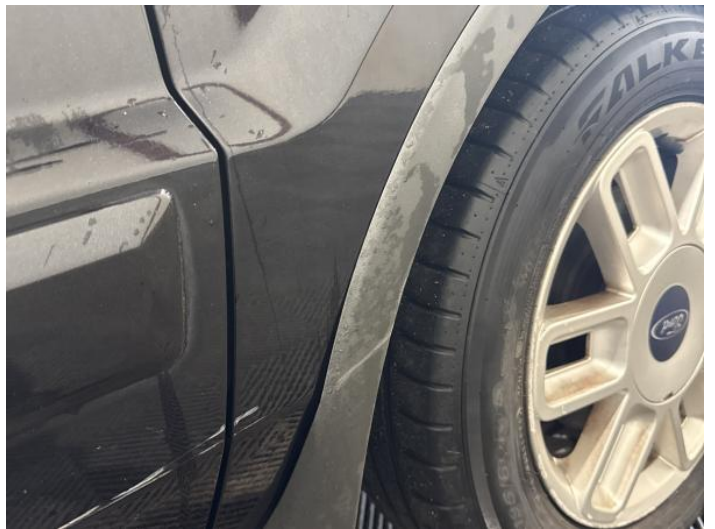
24: Wing osf
Scratched
Over 25mm Thru Paint

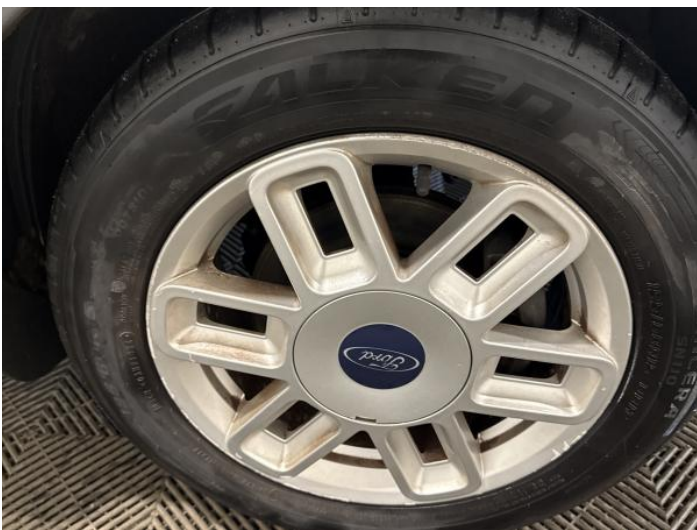
25: Wheel osf
Scratched
Over 50mm

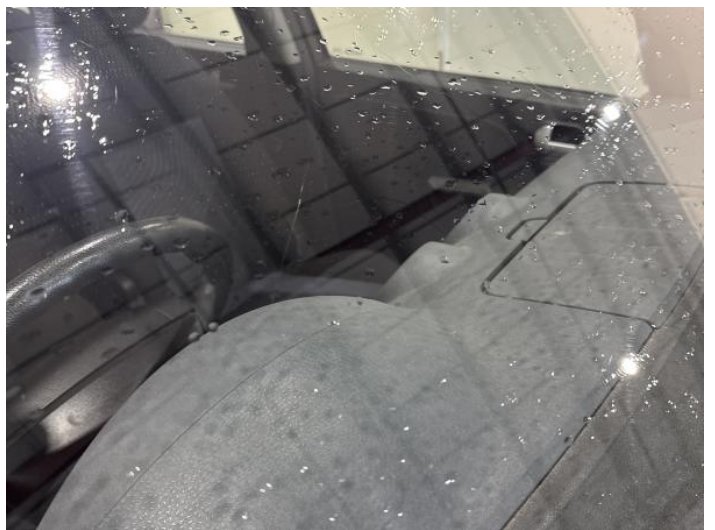
26: Screen Front
Scratched
Over 30mm

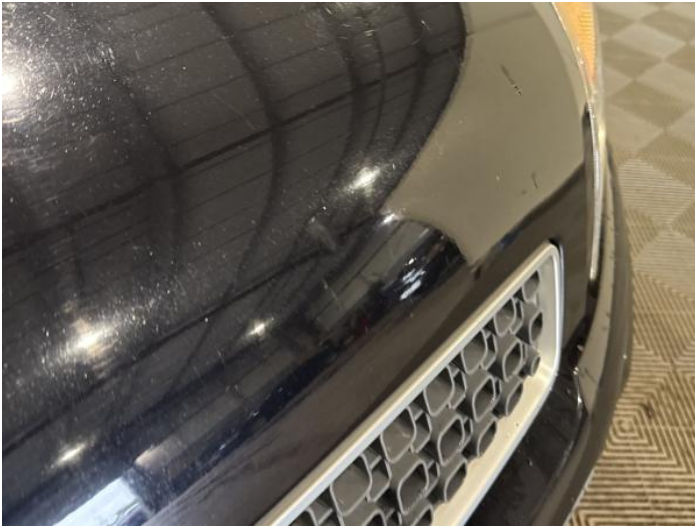
27: Bonnet
Dented
Between 10mm + 30mm

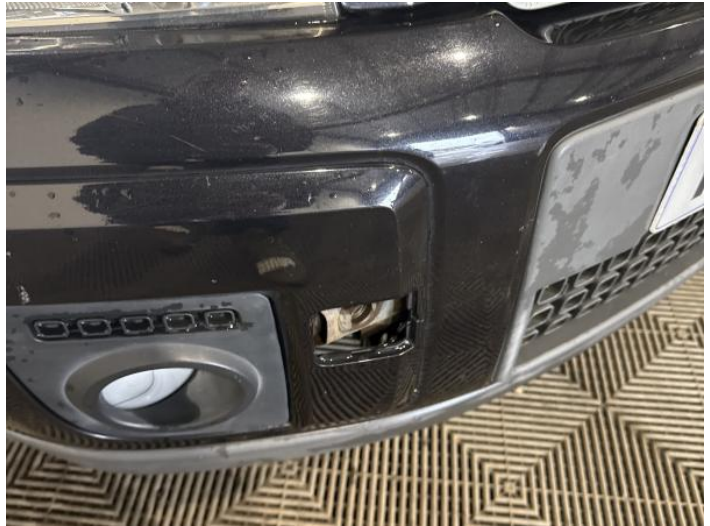
28: Front TowEye Cvr
Missing
Replace
