VEHICLE INSPECTION REPORT

FA15AZC

Nissan Qashqai 1.5 dCi [110] Acenta 5dr

nama
GRADE
5

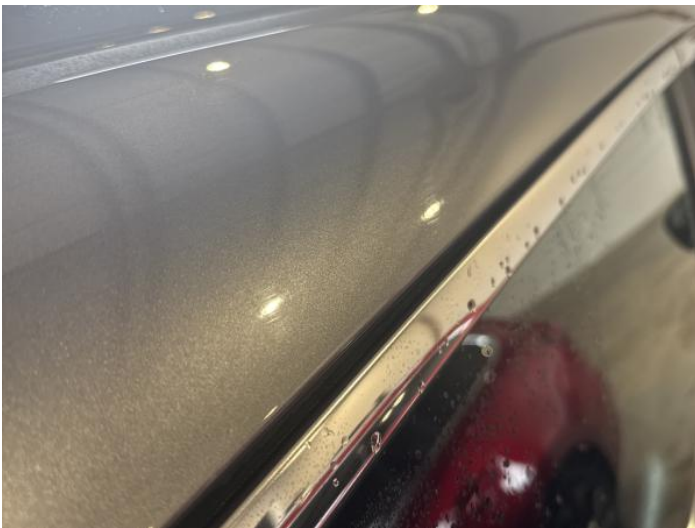
1: B Post os
Dented
Over 30mm

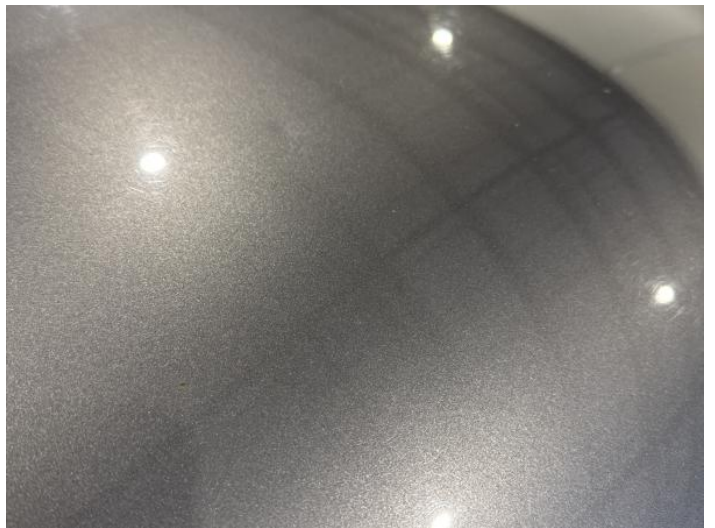
2: Bonnet
Dented
Between 10mm + 30mm

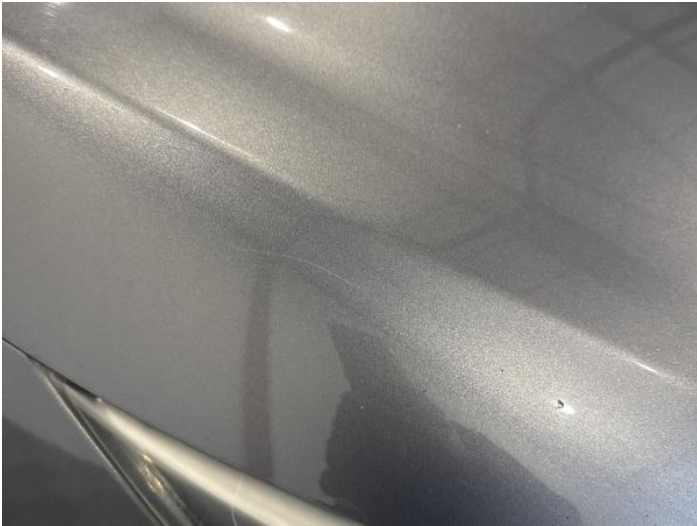
3: Bonnet
Scratched
Over 25mm Thru Paint

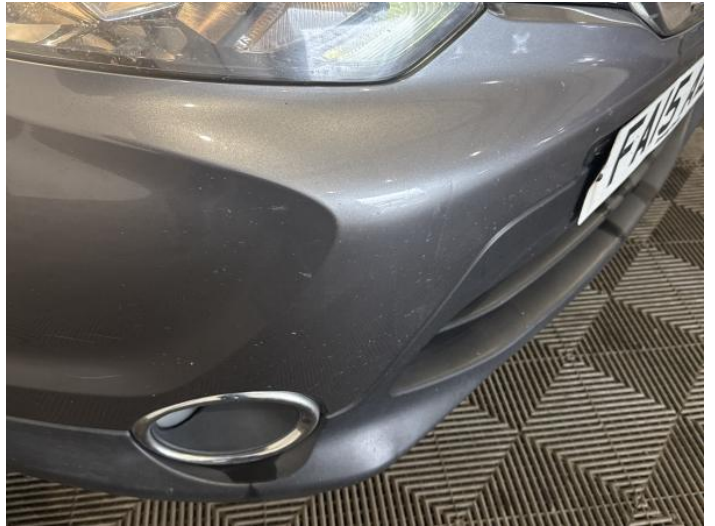
4: Bumper Front
Chipped
Multiple Chips

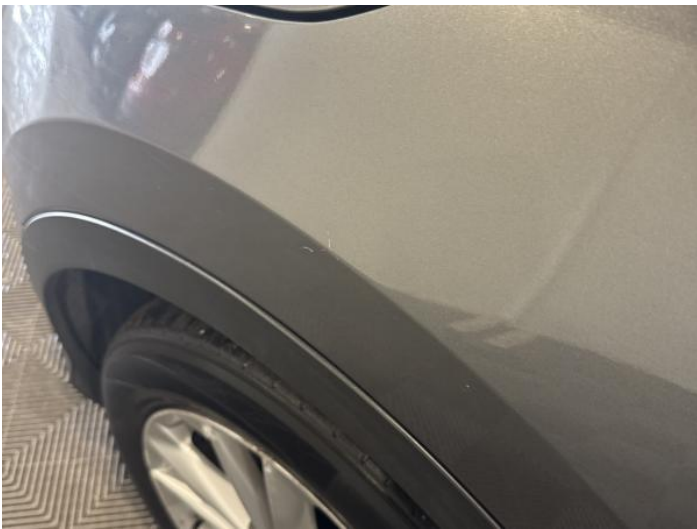
5: Wing nsf
Scratched
Over 25mm Thru Paint

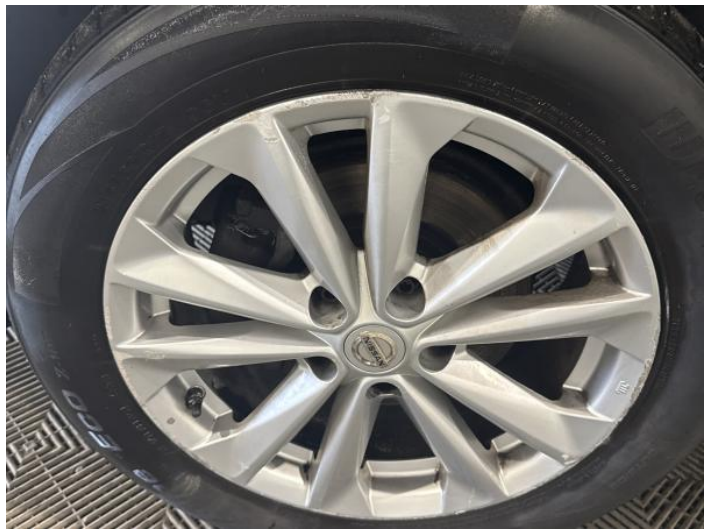
6: Wheel nsf
Scratched
Over 50mm

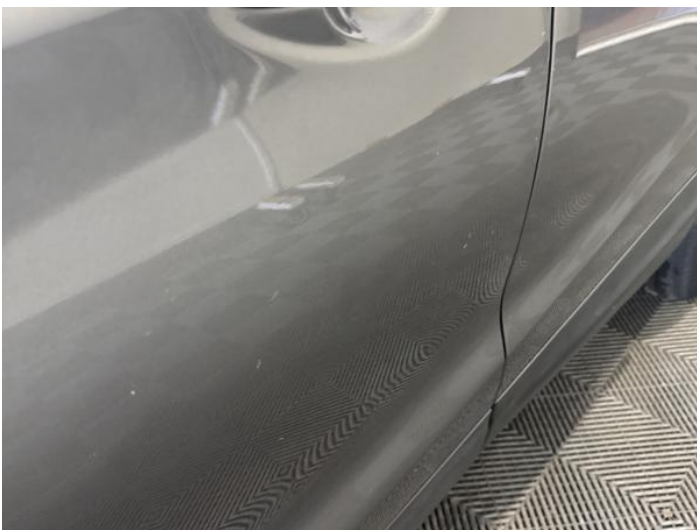
7: Door nsf
Dented
Over 30mm

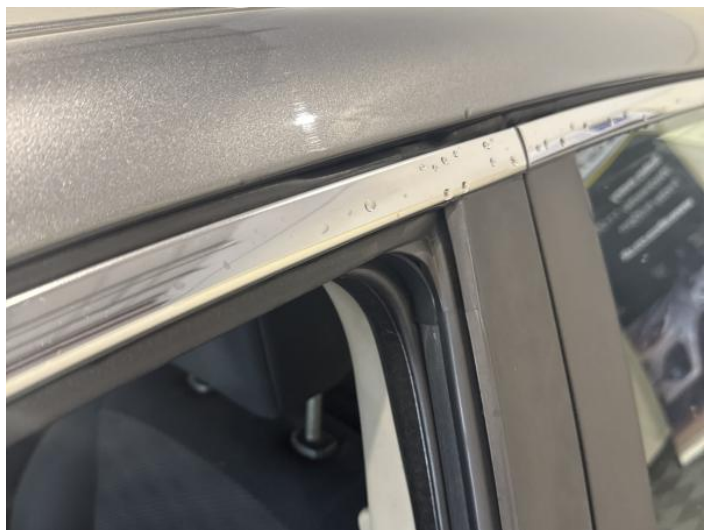
8: Aperture Seal nsf
Broken
Replace

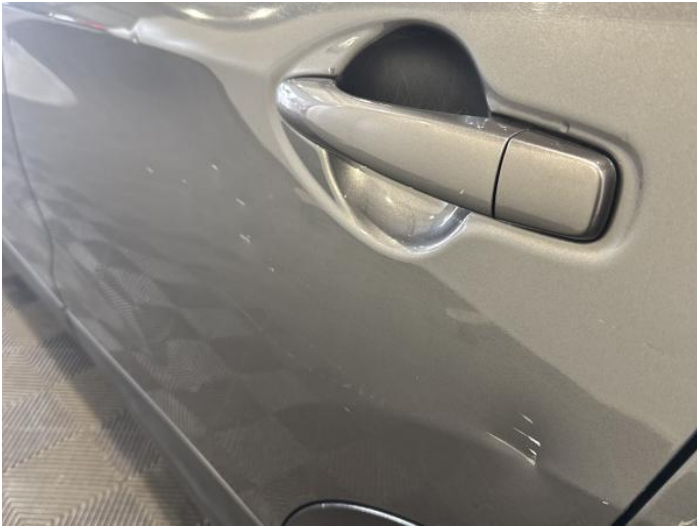
9: Door nsr
Dented
With Paint Damage

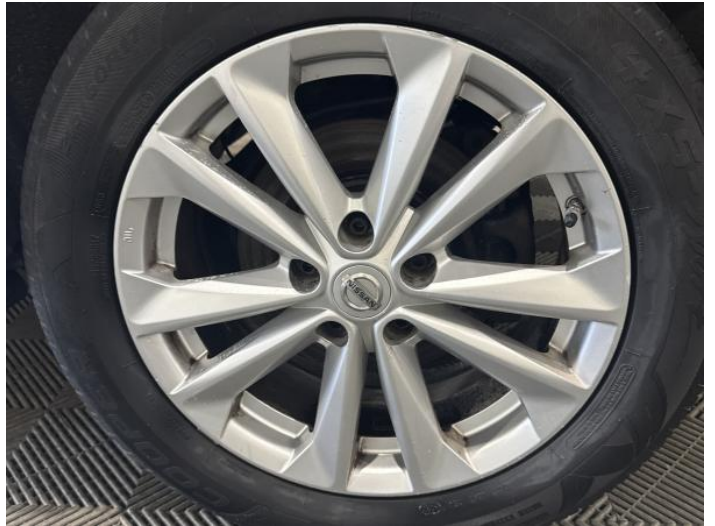
10: Wheel nsr
Scratched
Over 50mm

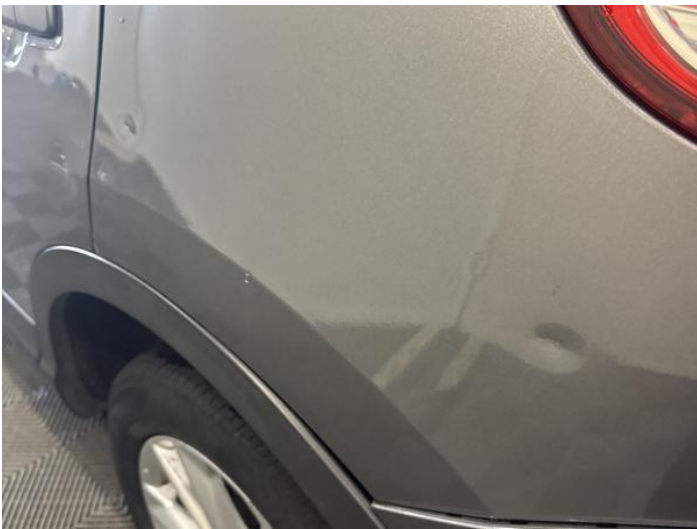
11: Qtr Panel osr
Dented
With Paint Damage

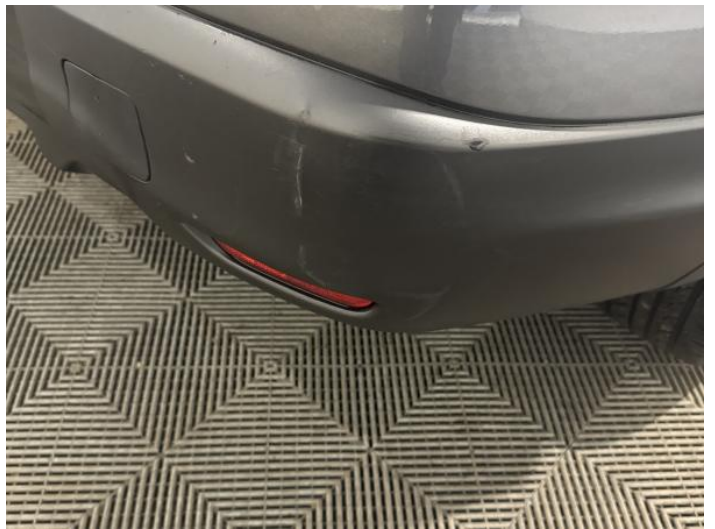
12: Bumper Rear Moulding
Scuffed (Unpainted)
Over 100mm

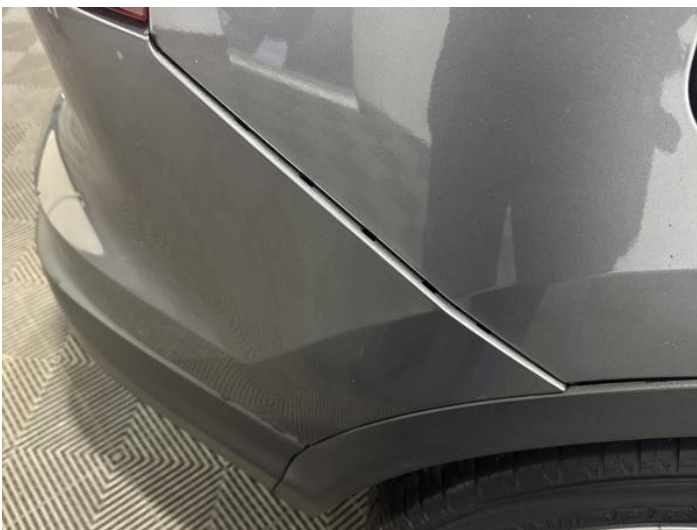
13: Bumper Rear
Insecure
Action Required

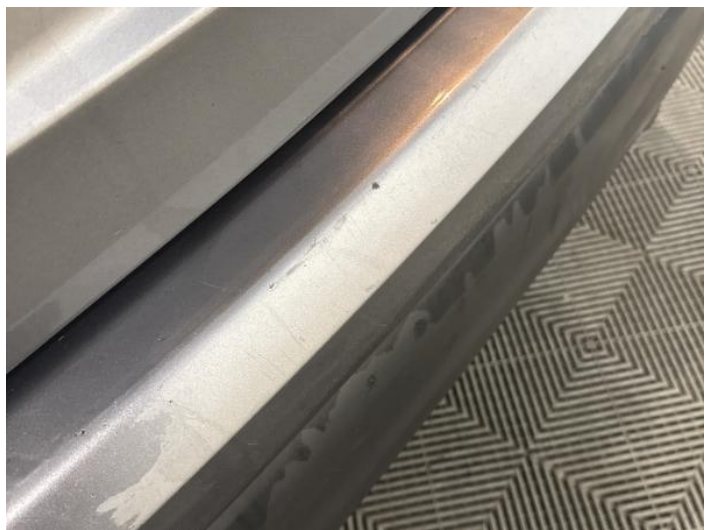
14: Bumper Rear
Scratched
25 to 100mm Thru Paint

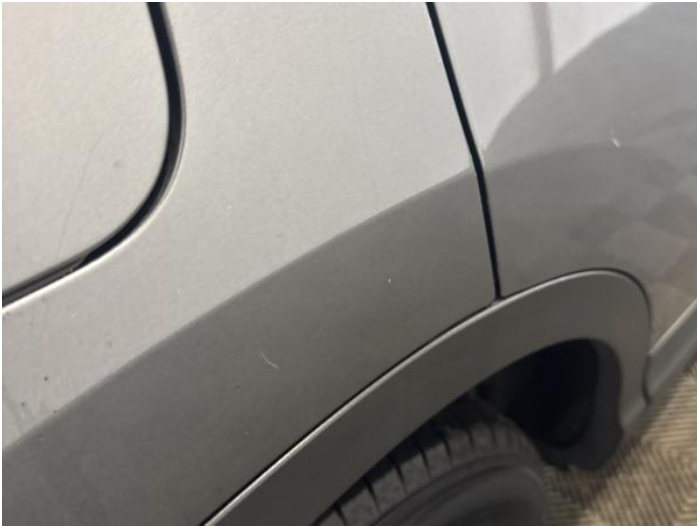
15: Qtr Panel osr
Dented
Between 10mm + 30mm

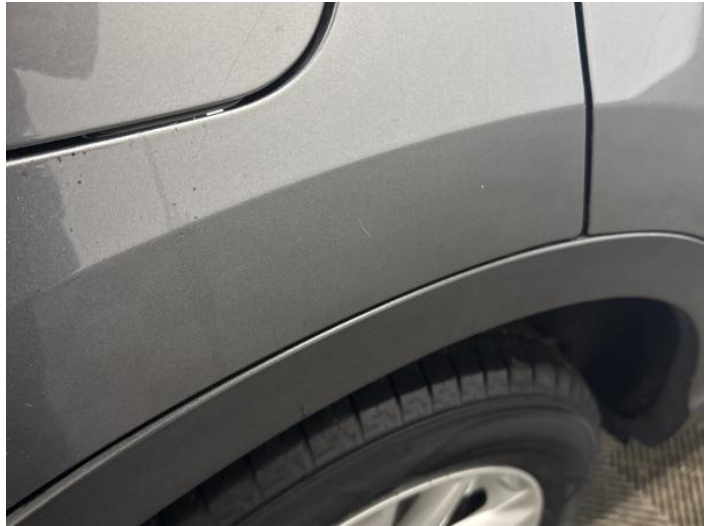
16: Qtr Panel osr
Scratched
UpTo 25mm Thru Paint

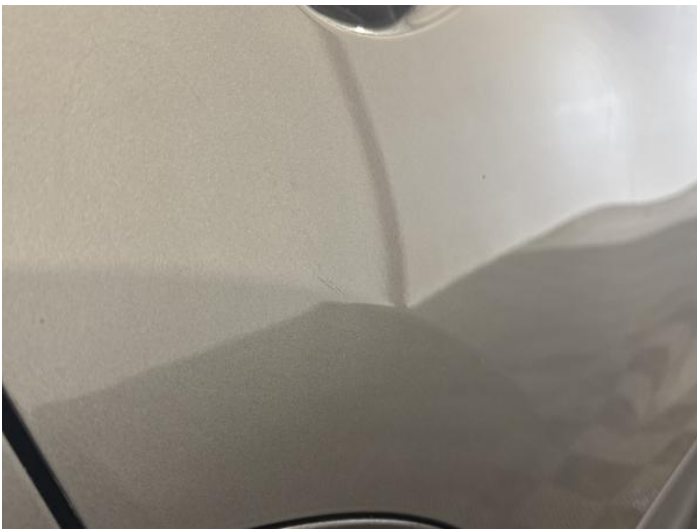
17: Door osr
Dented
Over 30mm

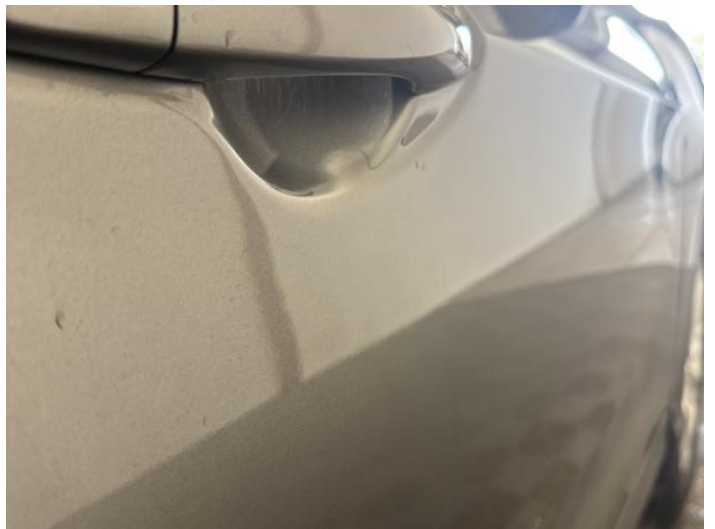
18: Door osf
Dented
Over 30mm

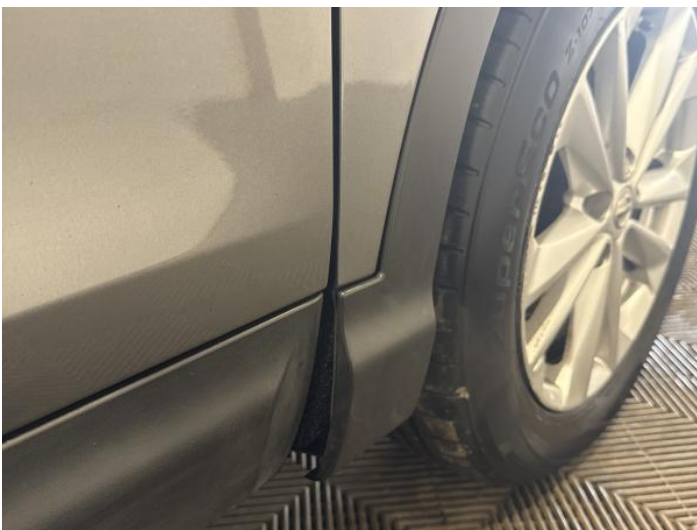
19: Wing osf
Dented
Over 30mm

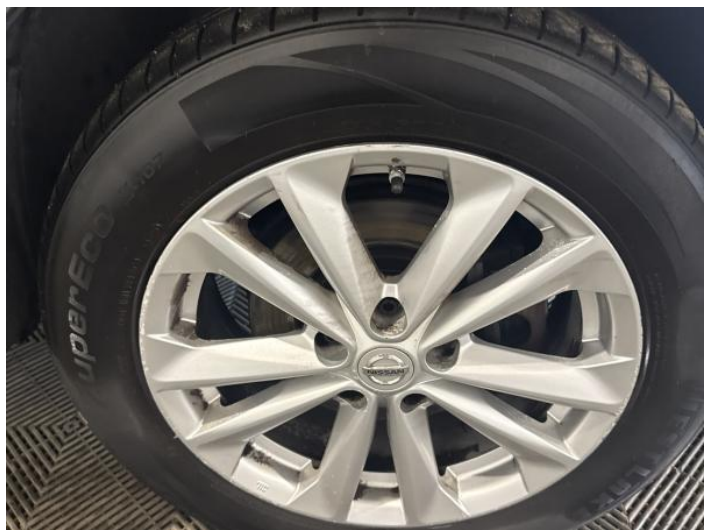
20: Wheel osf
Scratched
Over 50mm

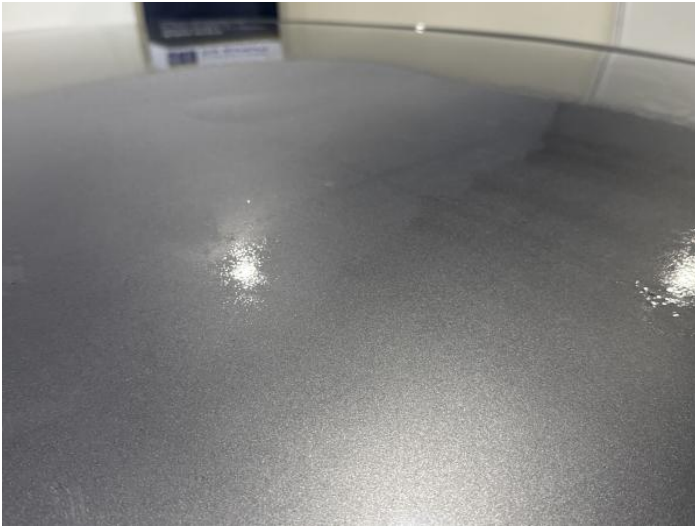
21: Roof
Dented
Over 30mm
