VEHICLE INSPECTION REPORT

BX16HDN

Vauxhall Meriva 1.4T 16V SE 5dr

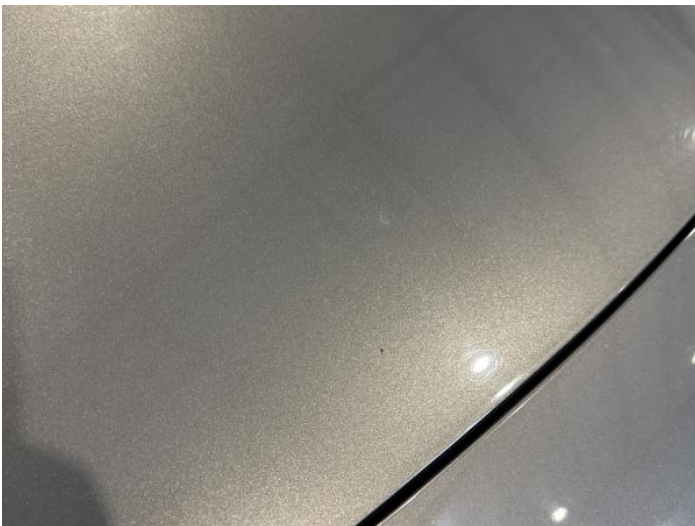
1: Bonnet
Chipped
1 To 5

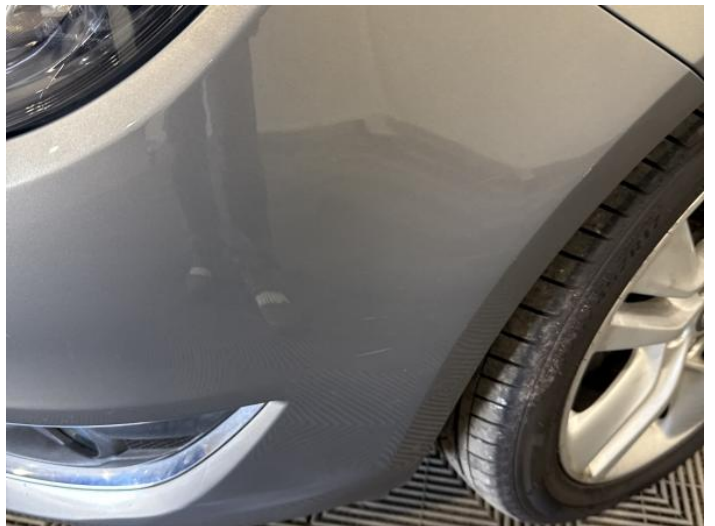
2: Bumper Front
Scratched
25 to 100mm Thru Paint

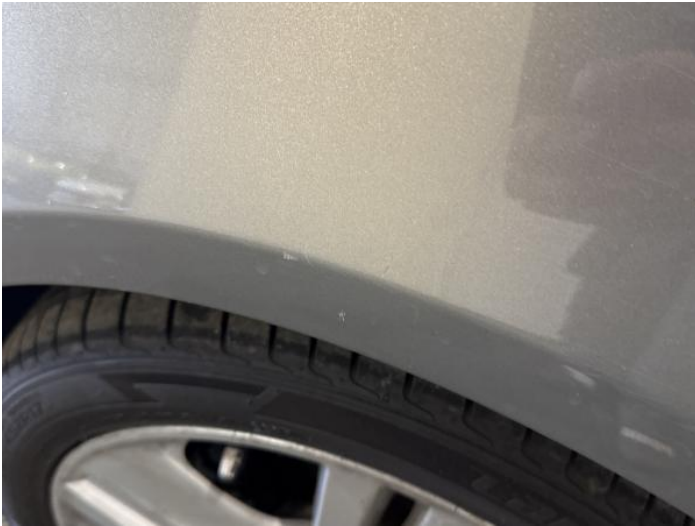
3: Wing nsf
Chipped
1 To 5

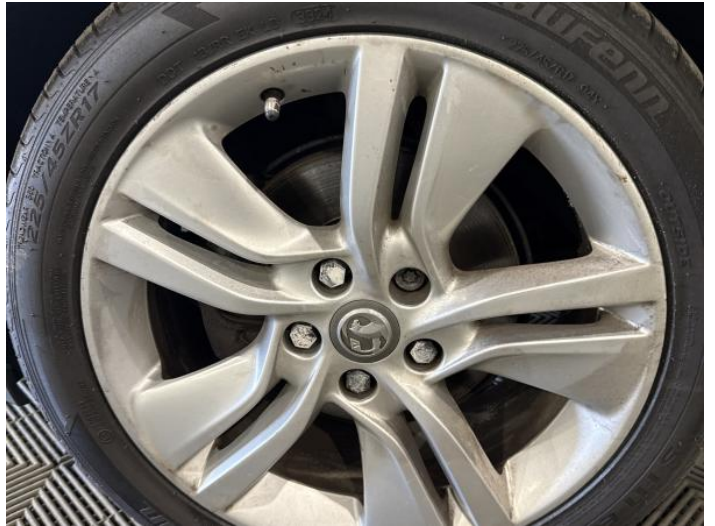
4: Wheel nsf
Scratched
Up To 50mm

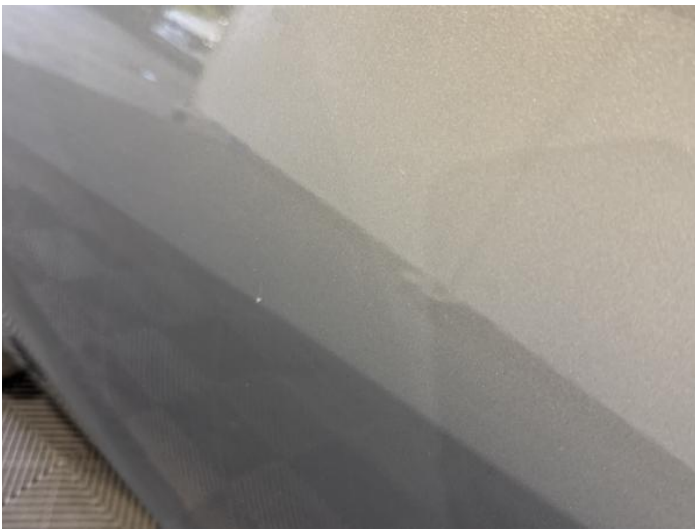
5: Door nsf
Chipped
1 To 5

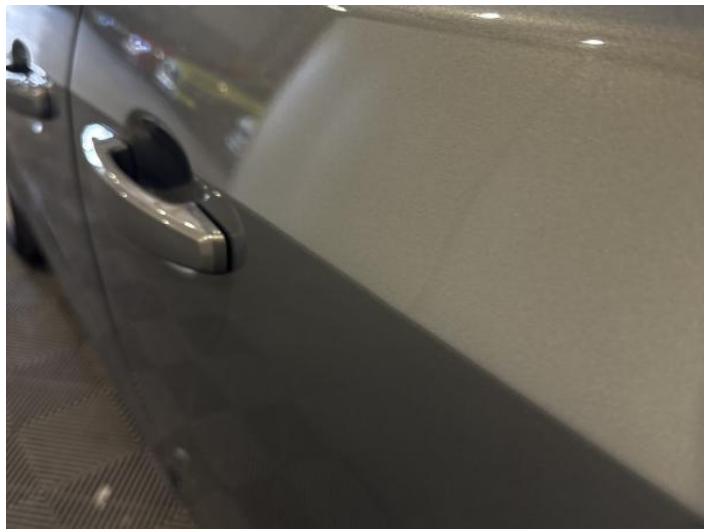
6: Door nsr
Dented
2 Or Less Up To 10mm

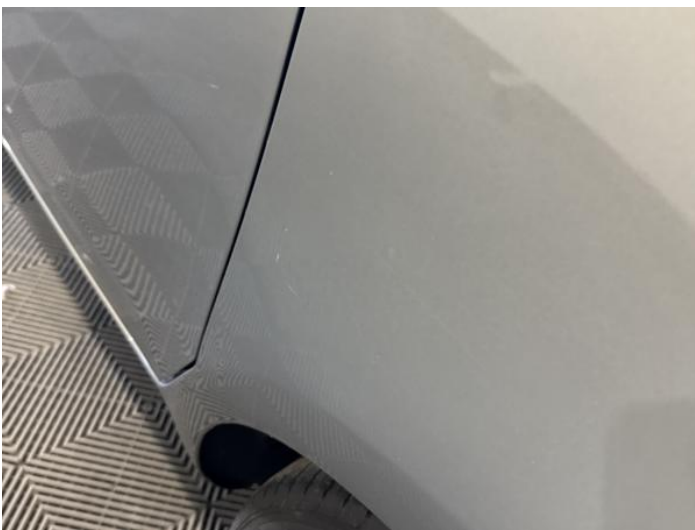
7: Qtr Panel nsr
Chipped
1 To 5

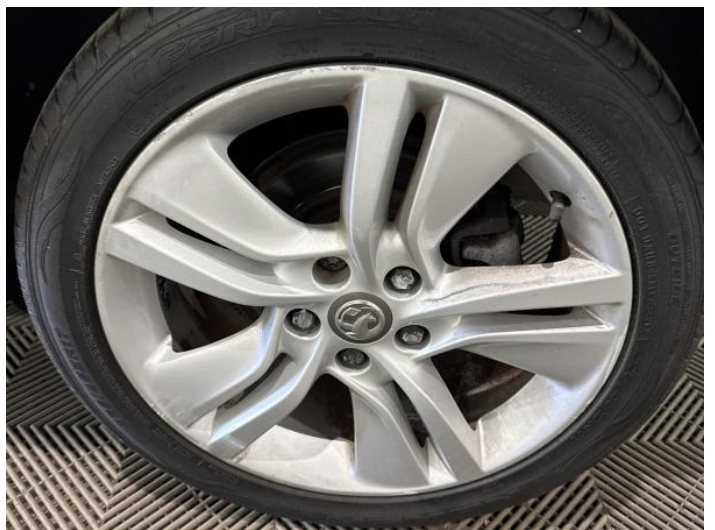
8: Wheel nsr
Scratched
Over 50mm

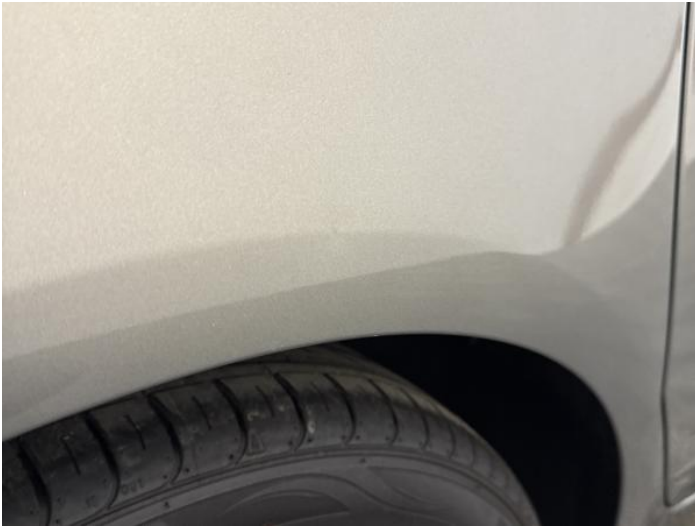
9: Qtr Panel osr
Dented
Between 10mm + 30mm

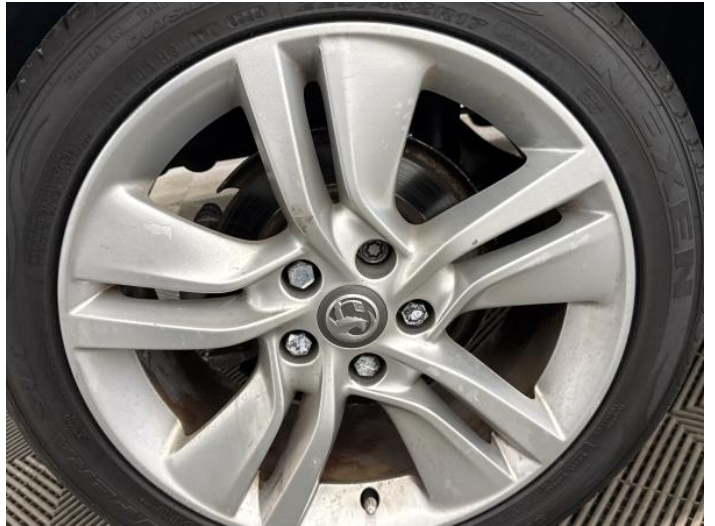
10: Wheel osr
Scratched
Over 50mm

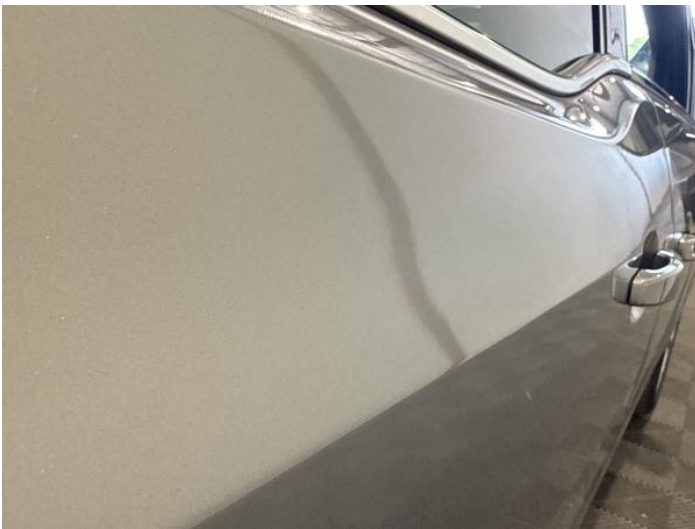
11: Door osr
Poor Previous Repair
Poor Paint

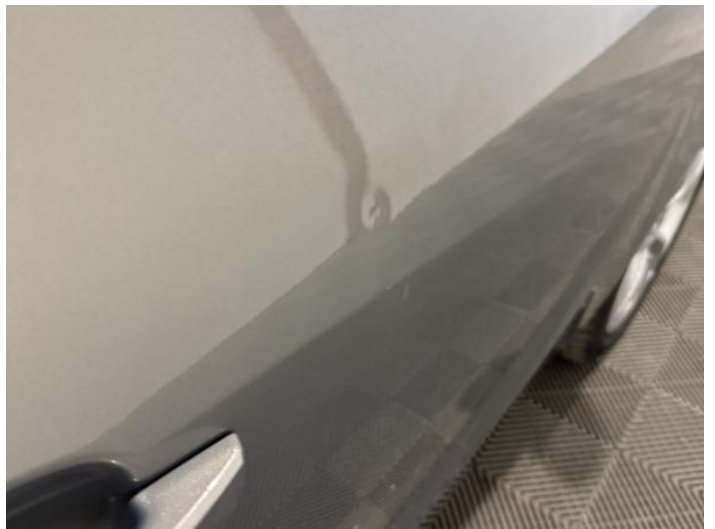
12: Door osf
Dented
Over 30mm

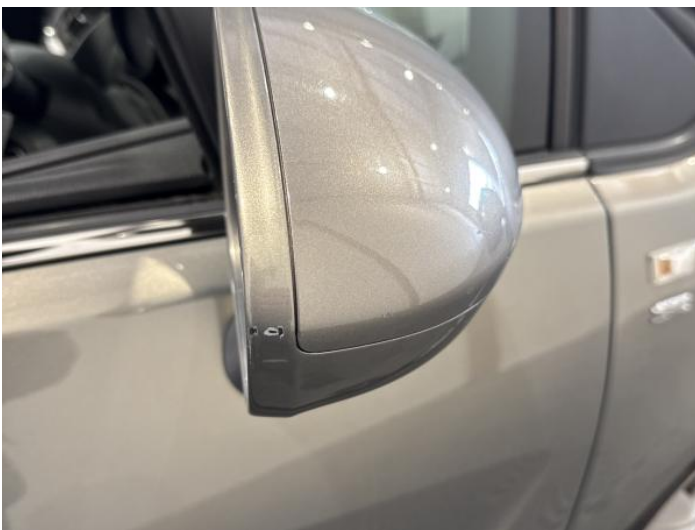
13: Door Mirror Assy osf
Scratched (Painted)
UpTo 25mm Thru Paint

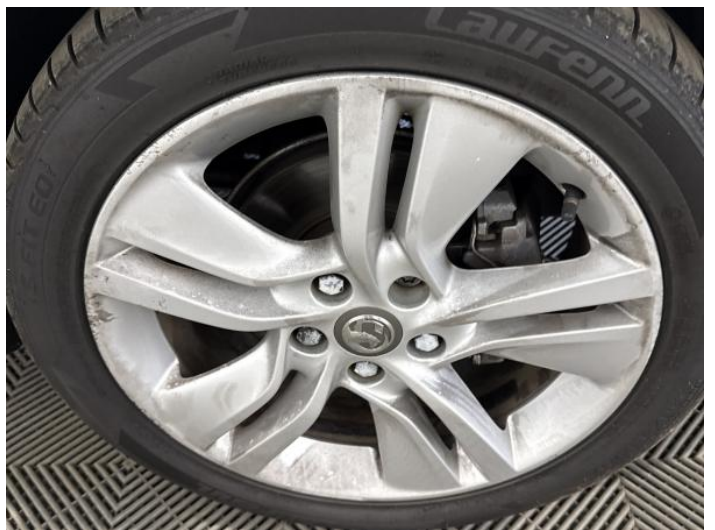
14: Wheel osf
Scratched
Over 50mm

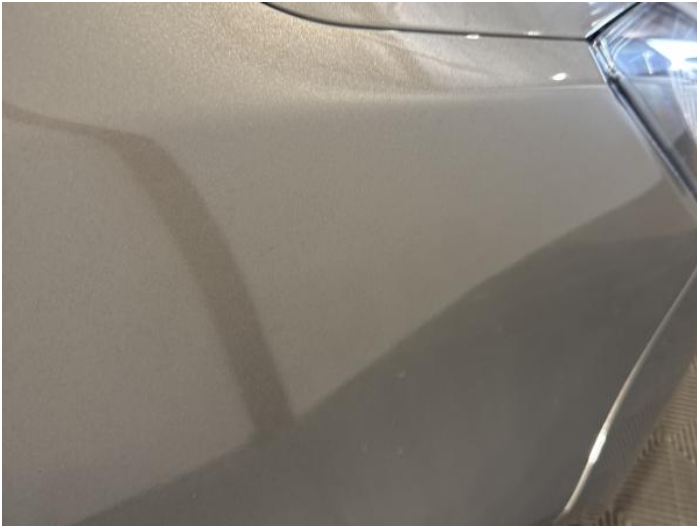
15: Wing osf
Chipped
1 To 5
