VEHICLE INSPECTION REPORT

GV65KHW

Mercedes-Benz GLA GLA 220d 4Matic AMG Line 5dr Auto [Premium]

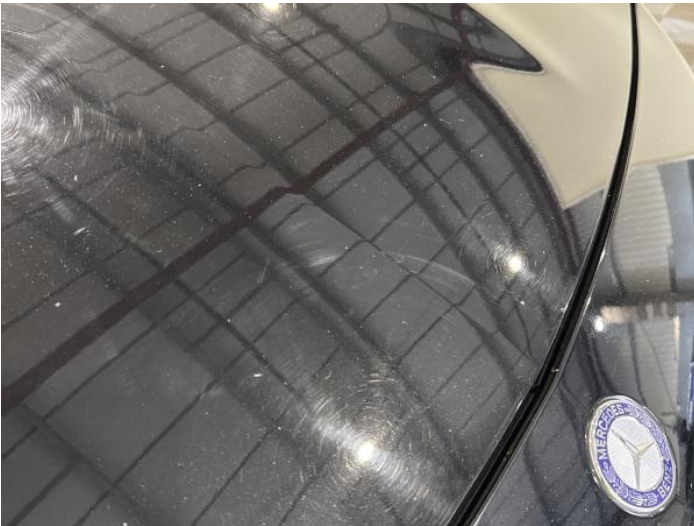
1: Bonnet
Chipped
Multiple Chips

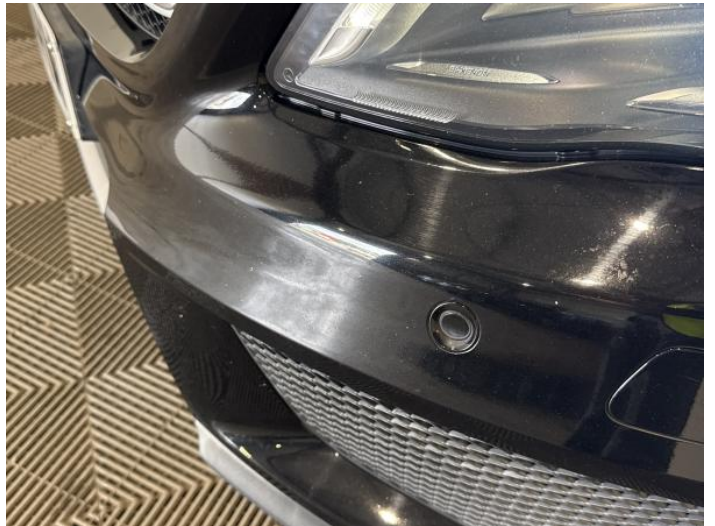
2: Bumper Front
Chipped
Multiple Chips

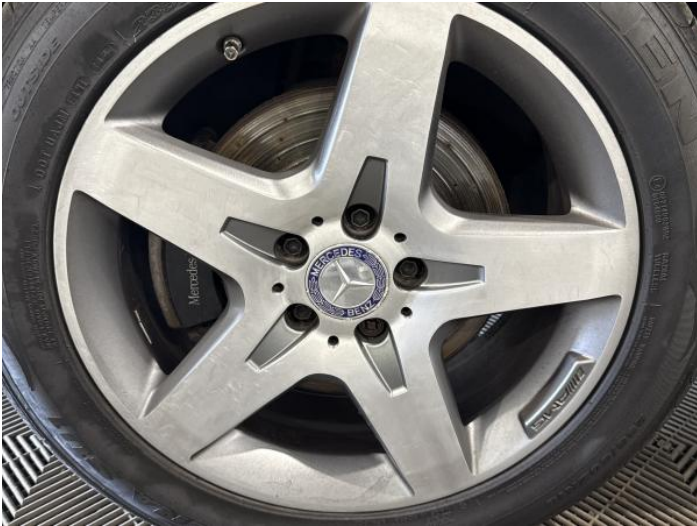
3: Wheel nsf
Scratched
Over 50mm

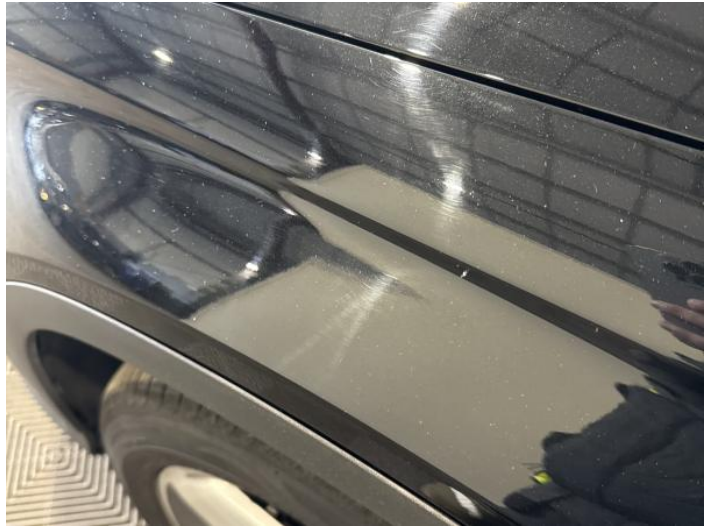
4: Wing nsf
Chipped
1 To 5

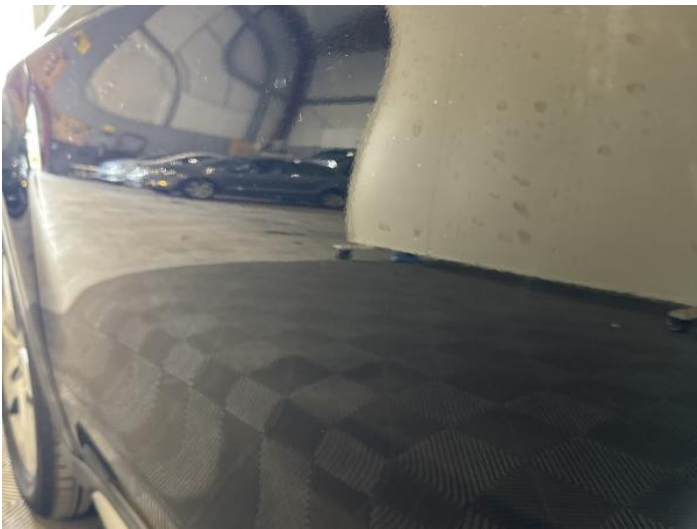
5: Door nsf
Dented
Between 10mm + 30mm

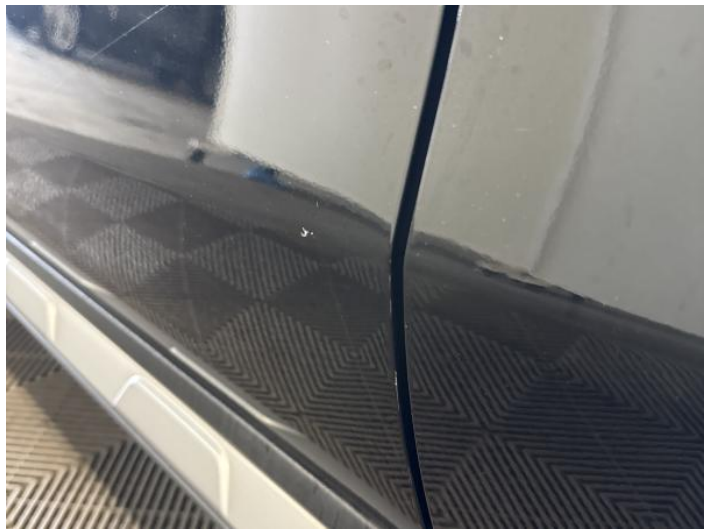
6: Door nsf
Chipped
1 To 5

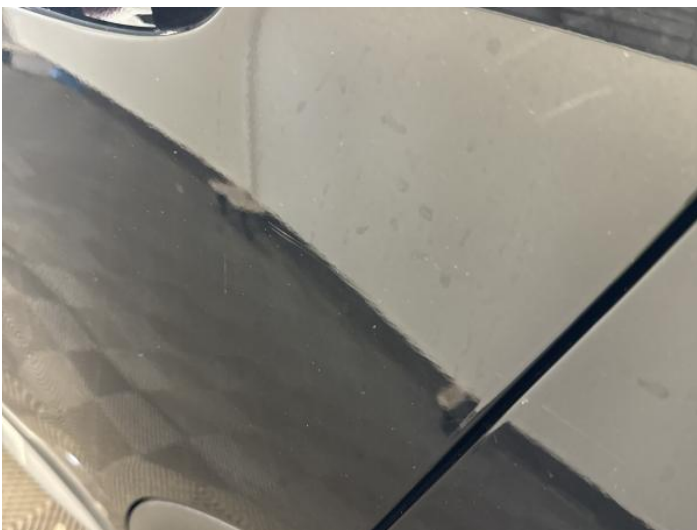
7: Door nsr
Scratched
UpTo 25mm Thru Paint

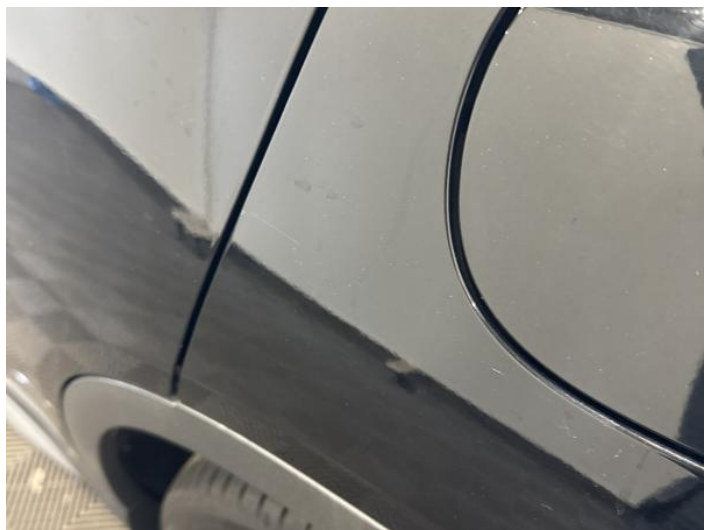
8: Qtr Panel nsr
Scratched
UpTo 25mm Thru Paint

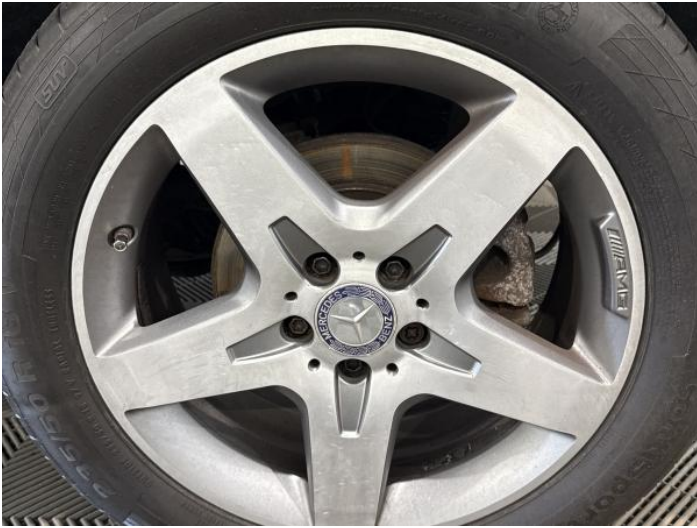
9: Wheel nsr
Scratched
Over 50mm

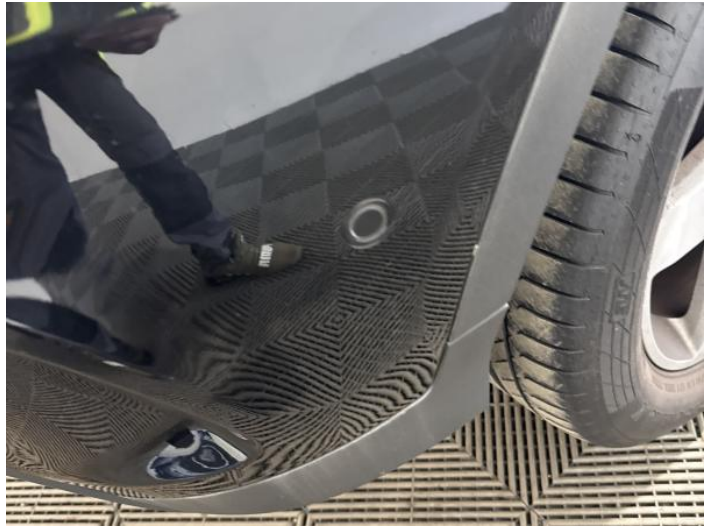
10: Bumper Rear
Chipped
1 To 5

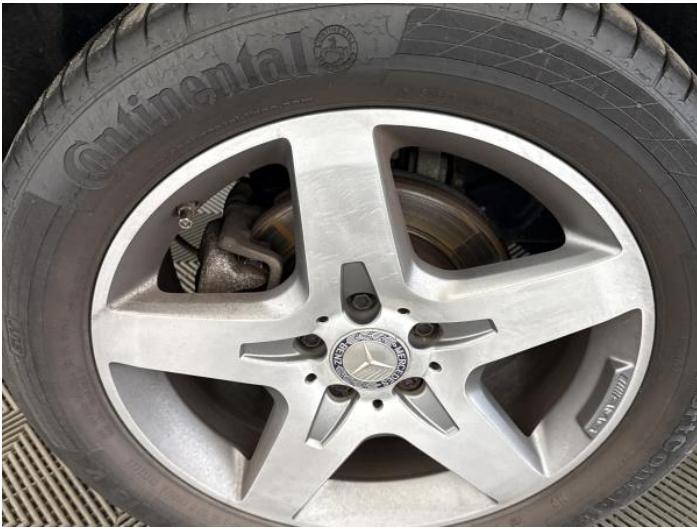
11: Wheel osr
Scratched
Over 50mm

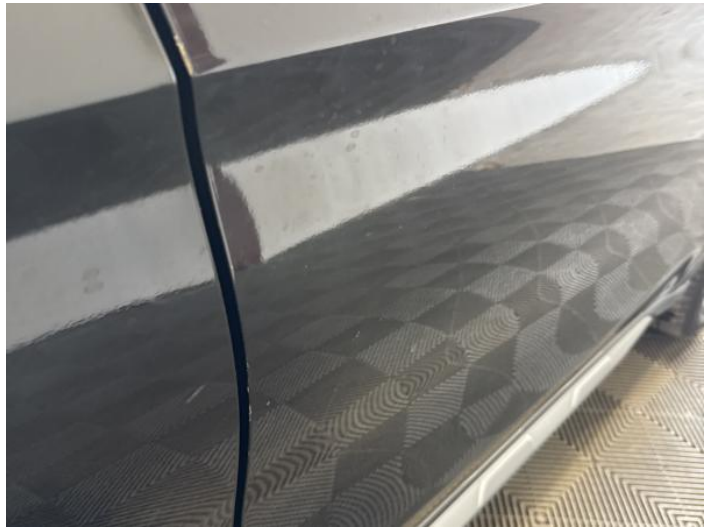
12: Door osf
Chipped
Edge Chip

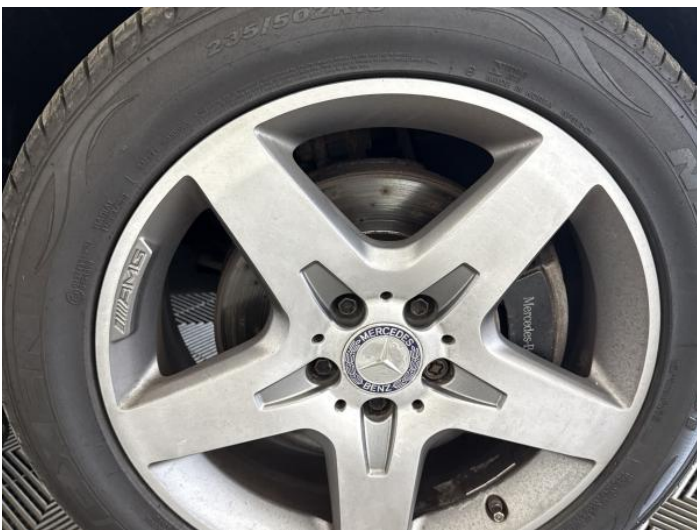
13: Wheel osf
Scratched
Over 50mm

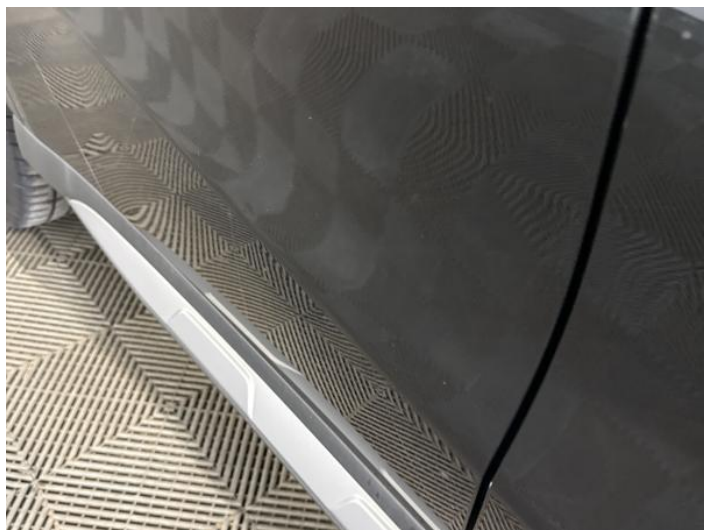
14: Door osr
Dented
Between 10mm + 30mm
