VEHICLE INSPECTION REPORT

LW19ACV

Nissan X-Trail 1.3 DiG-T N-Connecta 5dr DCT

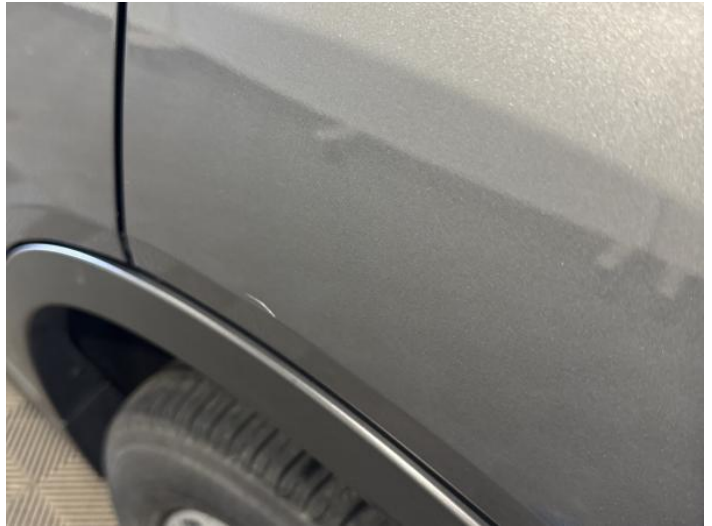
10: Qtr Panel nsr
Scratched
UpTo 25mm Thru Paint

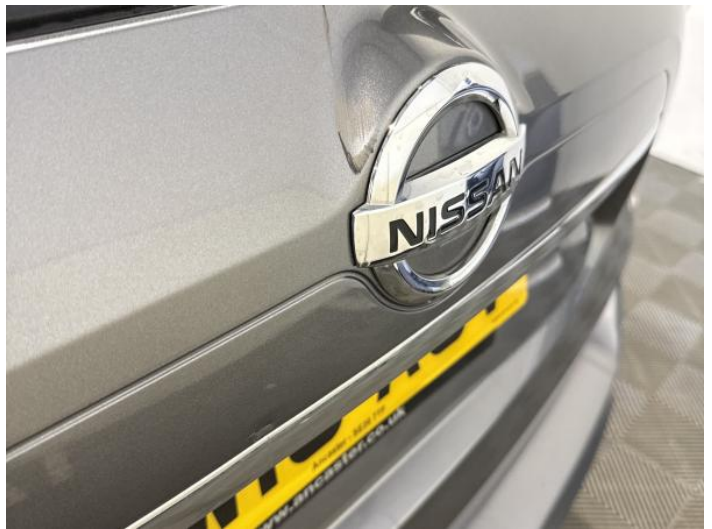
12: Tailgate
Scratched
Over 25mm Thru Paint

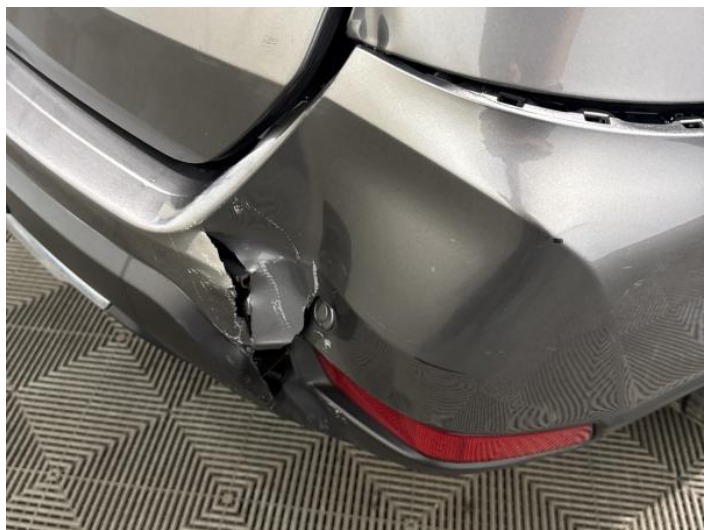
14: Bumper Rear
Cracked
Over 25mm
