# VEHICLE INSPECTION REPORT

**GX63NVC**

## Vauxhall Astra 1.7 CDTi 16V ecoFLEX Energy 5dr

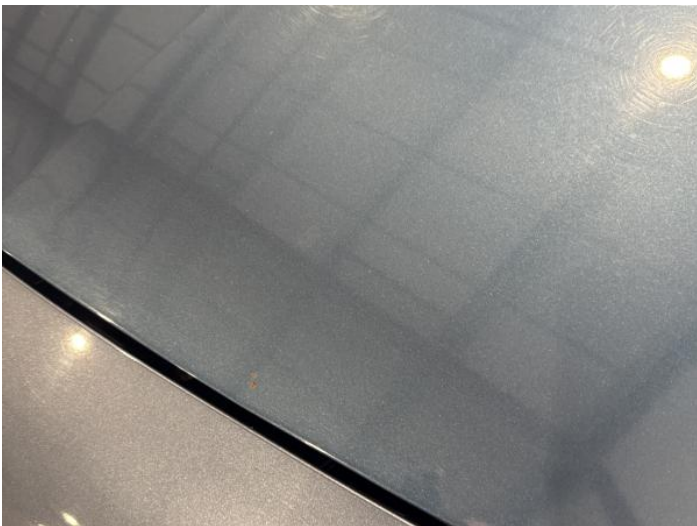
1: Bonnet  
Chipped  
1 To 5

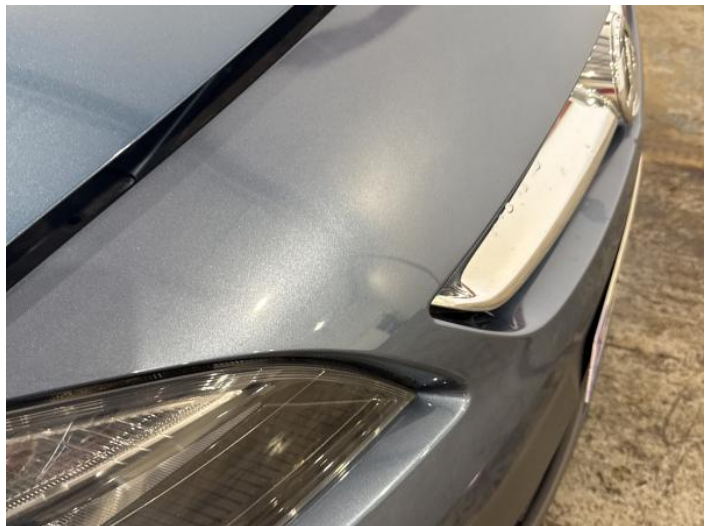
2: Bumper Front  
Cracked  
Over 25mm

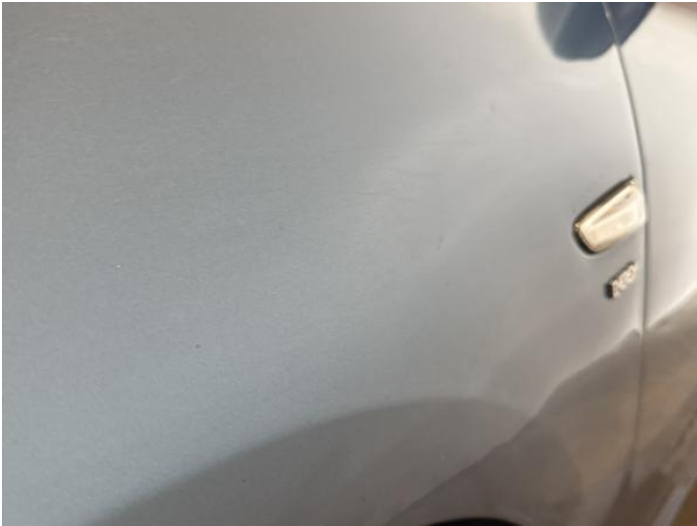
3: Wing nsf  
Poor Previous Repair  
Poor Paint

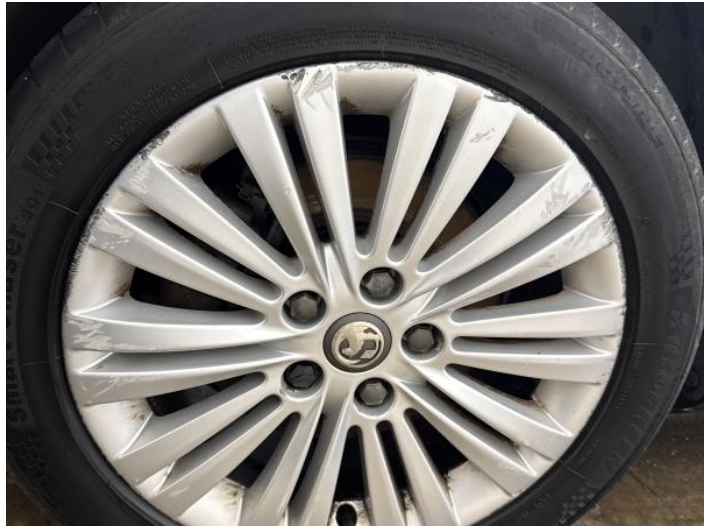
4: Wheel nsf  
Scratched  
Over 50mm

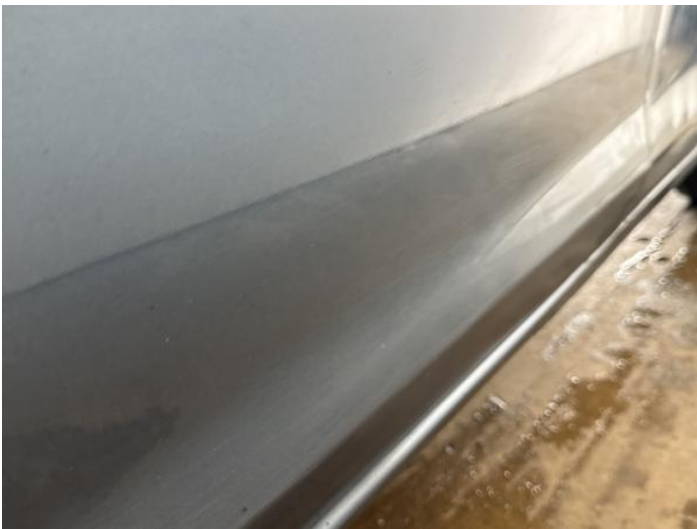
5: Door nsf  
Dented  
With Paint Damage

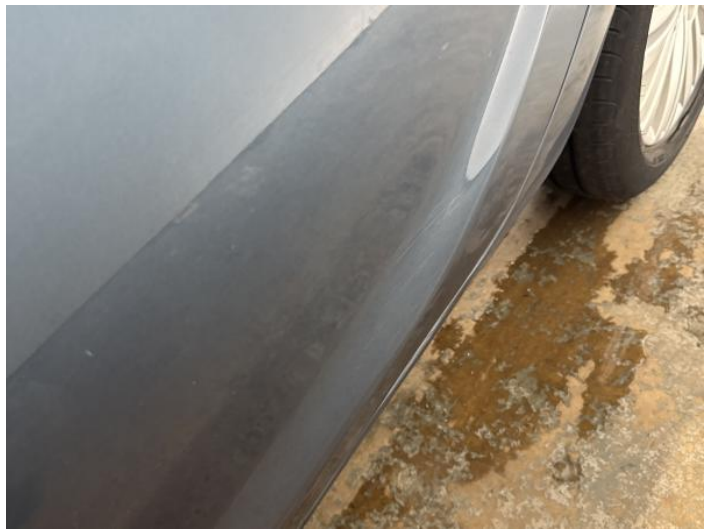
6: Door nsr  
Scratched  
Over 25mm Thru Paint

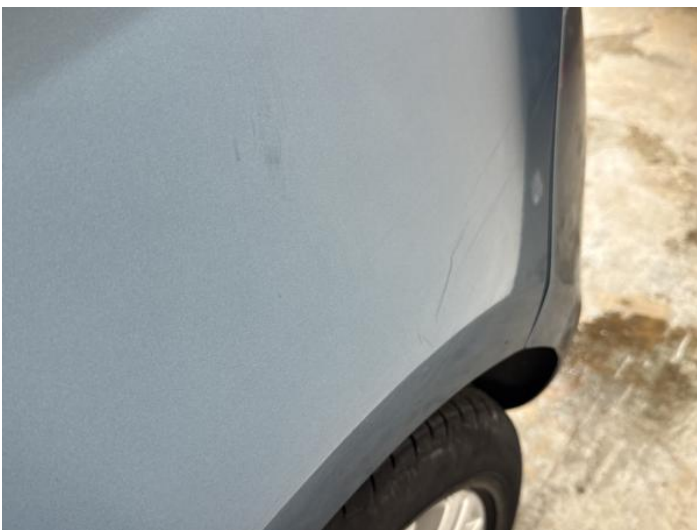
7: Qtr Panel nsr  
Scratched  
Over 25mm Thru Paint

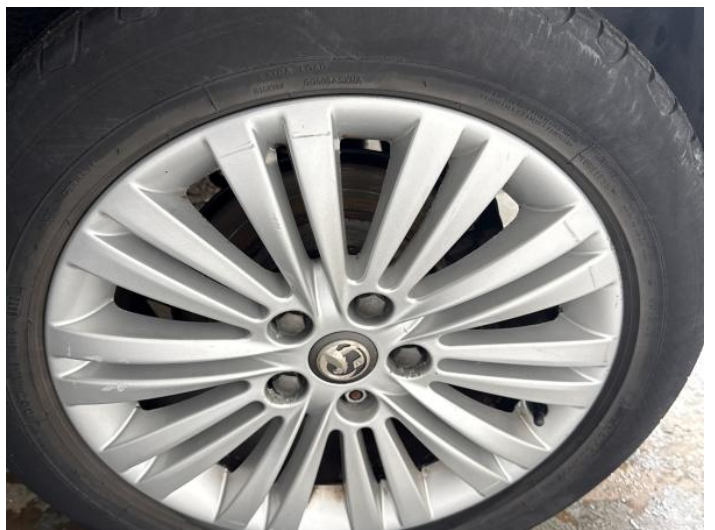
8: Wheel nsr  
Scratched  
Up To 50mm

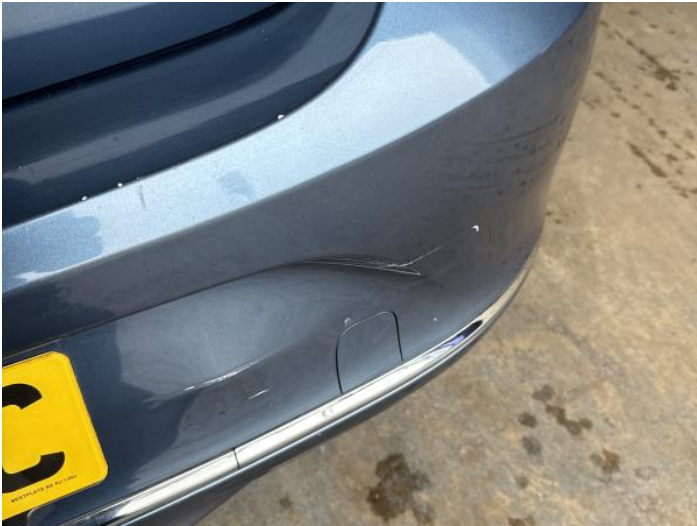
9: Bumper Rear  
Dented  
With Paint Damage

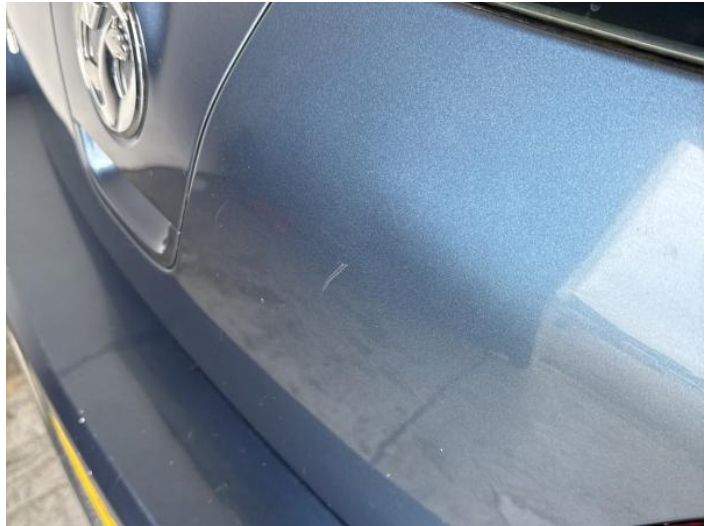
10: Tailgate  
Dented  
With Paint Damage

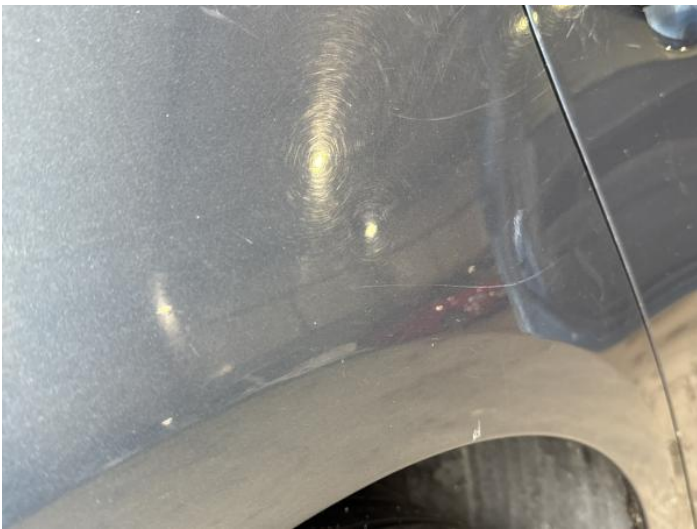
11: Qtr Panel osr  
Scratched  
Over 25mm Thru Paint

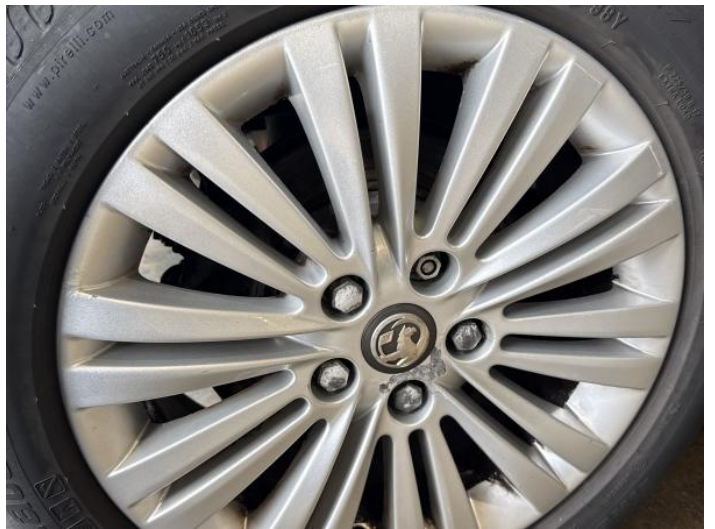
12: Wheel osr  
Scratched  
Over 50mm

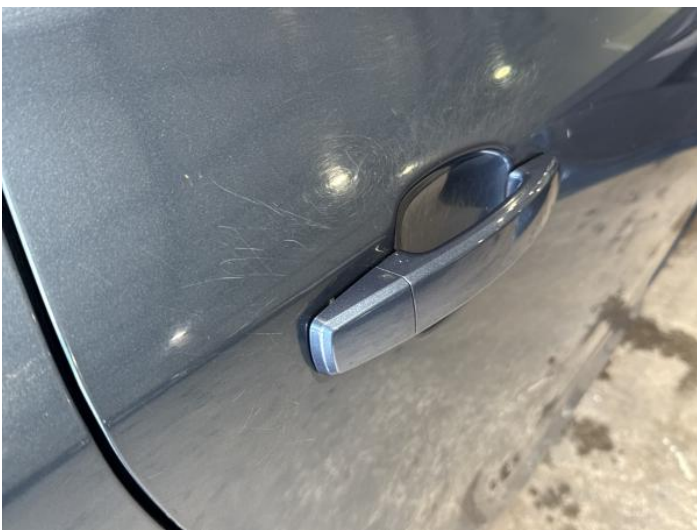
13: Door osr  
Scratched  
Over 25mm Thru Paint

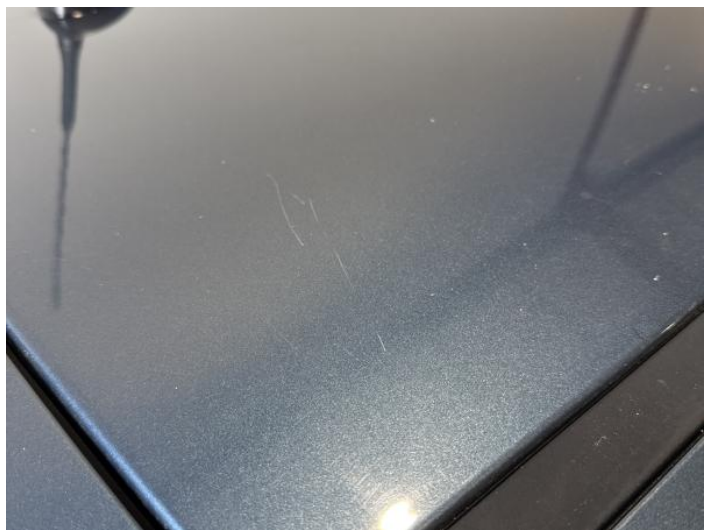
14: Roof  
Scratched  
Over 25mm Thru Paint

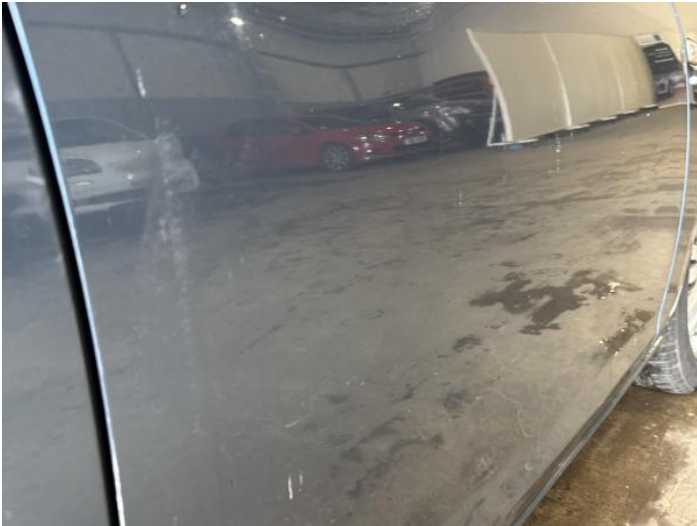
15: Door osf  
Dented  
With Paint Damage

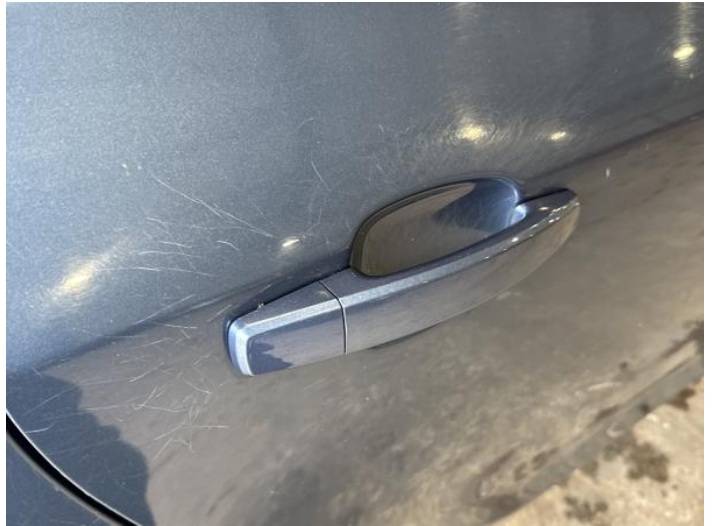
16: Door osr  
Scratched  
Over 25mm Thru Paint

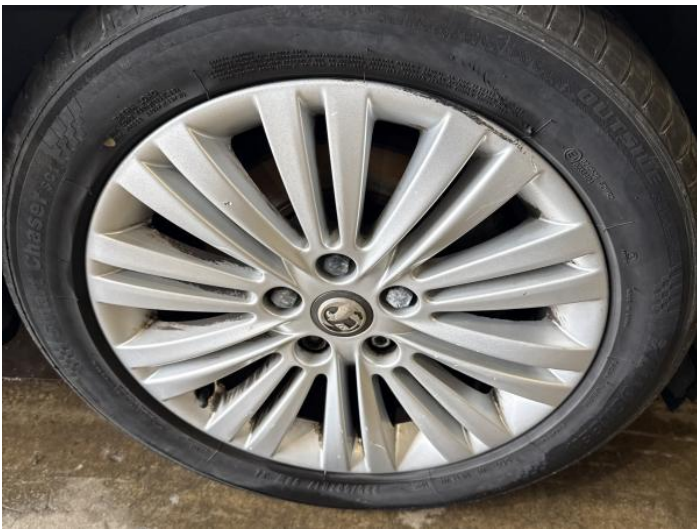
17: Wheel osf  
Scratched  
Over 50mm

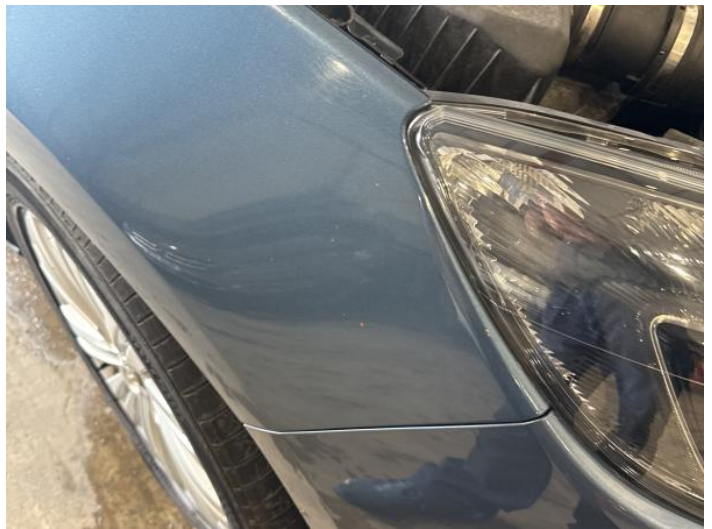
18: Wing osf  
Chipped  
1 To 5

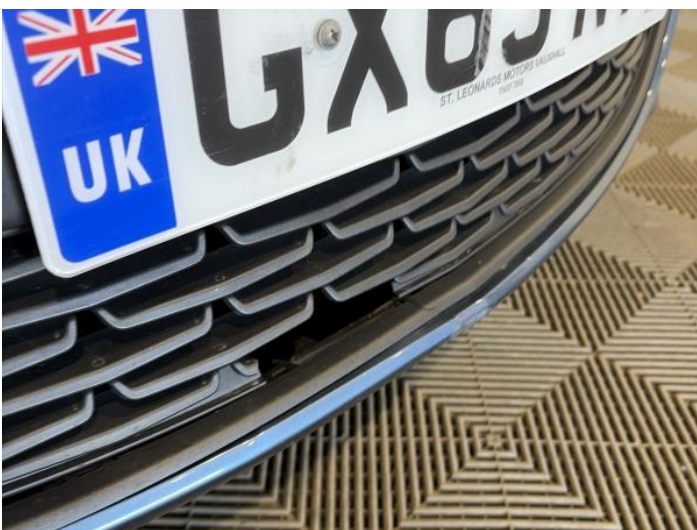
19: Bumper Front Grill  
Broken  
Replace

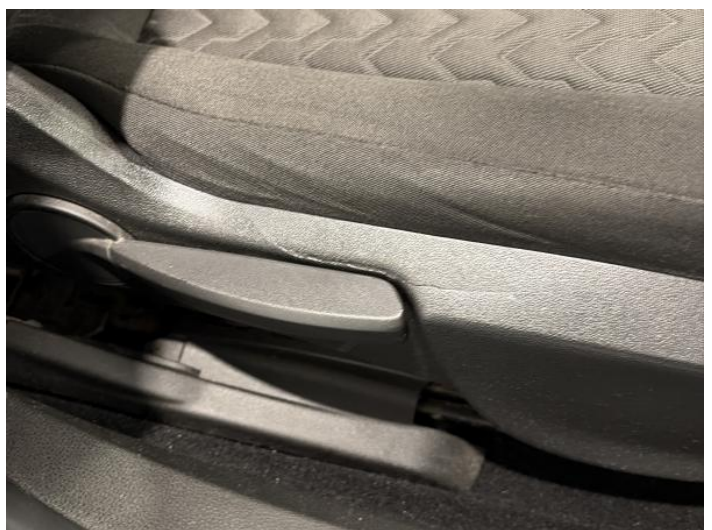
20: Fascia Trim  
Damaged  
Replace
