# VEHICLE INSPECTION REPORT

**YR60CMV**

## Kia Soul 1.6 CRDi 2 5dr Auto

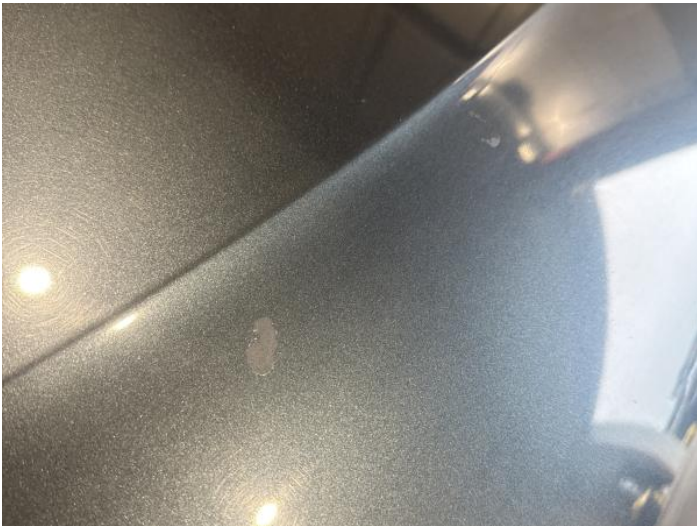
1: Bonnet  
Poor Previous Repair  
Paint Flake

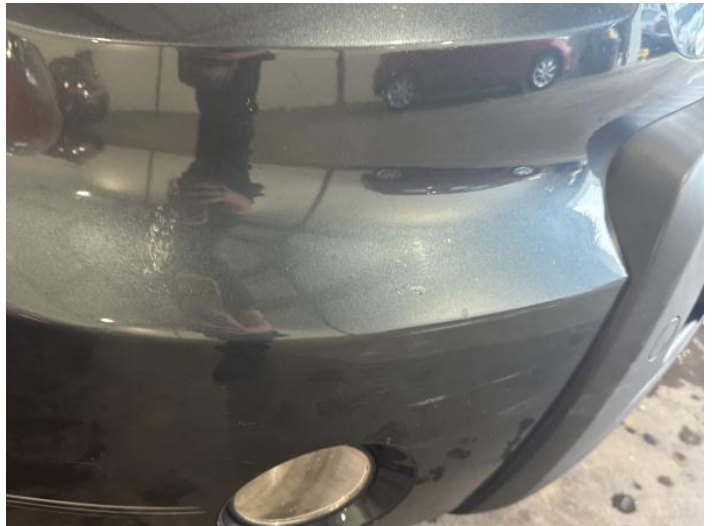
2: Bumper Front  
Scratched  
Over 100mm Thru Paint

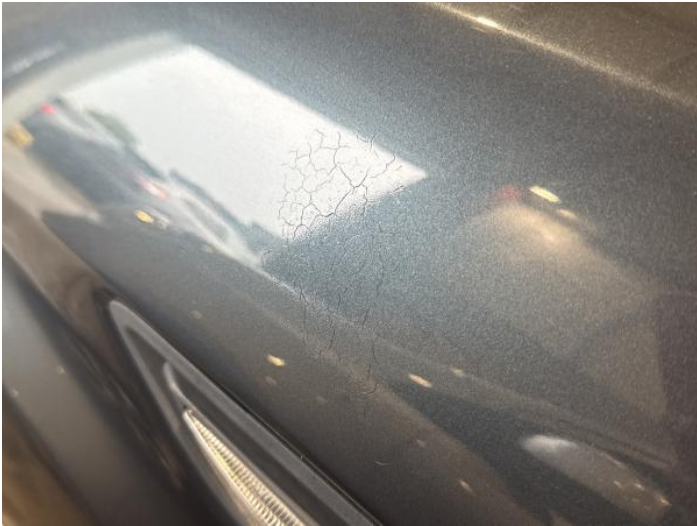
3: Wing nsf  
Poor Previous Repair  
Poor Paint

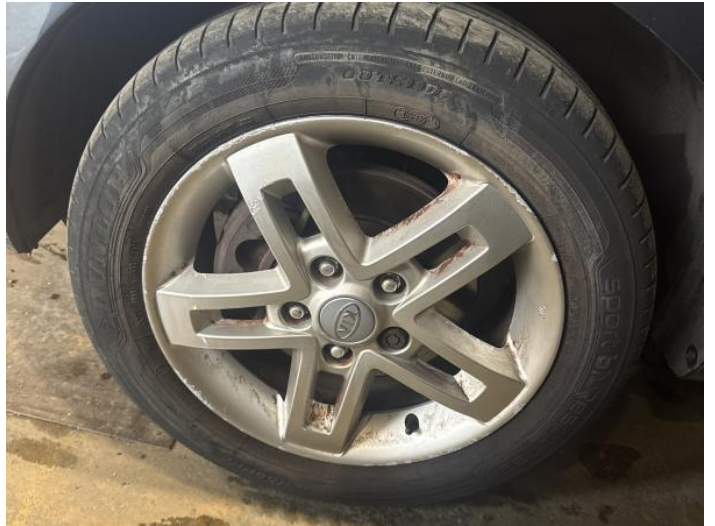
4: Wheel nsf  
Scratched  
Over 50mm

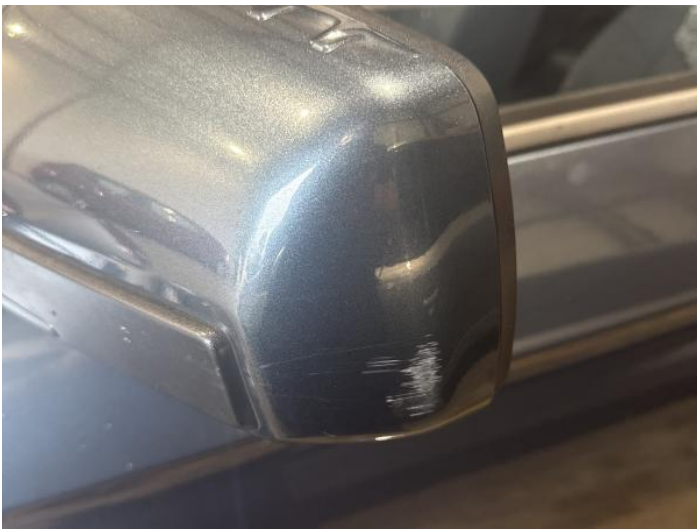
5: Door Mirror Assy nsf  
Scratched (Painted)  
Over 25mm Thru Paint

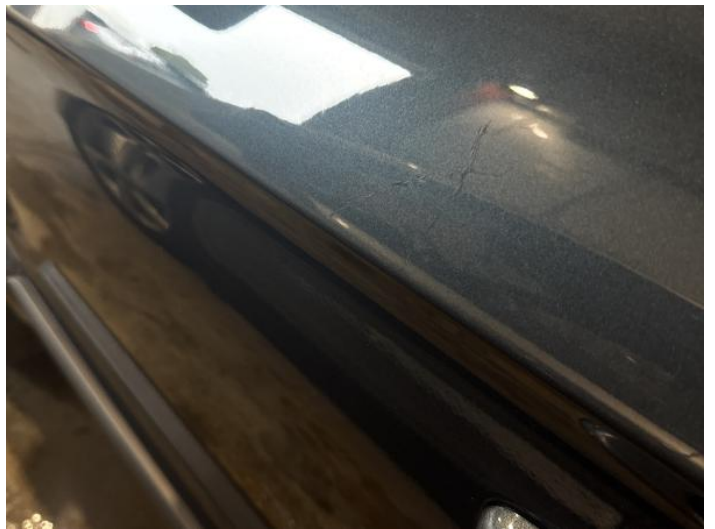
6: Door nsf  
Dented  
With Paint Damage

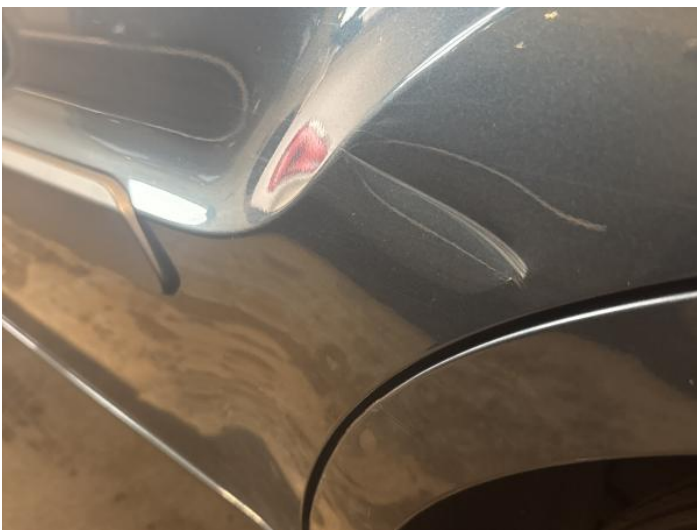
7: Door nsr  
Dented  
With Paint Damage

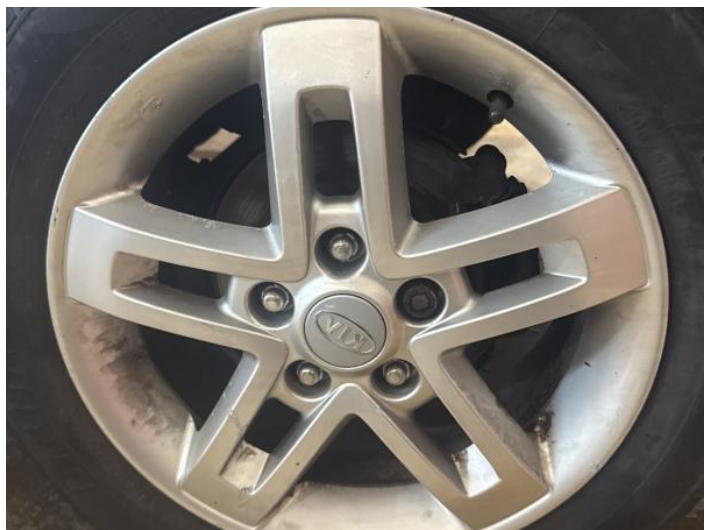
8: Wheel nsr  
Corroded  
Light

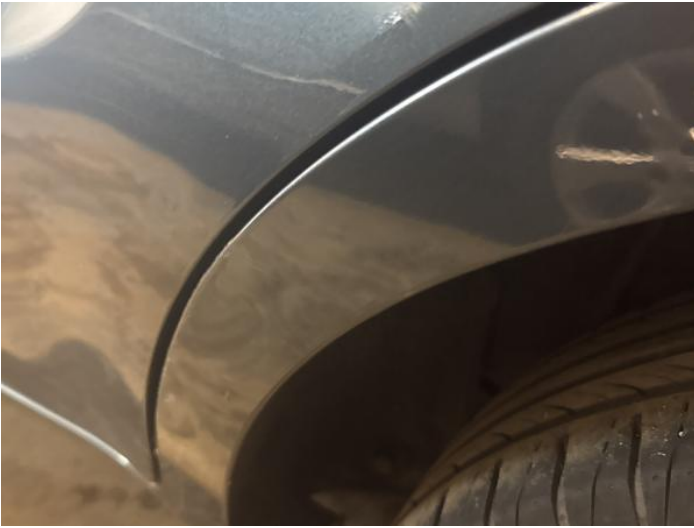
9: Qtr Panel nsr  
Dented  
Between 10mm + 30mm

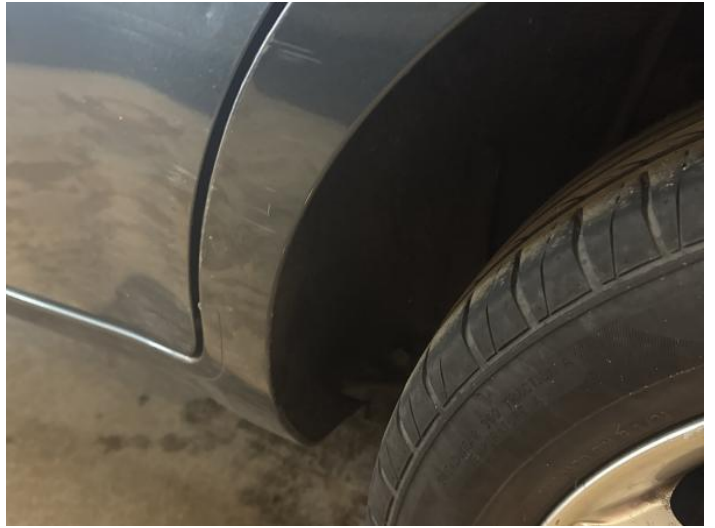
10: Qtr Panel nsr  
Scratched  
Over 25mm Thru Paint

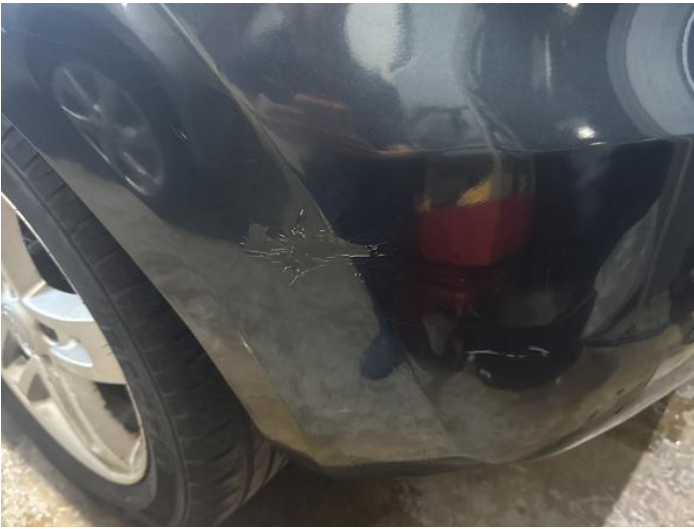
11: Bumper Rear  
Poor Previous Repair  
Poor Paint

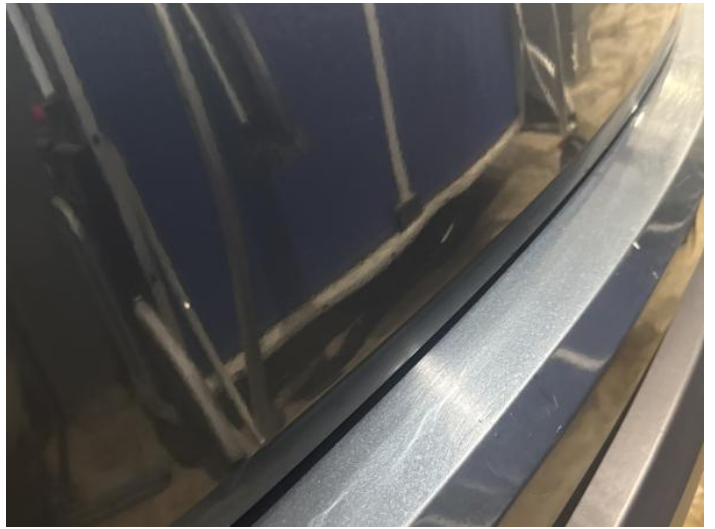
12: Tailgate  
Dented  
Over 30mm

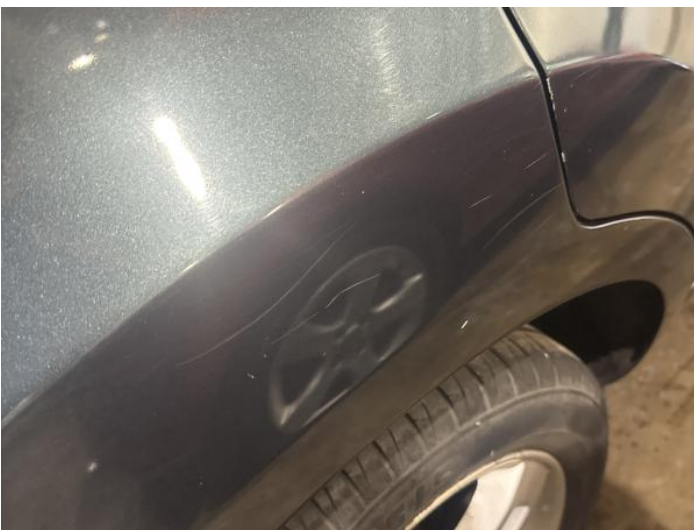
13: Qtr Panel osr  
Scratched  
Over 25mm Thru Paint

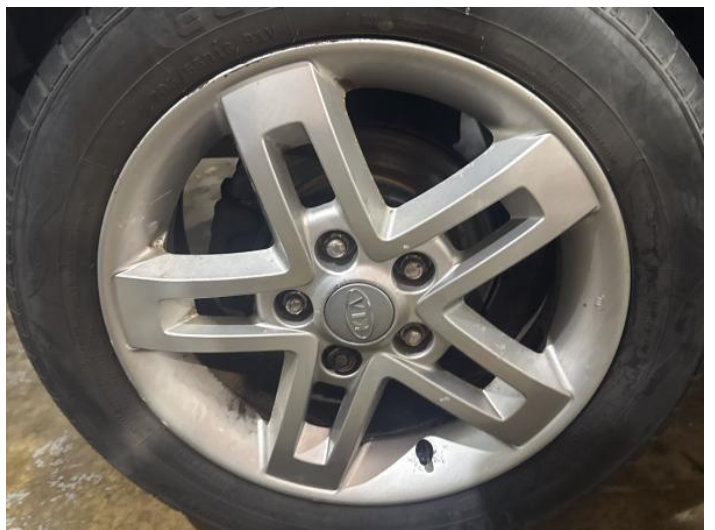
14: Wheel osr  
Scratched  
Over 50mm

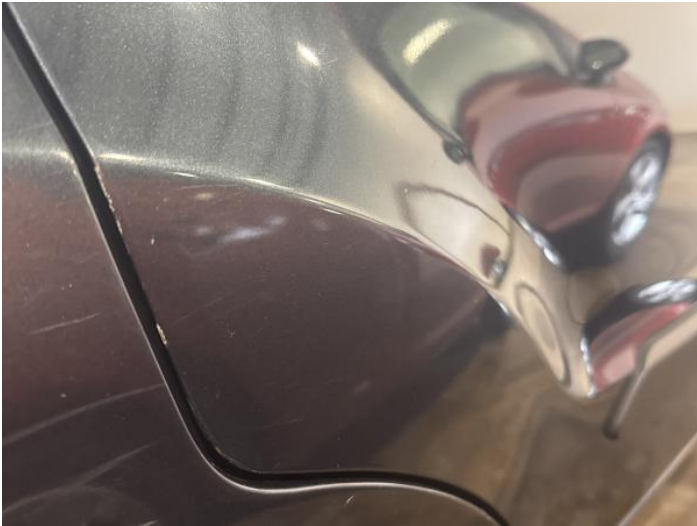
15: Door osr  
Scratched  
Over 25mm Thru Paint

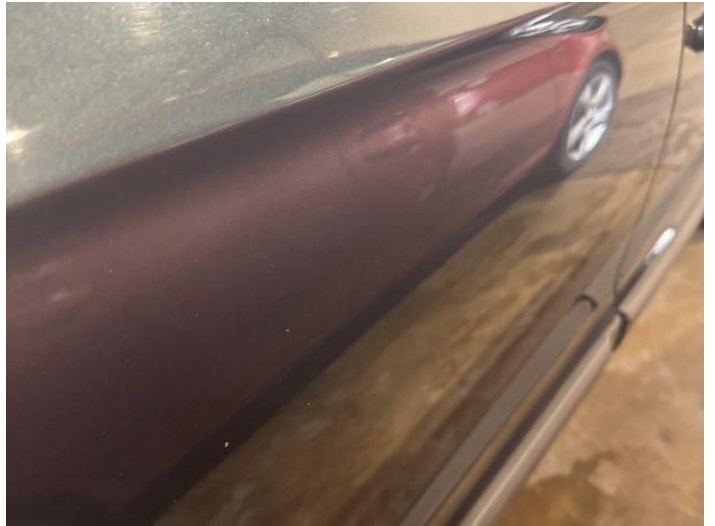
16: Door osr  
Dented  
Between 10mm + 30mm

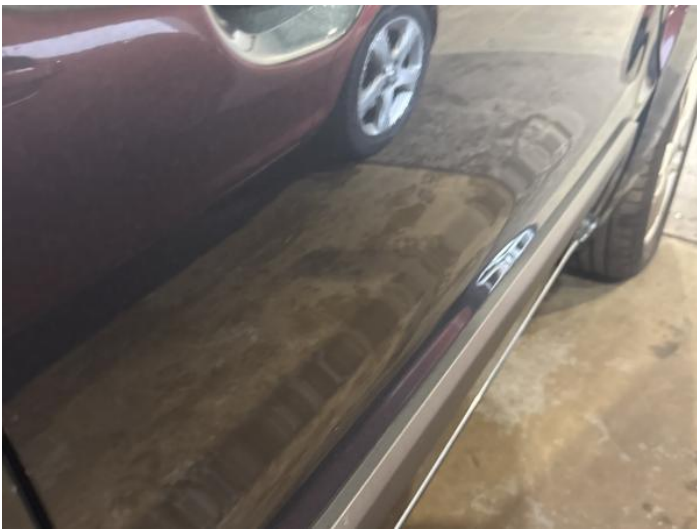
17: Door osf  
Dented  
Between 10mm + 30mm

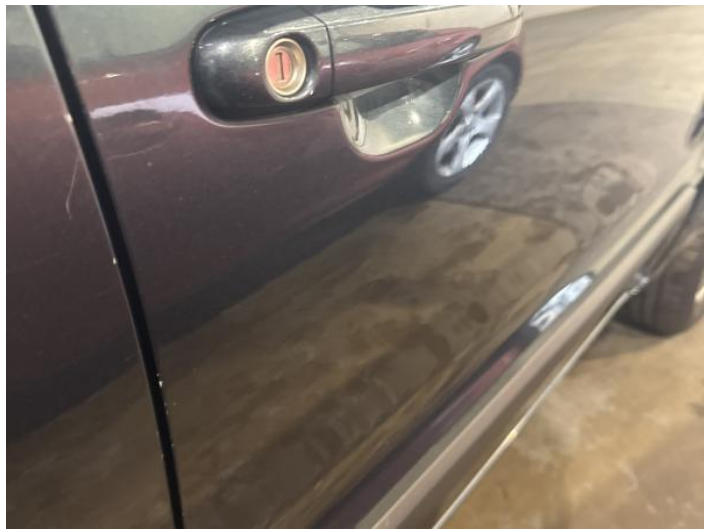
18: Door osf  
Chipped  
Edge Chip

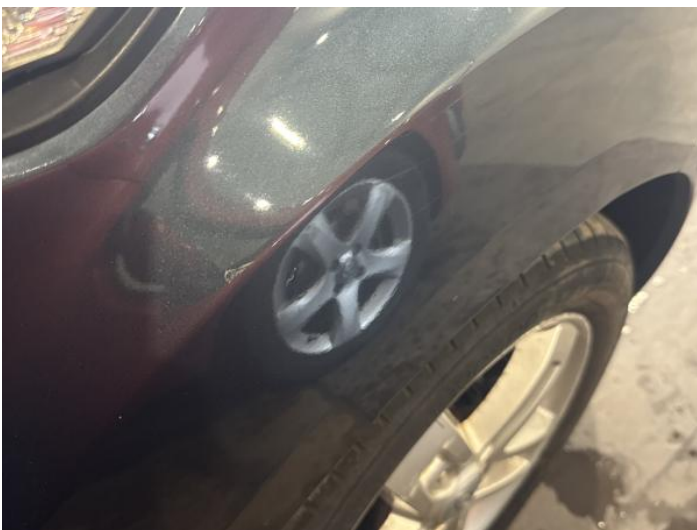
19: Wing osf  
Scratched  
Over 25mm Thru Paint

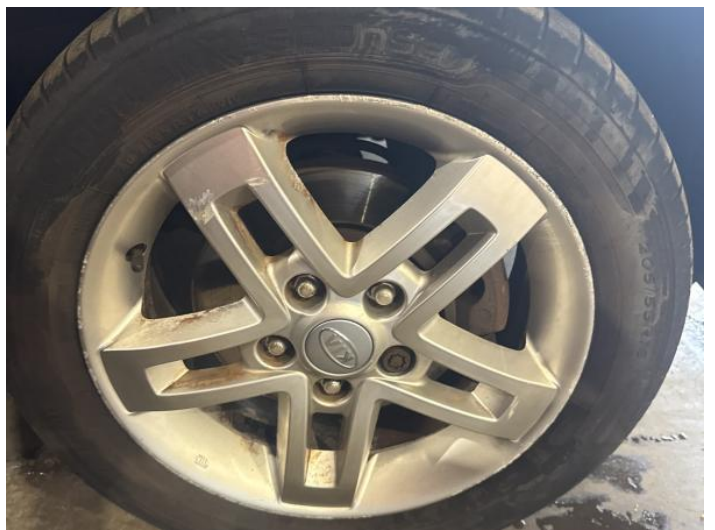
20: Wheel osf  
Scratched  
Over 50mm
