# VEHICLE INSPECTION REPORT

**GU63PKD**

## Toyota Yaris 1.33 VVT-i TR 5dr

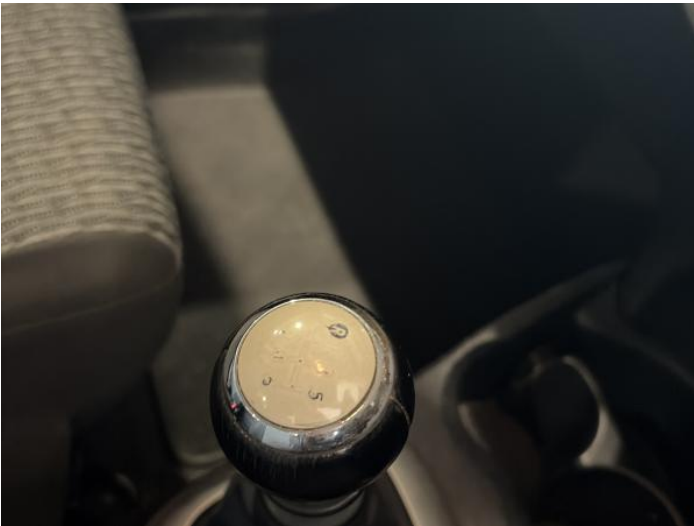
1: Switches And Controls  
Broken  
Replace

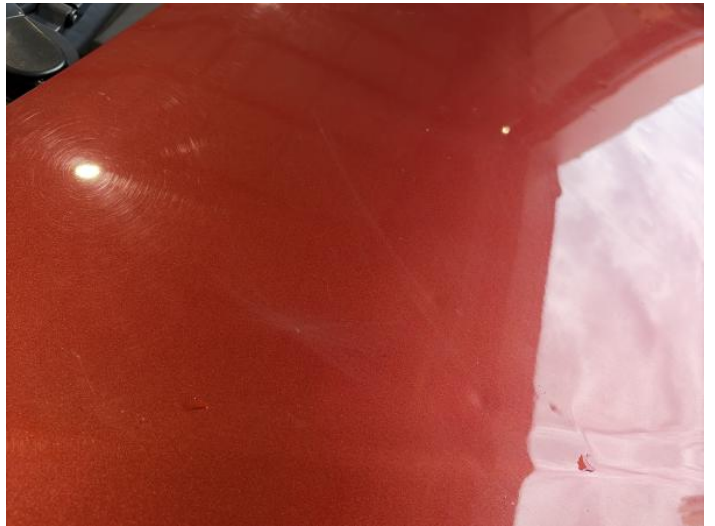
2: Bonnet  
Dented  
Hail - Moderate

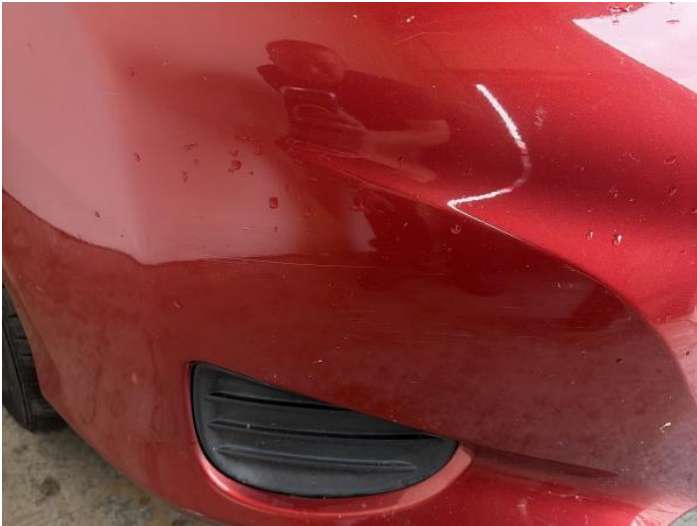
3: Bumper Front  
Scratched  
Over 100mm Thru Paint

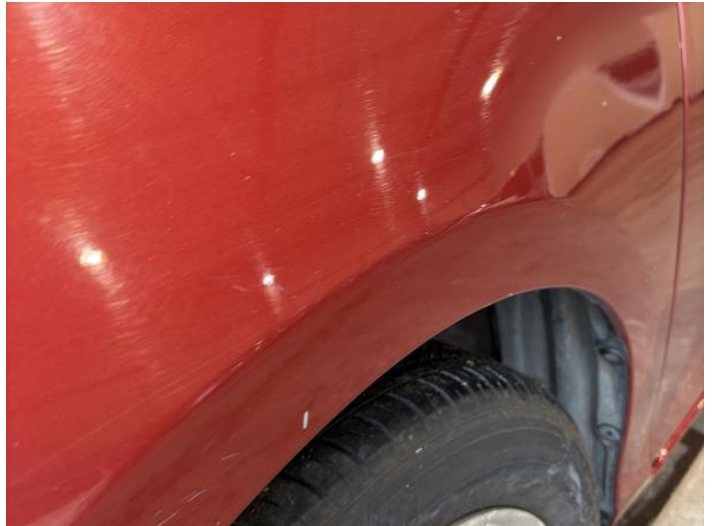
4: Wing nsf  
Scratched  
Over 25mm Thru Paint

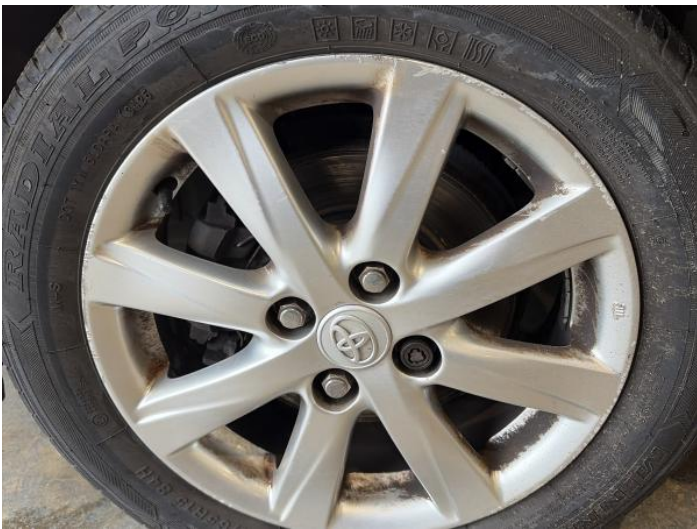
5: Wheel nsf  
Scratched  
Over 50mm

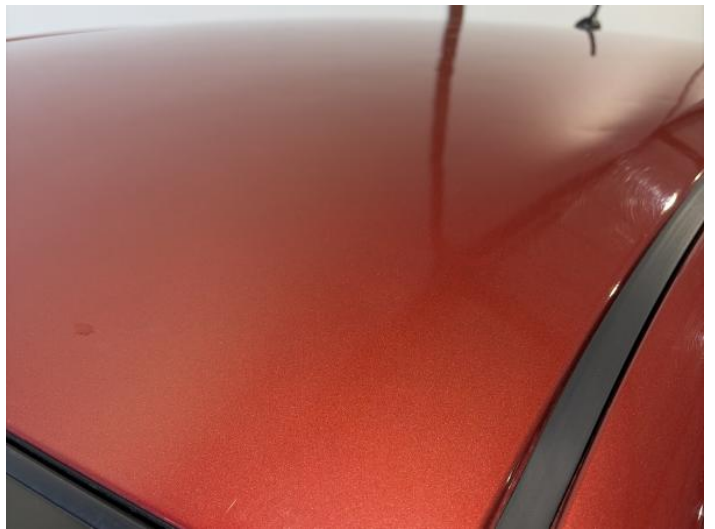
6: Roof  
Dented  
Hail - Severe

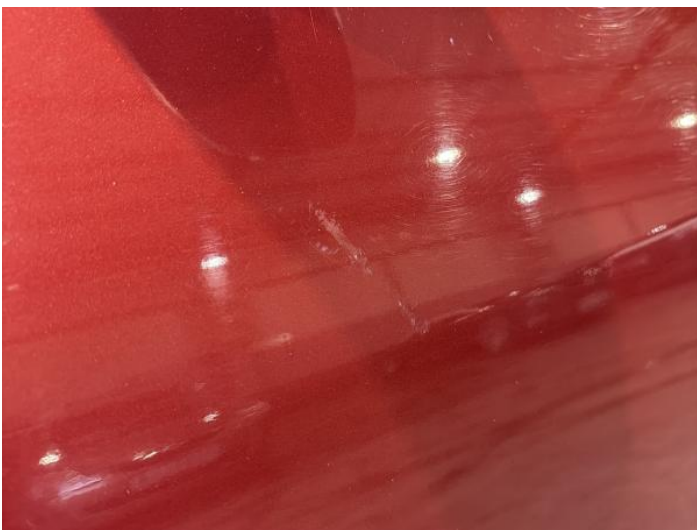
7: Door nsf  
Scratched  
Over 25mm Thru Paint

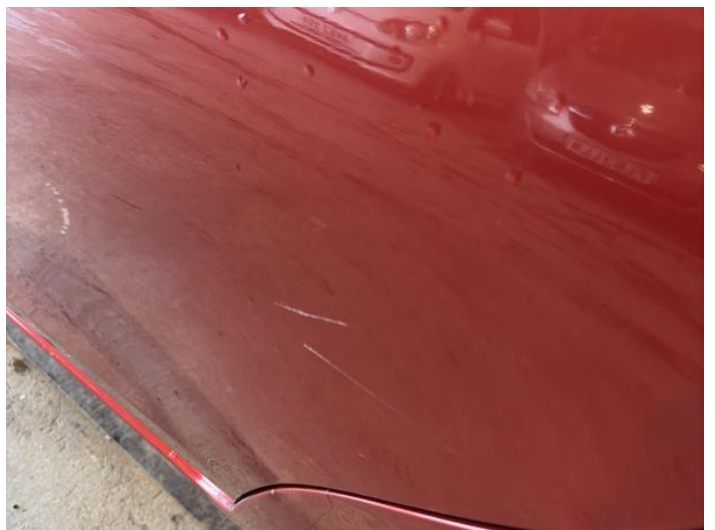
8: Door nsr  
Scratched  
Over 25mm Thru Paint

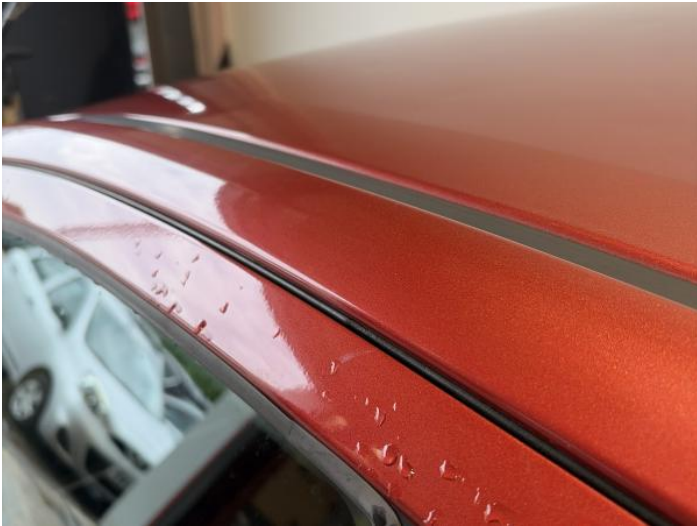
9: A Post ns  
Dented  
Hail - Moderate

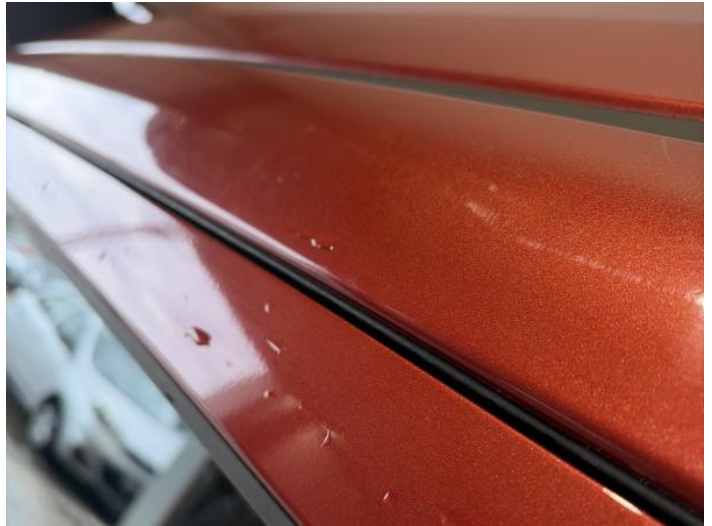
10: B Post ns  
Dented  
Hail - Moderate

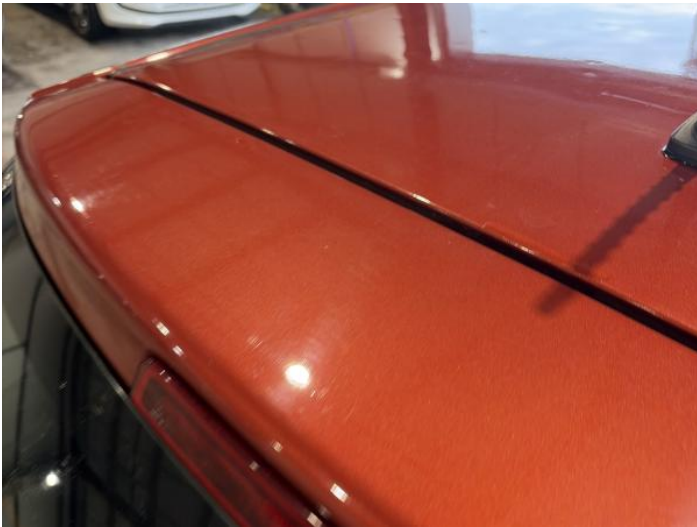
11: Tailgate  
Dented  
Hail - Moderate

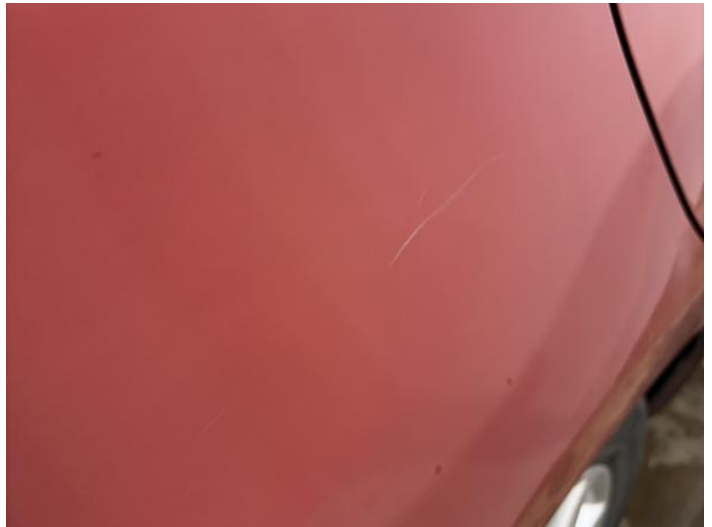
12: Qtr Panel osr  
Scratched  
Over 25mm Thru Paint

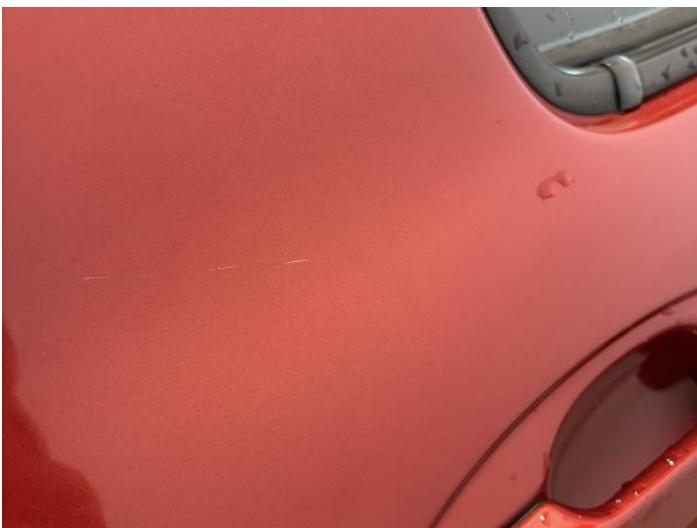
13: Door osr  
Scratched  
UpTo 25mm Thru Paint

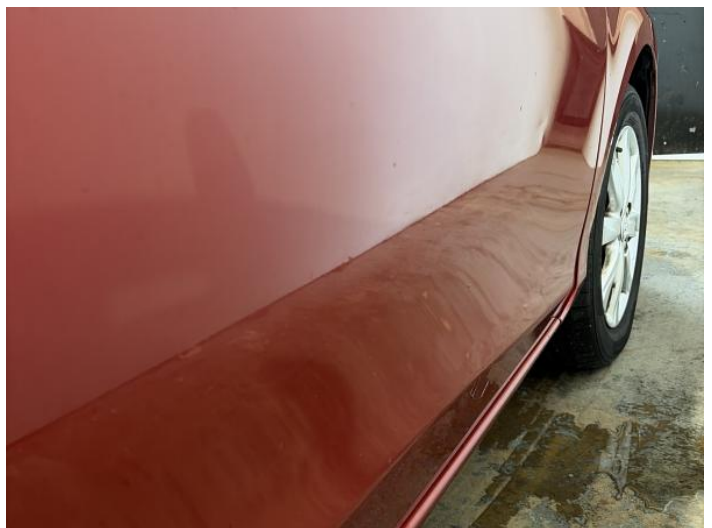
14: Door osf  
Dented  
Over 30mm

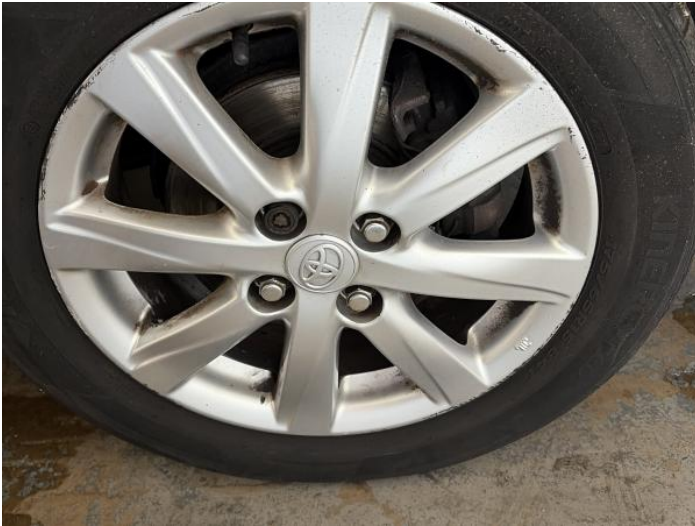
15: Wheel osf  
Scratched  
Over 50mm

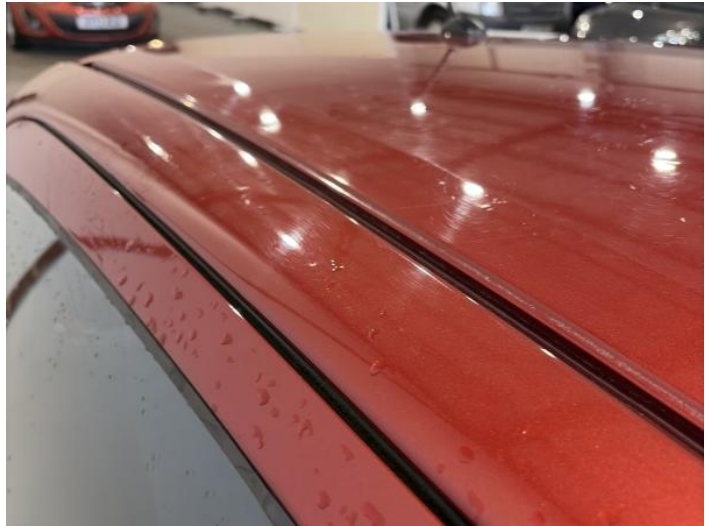
16: B Post os  
Dented  
Hail - Moderate
