VEHICLE INSPECTION REPORT

FD62JTY

Toyota Avensis 1.8 V-matic TR 5dr M-Drive S

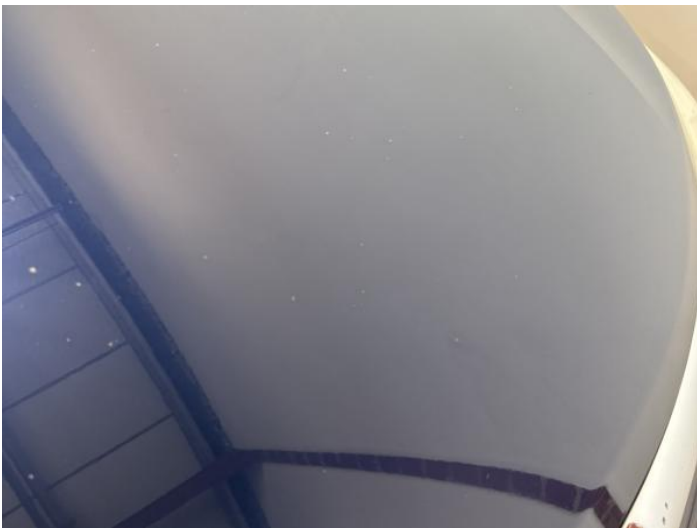
1: Bonnet
Chipped
Multiple Chips

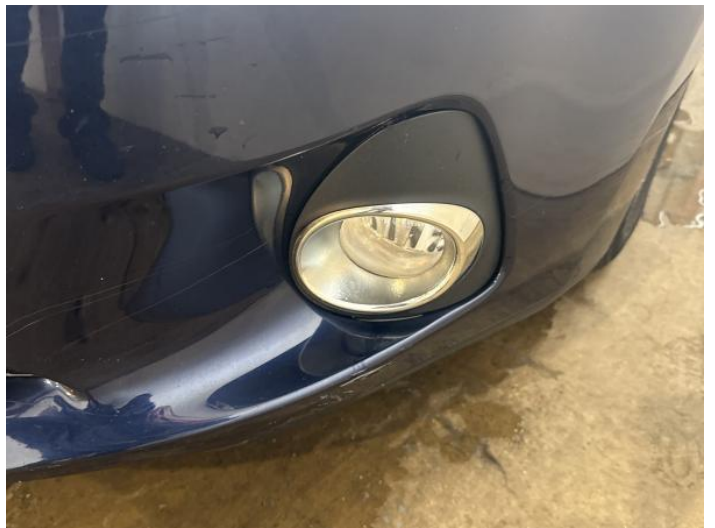
2: Bumper Front
Scratched
25 to 100mm Thru Paint

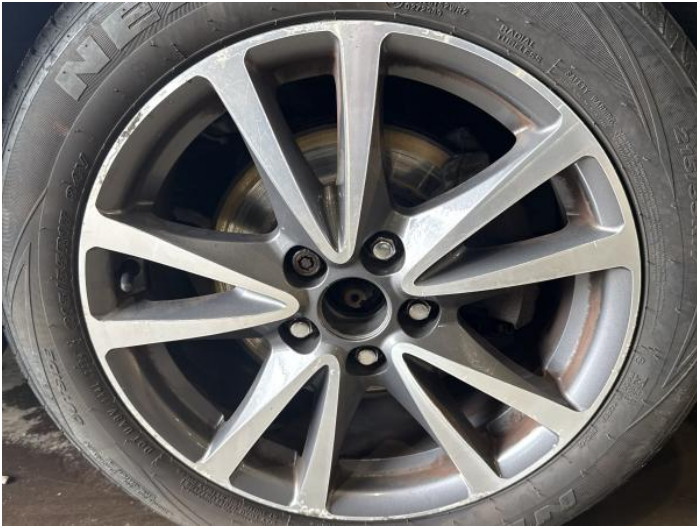
3: Wheel osf
Scratched
Over 50mm

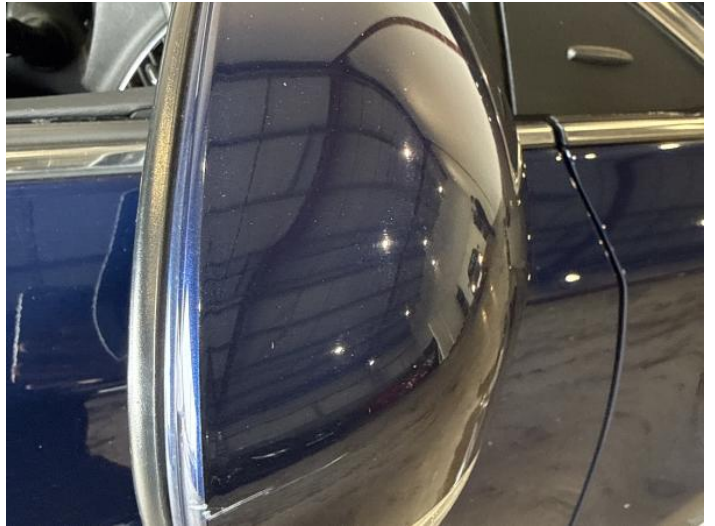
4: Door Mirror Assy nsf
Scratched (Painted)
UpTo 25mm Thru Paint

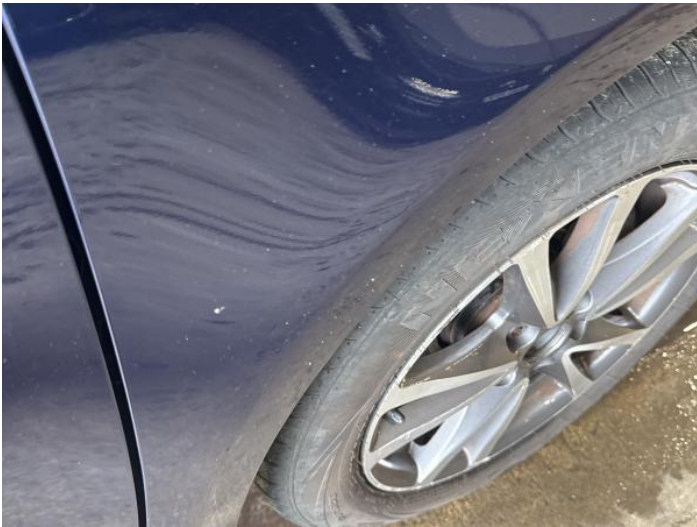
5: Wing osf
Chipped
1 To 5

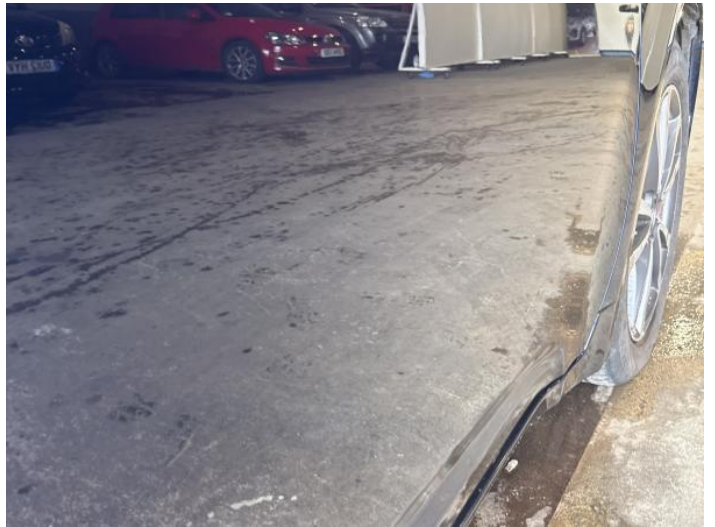
6: Door osf
Dented
Over 30mm

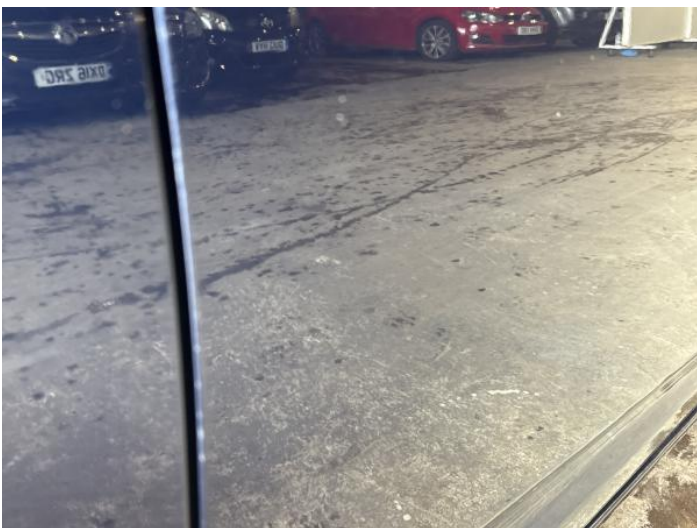
7: Door osf
Scratched
UpTo 25mm Thru Paint

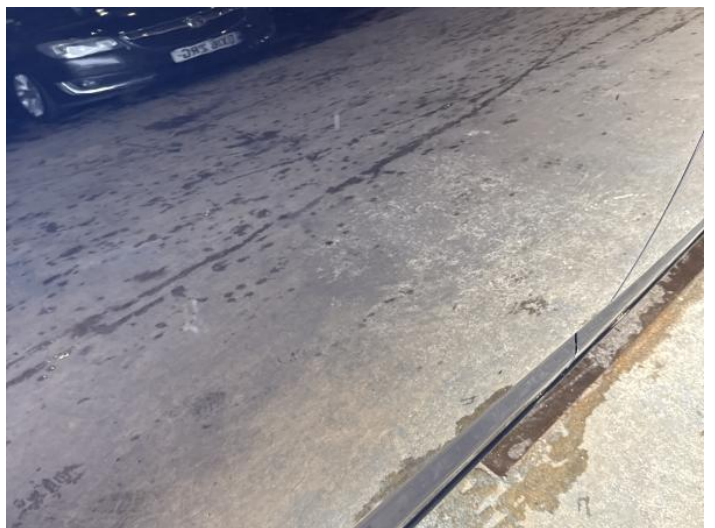
8: Door osr
Scratched
Over 25mm Thru Paint

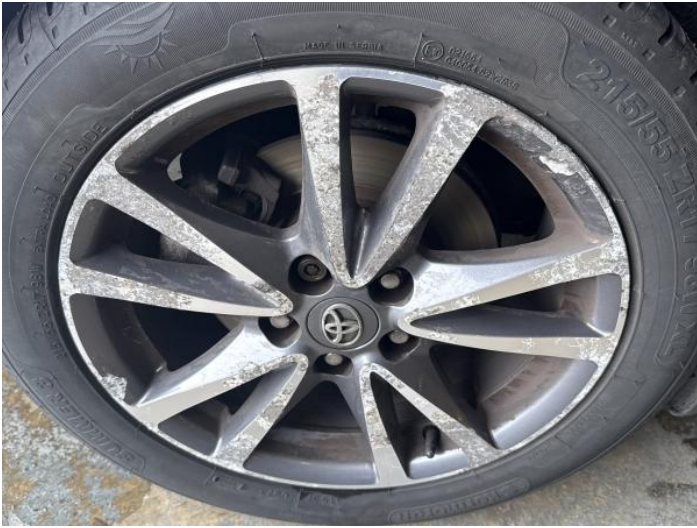
9: Wheel osr
Scratched
Over 50mm

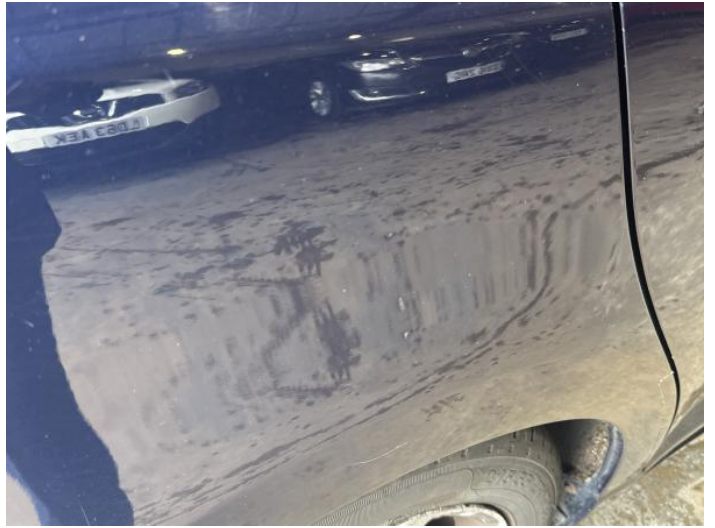
10: Qtr Panel osr
Scratched
Over 25mm Thru Paint

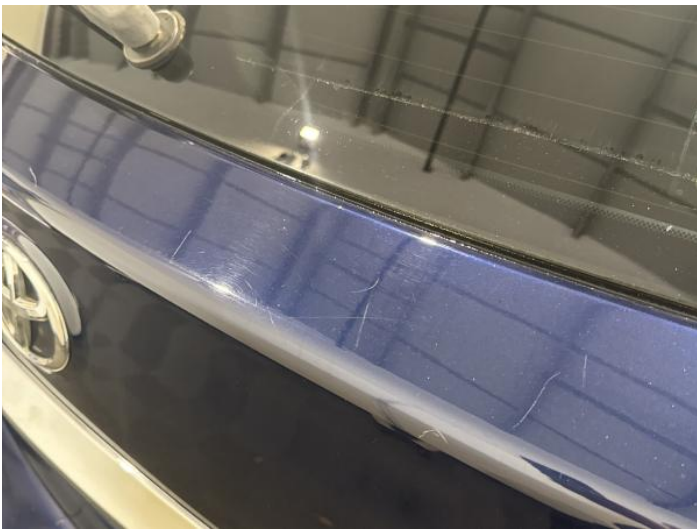
11: Tailgate
Scratched
Over 25mm Thru Paint

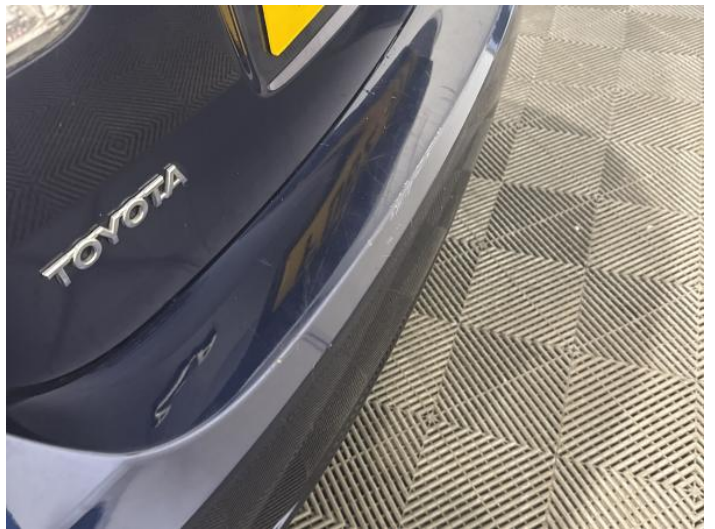
12: Bumper Rear
Scratched
Over 100mm Thru Paint

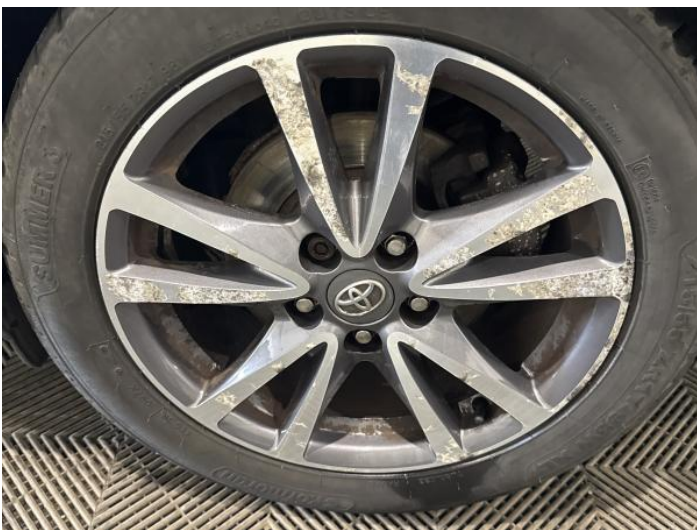
13: Wheel nsr
Scratched
Over 50mm

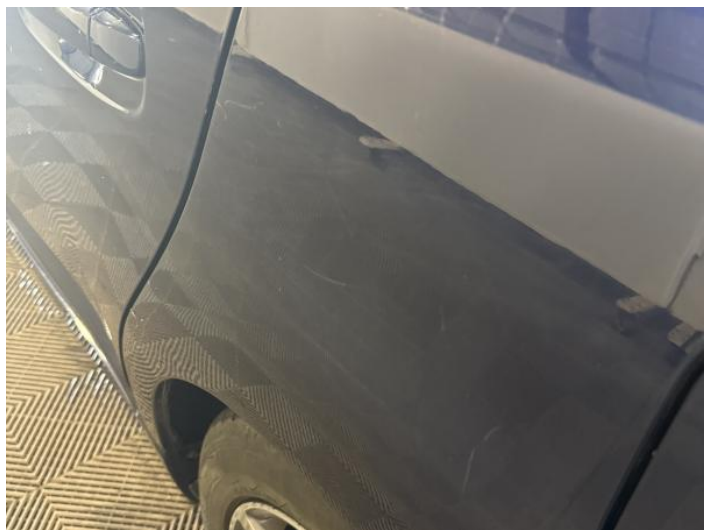
14: Qtr Panel osr
Scratched
Over 25mm Thru Paint

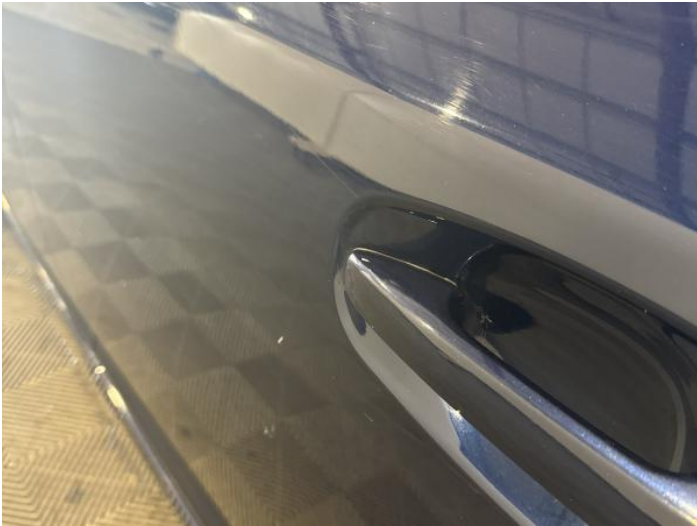
15: Door nsr
Scratched
Over 25mm Thru Paint

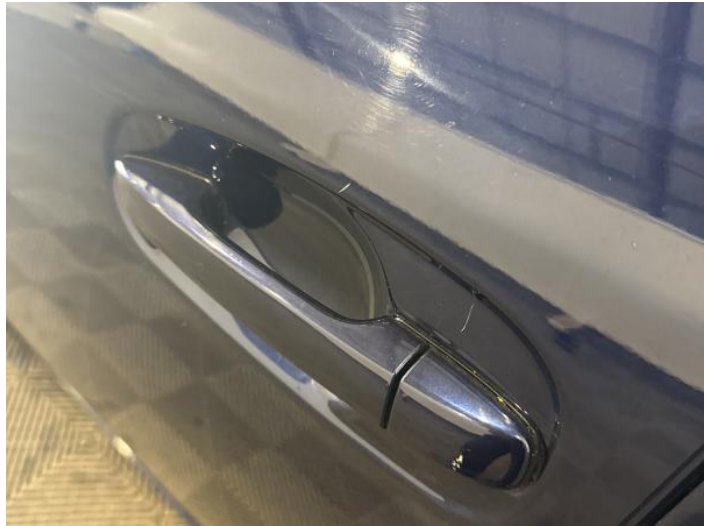
16: Door nsf
Scratched
UpTo 25mm Thru Paint

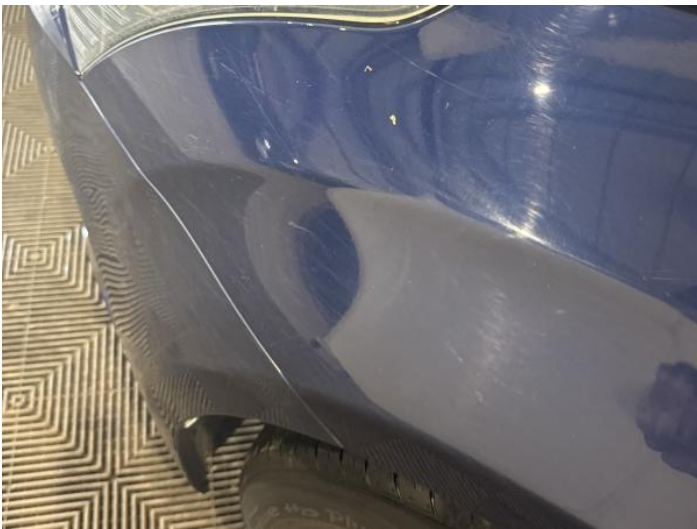
17: Wing nsf
Scratched
Over 25mm Thru Paint

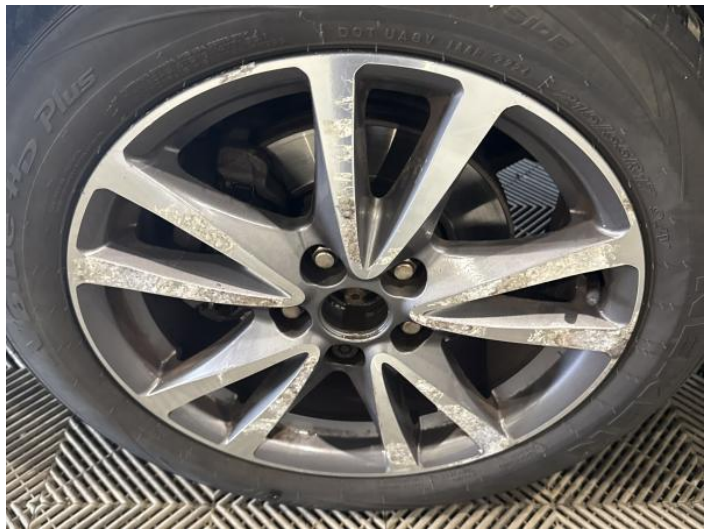
18: Wheel nsf
Scratched
Over 50mm

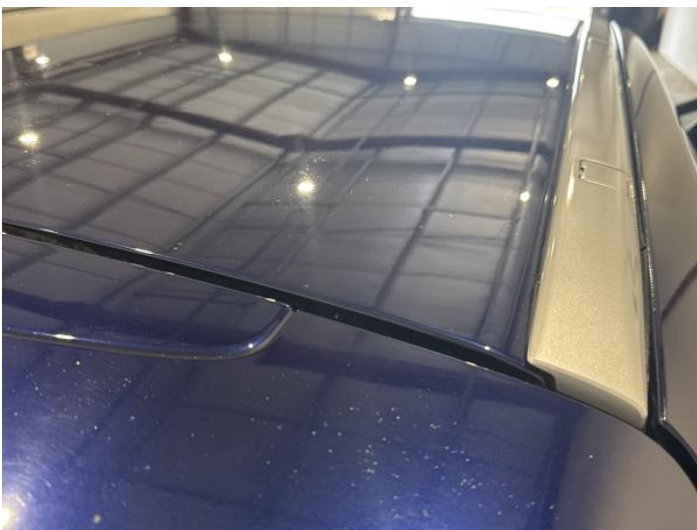
19: Roof
Dented
Hail - Moderate
