VEHICLE INSPECTION REPORT

RO08DYB

Honda Civic 1.8 i-VTEC Sport 5dr i-SHIFT Auto

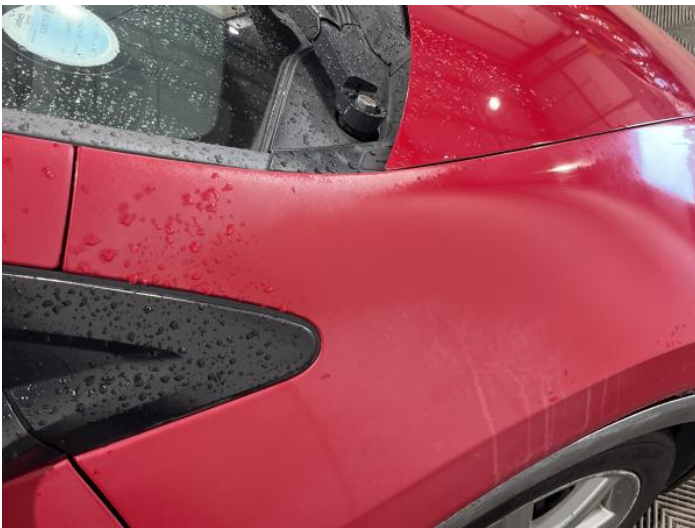
1: Wing osf
Poor Previous Repair
Poor Paint

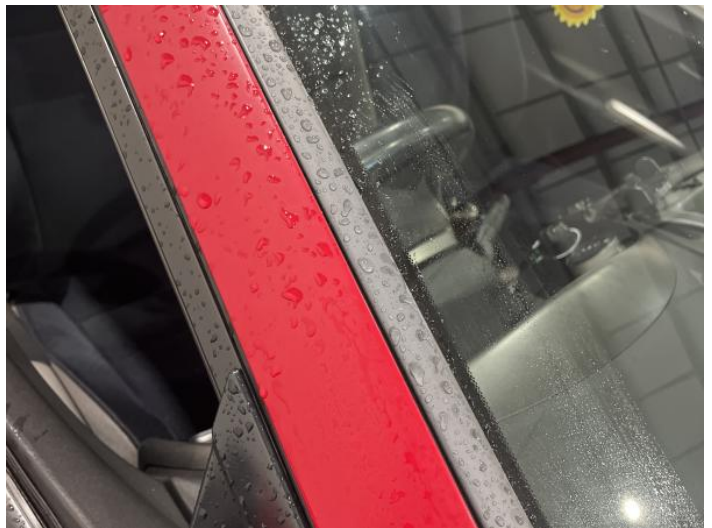
2: A Post os
Poor Previous Repair
Poor Colour

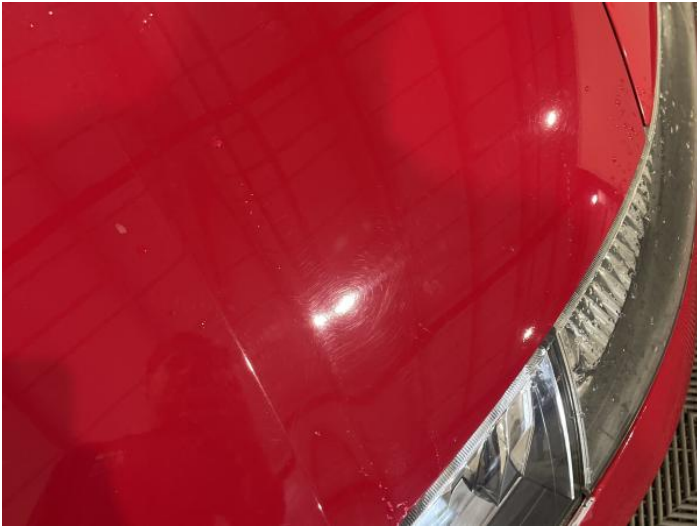
3: Bonnet
Poor Previous Repair
Poor Paint

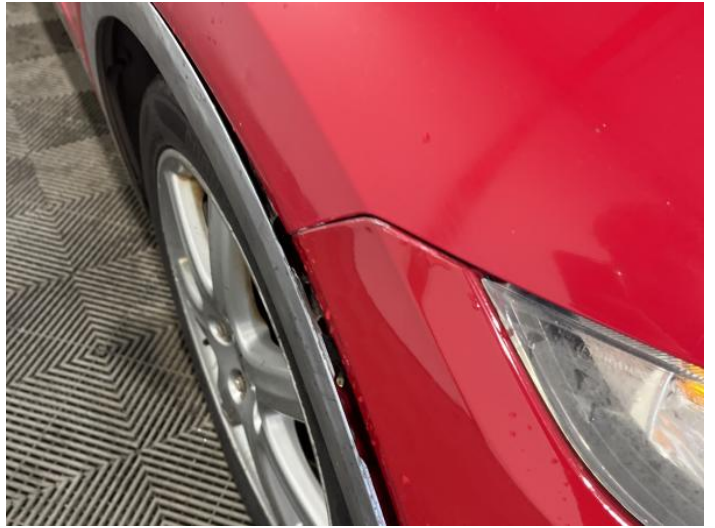
4: Wheel Trim nsf
Broken
Replace

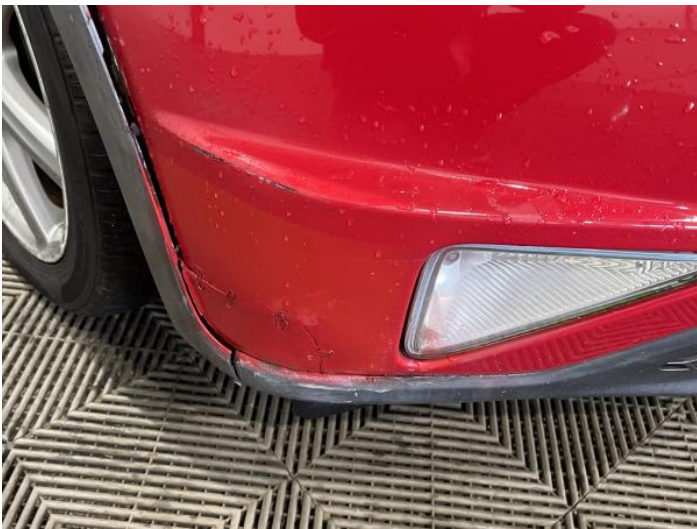
5: Bumper Front
Cracked
Over 25mm

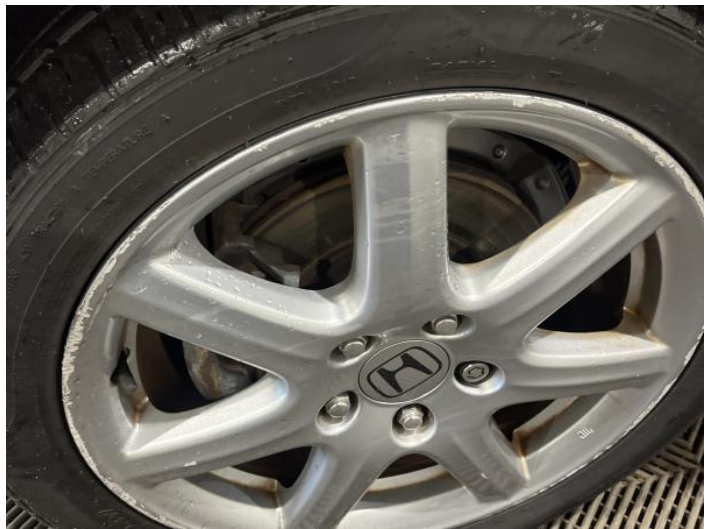
6: Wheel nsf
Scratched
Over 50mm

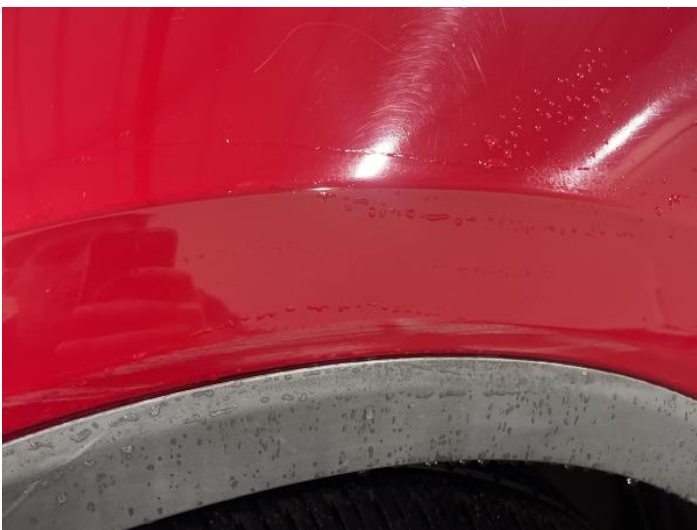
7: Wing nsf
Scratched
Over 25mm Thru Paint

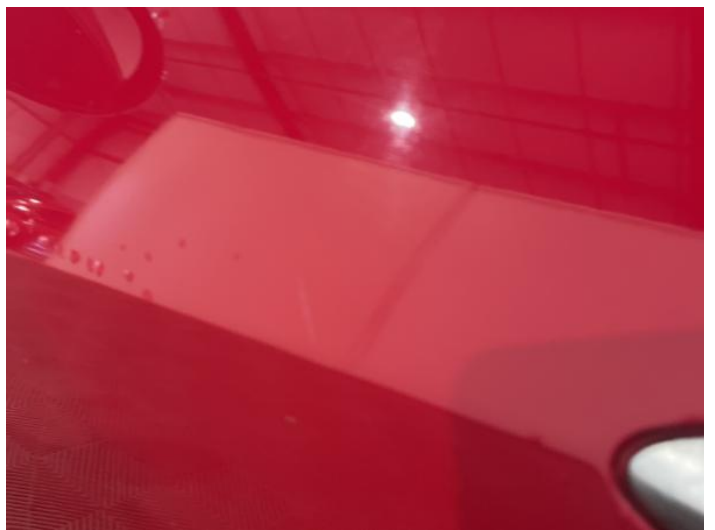
8: Door nsf
Scratched
Over 25mm Thru Paint

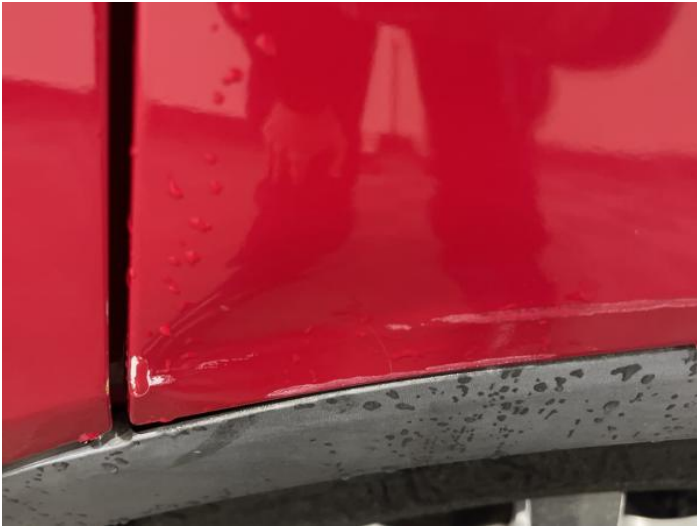
9: Qtr Panel nsr
Dented
With Paint Damage

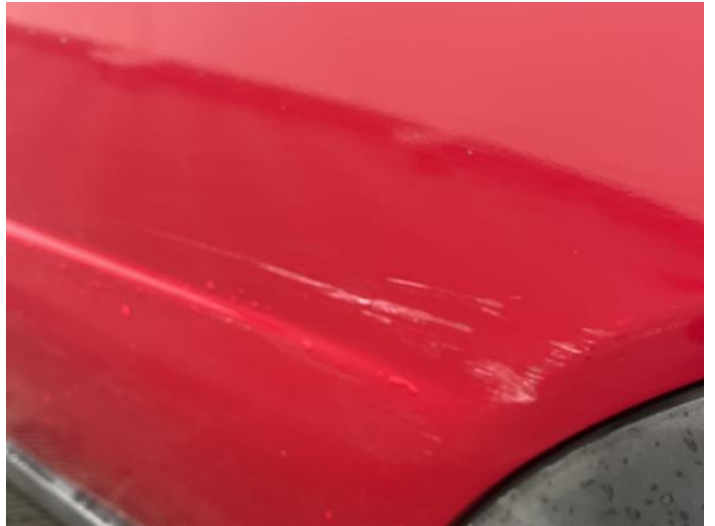
10: Door nsr
Scratched
Over 25mm Thru Paint

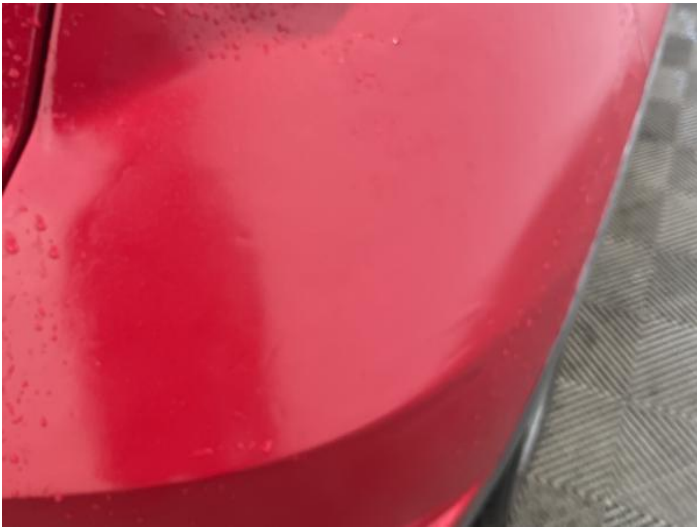
11: Bumper Rear
Poor Previous Repair
Poor Paint

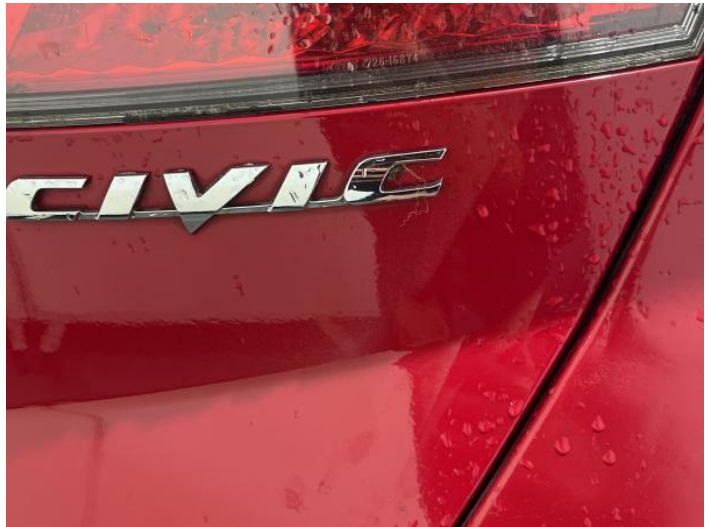
12: Tailgate
Poor Previous Repair
Poor Paint

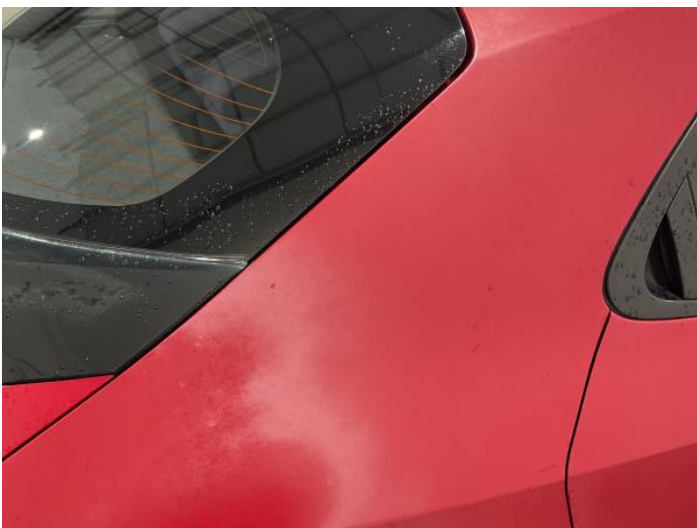
13: Qtr Panel osr
Poor Previous Repair
Poor Paint

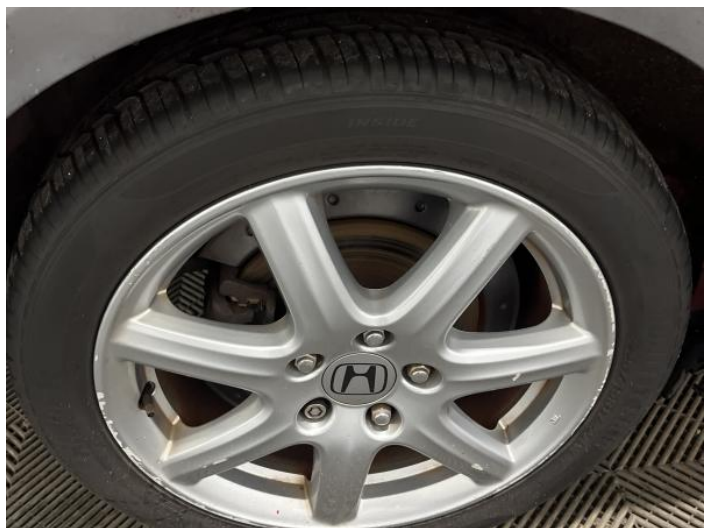
14: Wheel osr
Scratched
Over 50mm

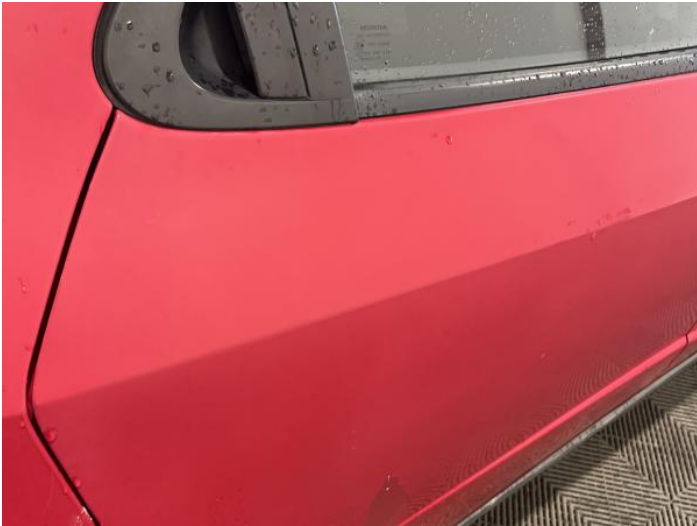
15: Door osr
Poor Previous Repair
Poor Paint

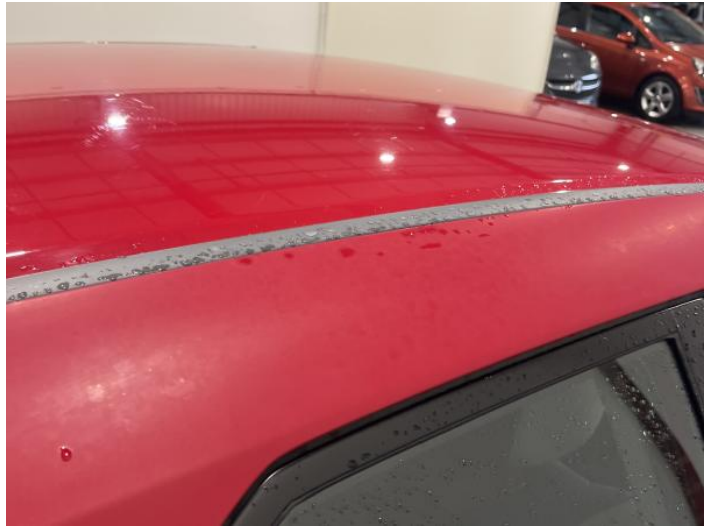
16: B Post os
Poor Previous Repair
Poor Paint

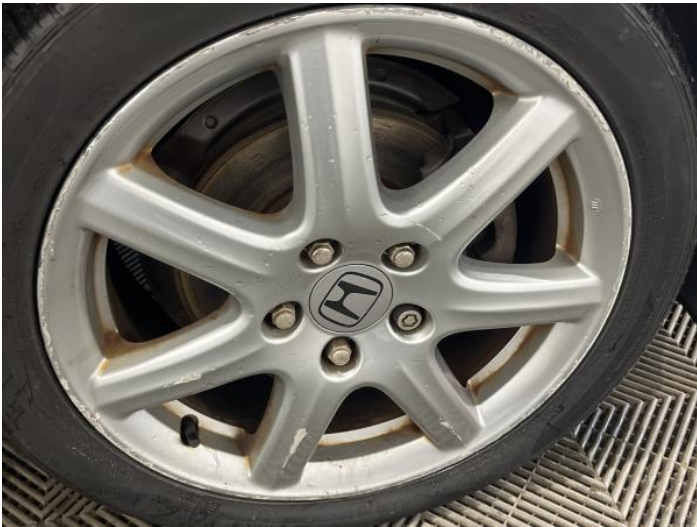
17: Wheel osf
Scratched
Over 50mm

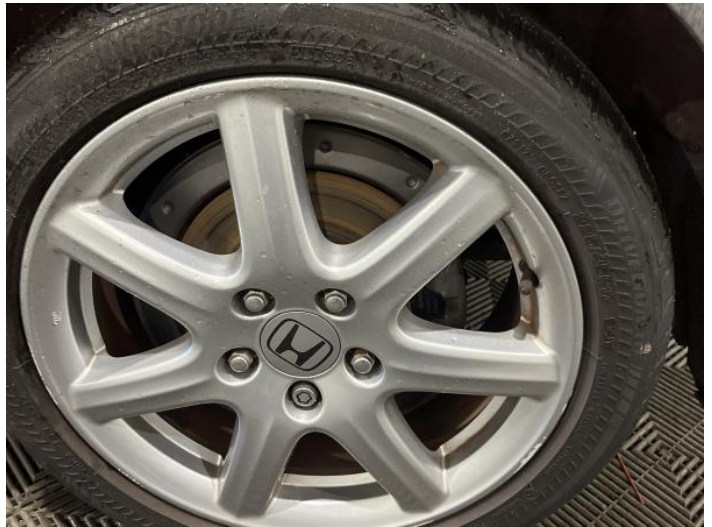
18: Wheel nsr
Scratched
Over 50mm
