VEHICLE INSPECTION REPORT

GX21YPW

Renault Kangoo ML20 44kW 33kWh Business i-Van Auto

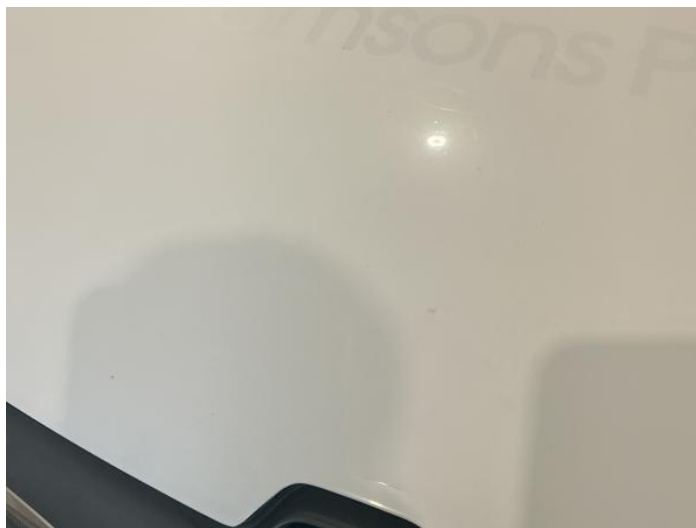
2: Bonnet
Dented
With Paint Damage

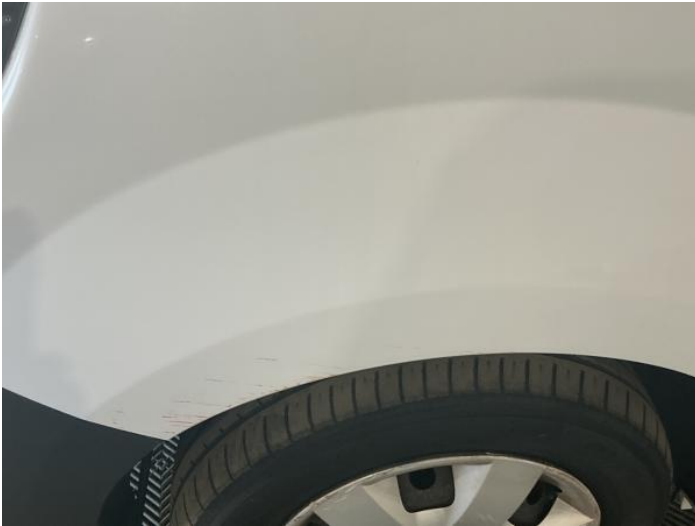
3: Wing nsf
Scratched
Over 25mm Thru Paint

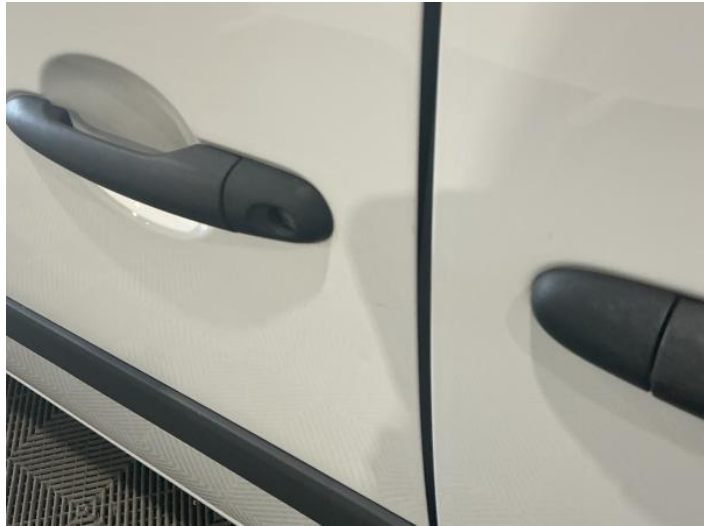
4: Door nsf
Dented
Over 2 UpTo 10mm

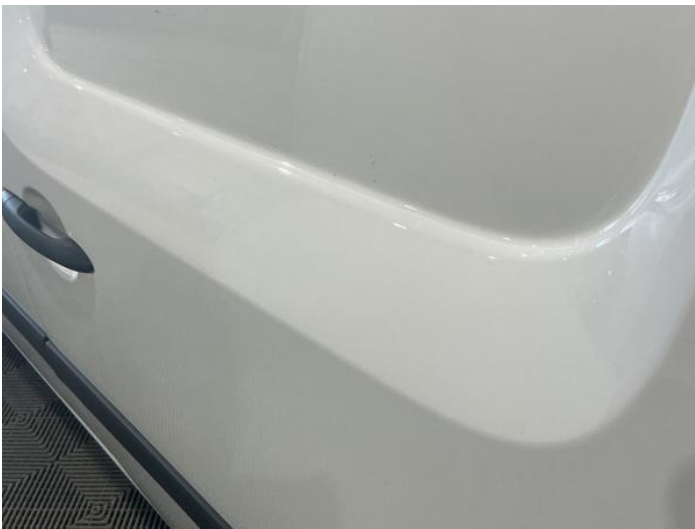
5: Door nsr
Dented
2 Or Less UpTo 10mm

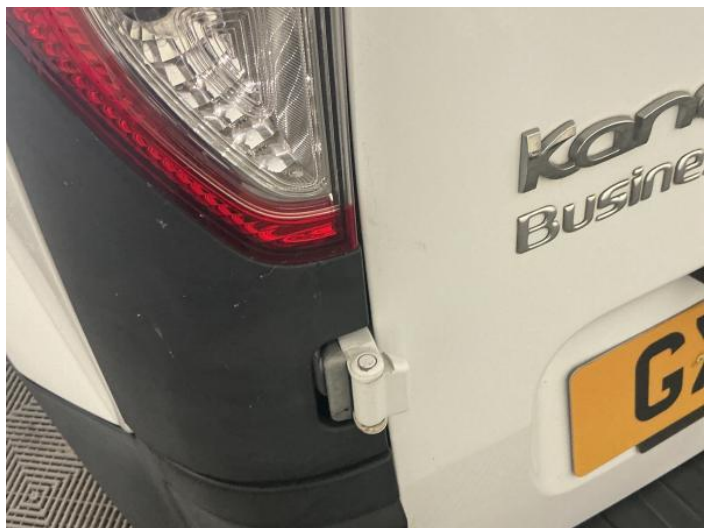
8: Bumper Rear Moulding
Scuffed (Unpainted)
Over 100mm

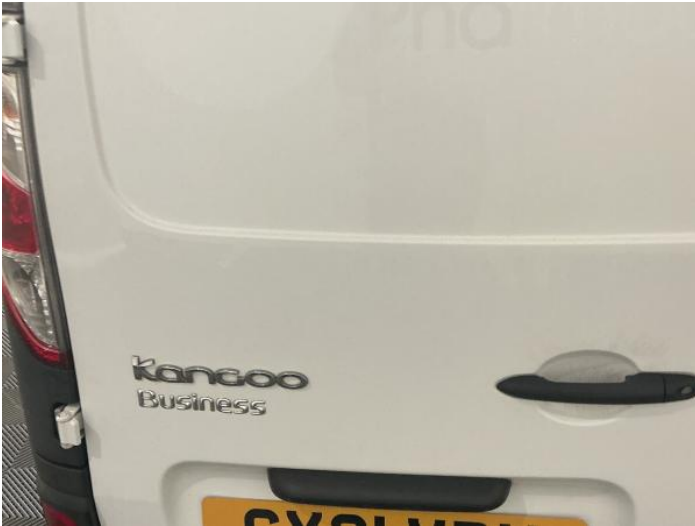
9: Boot Lid
Chipped
1 To 5

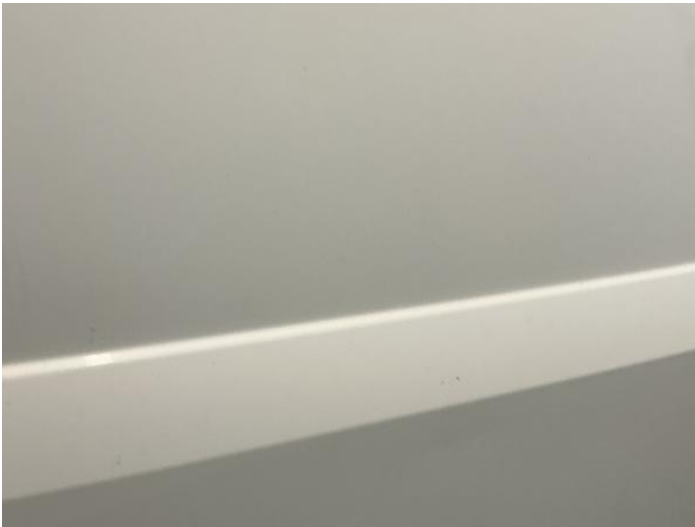
11: Qtr Panel osr
Chipped
1 To 5

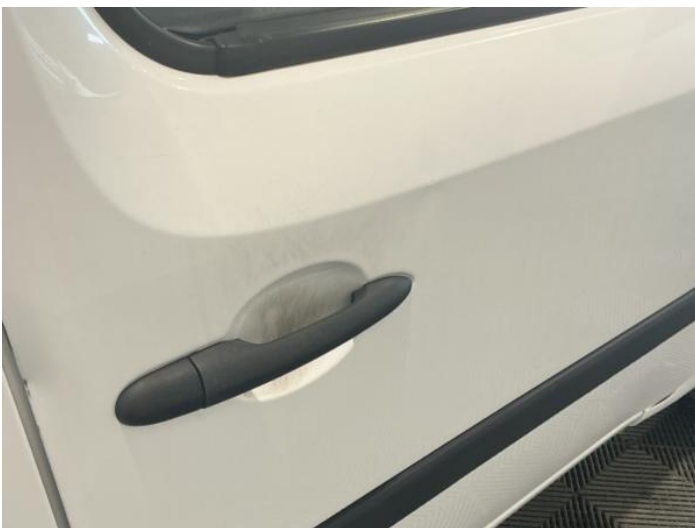
13: Door osf
Dented
With Paint Damage

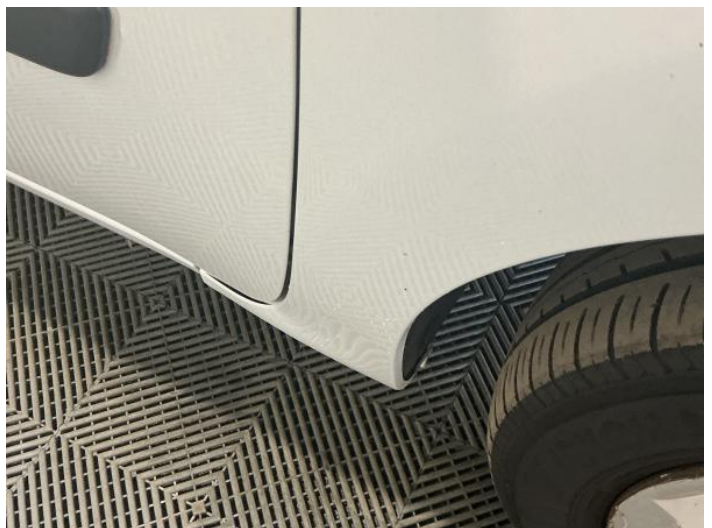
14: Wing osf
Dented
Over 30mm
