VEHICLE INSPECTION REPORT

DN17ONV

Ford Focus 1.0 EcoBoost 125 Titanium 5dr

nama
 GRADE
5

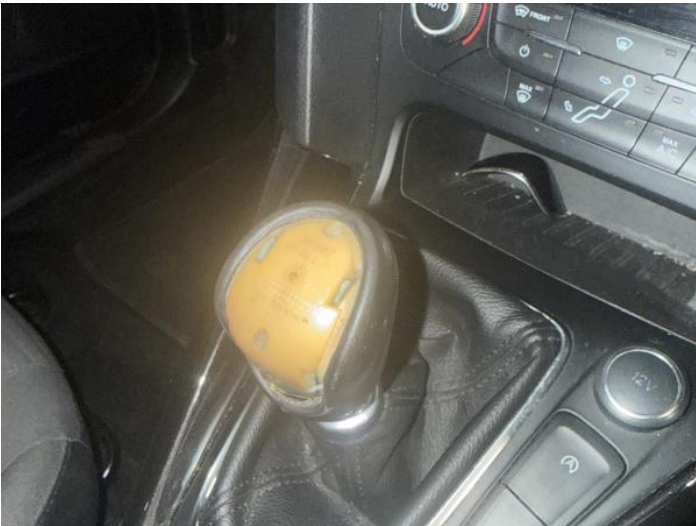
1: Switches And Controls
Broken
Replace

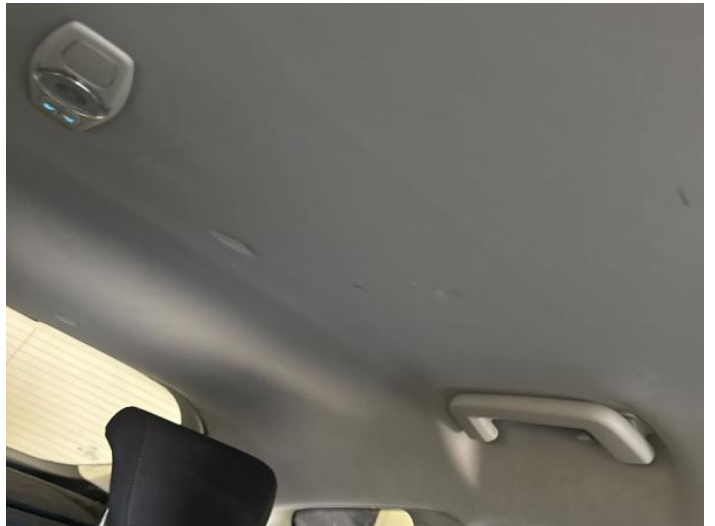
2: Roof Lining
Scuffed
Over 25mm

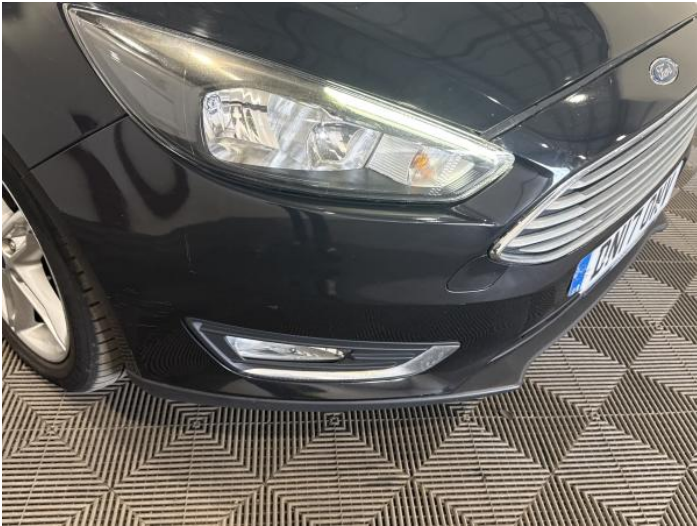
3: Bumper Front
Poor Previous Repair
Poor Paint

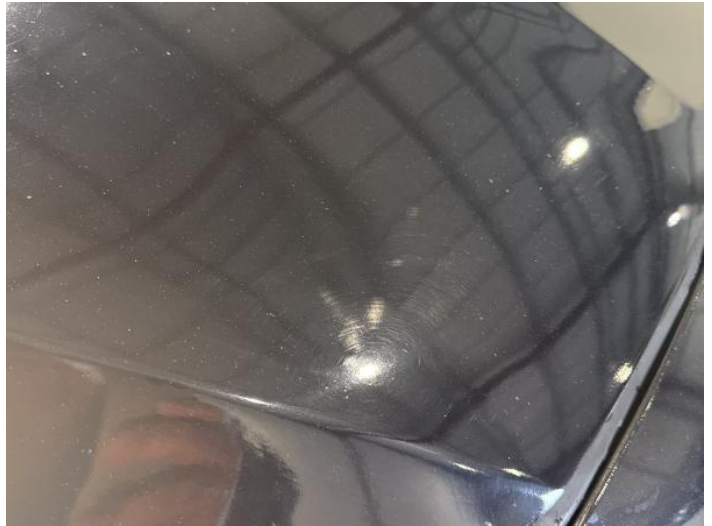
4: Bonnet
Poor Previous Repair
Poor Paint

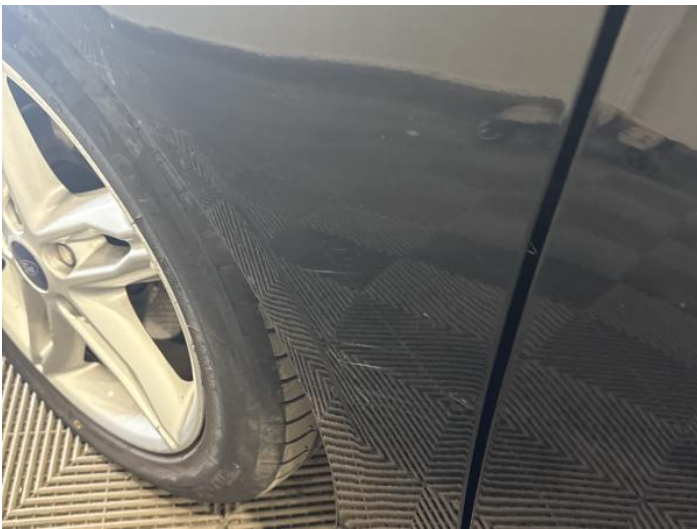
5: Wing nsf
Scratched
Over 25mm Thru Paint

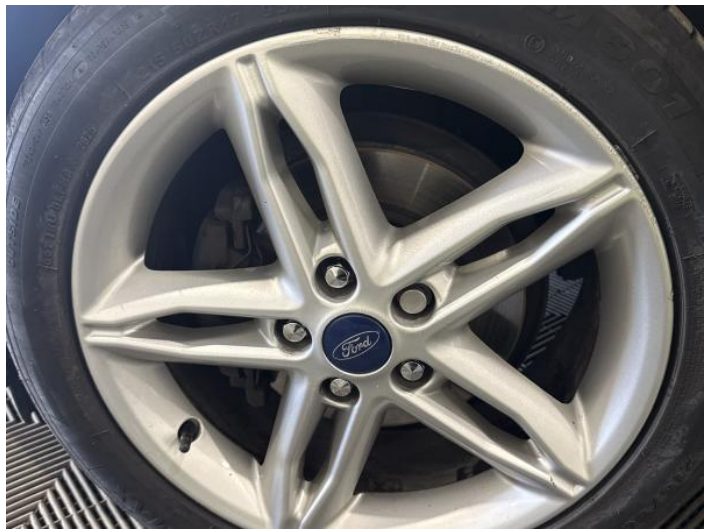
6: Wheel nsf
Scratched
Over 50mm

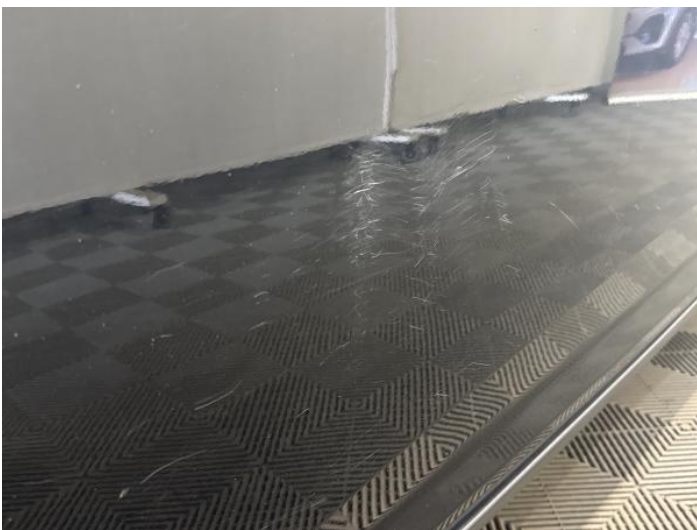
7: Door nsf
Scratched
Over 25mm Thru Paint

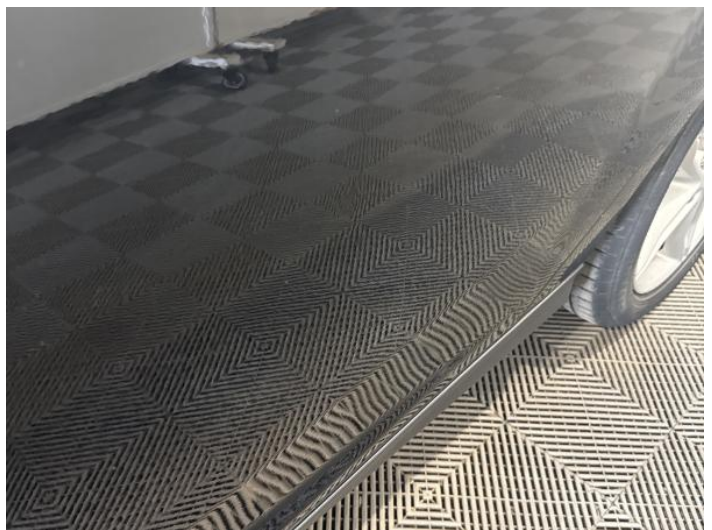
8: Door nsr
Dented
Between 10mm + 30mm

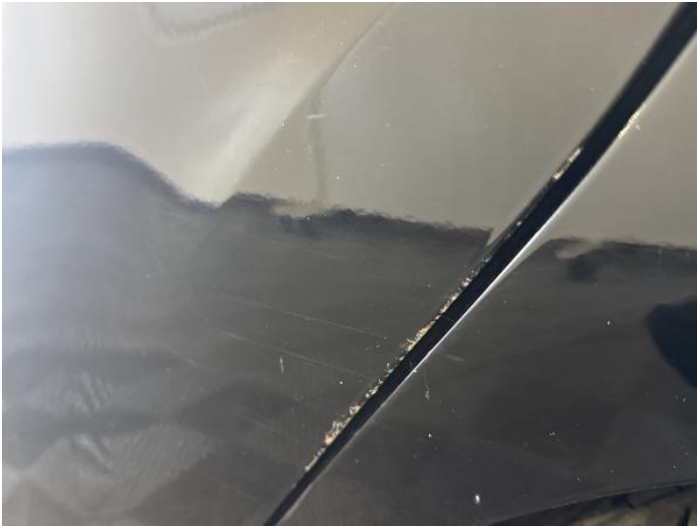
9: Door nsr
Chipped
Edge Chip

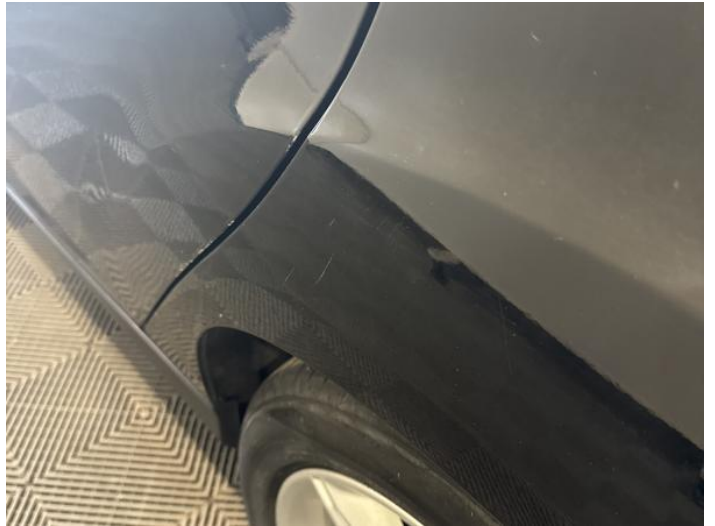
10: Qtr Panel nsr
Scratched
Over 25mm Thru Paint

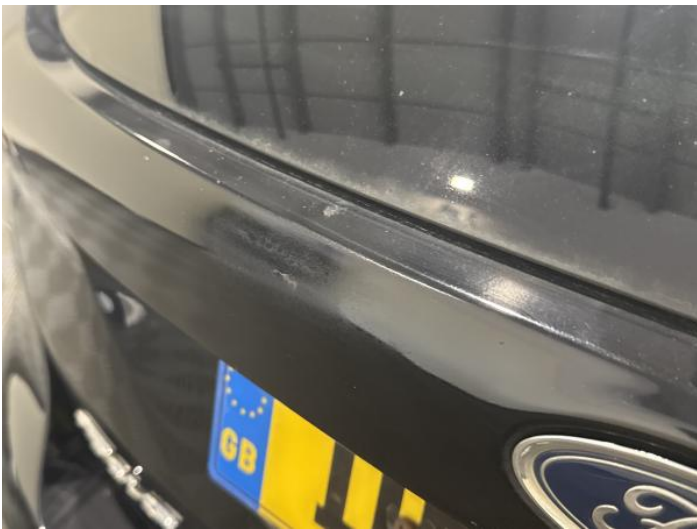
11: Tailgate
Poor Previous Repair
Poor Paint

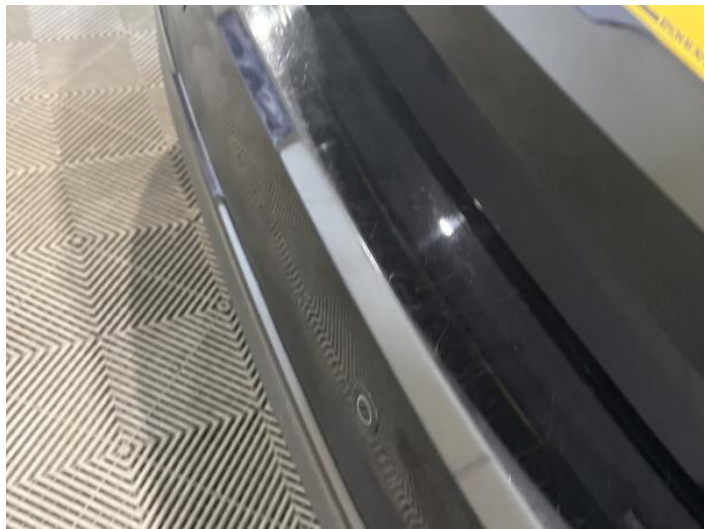
12: Bumper Rear
Scratched
25 to 100mm Thru Paint

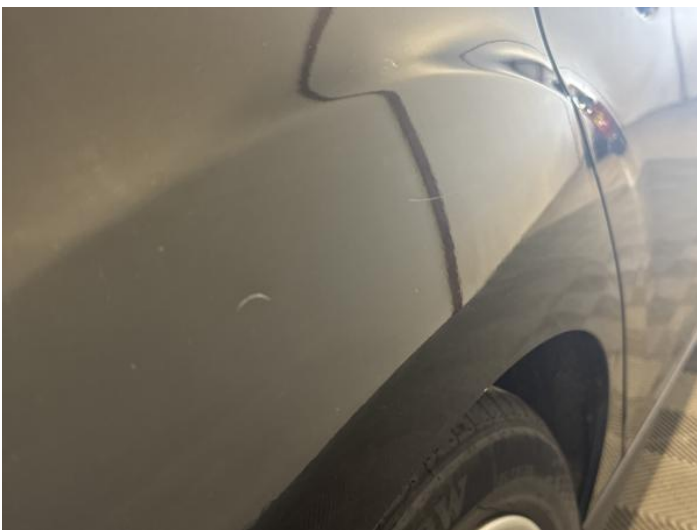
13: Qtr Panel osr
Scratched
Over 25mm Thru Paint

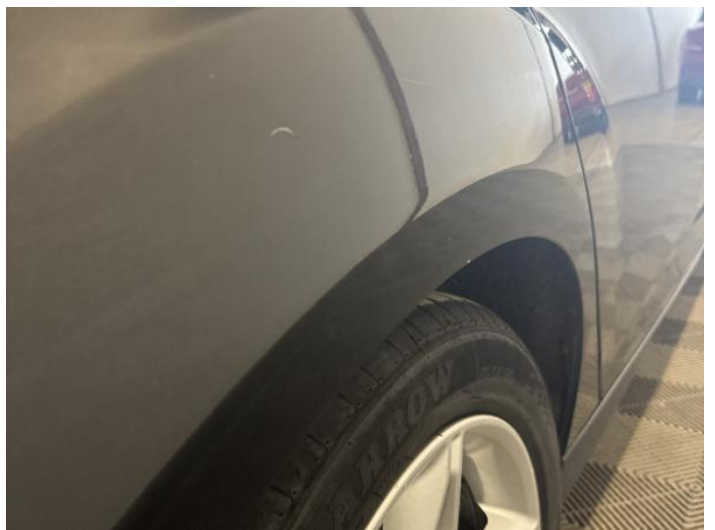
14: Qtr Panel osr
Dented
2 Or Less Up To 10mm

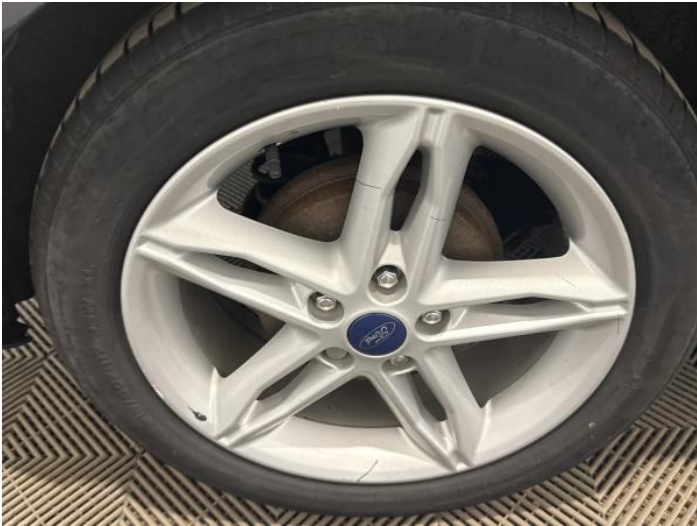
15: Wheel osr
Scratched
Over 50mm

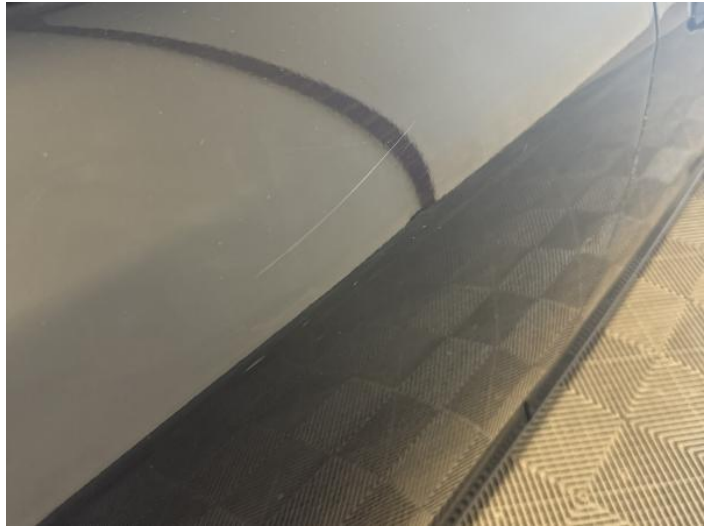
16: Door osr
Scratched
Over 25mm Thru Paint

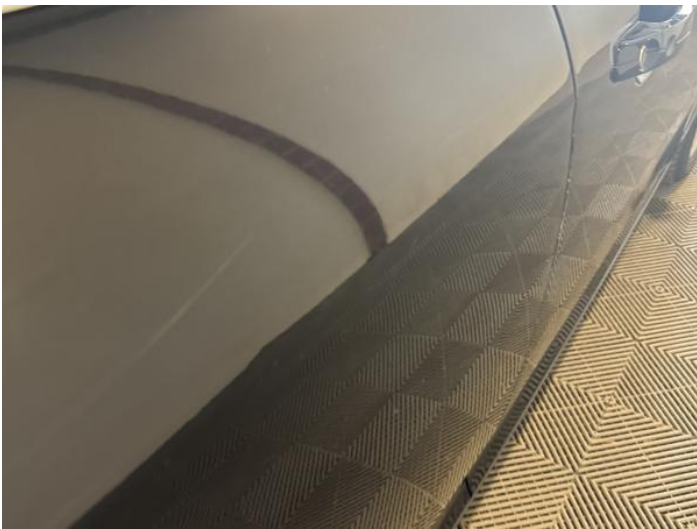
17: Door osr
Dented
Between 10mm + 30mm

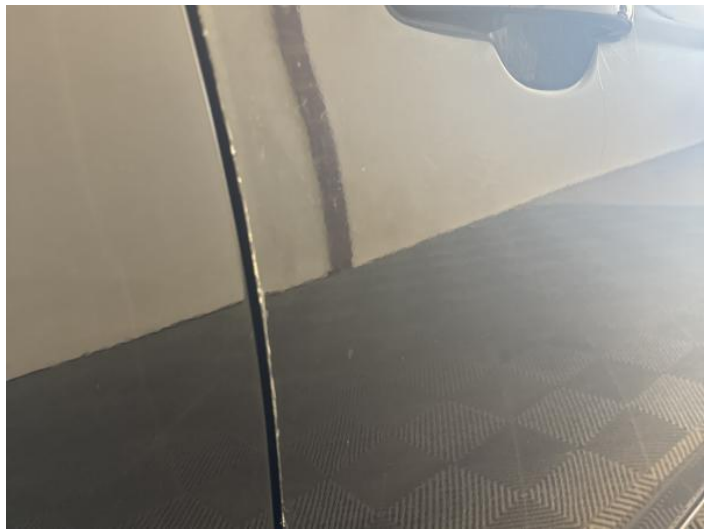
18: Door osf
Chipped
Edge Chip

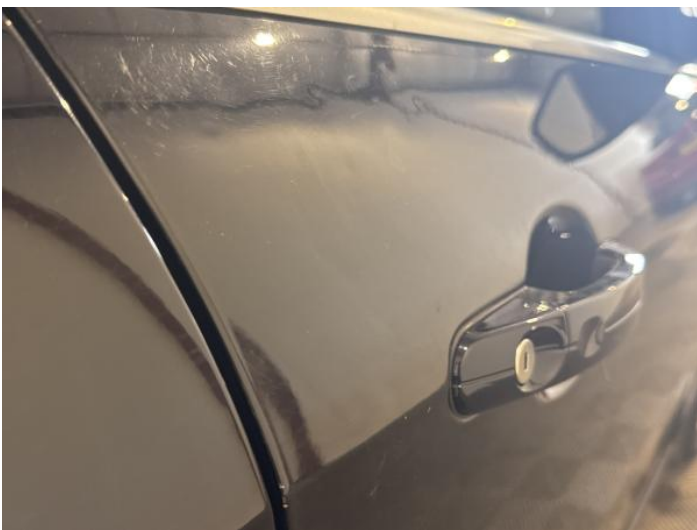
19: Door osf
Dented
Over 30mm

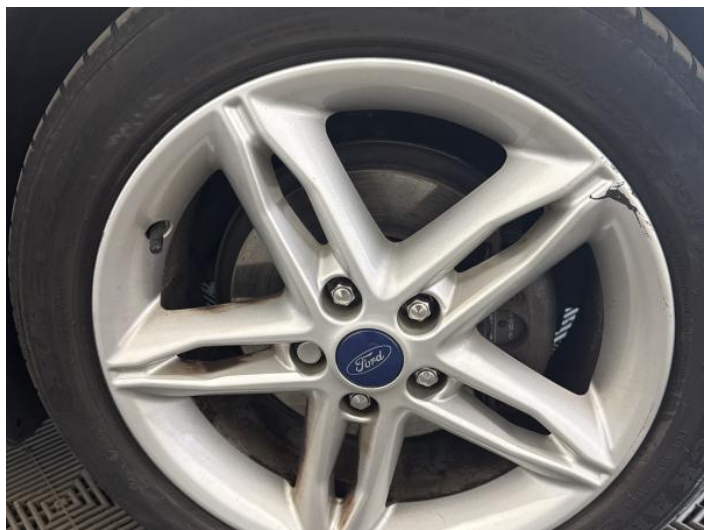
20: Wheel osf
Scratched
Over 50mm

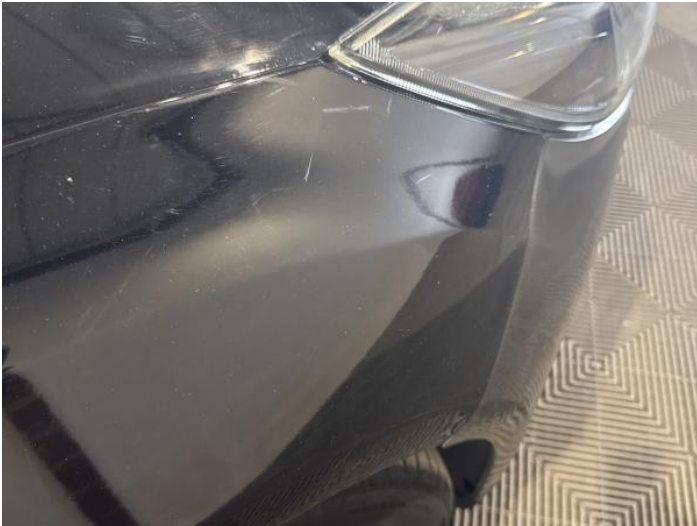
21: Wing osf
 Scratched
 Over 25mm Thru Paint

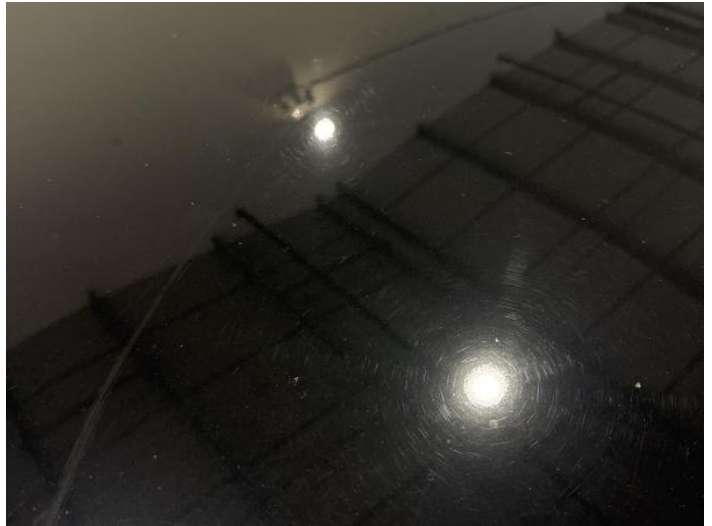
22: Roof
 Scratched
 Over 25mm Thru Paint

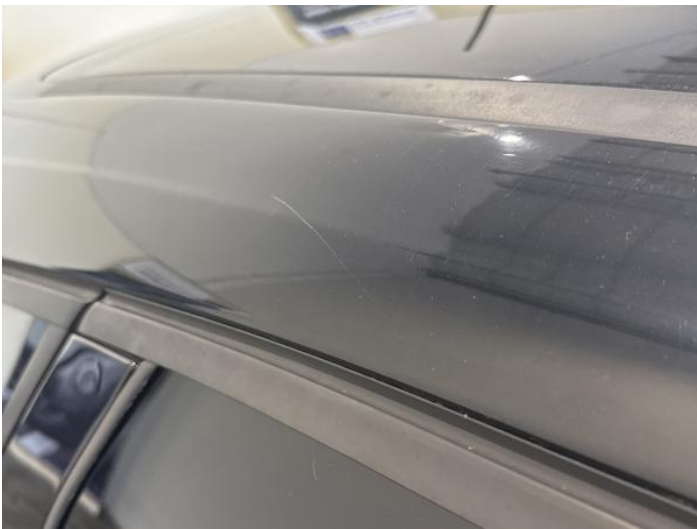
23: B Post os
 Scratched
 Over 25mm Thru Paint

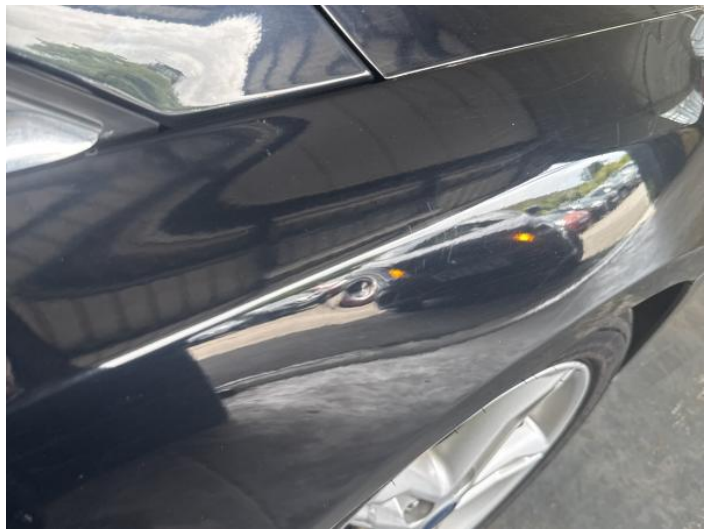
24: Wing osf
 Dented
 Between 10mm + 30mm
