VEHICLE INSPECTION REPORT

AJ72KXS

Volkswagen Polo 1.0 TSI Style 5dr

nama
GRADE
4

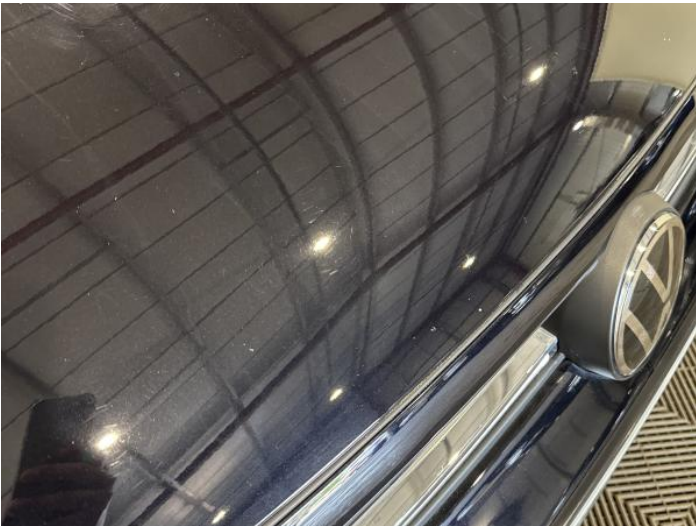
1: Bonnet
Chipped
1 To 5

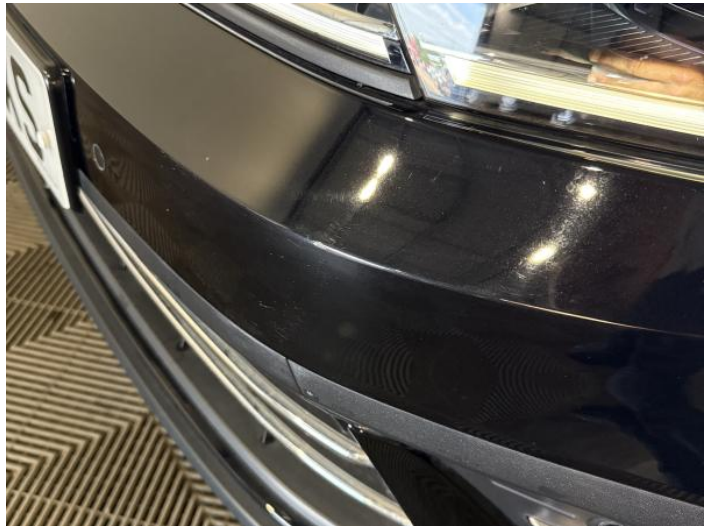
2: Bumper Front
Scratched
25 to 100mm Thru Paint

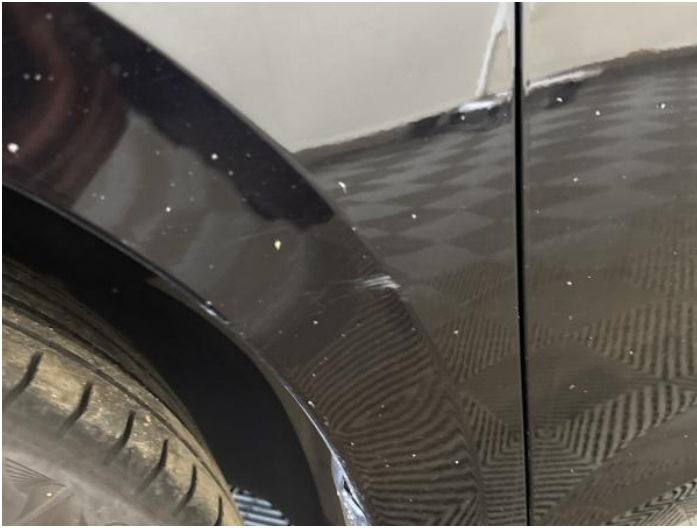
3: Wing nsf
Scratched
UpTo 25mm Thru Paint

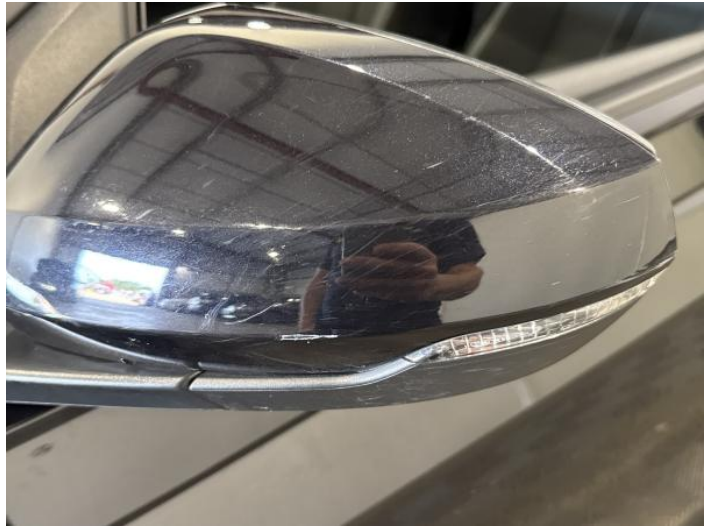
4: Door Mirror Assy nsf
Scratched (Painted)
UpTo 25mm Thru Paint

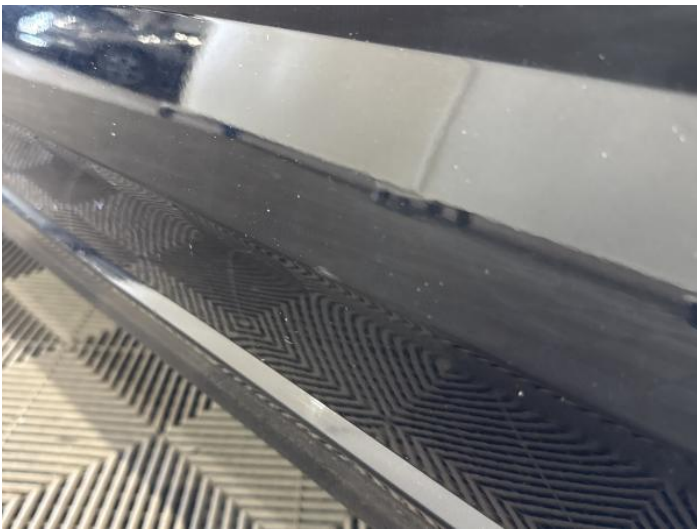
5: Door nsf
Chipped
1 To 5

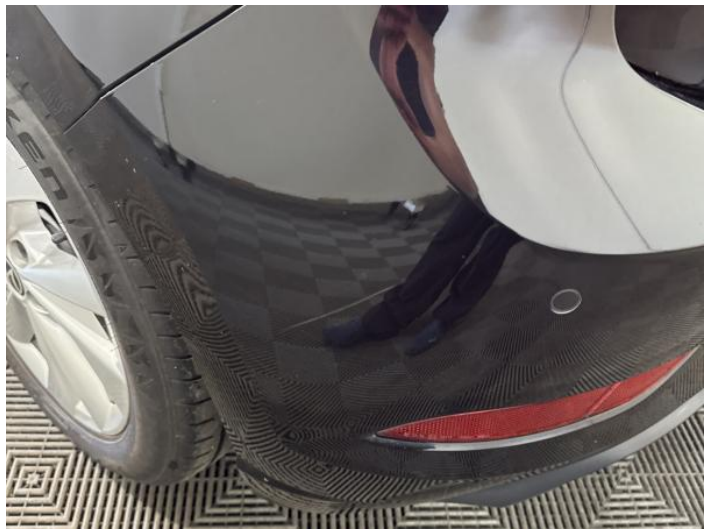
6: Bumper Rear
Scratched
Over 100mm Thru Paint

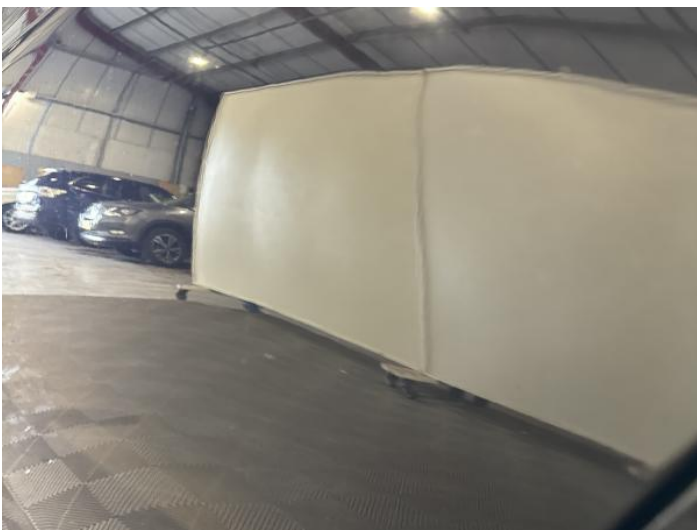
7: Door nsr
Poor Previous Repair
Poor Paint

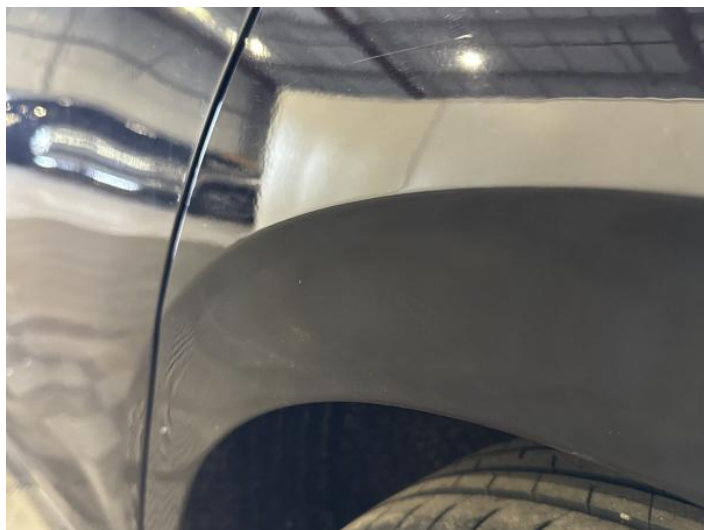
8: Qtr Panel nsr
Scratched
Over 25mm Thru Paint

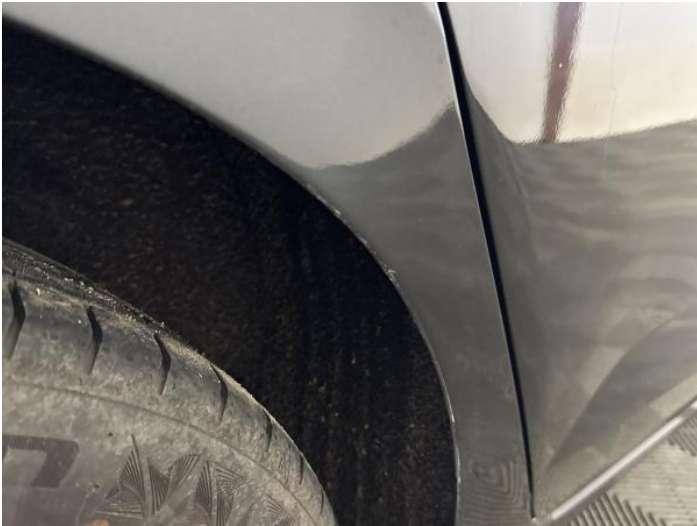
9: Qtr Panel osr
Scratched
Over 25mm Thru Paint

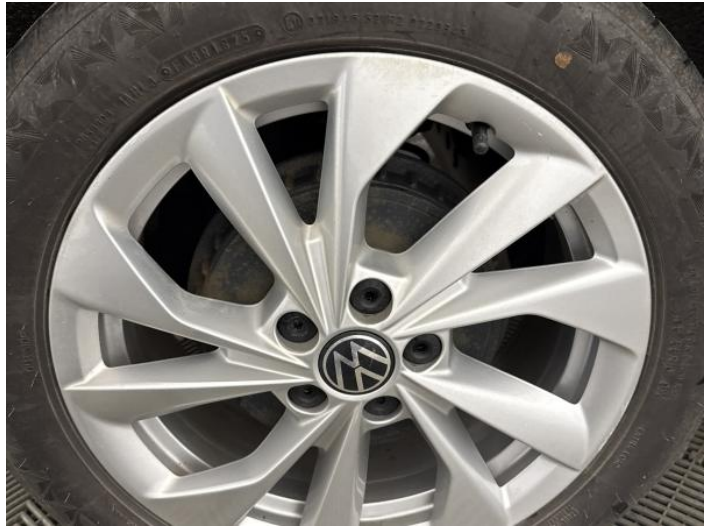
10: Wheel osr
Scratched
Over 50mm

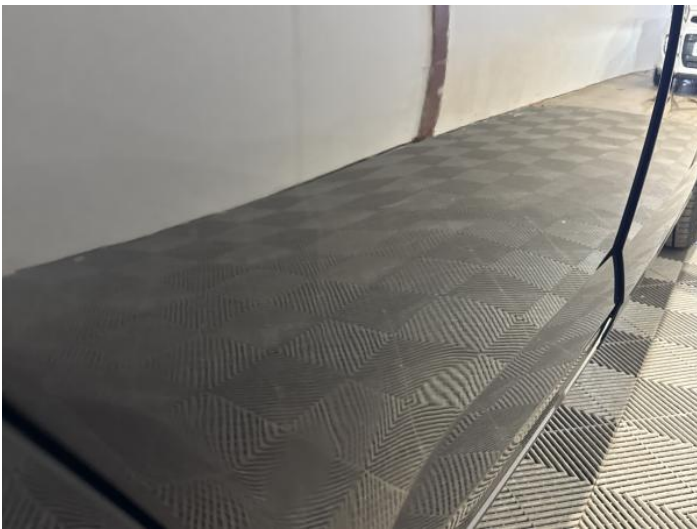
11: Door osr
Poor Previous Repair
Poor Paint

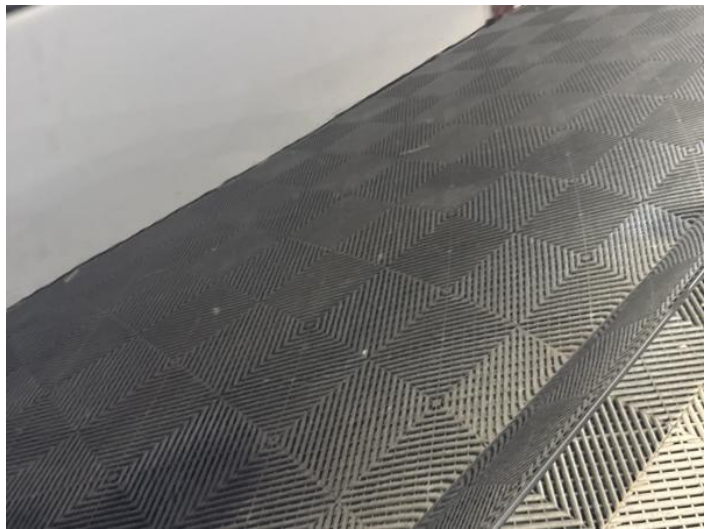
12: Door osf
Scratched
Over 25mm Thru Paint

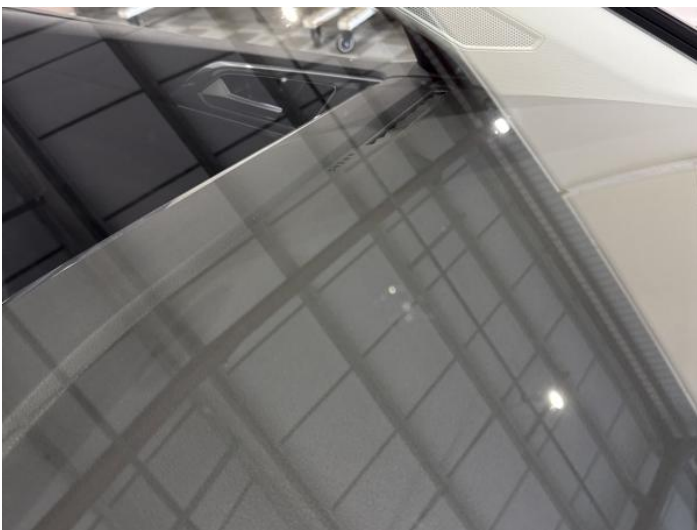
13: Screen Front
Chipped
Over 10mm

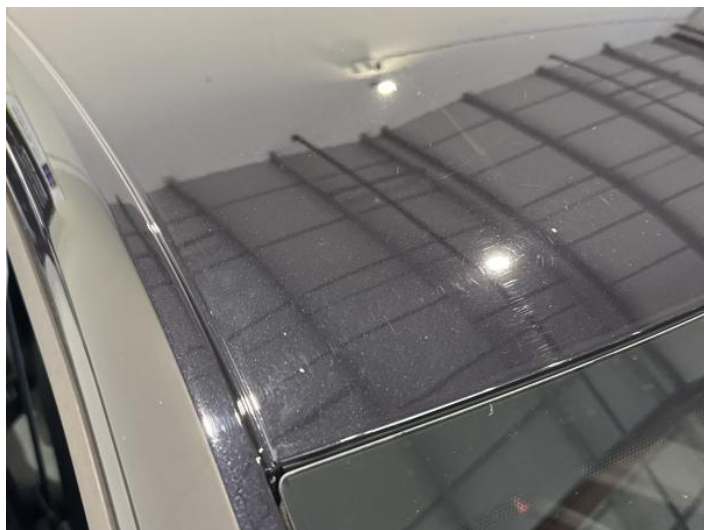
14: Roof
Chipped
1 To 5

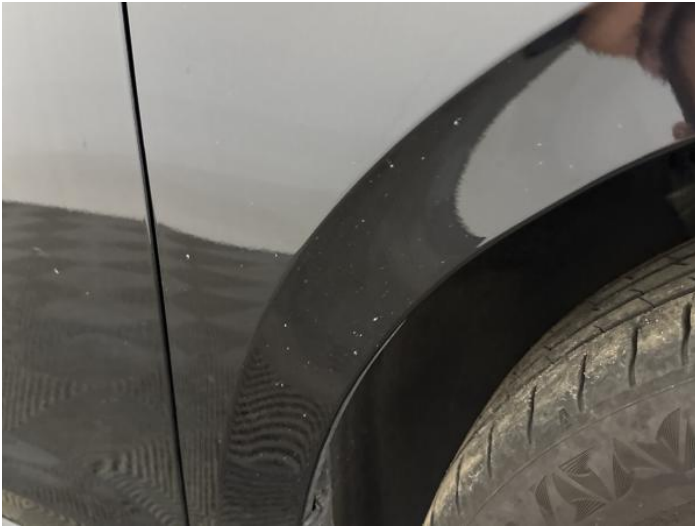
15: Wing osf
Chipped
1 To 5

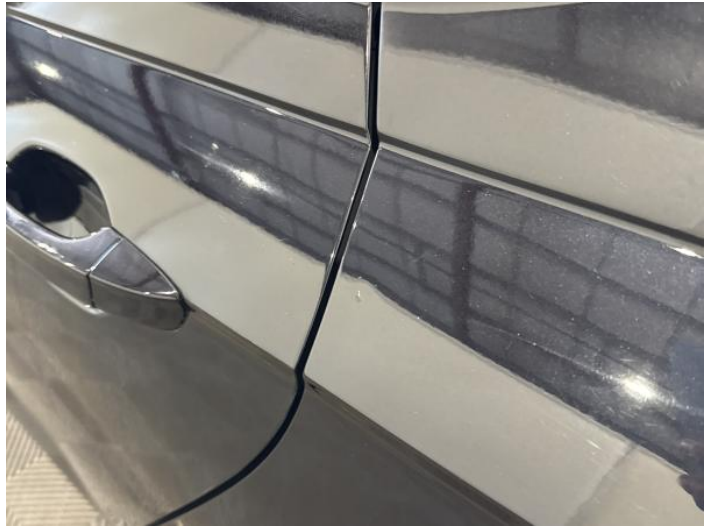
16: Qtr Panel nsr
Dented
2 Or Less UpTo 10mm
