VEHICLE INSPECTION REPORT

HV03NTY

Volkswagen Golf Mk4 MATCH

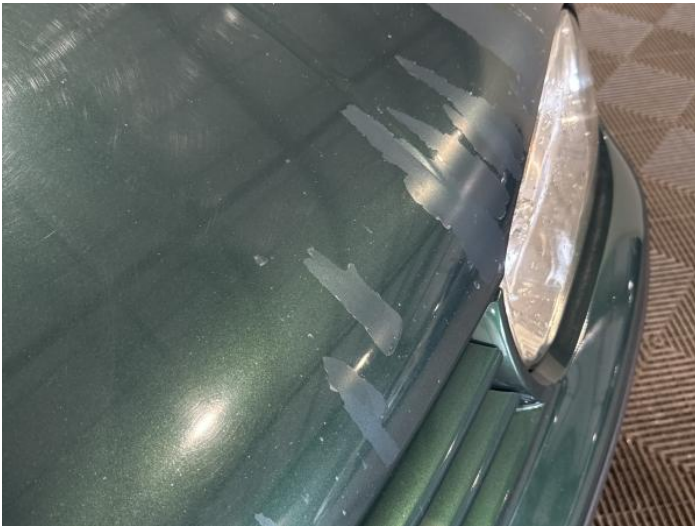
1: Bonnet
Poor Previous Repair
Paint Flake

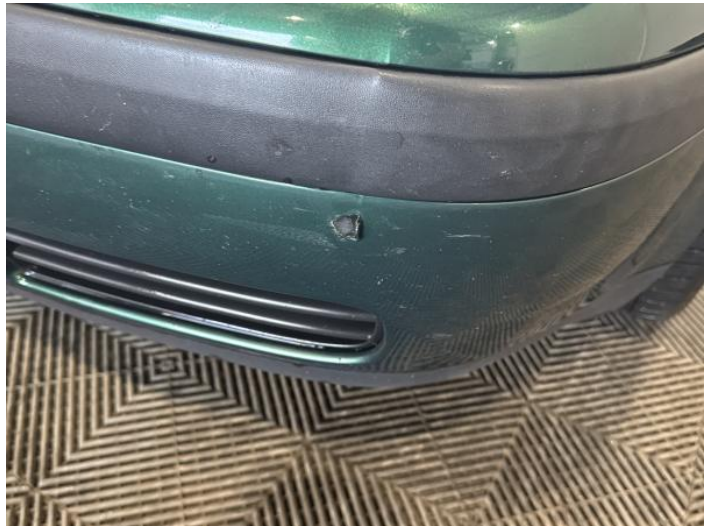
2: Bumper Front
Scratched
Over 100mm Thru Paint

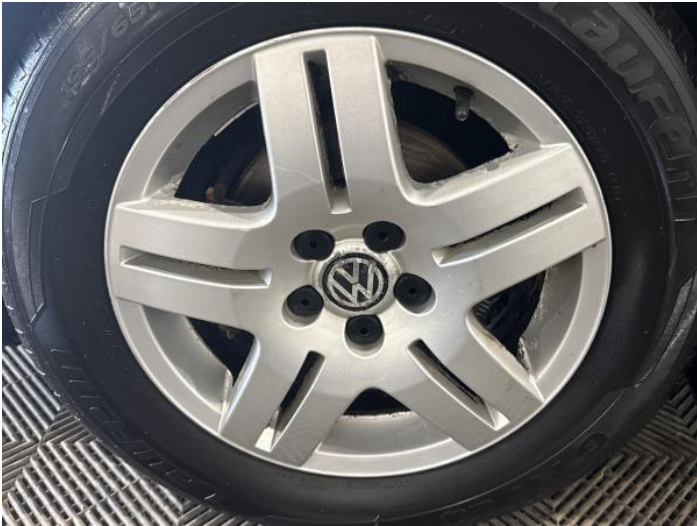
3: Wheel nsf
Corroded
Light

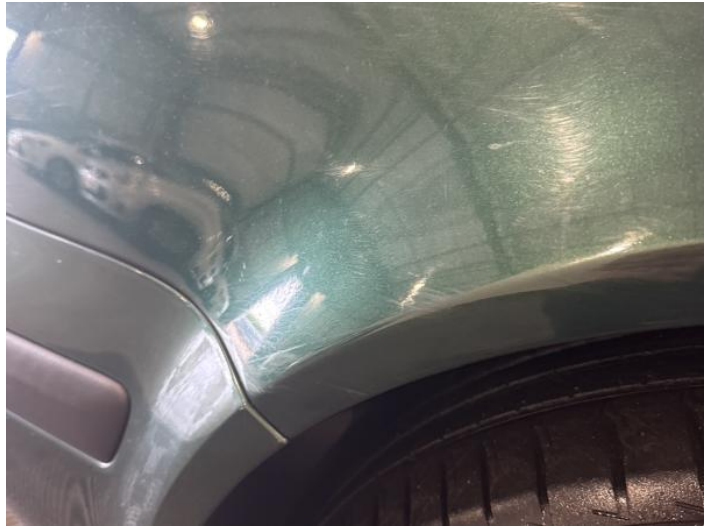
4: Wing nsf
Scratched
UpTo 25mm Thru Paint

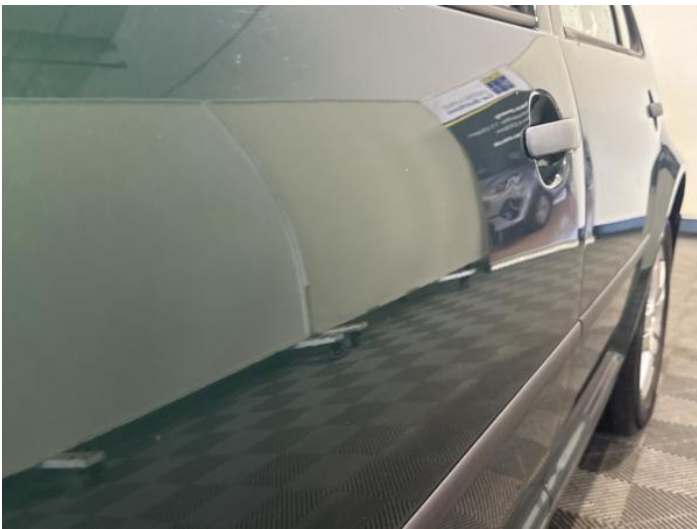
5: Door nsf
Dented
Over 30mm

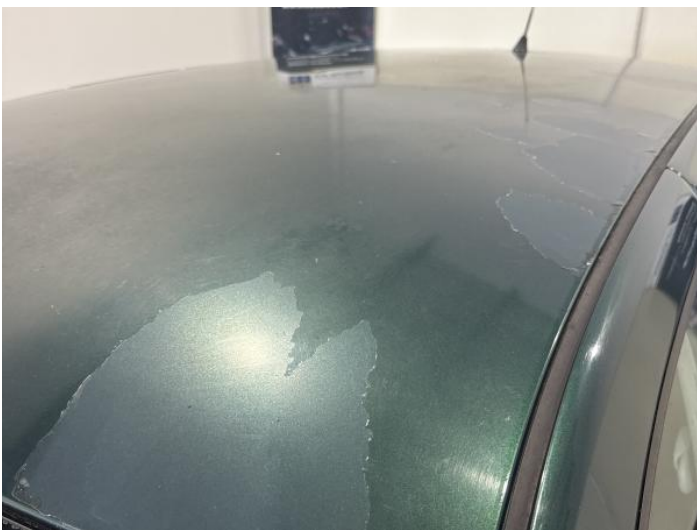
7: Roof
Poor Previous Repair
Paint Flake

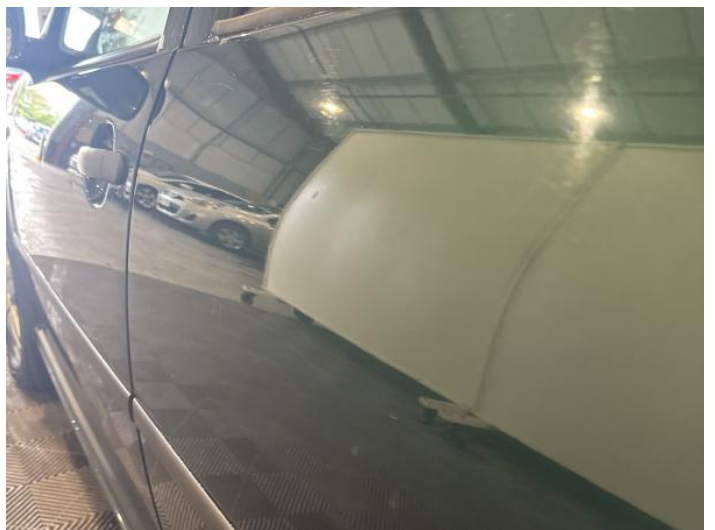
8: Door nsr
Dented
Between 10mm + 30mm

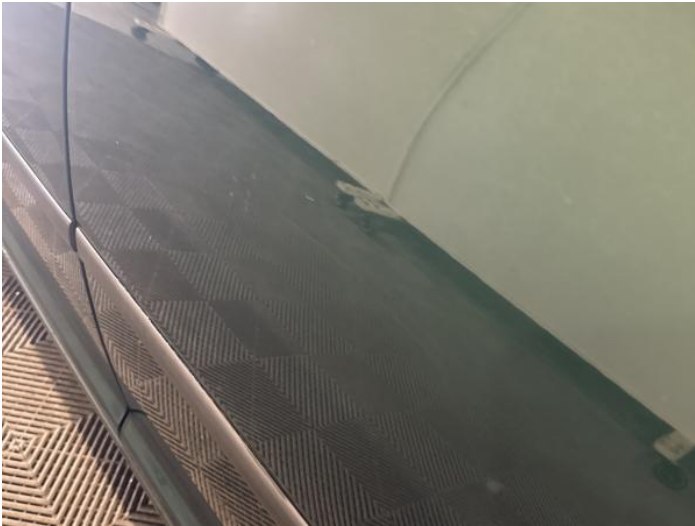
9: Door nsr
Chipped
Multiple Chips

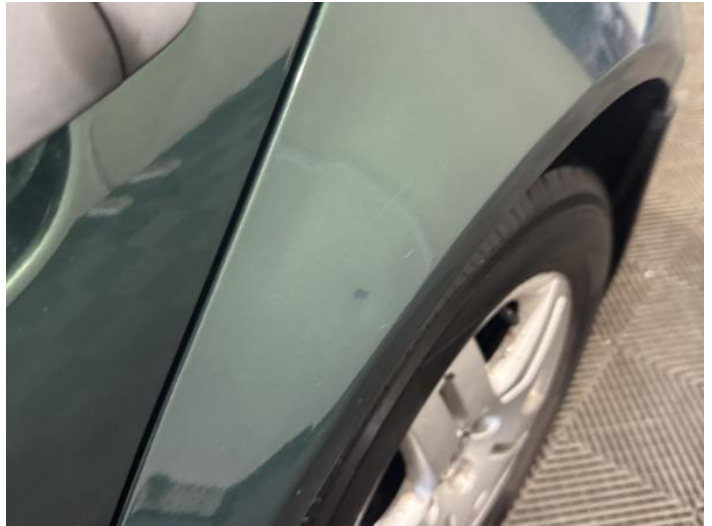
10: Qtr Panel nsr
Dented
Between 10mm + 30mm

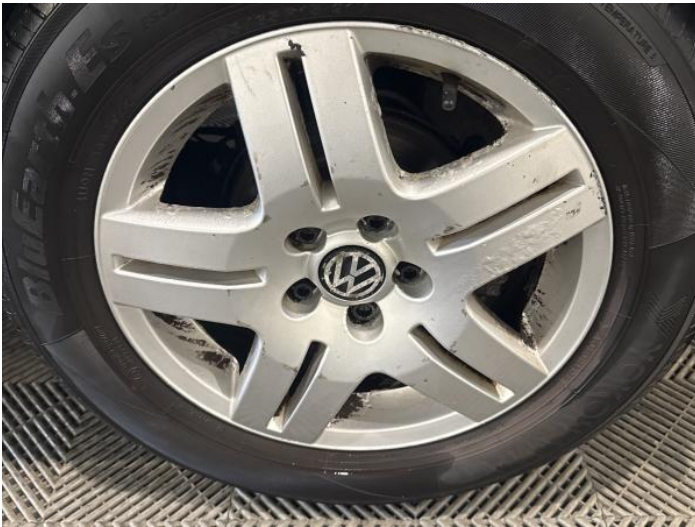
11: Wheel nsr
Scratched
Over 50mm

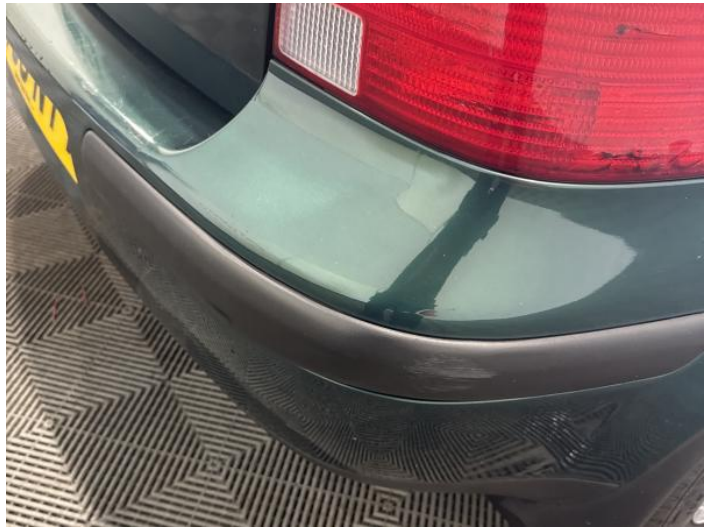
12: Bumper Rear
Scratched
25 to 100mm Thru Paint

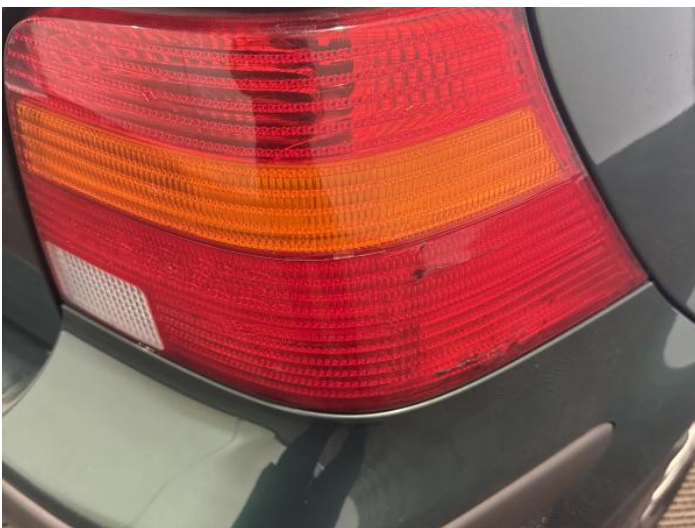
13: Lamp nsr
Broken
Replace

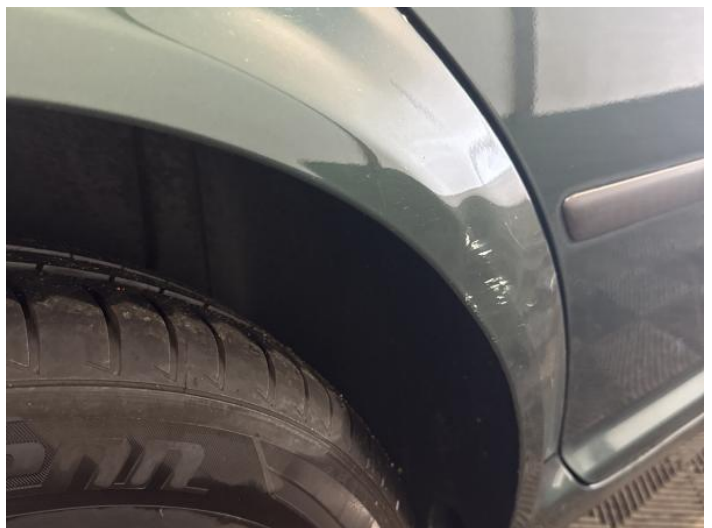
14: Qtr Panel osr
Dented
With Paint Damage

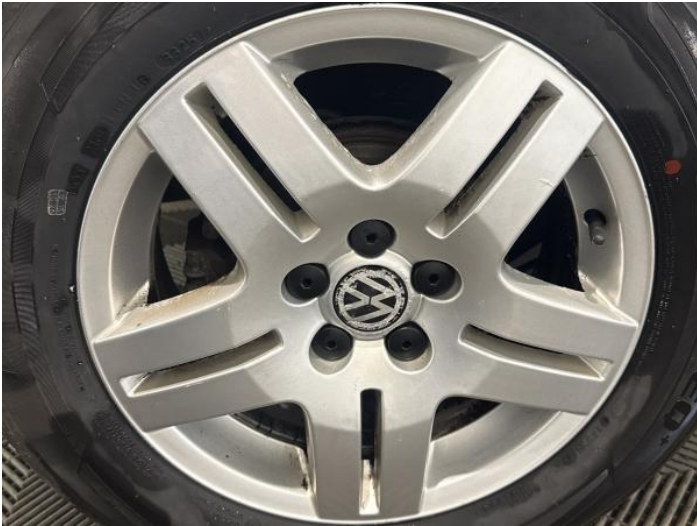
15: Wheel osr
Corroded
Light

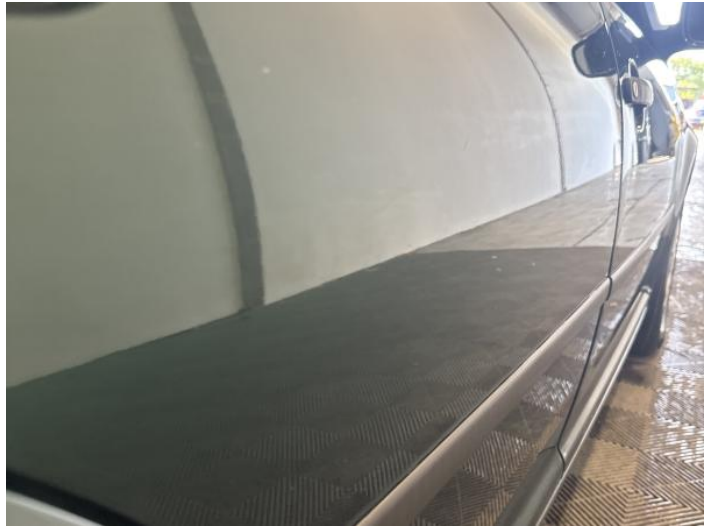
16: Door osr
Dented
Over 30mm

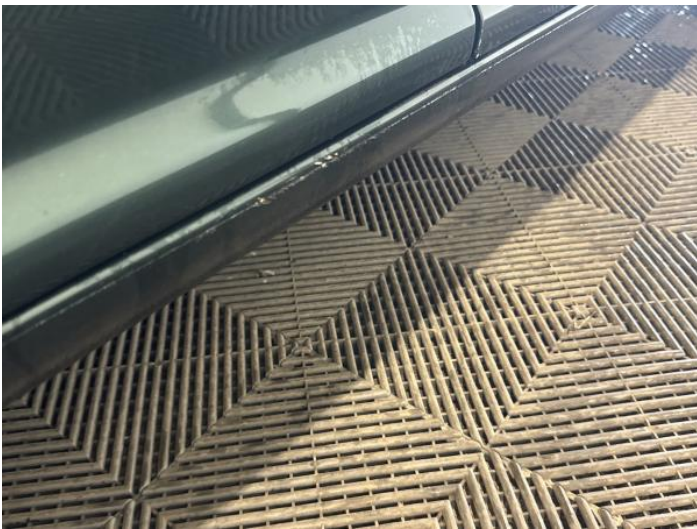
17: Sill os
Scratched
Over 25mm Thru Paint

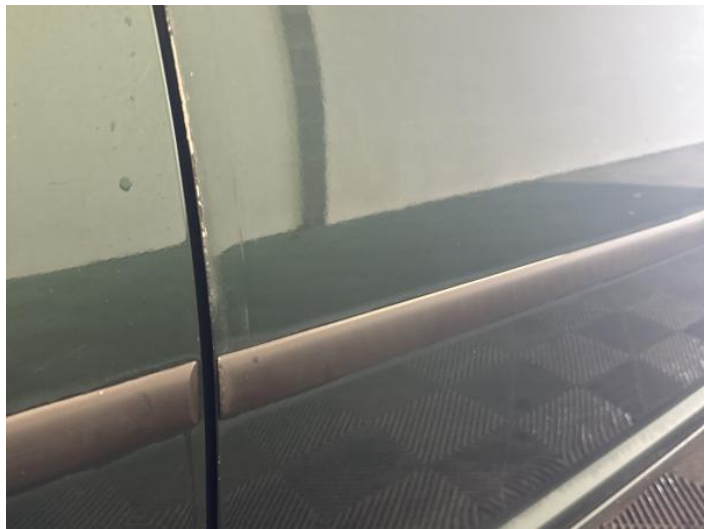
18: Door osf
Chipped
Edge Chip

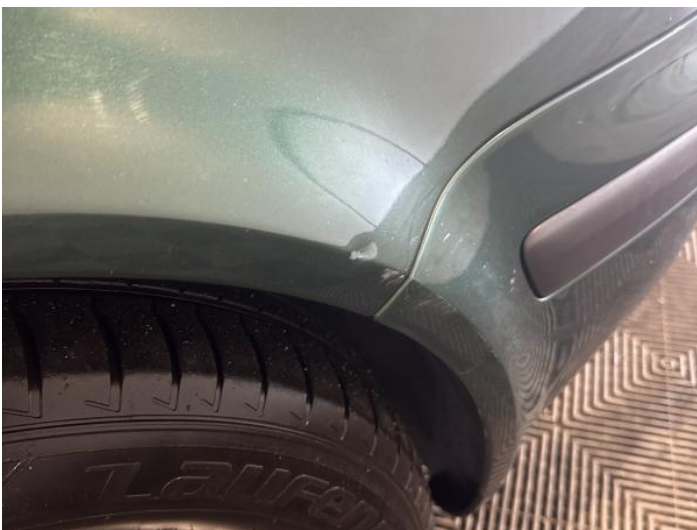
19: Wing osf
Dented
Between 10mm + 30mm

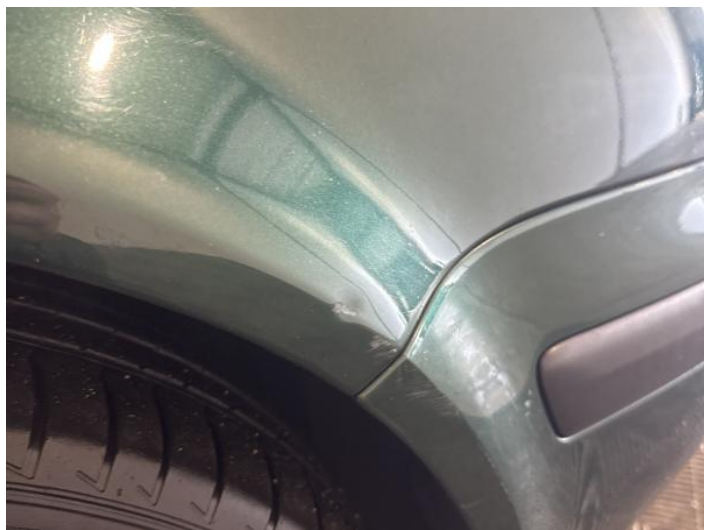
20: Wing osf
Scratched
Over 25mm Thru Paint

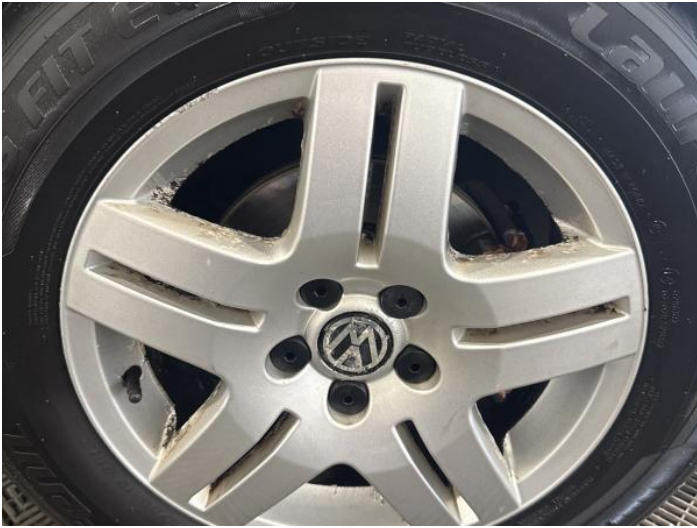
21: Wheel osf
Corroded
Light

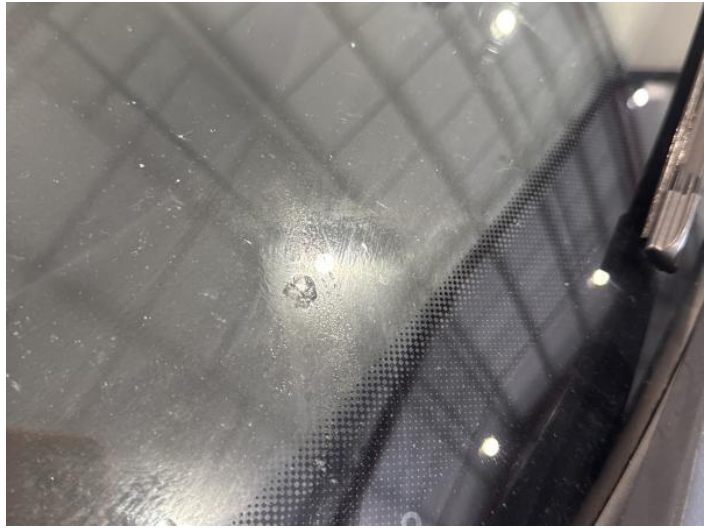
22: Screen Front
Chipped
Over 10mm
