VEHICLE INSPECTION REPORT

DP67GFJ

Nissan Qashqai 1.2 DiG-T N-Connecta 5dr

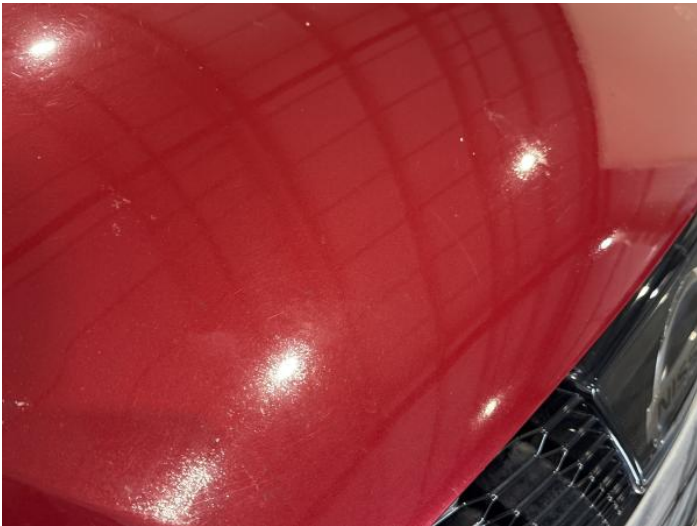
1: Bonnet
Poor Previous Repair
Poor Paint

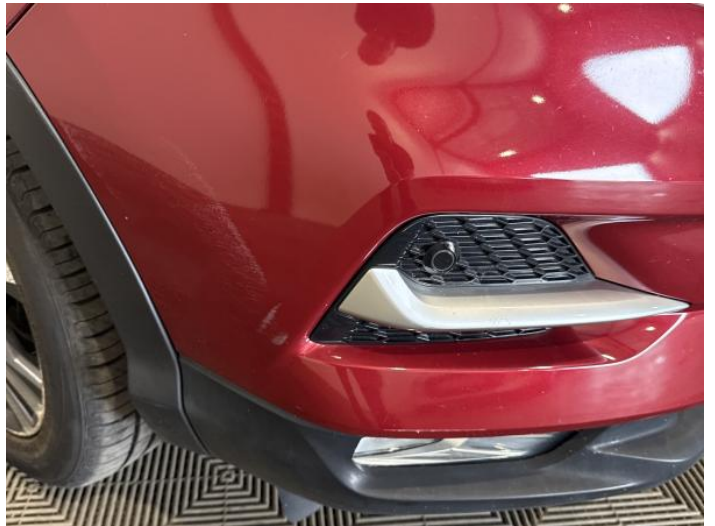
2: Bumper Front
Scratched
25 to 100mm Thru Paint

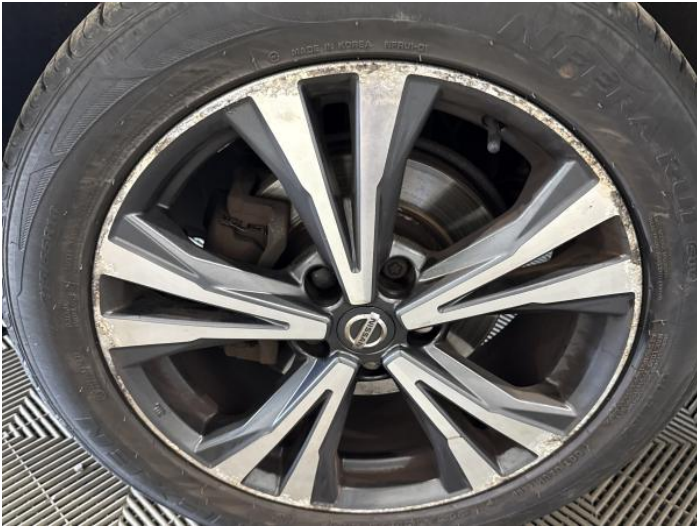
3: Wheel nsf
Scratched
Over 50mm

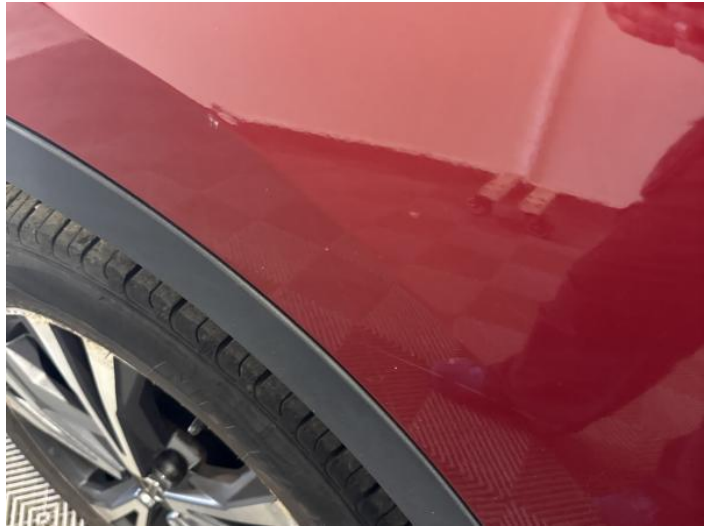
4: Wing nsf
Scratched
Over 25mm Thru Paint

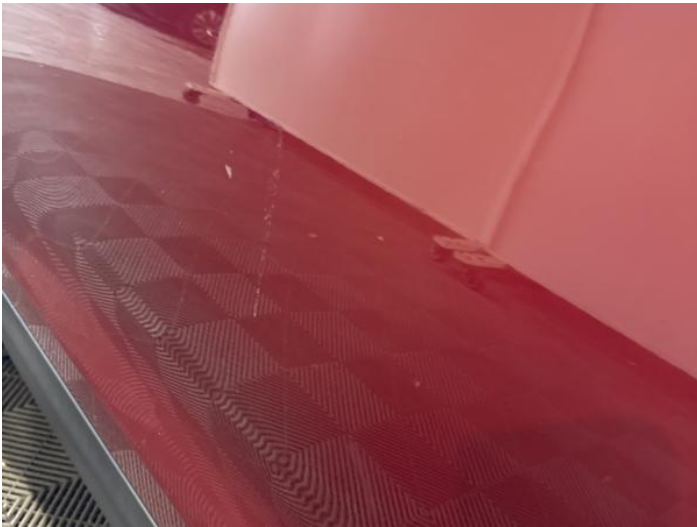
5: Door nsf
Scratched
Over 25mm Thru Paint

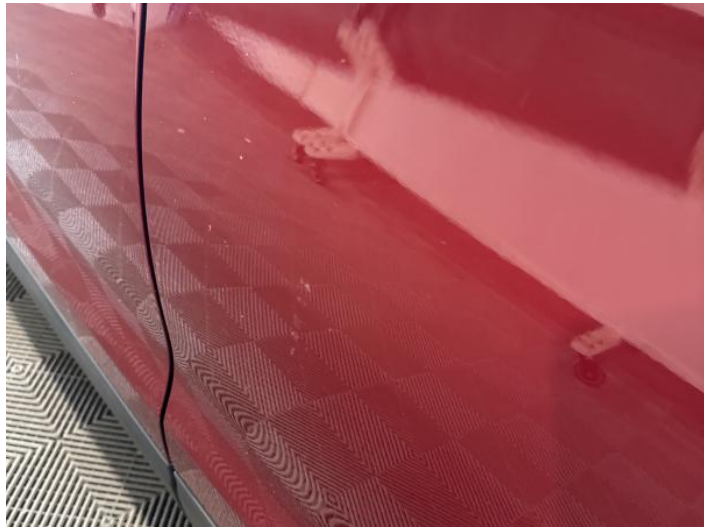
6: Door nsr
Scratched
Over 25mm Thru Paint

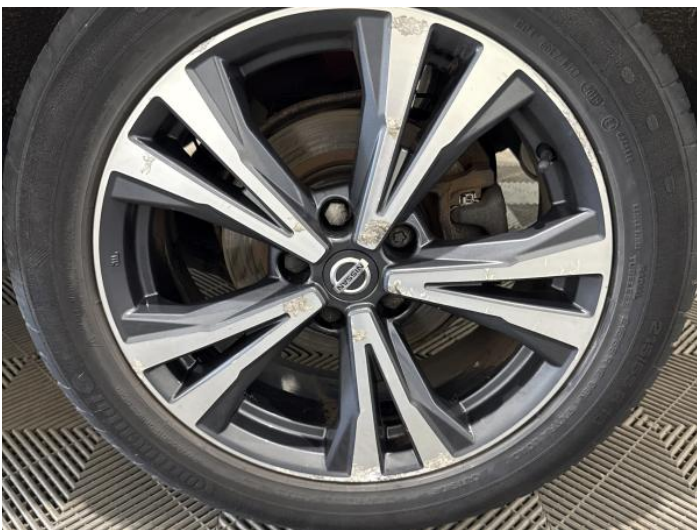
7: Wheel nsr
Scratched
Over 50mm

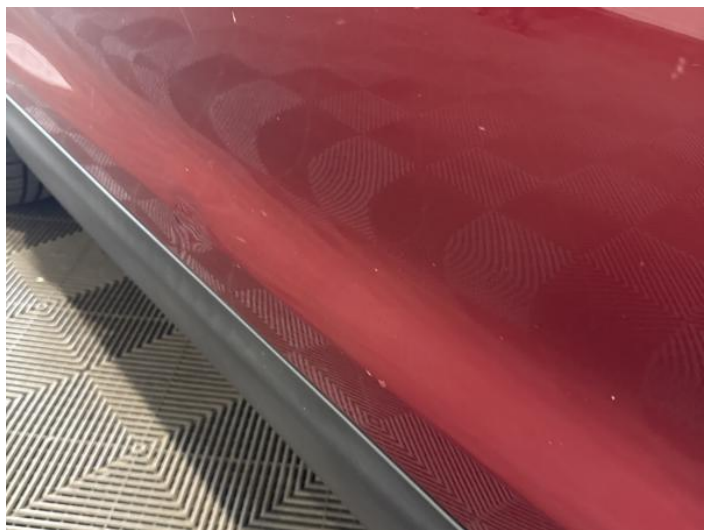
8: Door nsf
Dented
Over 30mm

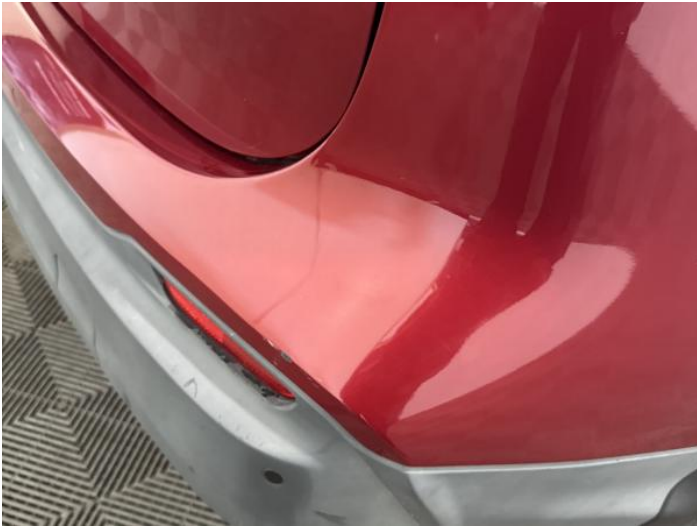
9: Bumper Rear
Scratched
25 to 100mm Thru Paint

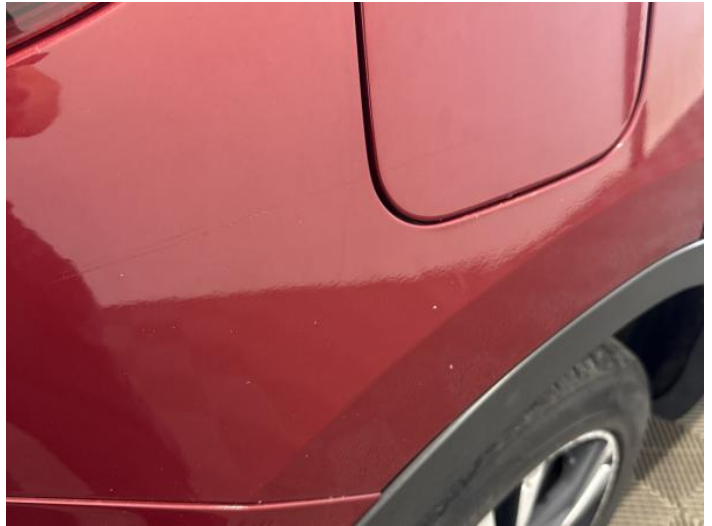
10: Qtr Panel osr
Scratched
Over 25mm Thru Paint

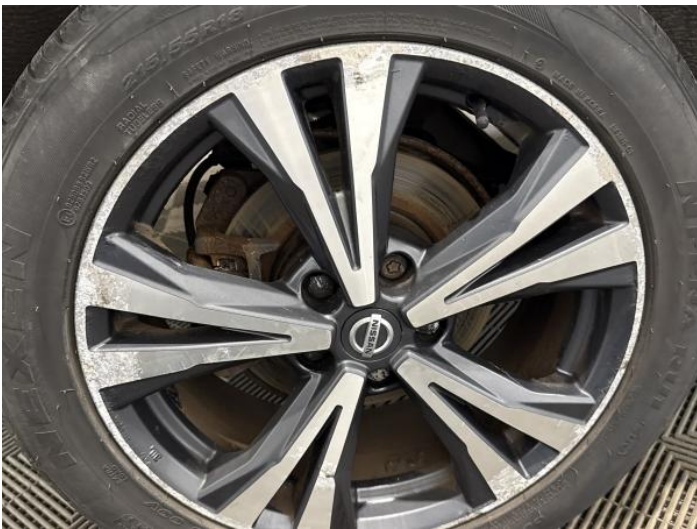
11: Wheel osr
Scratched
Over 50mm

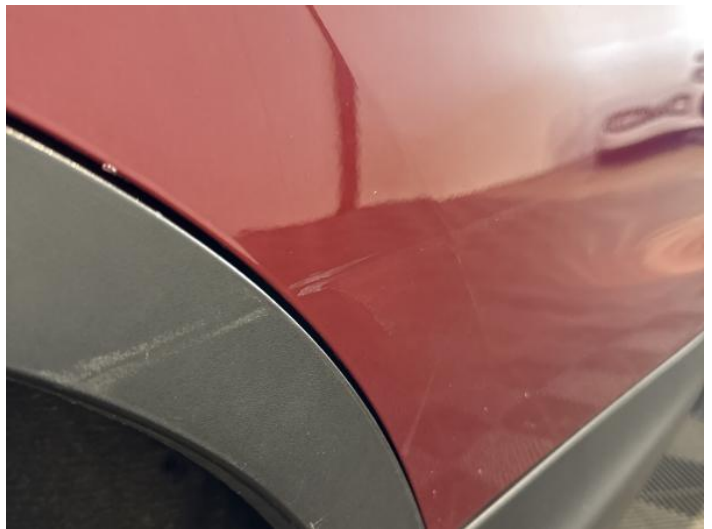
12: Door osr
Dented
With Paint Damage

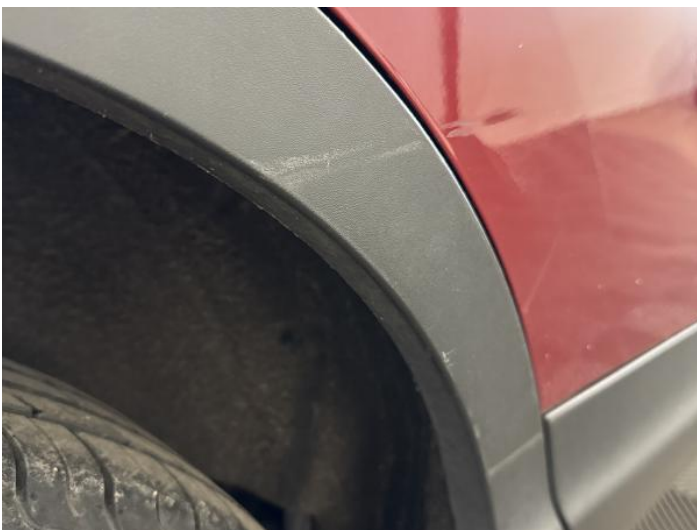
13: Qtr Panel Arch Extension os
Scuffed (Unpainted)
Over 100mm

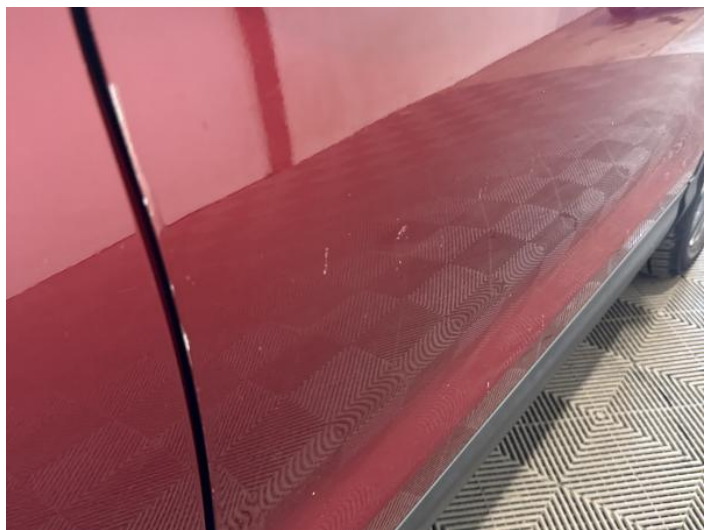
14: Door osf
Scratched
Over 25mm Thru Paint

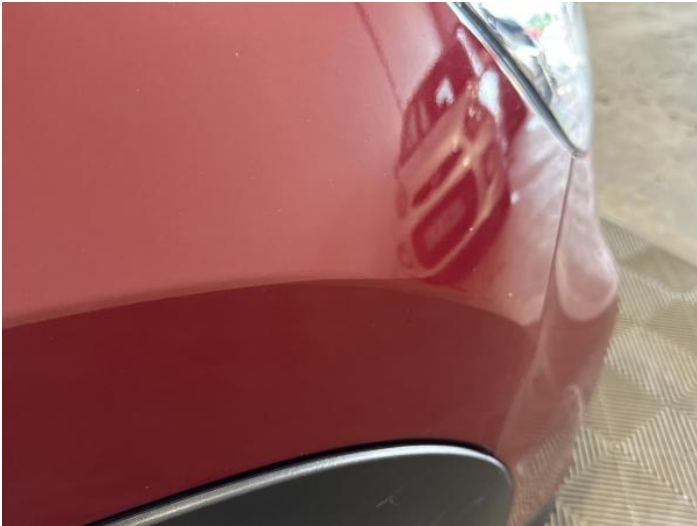
15: Wing of
Poor Previous Repair
Poor Paint

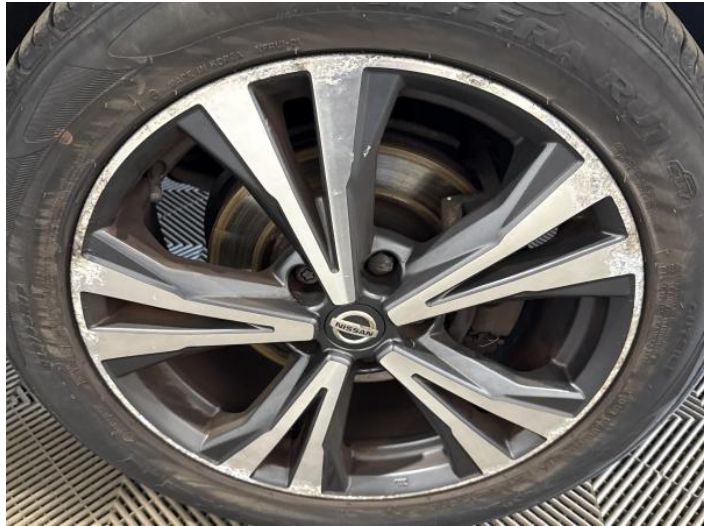
16: Wheel of
Scratched
Over 50mm

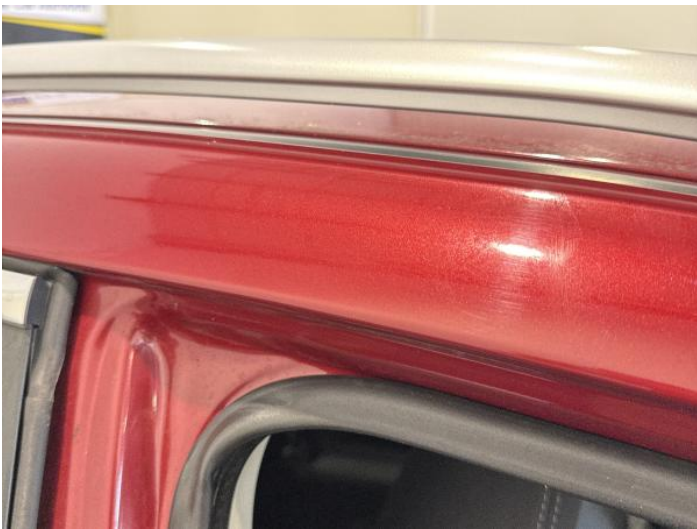
17: A Post of
Poor Previous Repair
Poor Paint
