VEHICLE INSPECTION REPORT

RJ62YVD

Volkswagen Golf 1.4 TSI SE 5dr DSG

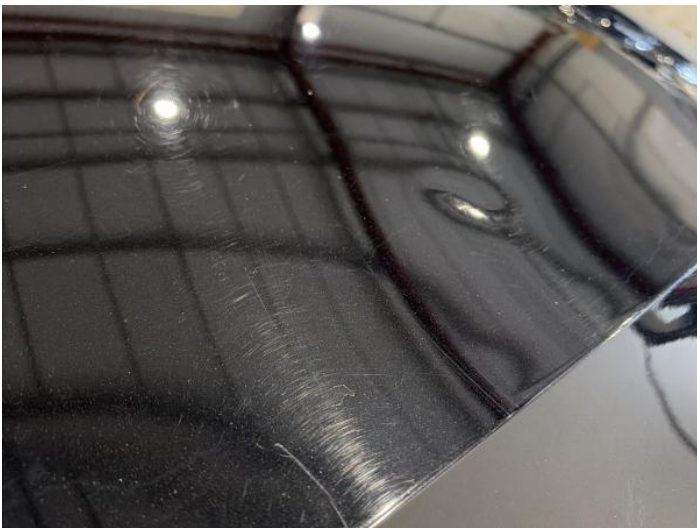
1: Bonnet
Dented
Over 30mm

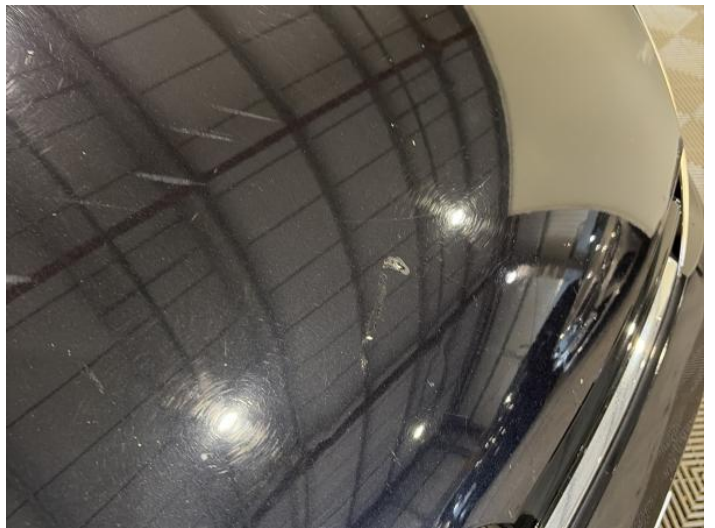
2: Bonnet
Scratched
Over 25mm Thru Paint

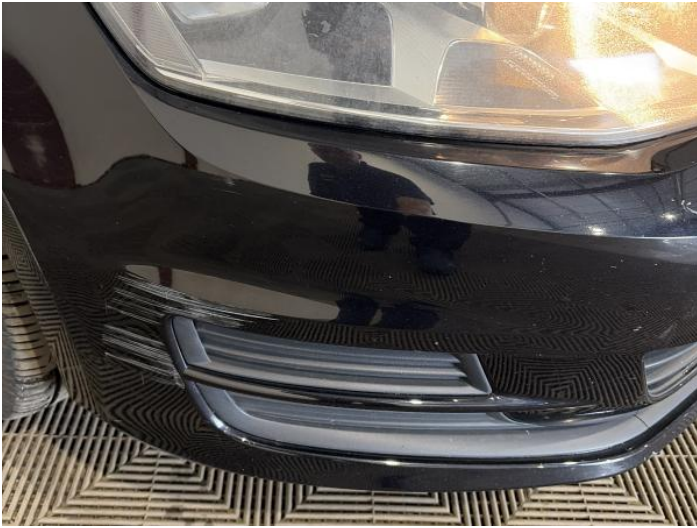
3: Bumper Front
Scratched
Over 100mm Thru Paint

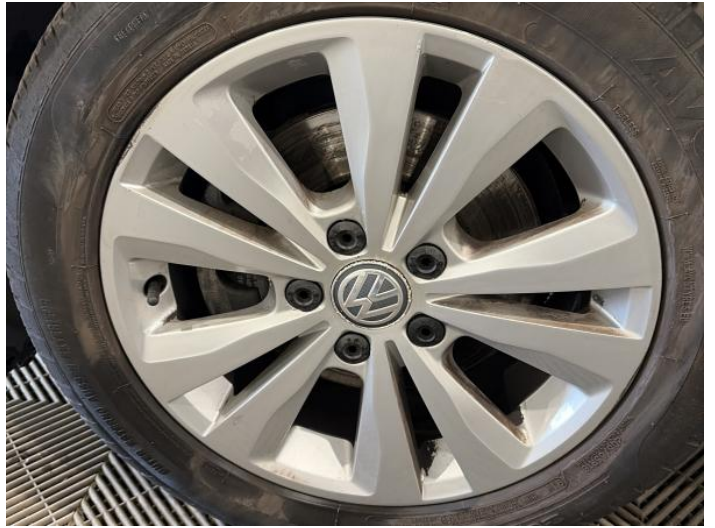
4: Wheel nsf
Scratched
Up To 50mm

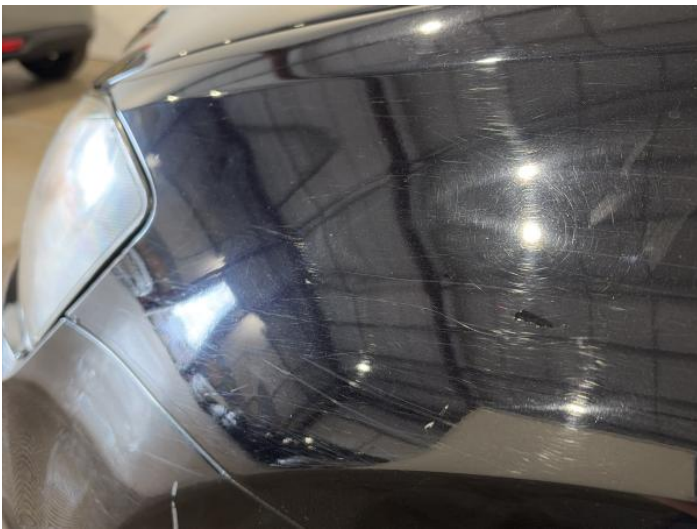
5: Wing nsf
Scratched
Over 25mm Thru Paint

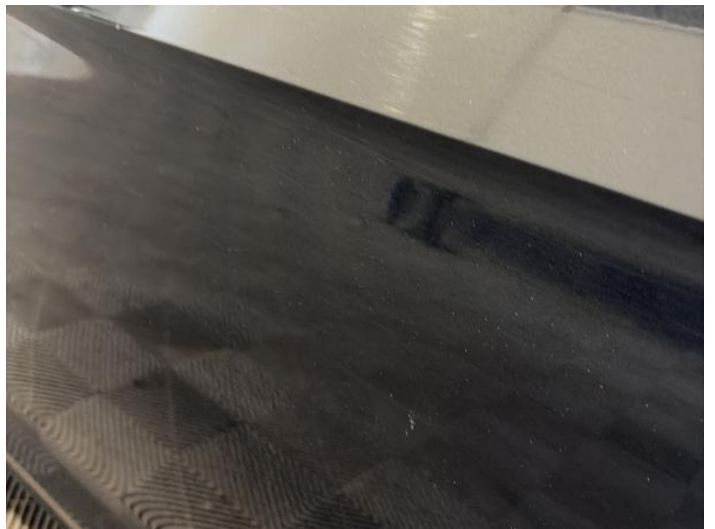
6: Door nsf
Chipped
1 To 5

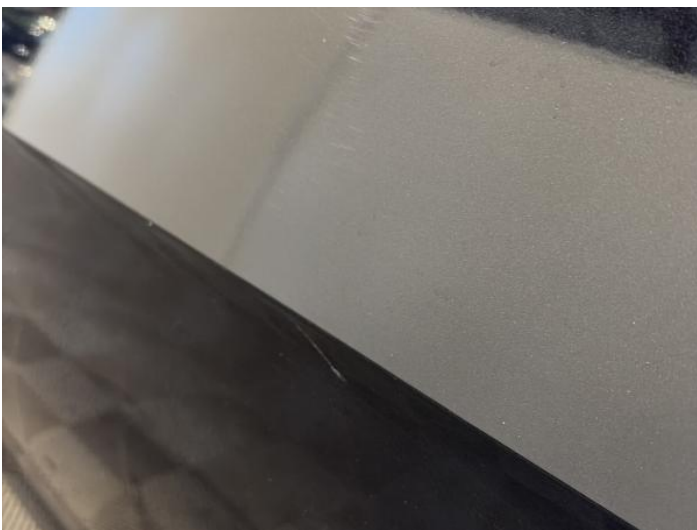
7: Door nsr
Scratched
Up To 25mm Thru Paint

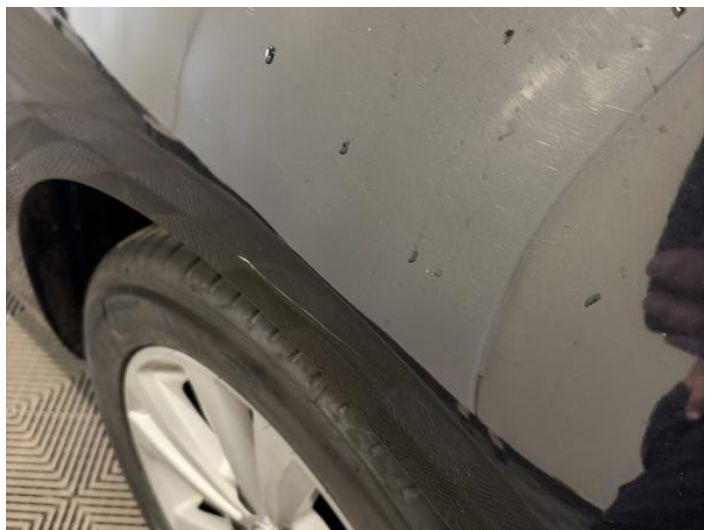
8: Qtr Panel nsr
Scratched
Over 25mm Thru Paint

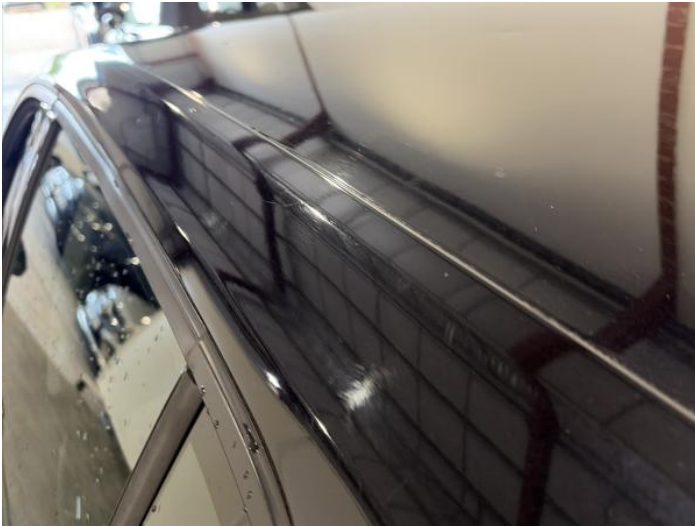
9: B Post ns
Dented
Between 10mm + 30mm

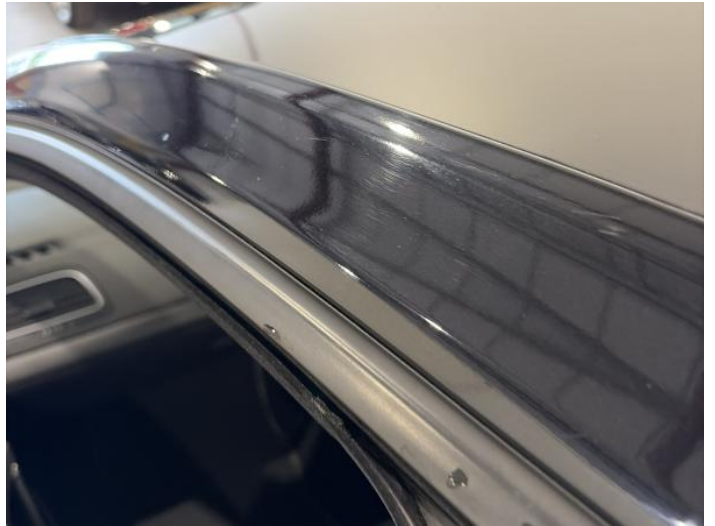
10: A Post ns
Dented
Between 10mm + 30mm

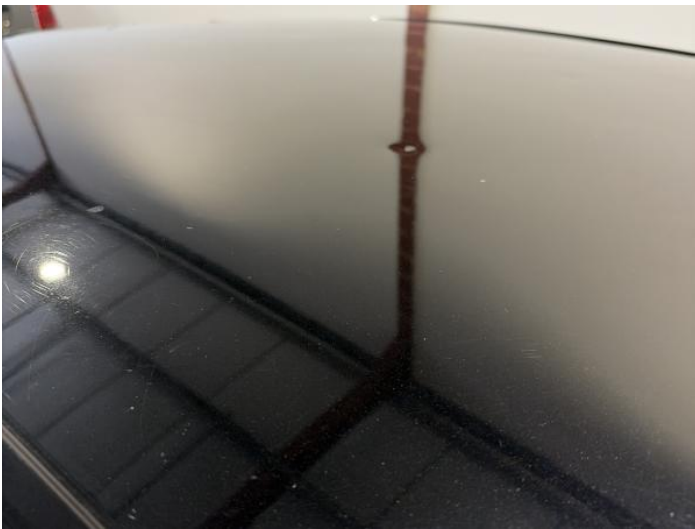
11: Roof
Dented
Over 30mm

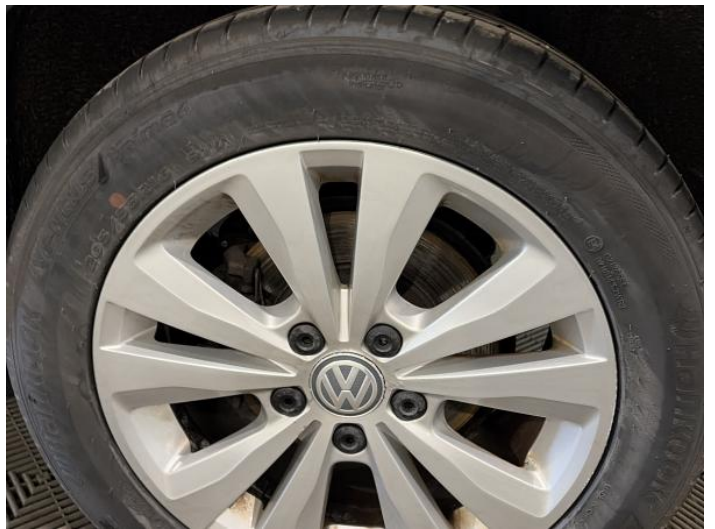
12: Wheel nsr
Scratched
Over 50mm

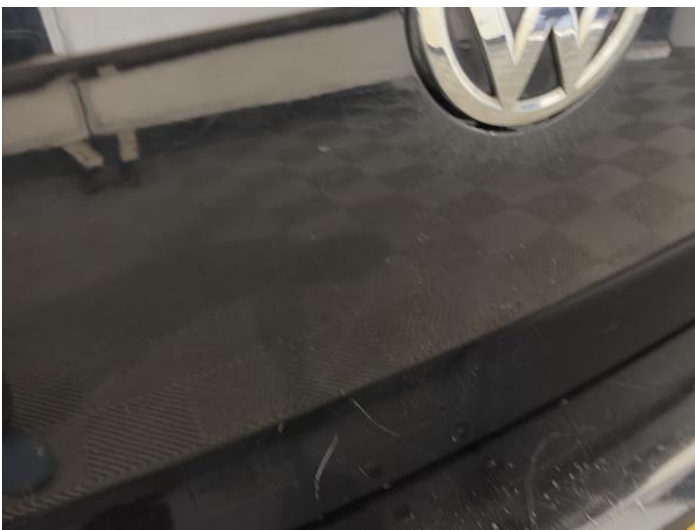
13: Tailgate
Scratched
Over 25mm Thru Paint

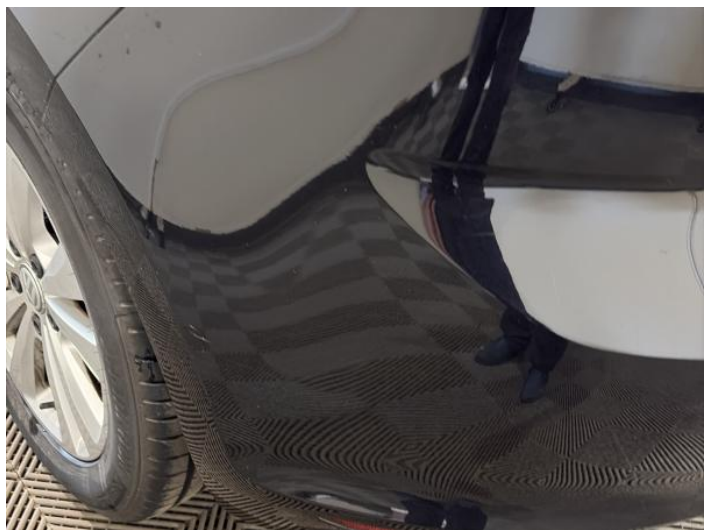
14: Bumper Rear
Scratched
Over 100mm Thru Paint

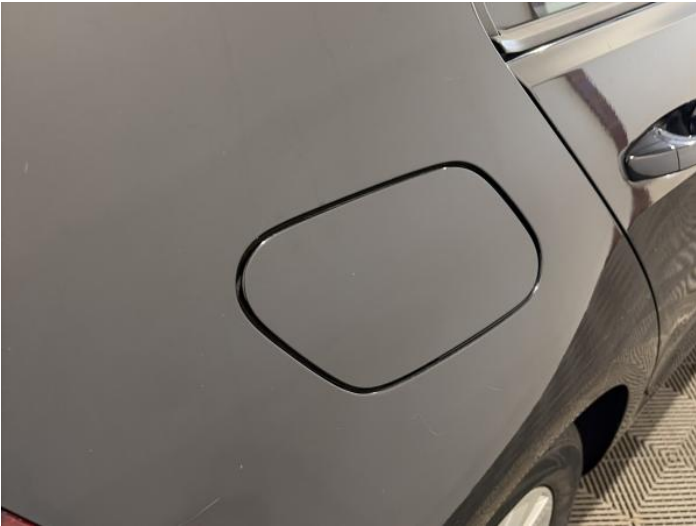
15: Qtr Panel nsr
Dented
With Paint Damage

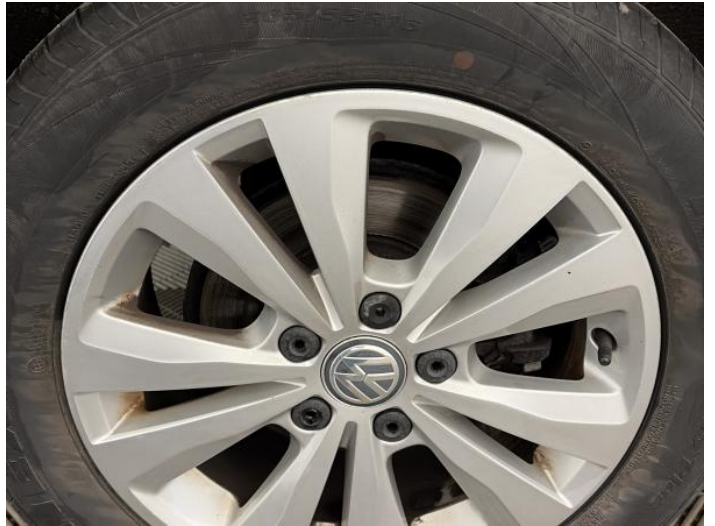
16: Wheel osr
Scratched
Up To 50mm

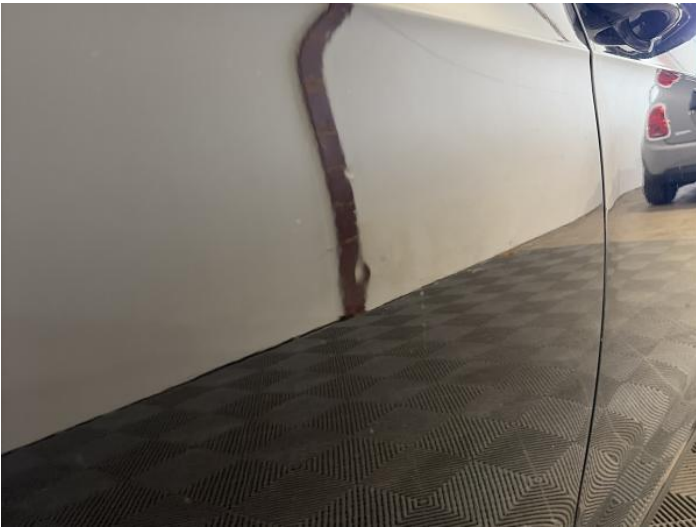
17: Door osr
Dented
Between 10mm + 30mm

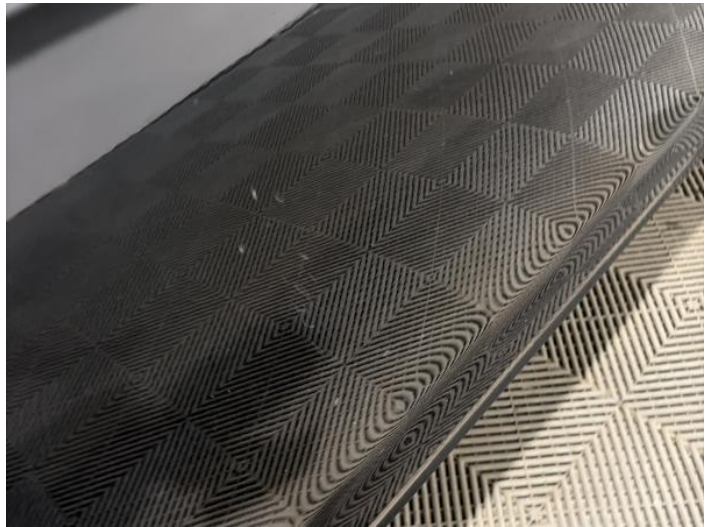
18: Door osf
Scratched
Over 25mm Thru Paint

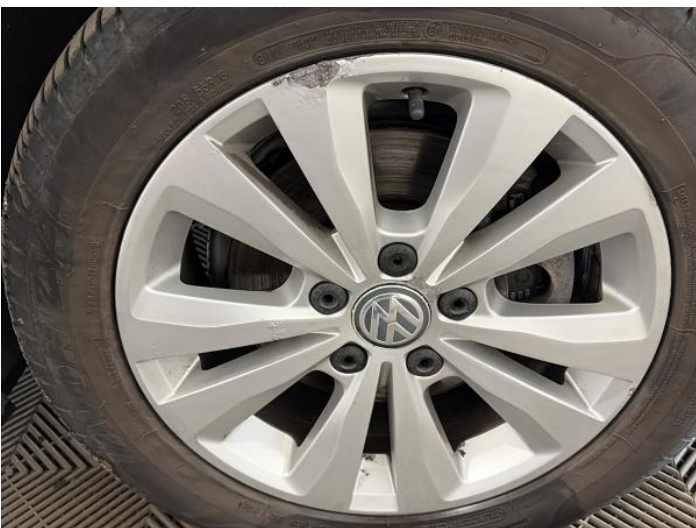
19: Wheel osf
Scratched
Over 50mm

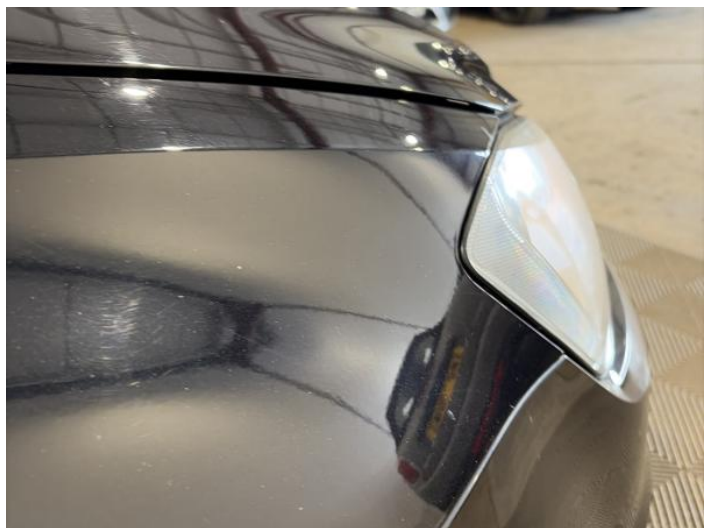
20: Wing osf
Chipped
1 To 5

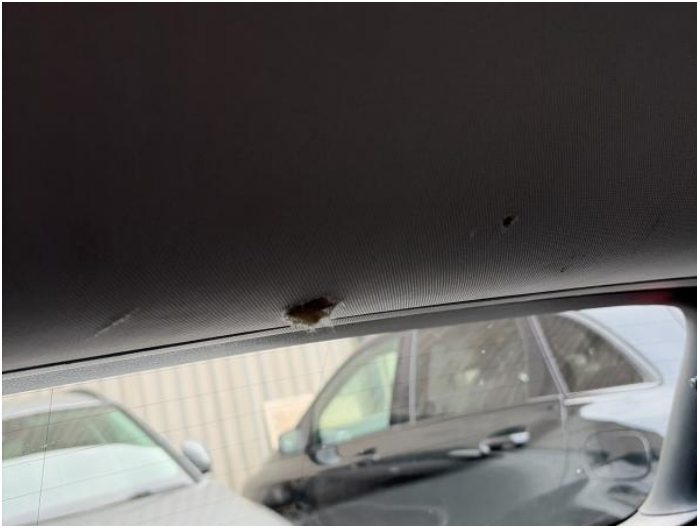
21: Roof Lining
Torn
Over 3mm
