VEHICLE INSPECTION REPORT

GY20HSA

Volkswagen Polo 1.0 TSI 95 Match 5dr

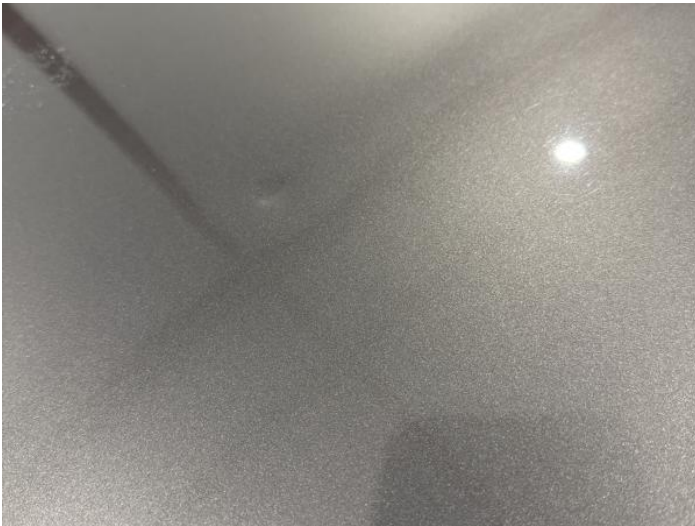
1: Bonnet
Dented
Between 10mm + 30mm

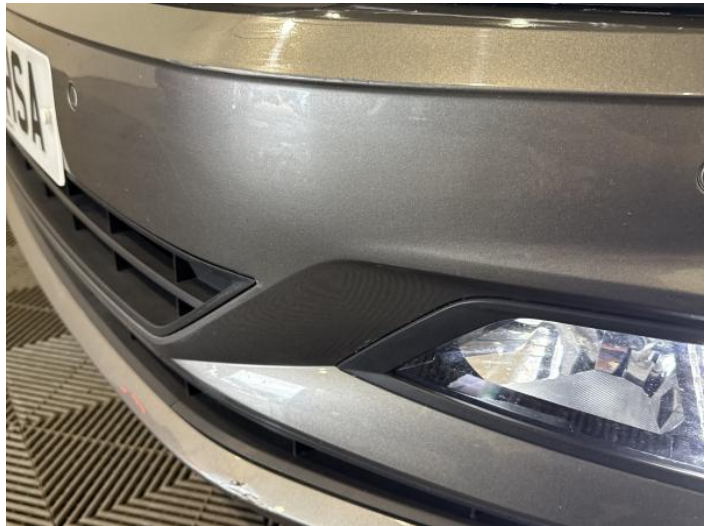
2: Bumper Front
Dented
With Paint Damage

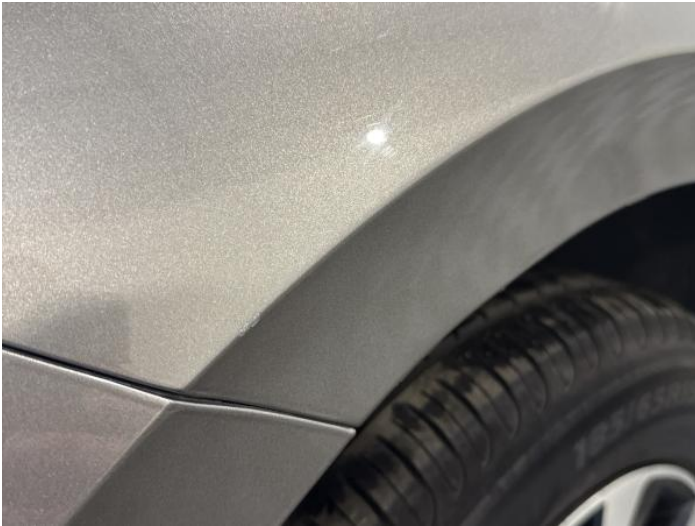
3: Wing nsf
Scratched
UpTo 25mm Thru Paint

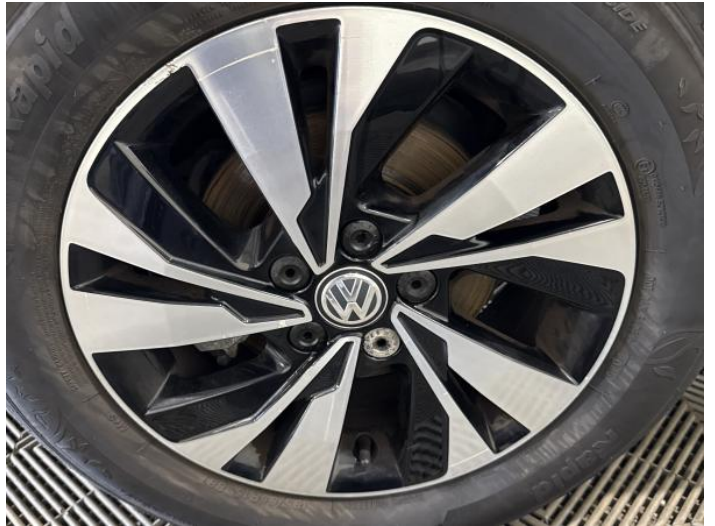
4: Wheel nsf
Scratched
Over 50mm

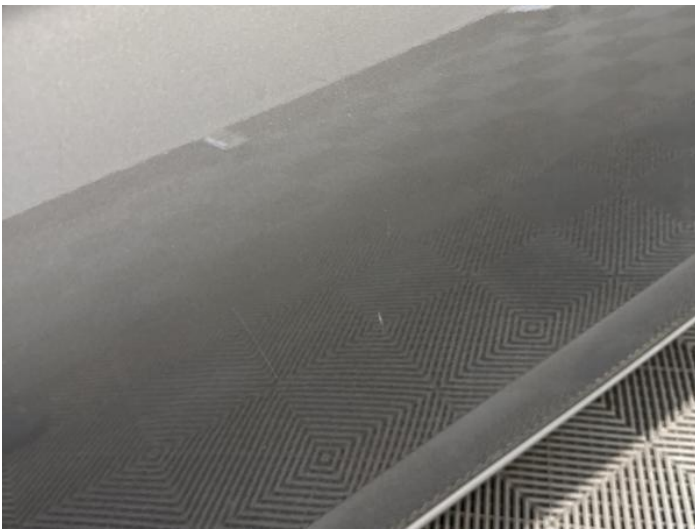
5: Door nsf
Scratched
Over 25mm Thru Paint

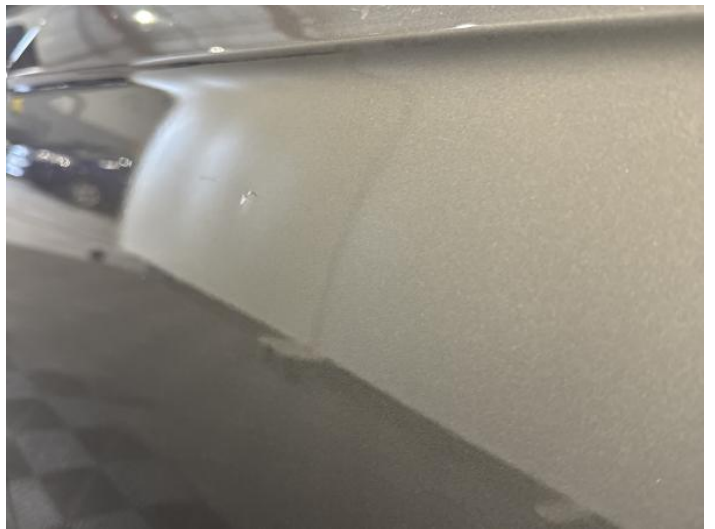
6: Door nsr
Dented
Between 10mm + 30mm

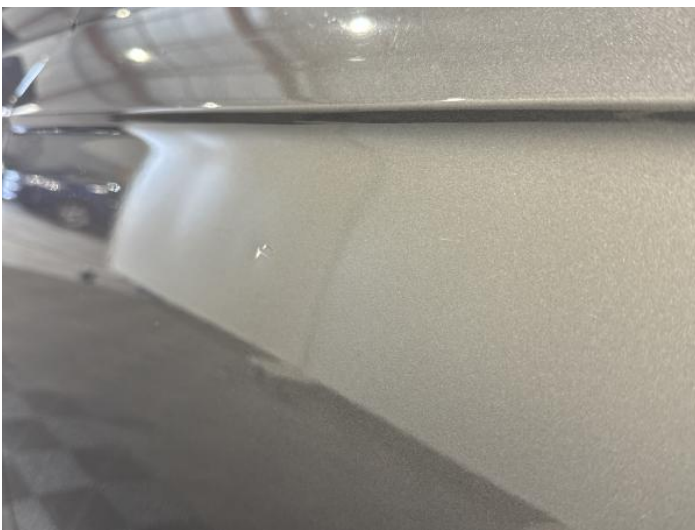
7: Door nsr
Scratched
UpTo 25mm Thru Paint

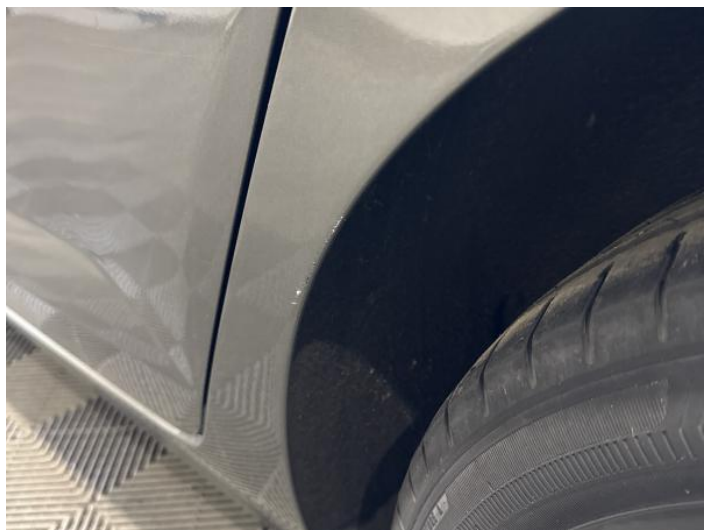
8: Qtr Panel nsr
Scratched
Over 25mm Thru Paint

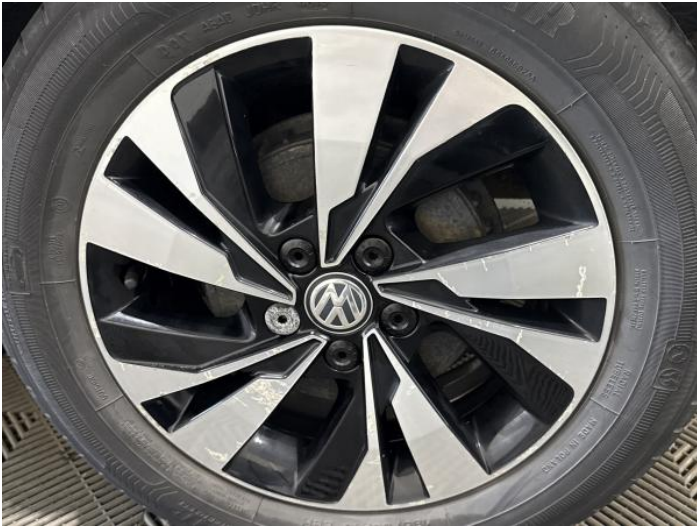
9: Wheel nsr
Scratched
Over 50mm

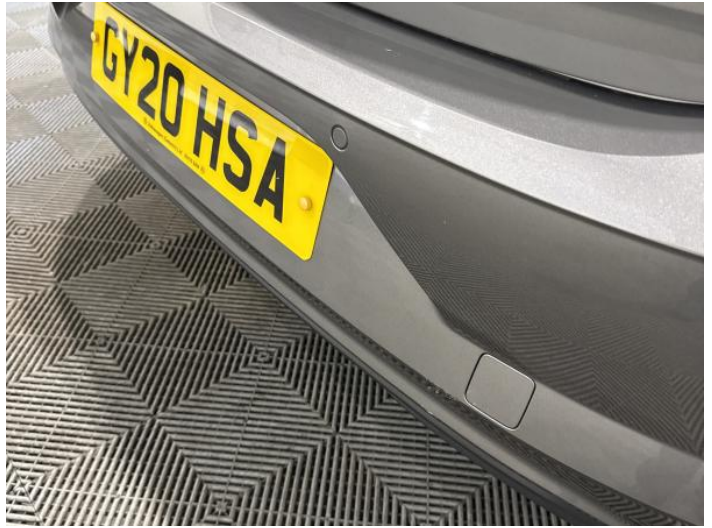
10: Bumper Rear
Scratched
25 to 100mm Thru Paint

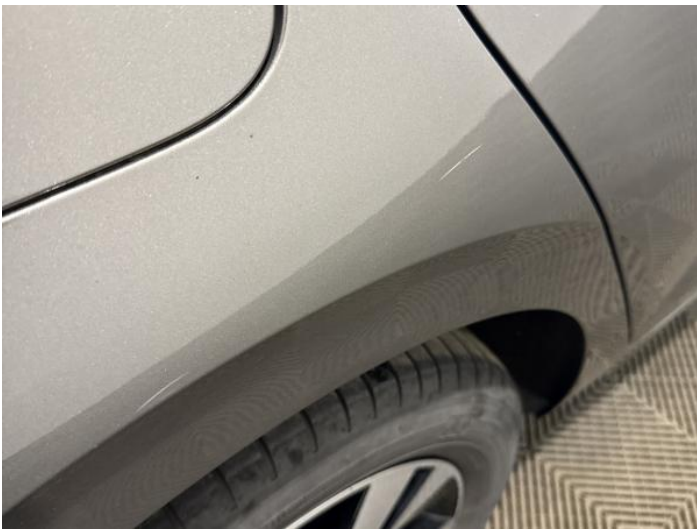
11: Qtr Panel osr
Scratched
Over 25mm Thru Paint

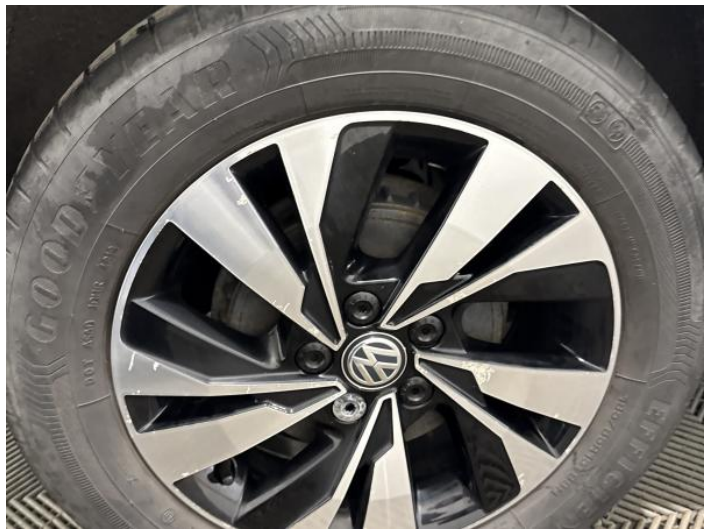
12: Wheel osr
Scratched
Over 50mm

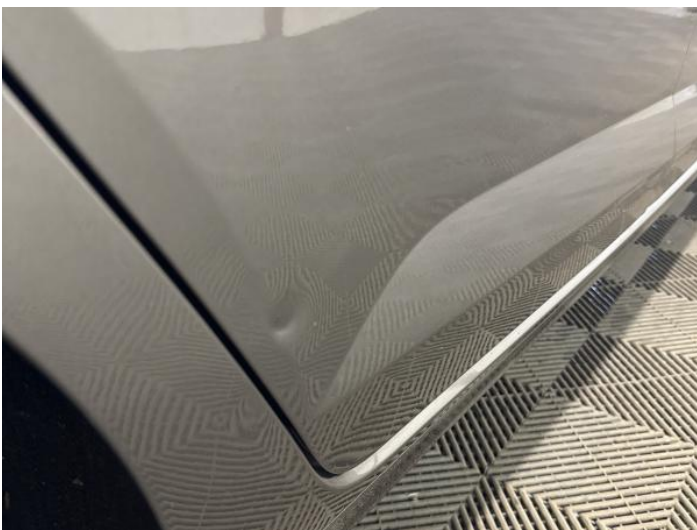
13: Door osr
Dented
Between 10mm + 30mm

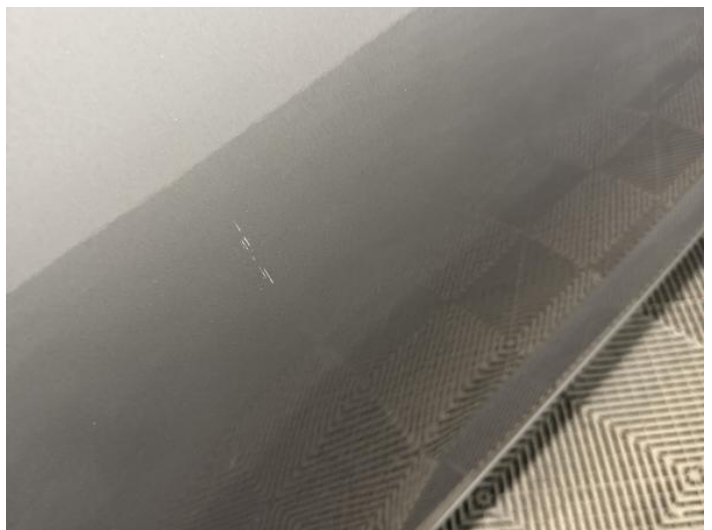
14: Door osr
Scratched
Over 25mm Thru Paint

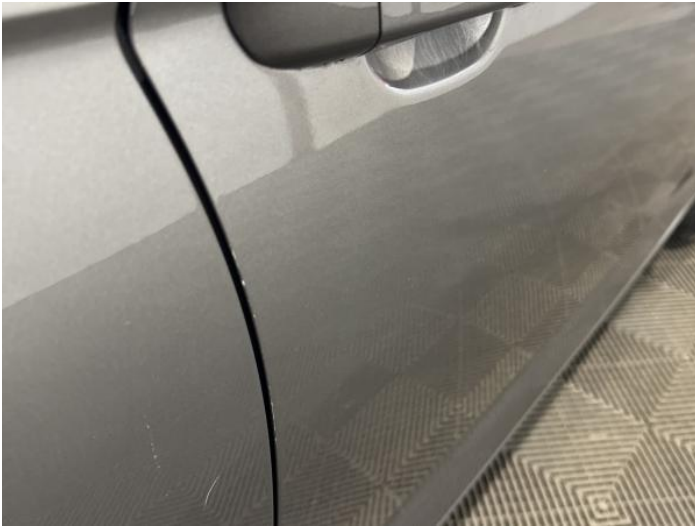
15: Door osf
Chipped
Edge Chip

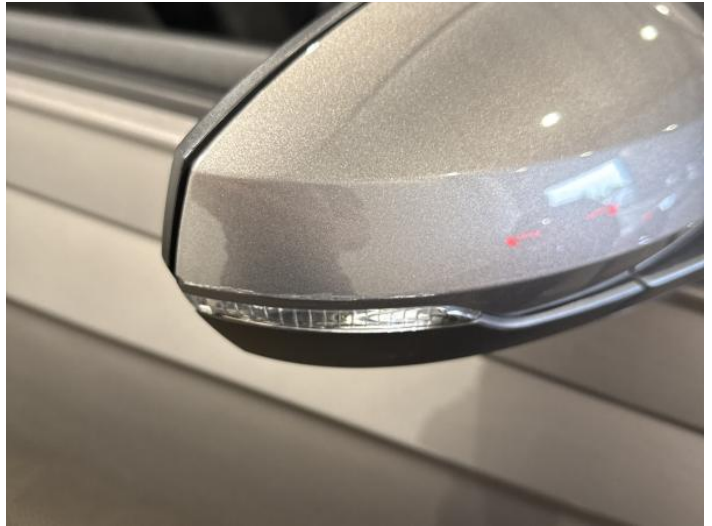
16: Door Mirror Assy osf
Scratched (Painted)
UpTo 25mm Thru Paint

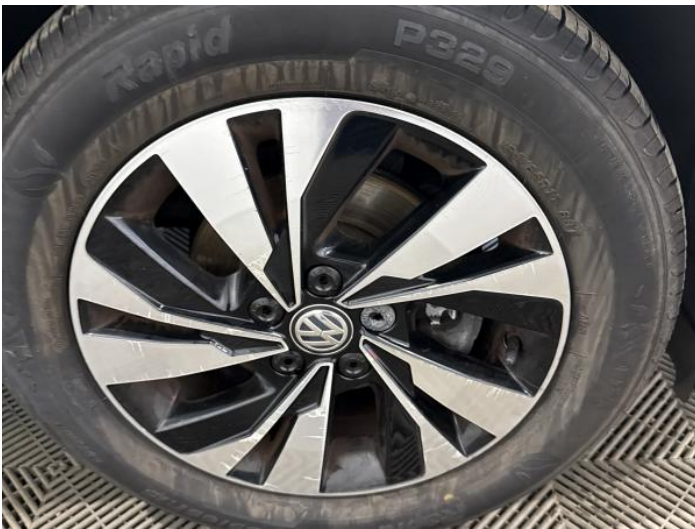
17: Wheel osf
Scratched
Over 50mm
