VEHICLE INSPECTION REPORT

WJ70EHD

Seat Leon 1.5 TSI EVO FR 5dr

nama
 GRADE
3

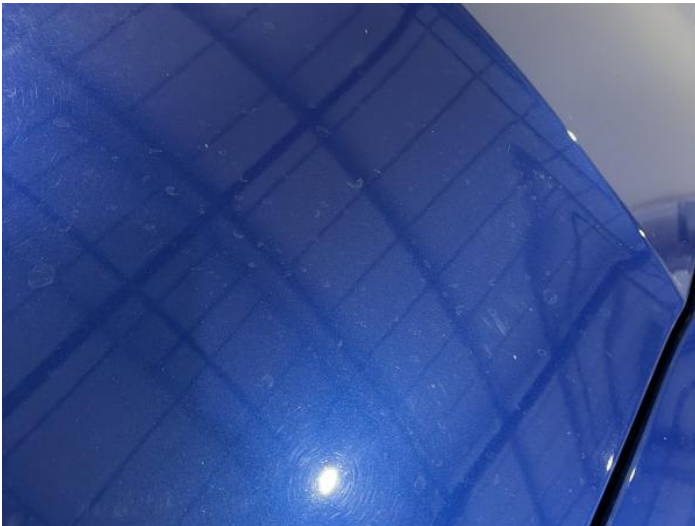
1: Bonnet
Chipped
1 To 5

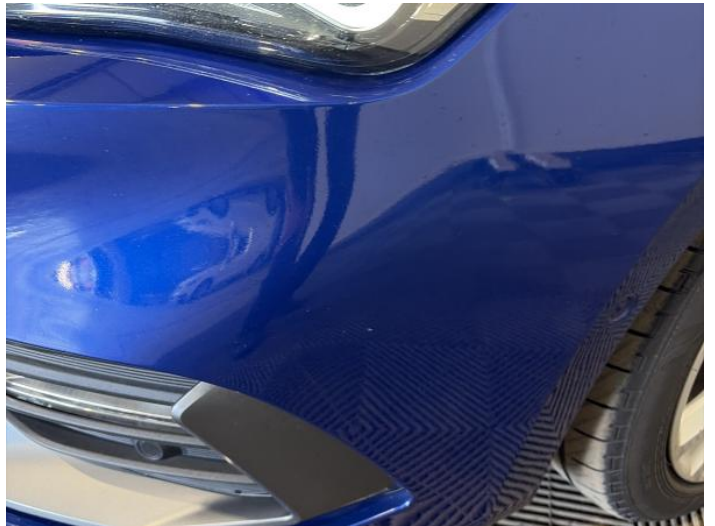
2: Bumper Front
Chipped
1 To 5

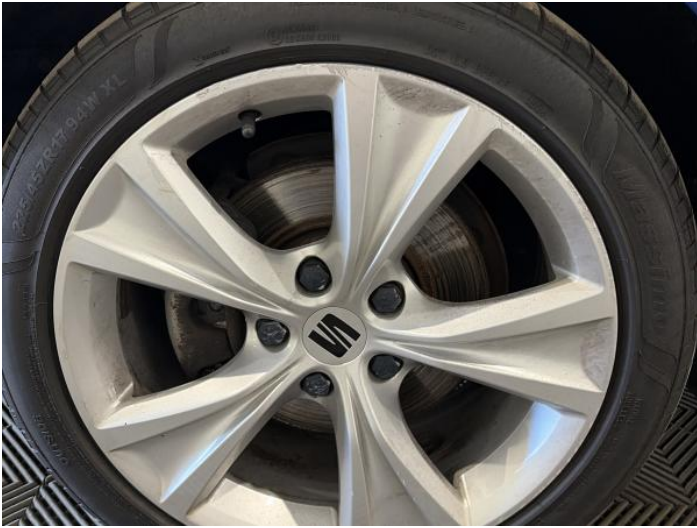
3: Wheel nsf
Scratched
Over 50mm

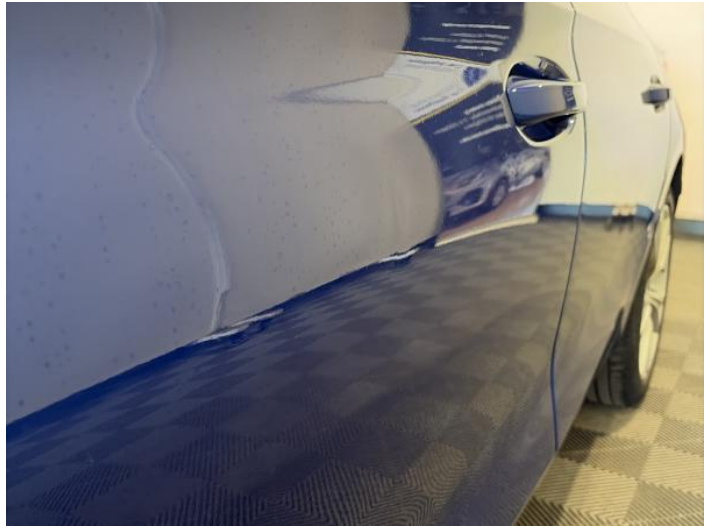
4: Door nsf
Dented
Over 30mm

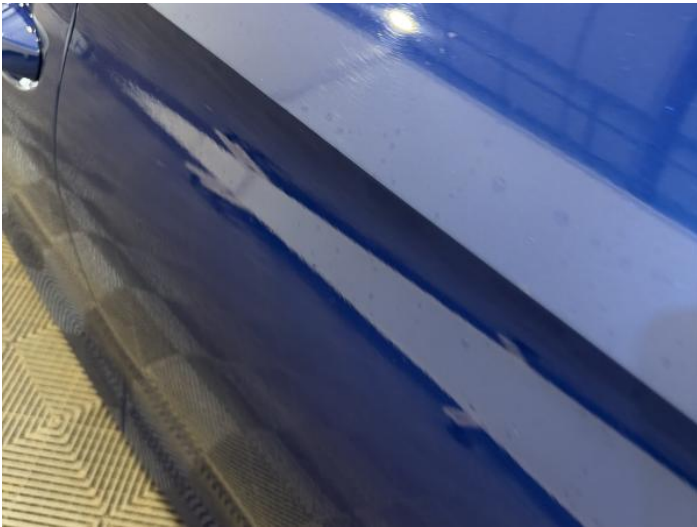
5: Door nsr
Dented
Between 10mm + 30mm

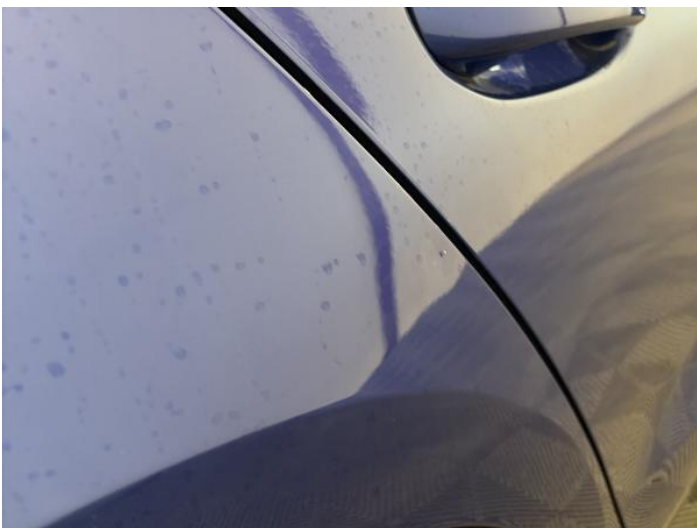
7: Qtr Panel osr
Dented
Between 10mm + 30mm

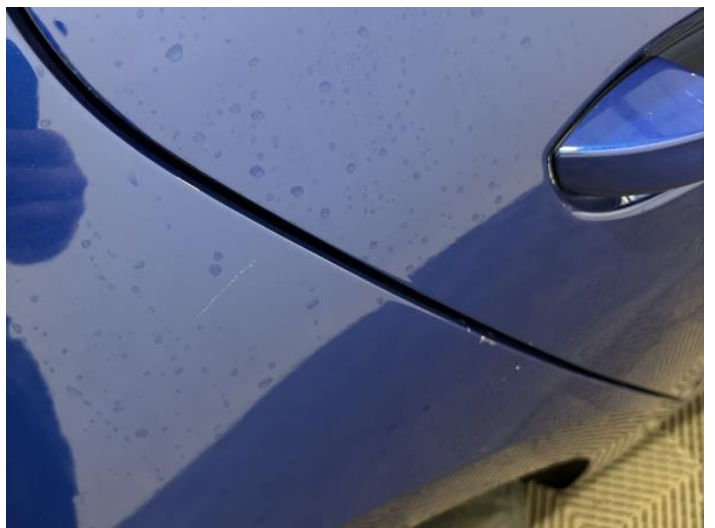
8: Qtr Panel osr
Scratched
Over 25mm Thru Paint

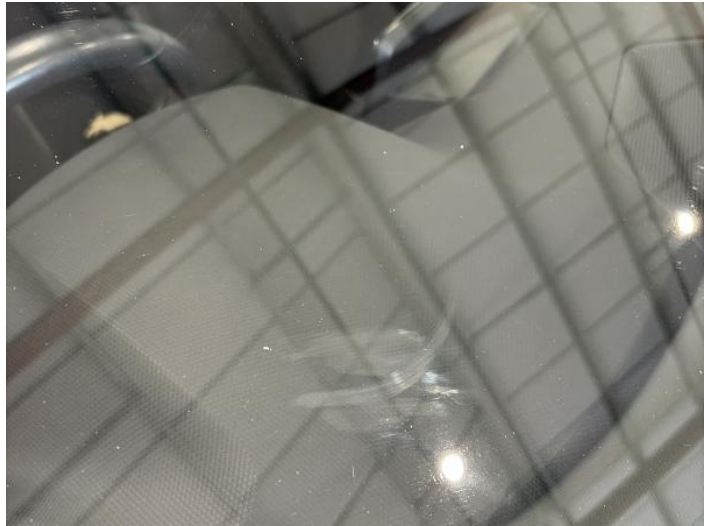
10: Screen Front
Chipped
UpTo 10mm

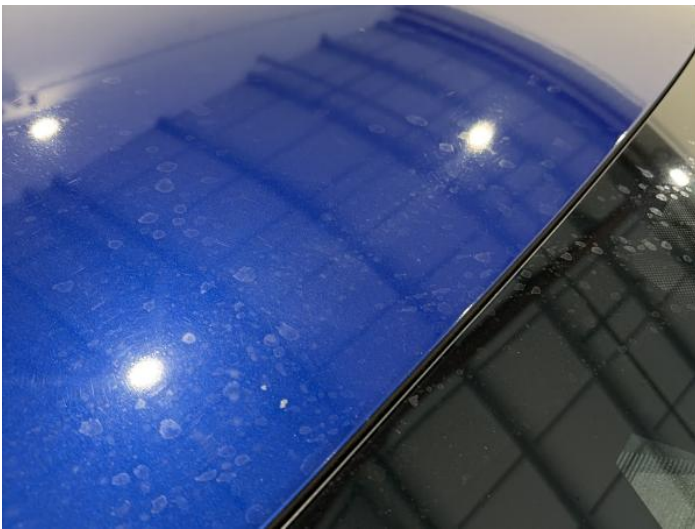
11: Roof
Chipped
1 To 5

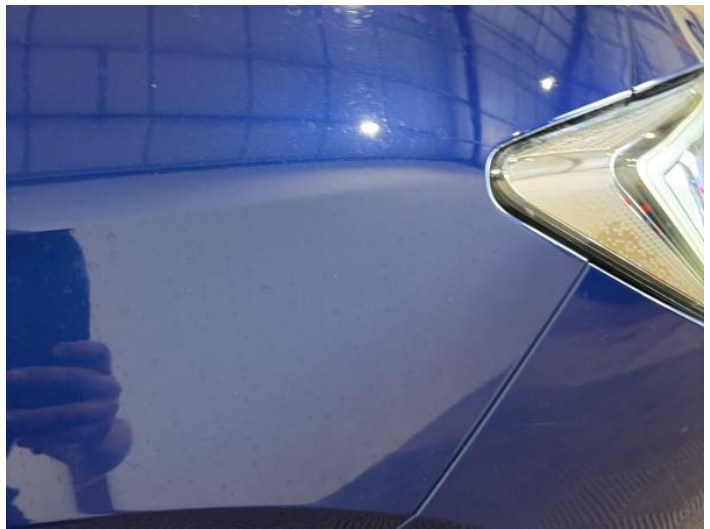
12: Wing osf
Chipped
1 To 5
