VEHICLE INSPECTION REPORT

MJ69FJZ

Peugeot 2008 1.2 PureTech 130 GT Line 5dr EAT6

nama
GRADE
4

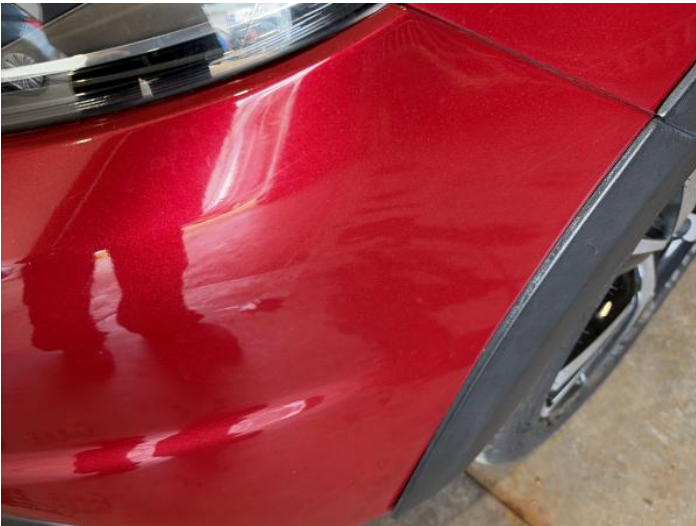
1: Bumper Front
Poor Previous Repair
Poor Paint

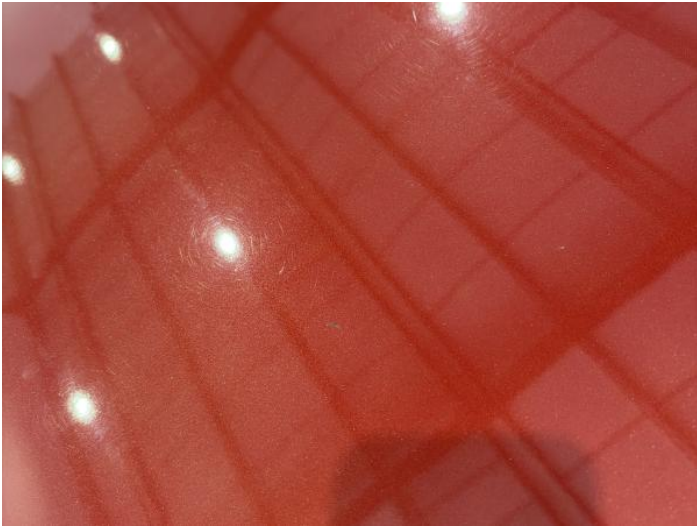
3: Bonnet
Chipped
1 To 5

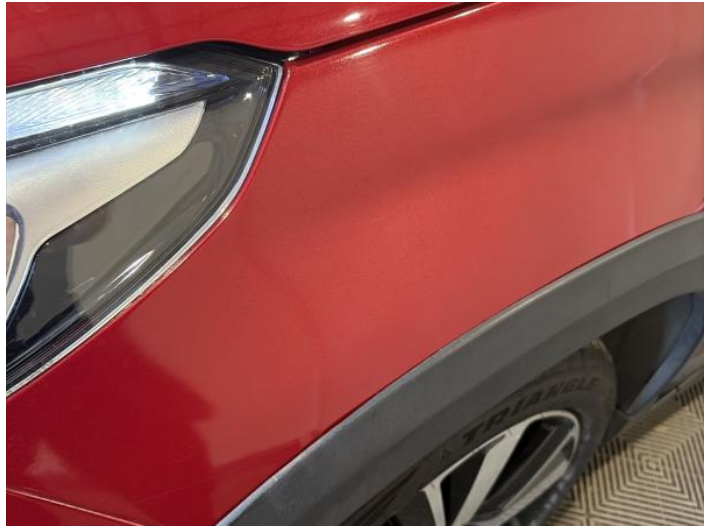
4: Wing nsf
Poor Previous Repair
Poor Paint

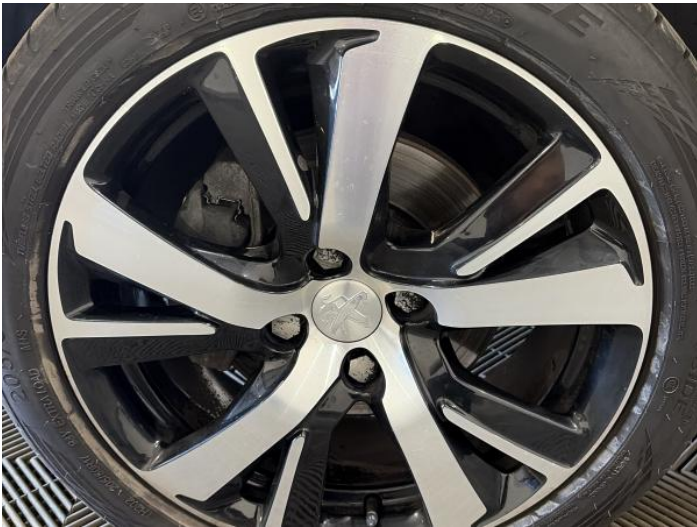
5: Wheel nsf
Scratched
Up To 50mm

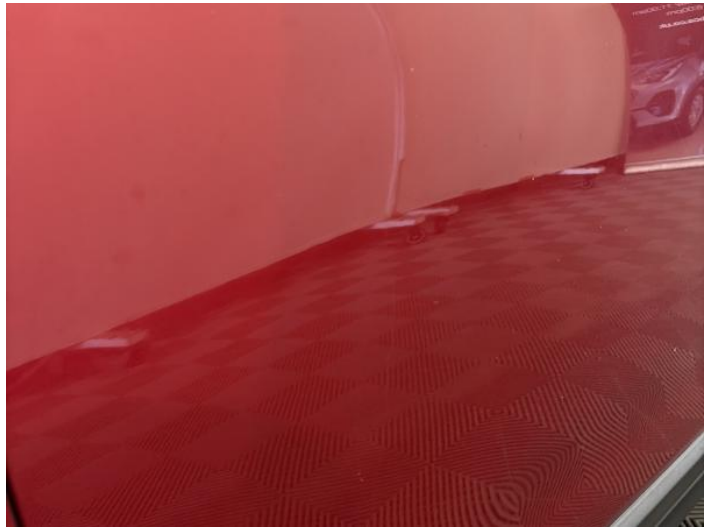
6: Door nsf
Poor Previous Repair
Poor Paint

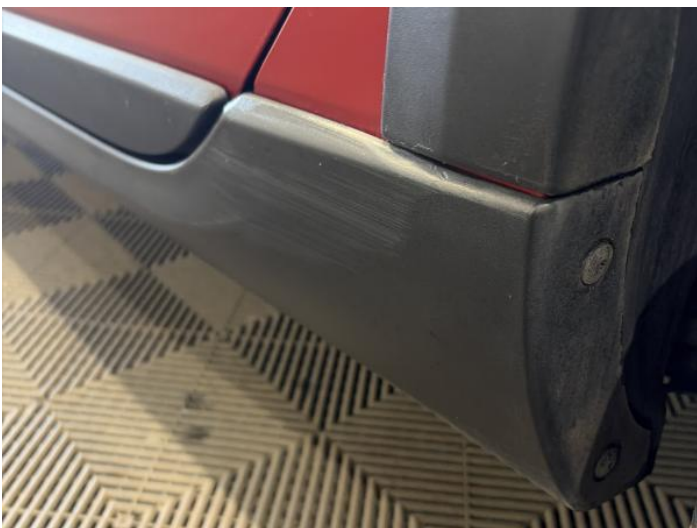
7: Sill Panel Trim ns
Scuffed (Unpainted)
Over 100mm

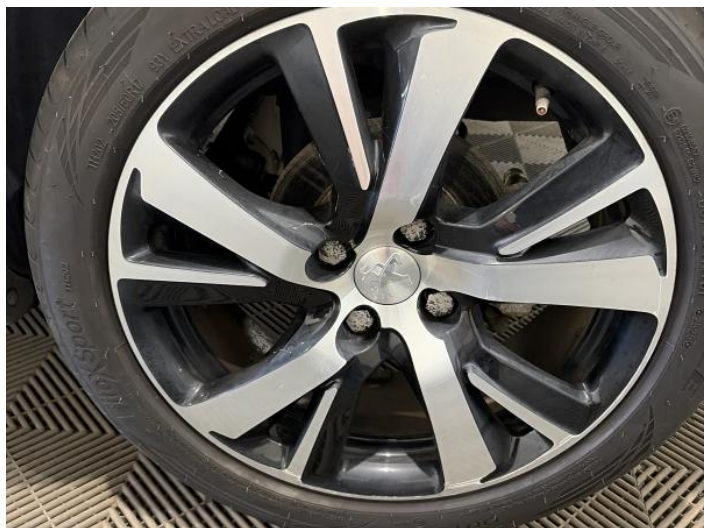
8: Wheel nsr
Scratched
Over 50mm

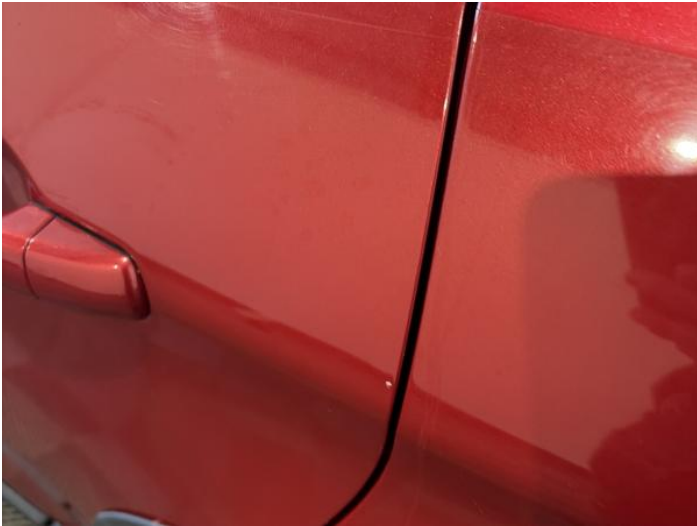
9: Door nsr
Poor Previous Repair
Poor Paint

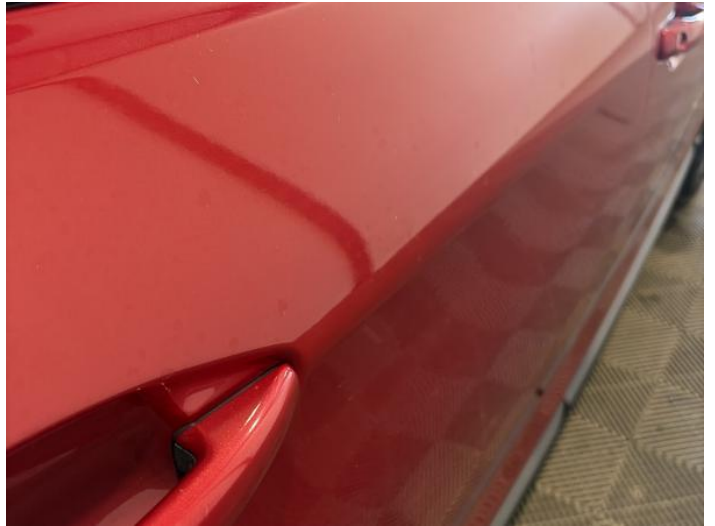
10: Door osr
Dented
Over 30mm

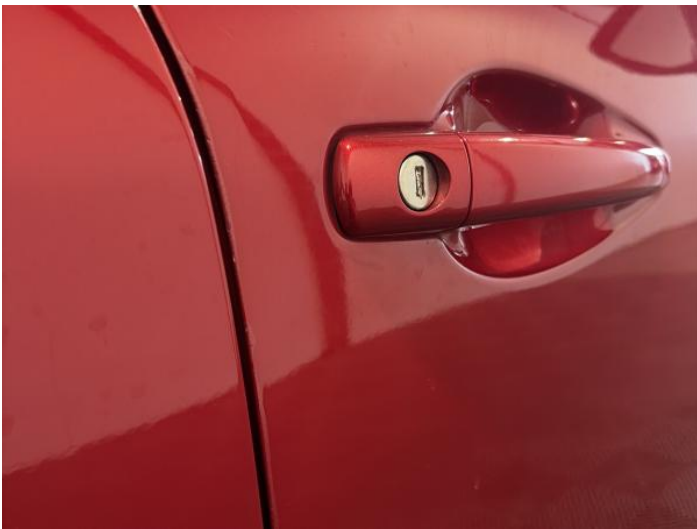
11: Door osf
Chipped
Edge Chip

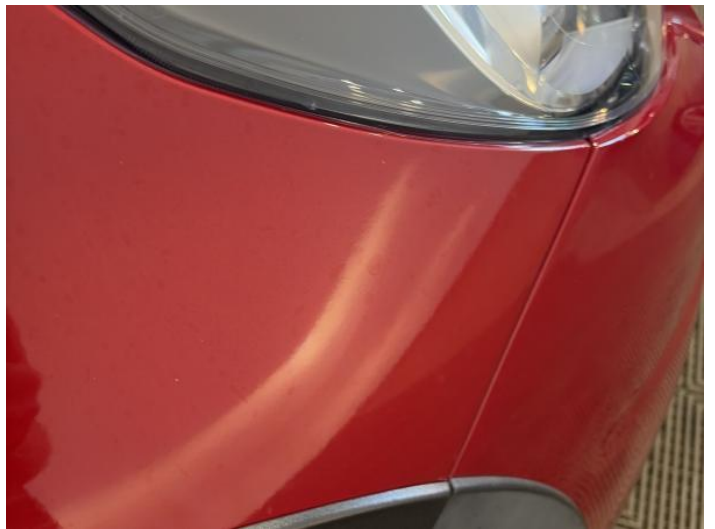
12: Wing osf
Chipped
1 To 5

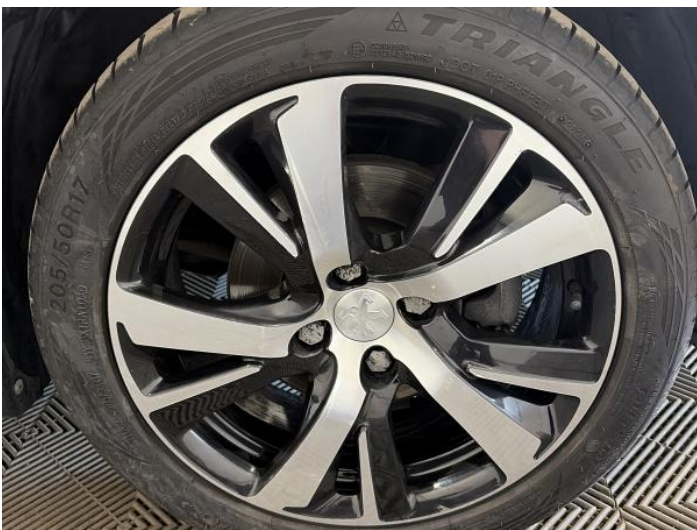
13: Wheel osf
Scratched
Over 50mm

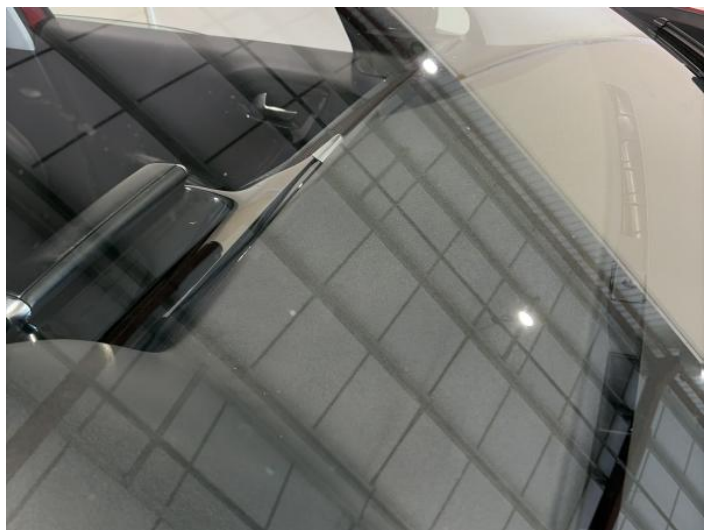
14: Screen Front
Chipped
UpTo 10mm

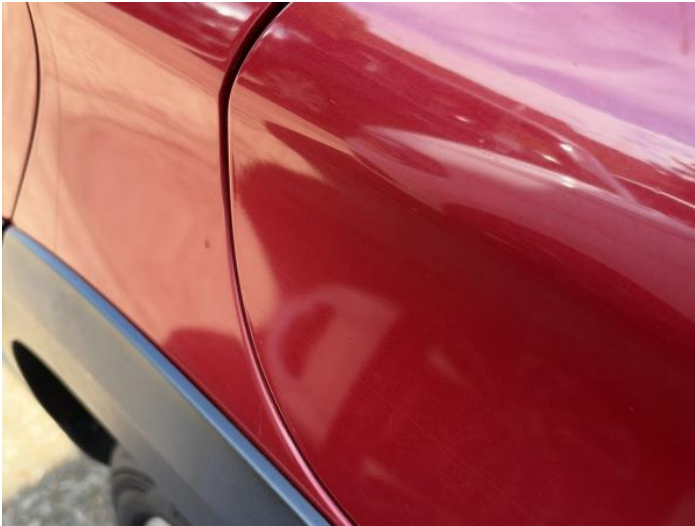
15: Qtr Panel nsr
 Poor Previous Repair
 Poor Paint
