# VEHICLE INSPECTION REPORT

**GJ60VWF**

## Renault Grand Scenic 1.5 dCi 110 Privilege TomTom 5dr

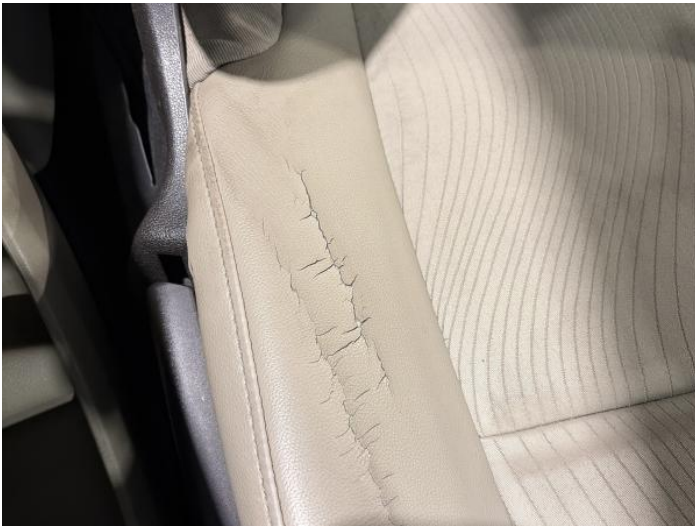
1: Seat Base Cover osf  
Scuffed  
Over 25mm

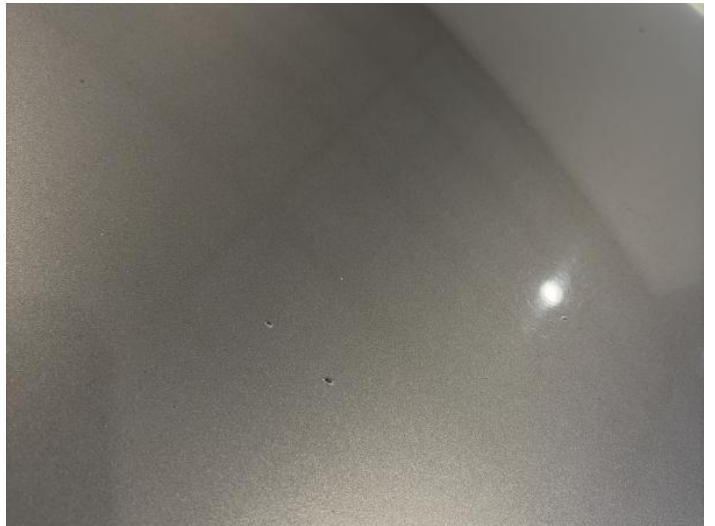
2: Bonnet  
Chipped  
1 To 5

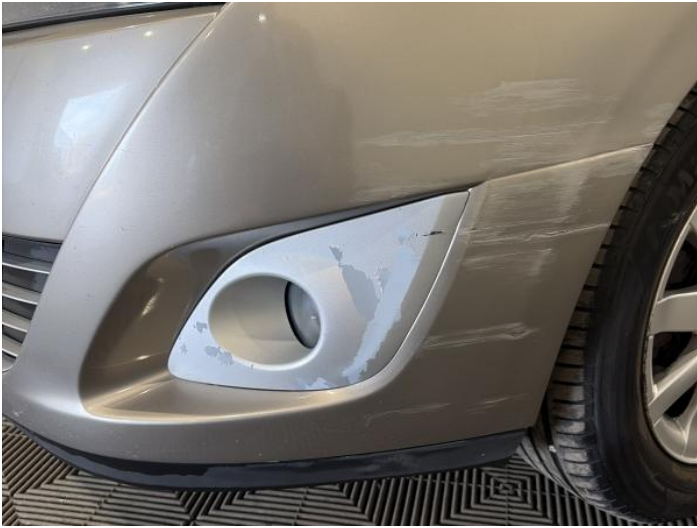
3: Bumper Front  
Scratched  
Over 100mm Thru Paint

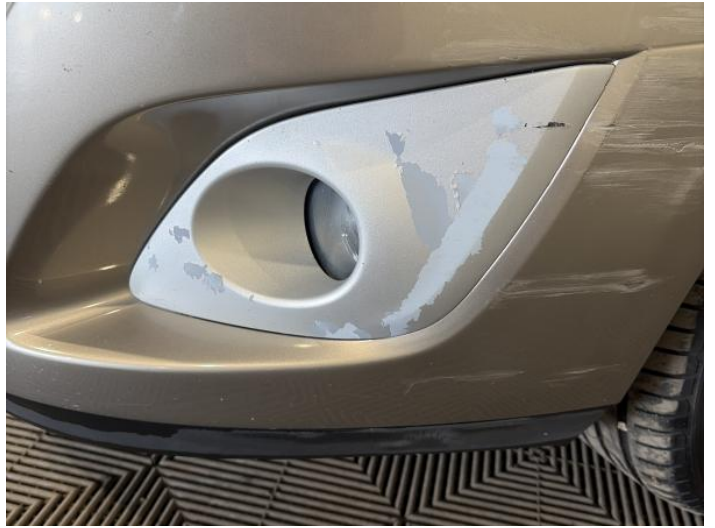
4: Fog Lamp Surround ns  
Scratched (Painted)  
Over 25mm Thru Paint

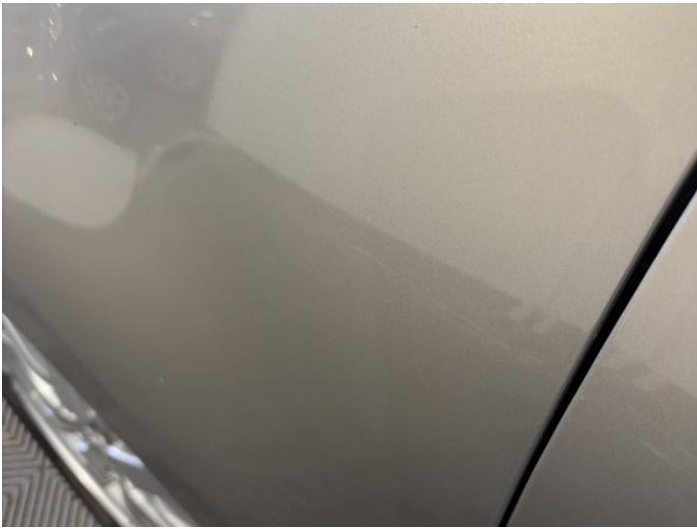
5: Wing nsf  
Scratched  
Over 25mm Thru Paint

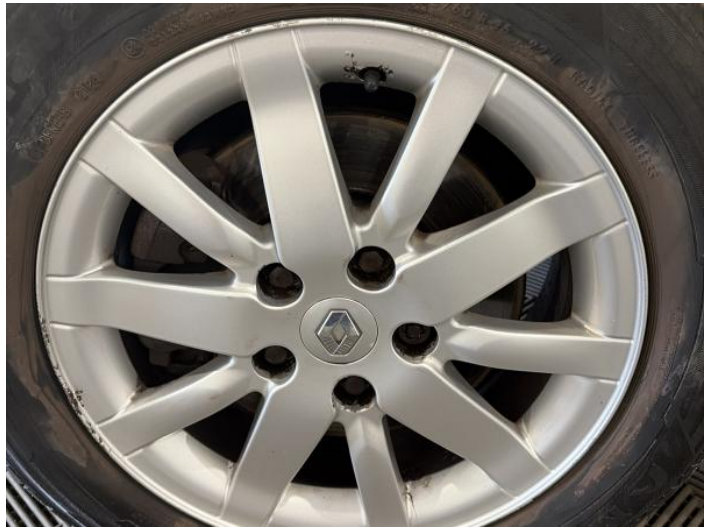
6: Wheel nsf  
Scratched  
Over 50mm

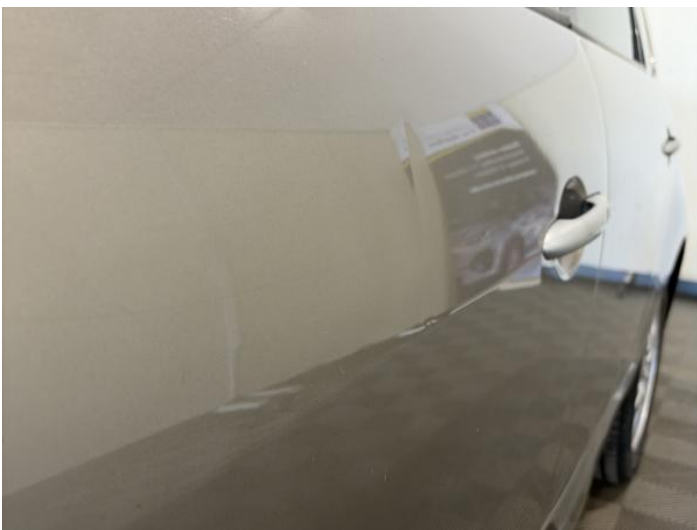
7: Door nsf  
Dented  
Over 30mm

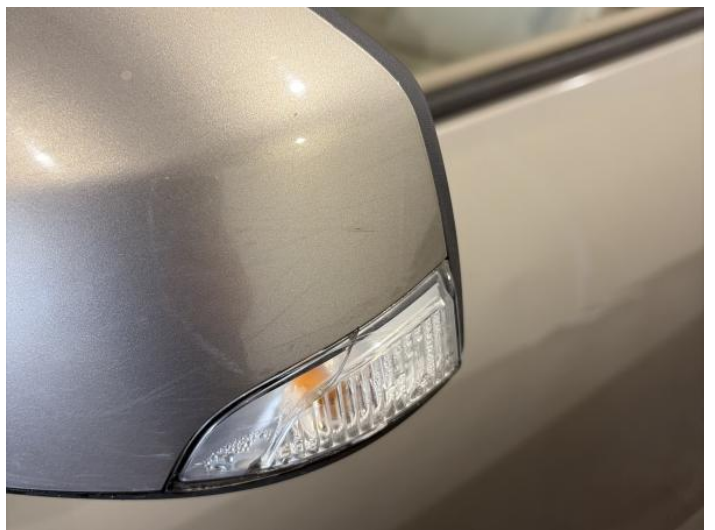
8: Flasher Side Repeater ns  
Broken  
Replace

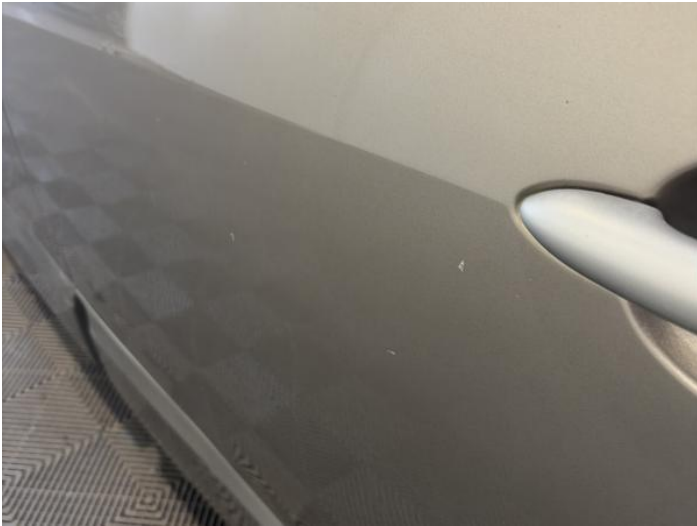
9: Door nsr  
Chipped  
Multiple Chips

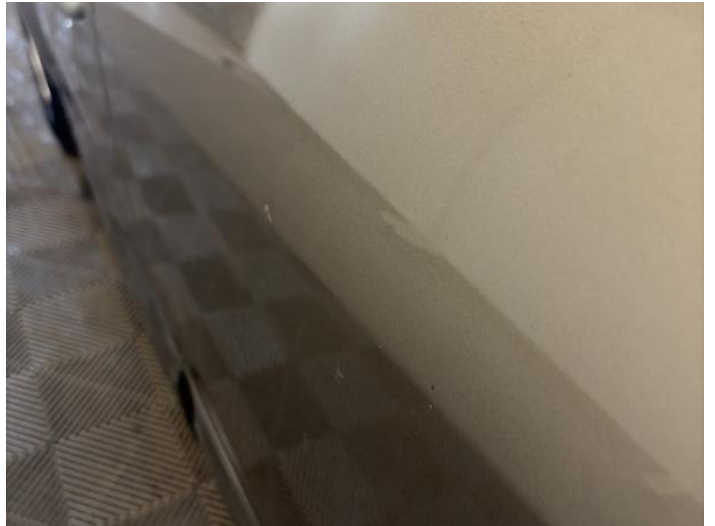
10: Door nsr  
Dented  
Between 10mm + 30mm

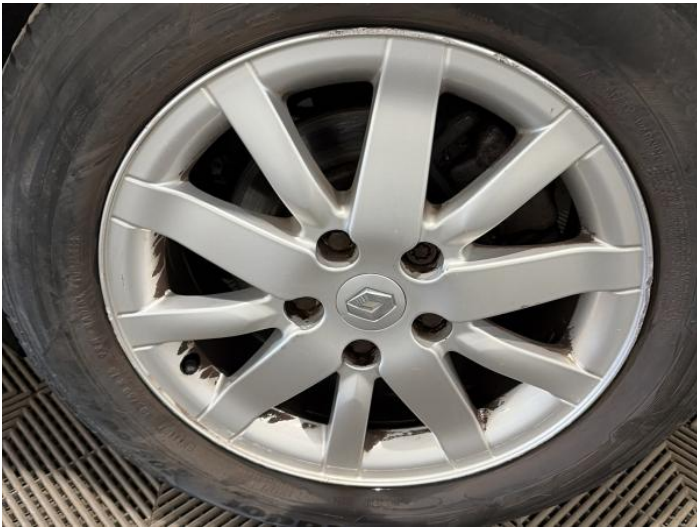
11: Wheel nsr  
Scratched  
Over 50mm

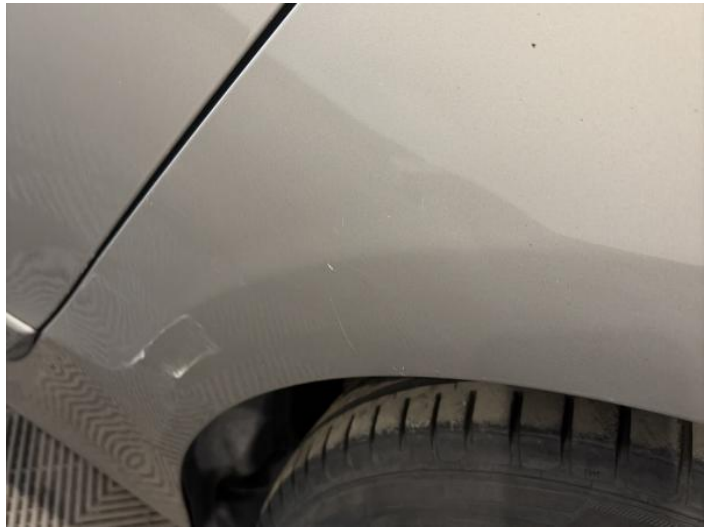
12: Qtr Panel nsr  
Dented  
With Paint Damage

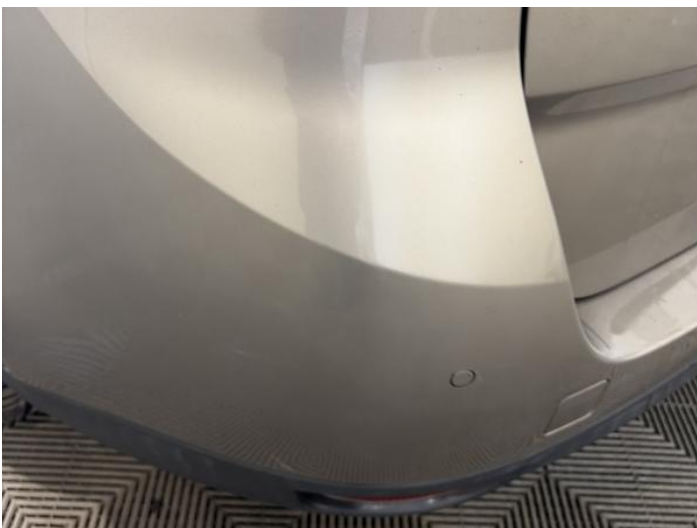
13: Bumper Rear  
Scratched  
25 to 100mm Thru Paint

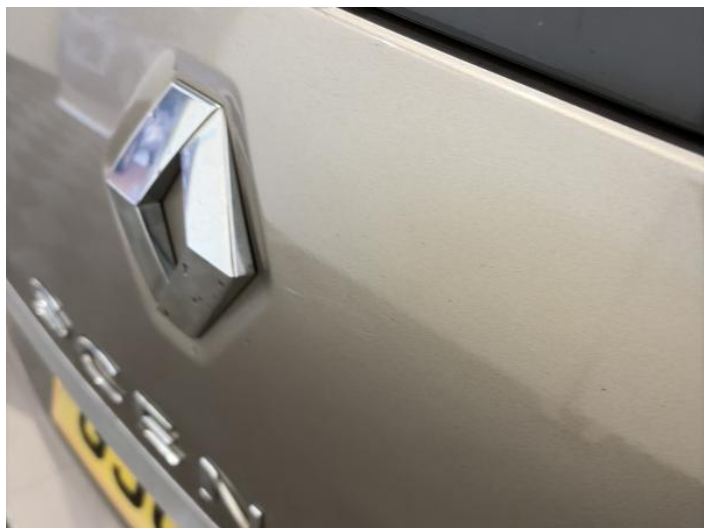
14: Tailgate  
Scratched  
UpTo 25mm Thru Paint

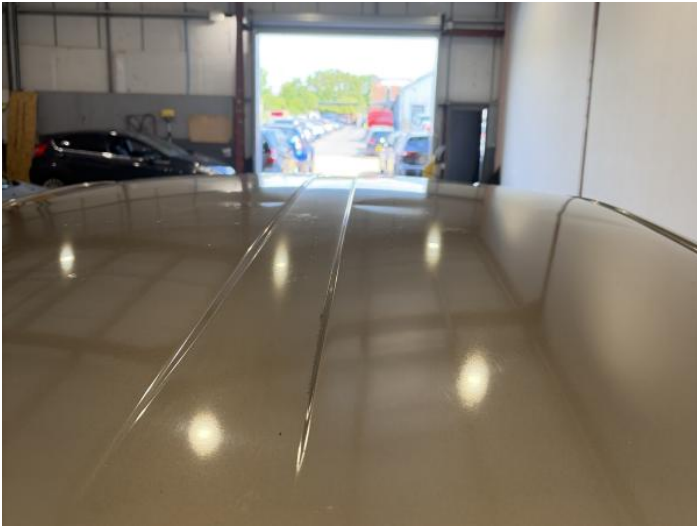
15: Roof  
Dented  
Over 30mm

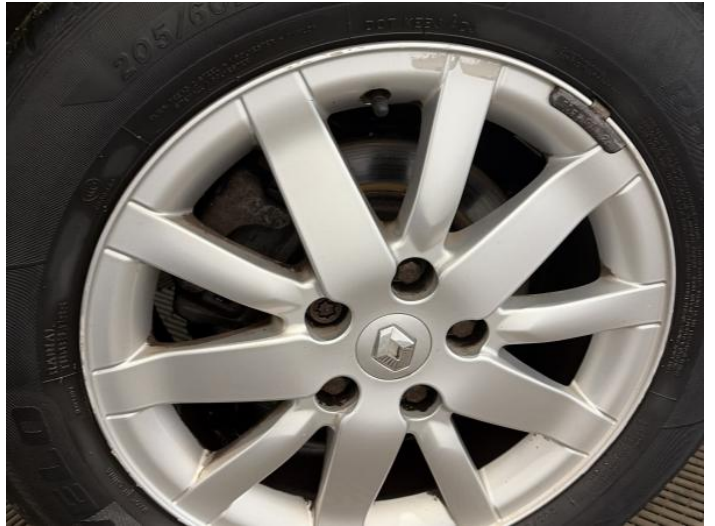
16: Wheel osr  
Scratched  
Over 50mm

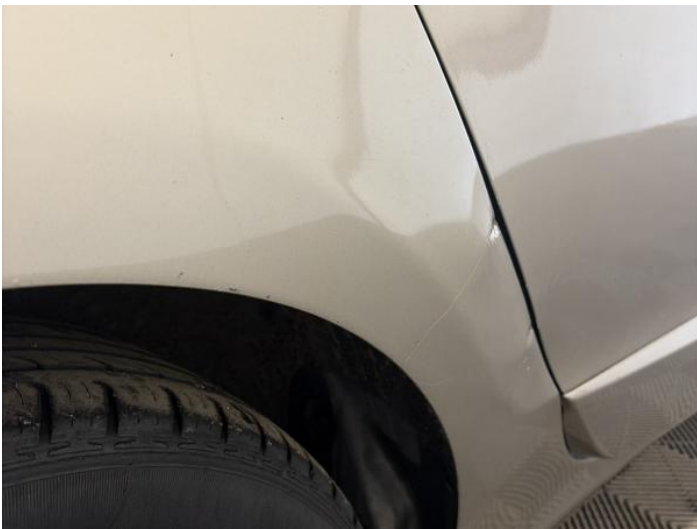
17: Qtr Panel osr  
Dented  
With Paint Damage

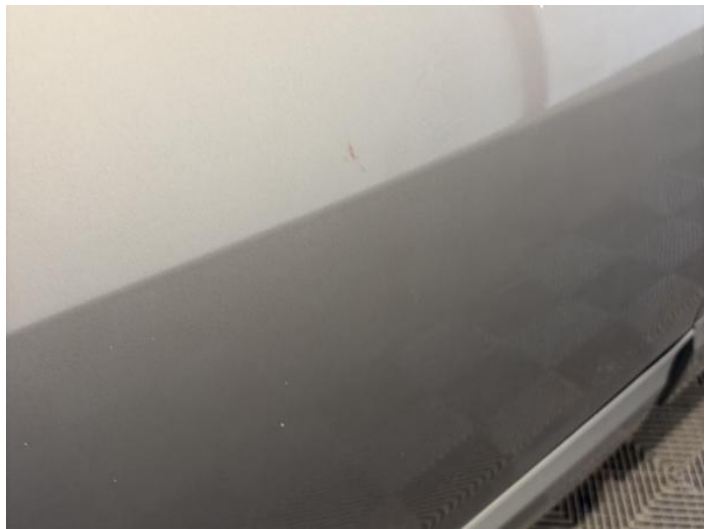
18: Door osr  
Chipped  
1 To 5

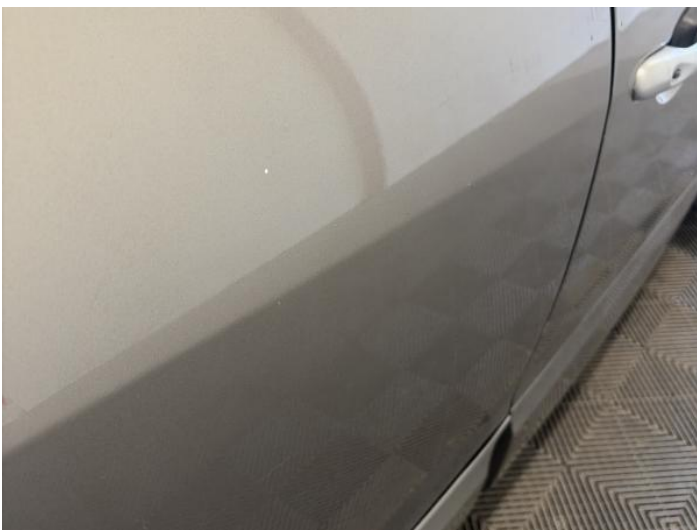
19: Door osr  
Dented  
Between 10mm + 30mm

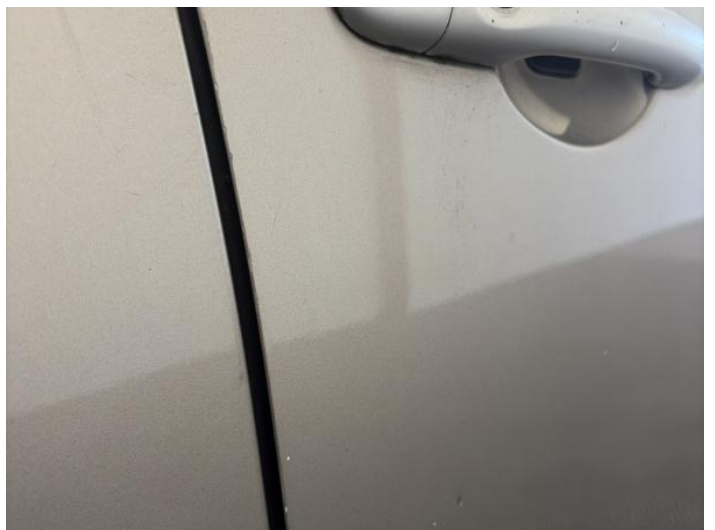
20: Door osf  
Chipped  
Edge Chip

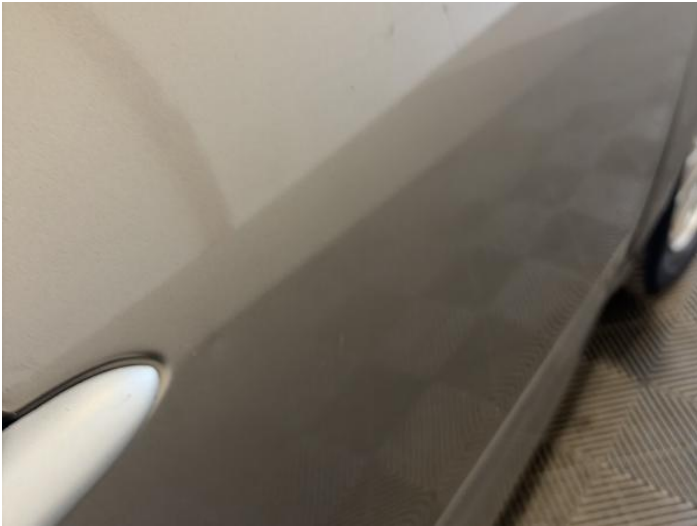
21: Door osf  
Dented  
2 Or Less UpTo 10mm

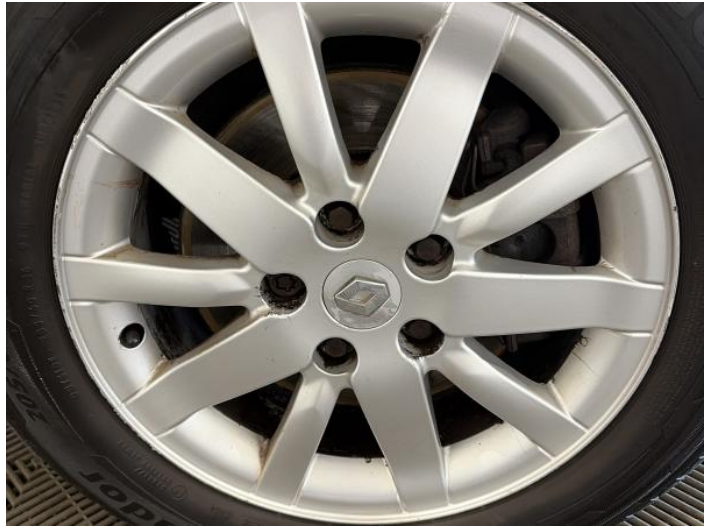
22: Wheel osf  
Scratched  
Over 50mm

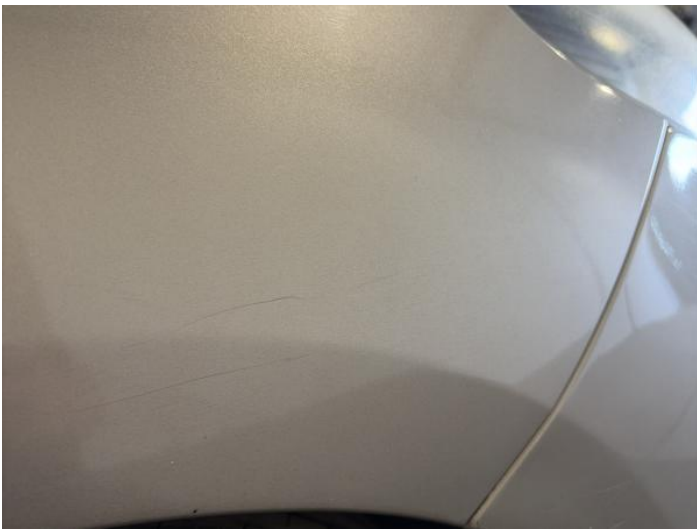
23: Wing osf  
Scratched  
Over 25mm Thru Paint

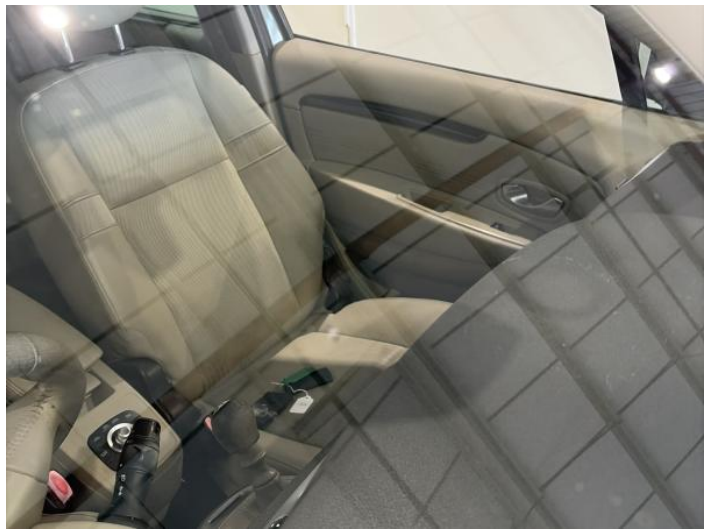
24: Screen Front  
Cracked  
Replace

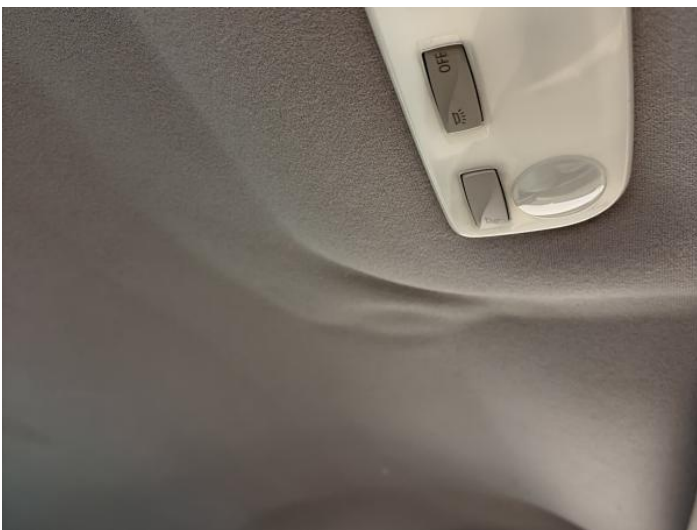
25: Roof Lining  
Scuffed  
Over 25mm
