VEHICLE INSPECTION REPORT

OE61BDZ

Ford C-Max 1.6 TDCi Zetec 5dr

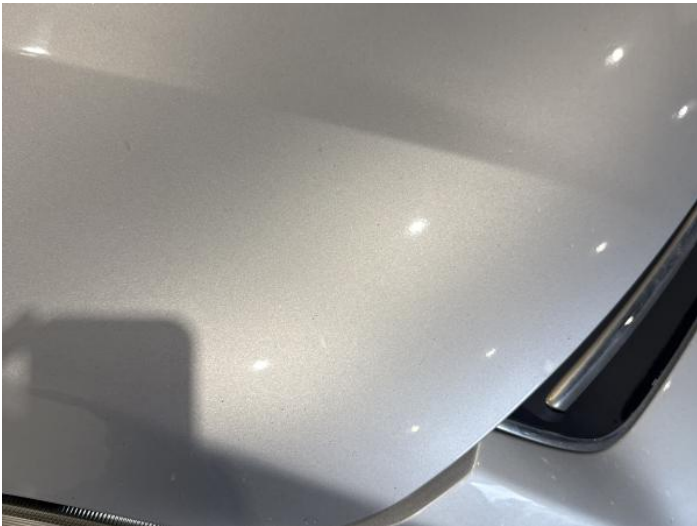
1: Bonnet
Chipped
Multiple Chips

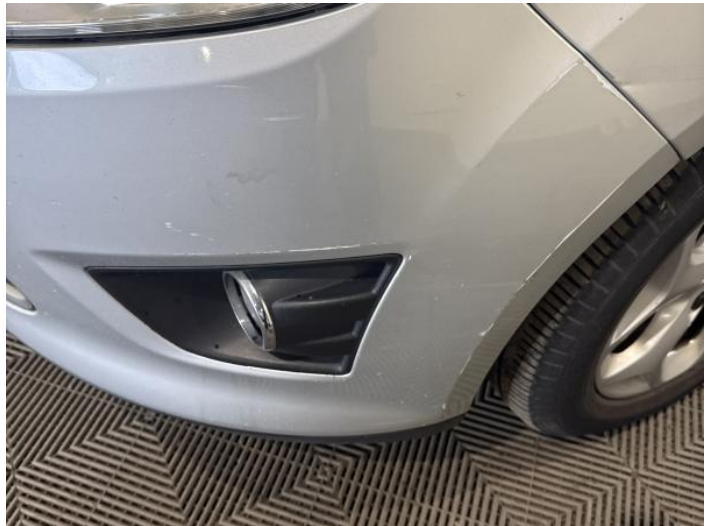
2: Bumper Front
Scratched
Over 100mm Thru Paint

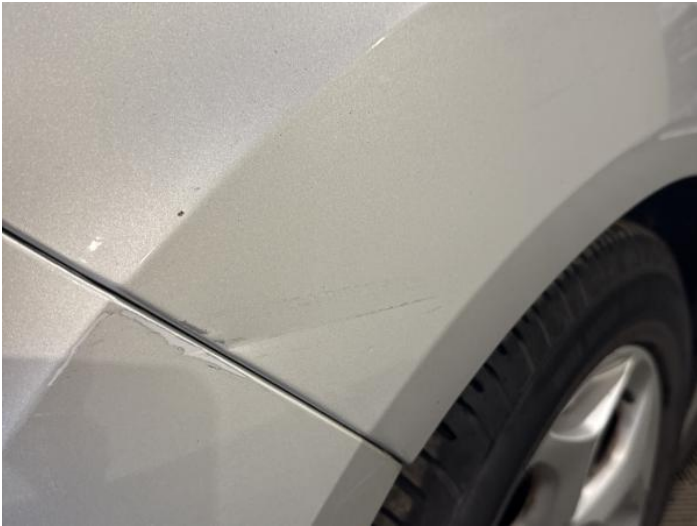
3: Wing nsf
Dented
With Paint Damage

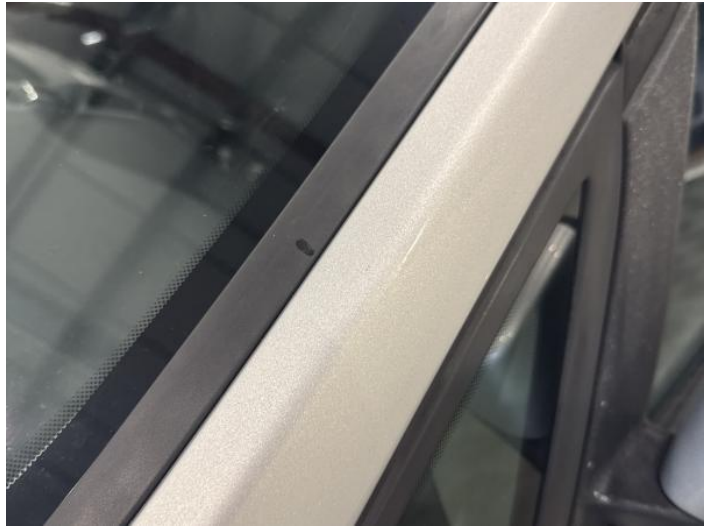
4: A Post ns
Chipped
1 To 5

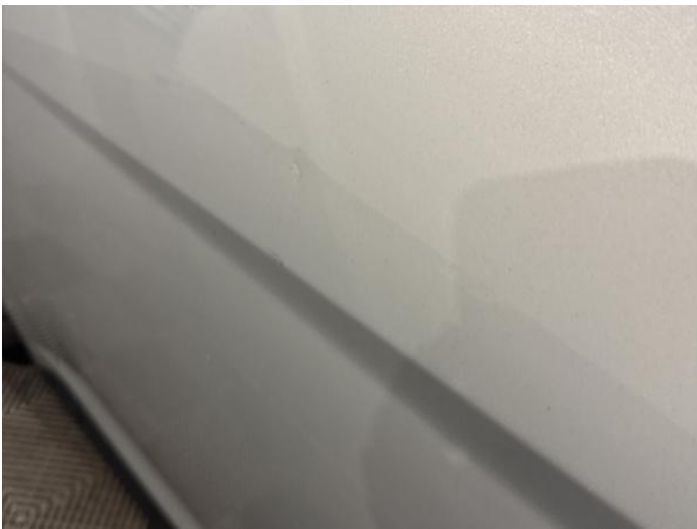
5: Door nsf
Dented
With Paint Damage

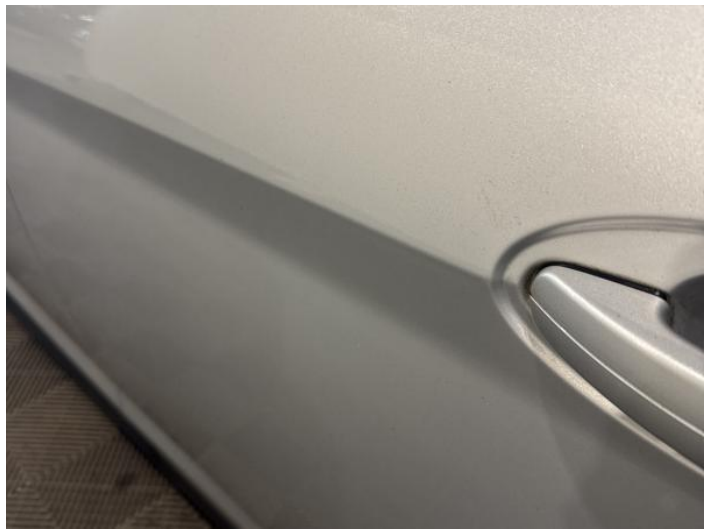
6: Door nsr
Chipped
1 To 5

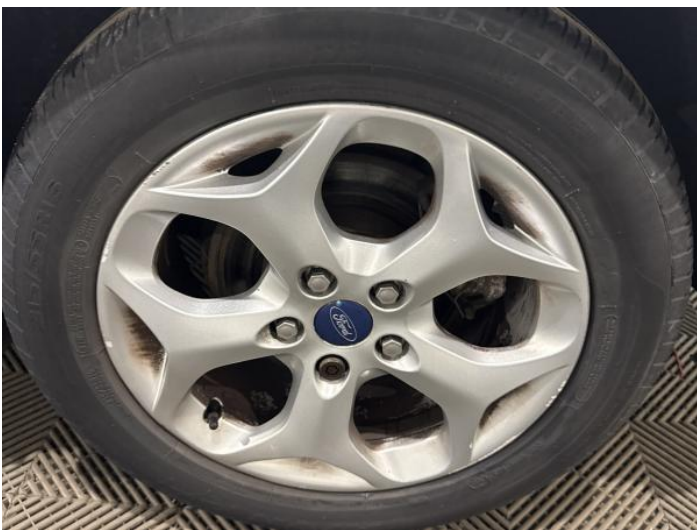
7: Wheel nsr
Scratched
Over 50mm

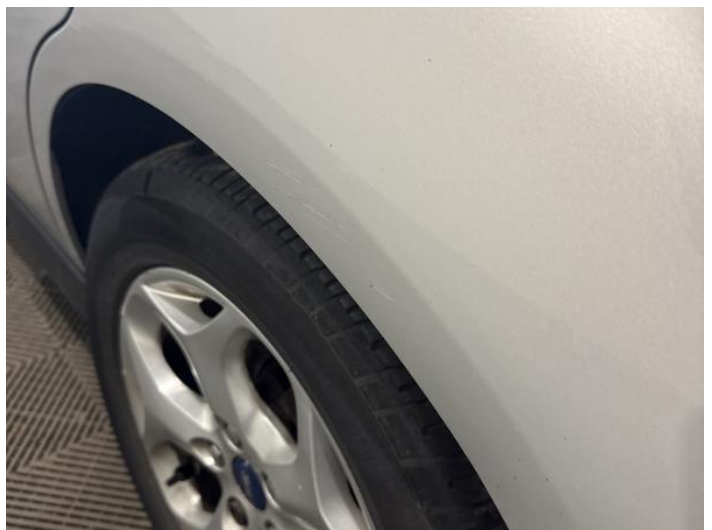
8: Qtr Panel nsr
Scratched
Over 25mm Thru Paint

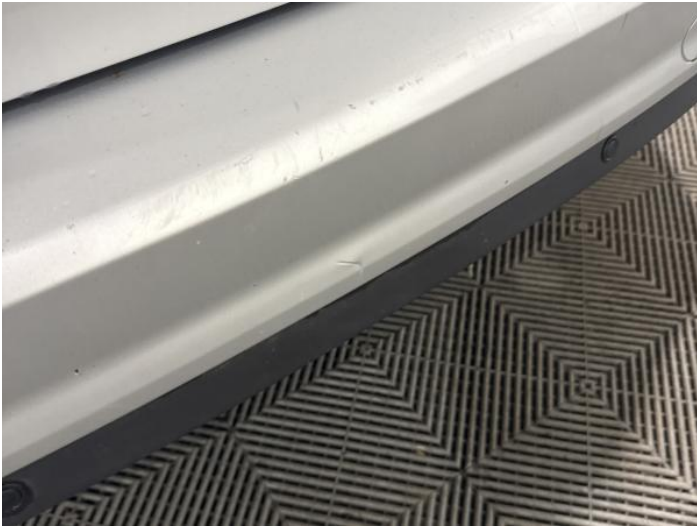
9: Bumper Rear
Scratched
Over 100mm Thru Paint

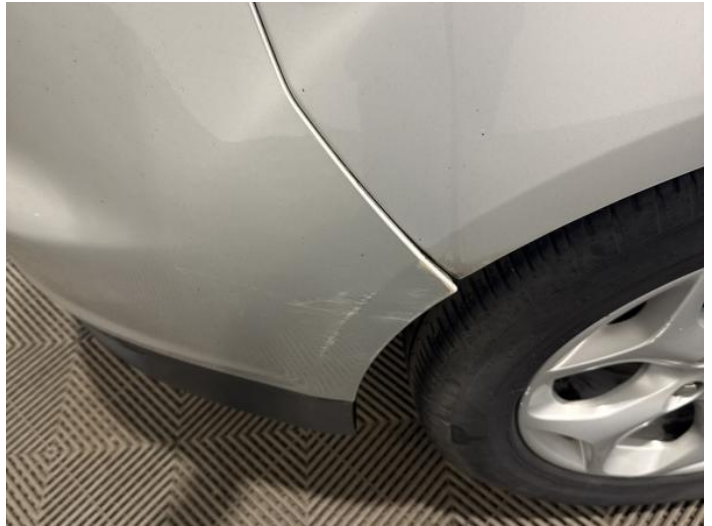
10: Bumper Rear
Insecure
Action Required

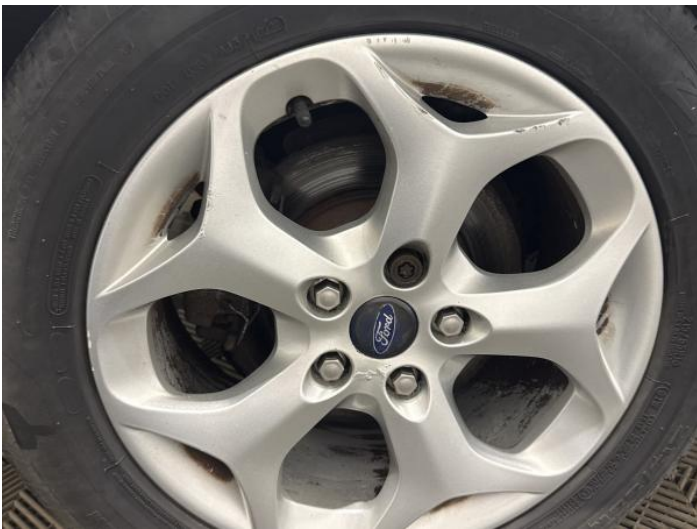
11: Wheel osr
Scratched
Over 50mm

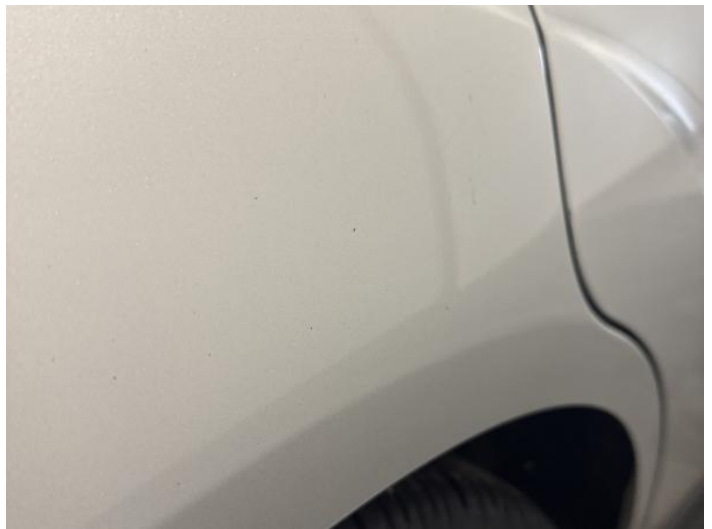
12: Qtr Panel osr
Dented
2 Or Less UpTo 10mm

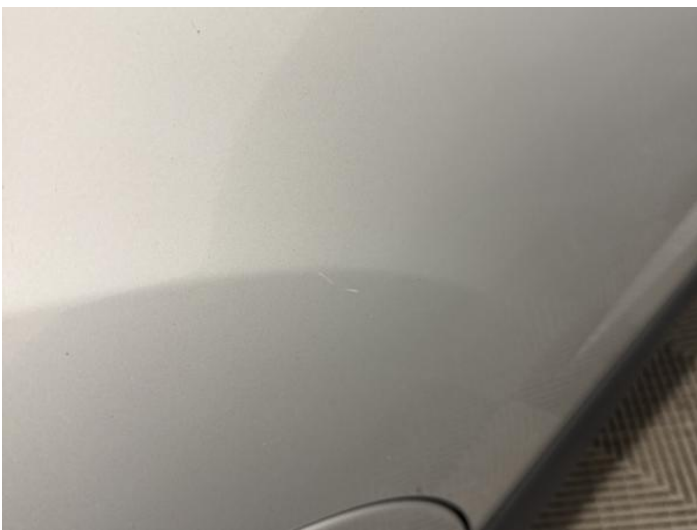
13: Door osr
Scratched
UpTo 25mm Thru Paint

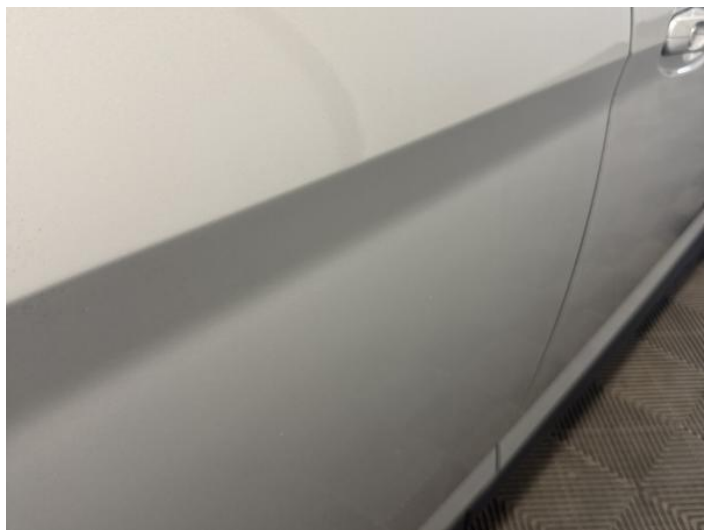
14: Door osr
Dented
2 Or Less UpTo 10mm

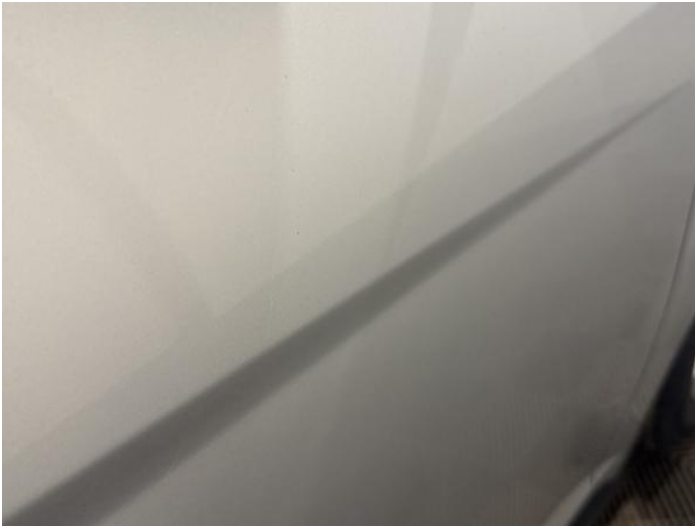
15: Door osf
Dented
Between 10mm + 30mm

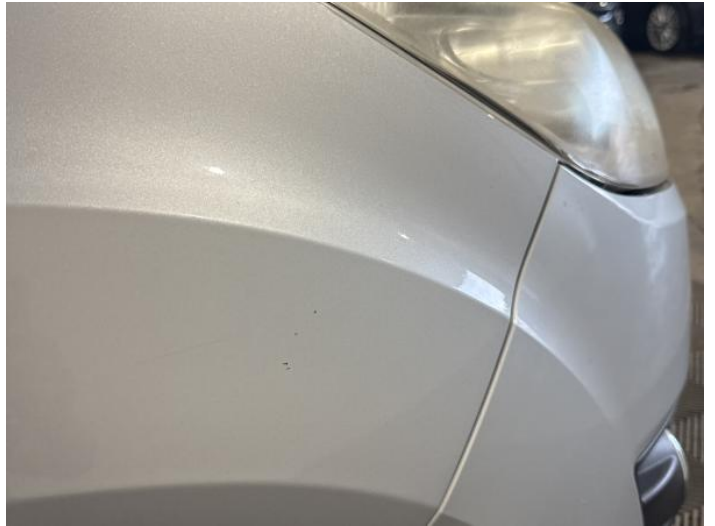
16: Wing osf
Chipped
1 To 5

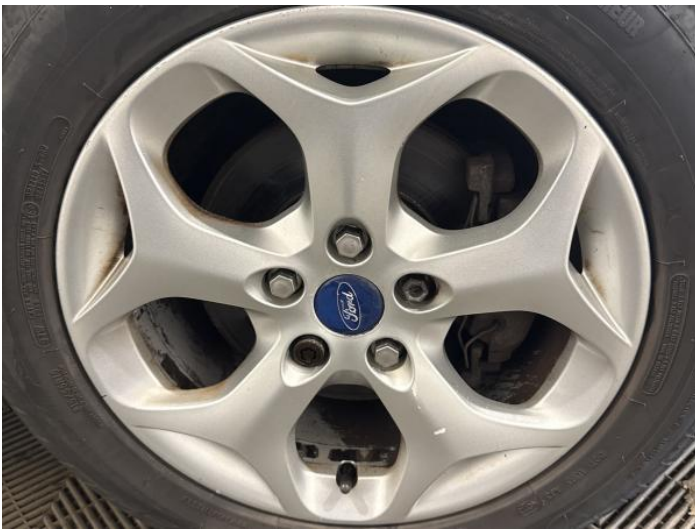
17: Wheel osf
Scratched
Up To 50mm

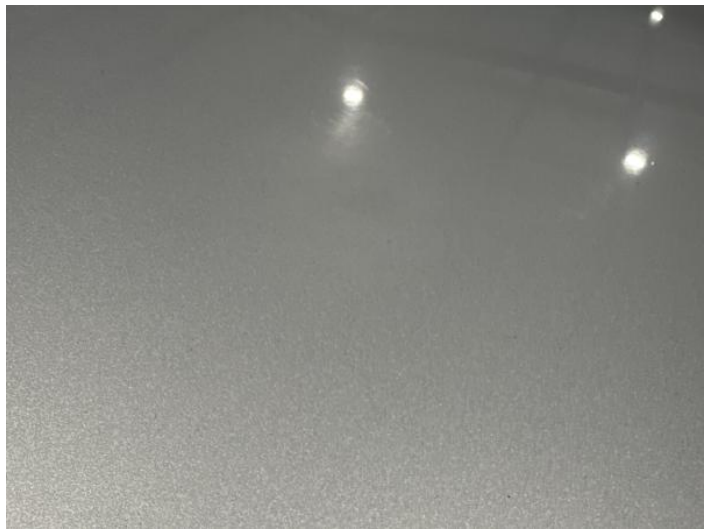
18: Roof
Scratched
Over 25mm Thru Paint

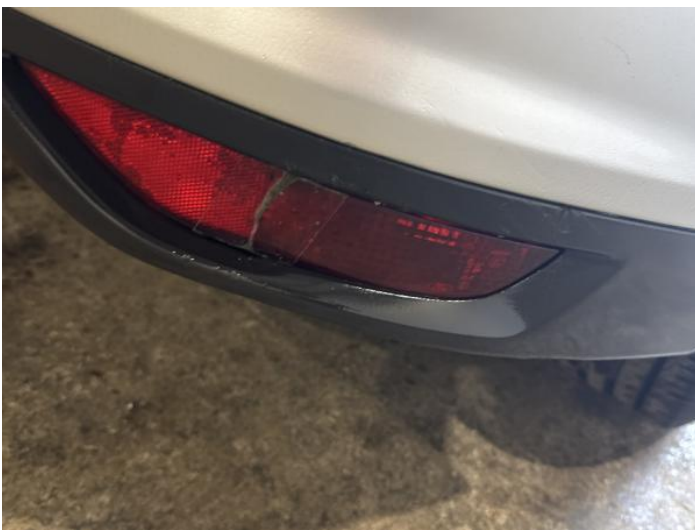
19: Bumper Reflector osr
Broken
Replace
