VEHICLE INSPECTION REPORT

EJ60OLE

Hyundai I10 1.2 Comfort 5dr

nama
 GRADE
4

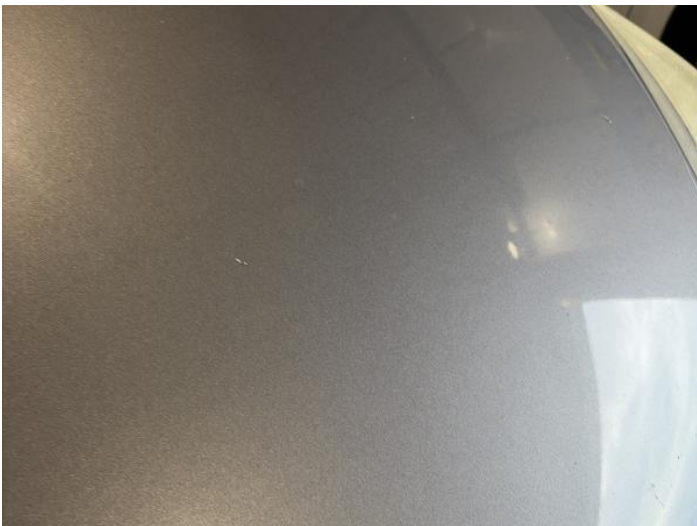
1: Bonnet
Chipped
Multiple Chips

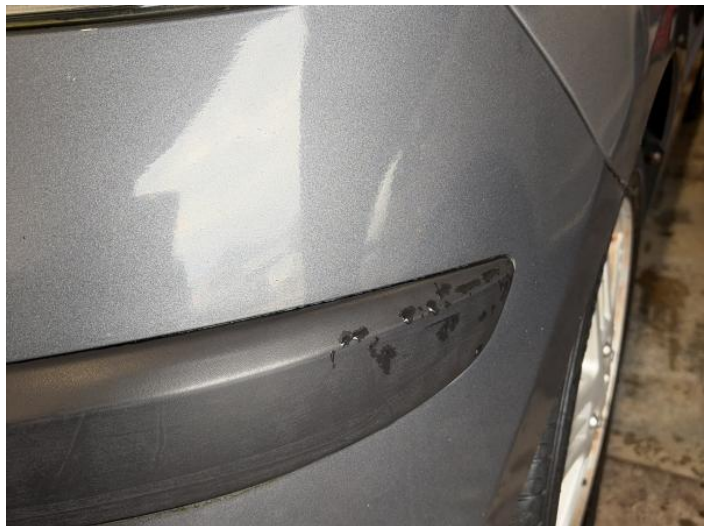
2: Bumper Front
Poor Previous Repair
Poor Paint

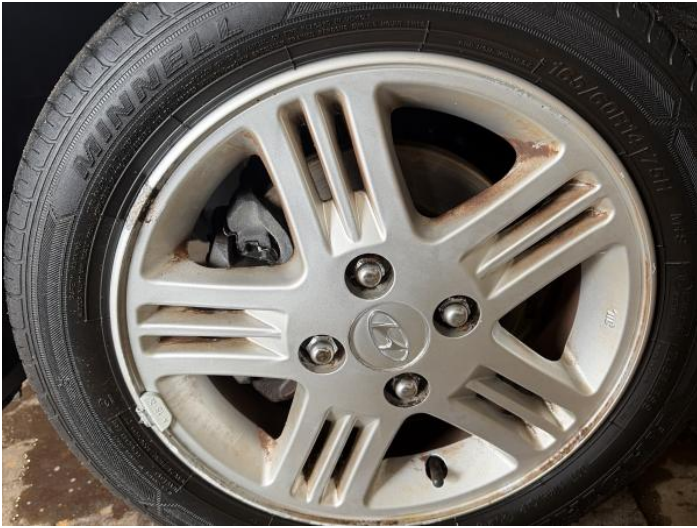
3: Wheel nsf
Scratched
Over 50mm

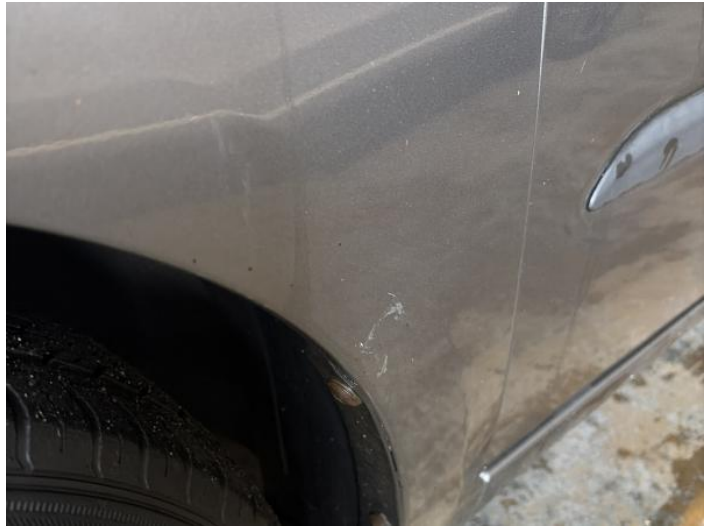
4: Wing nsf
Scratched
Over 25mm Thru Paint

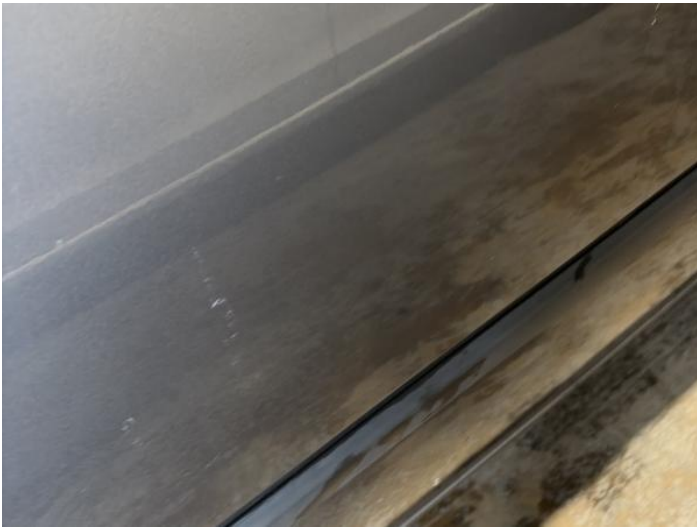
5: Door nsf
Scratched
Over 25mm Thru Paint

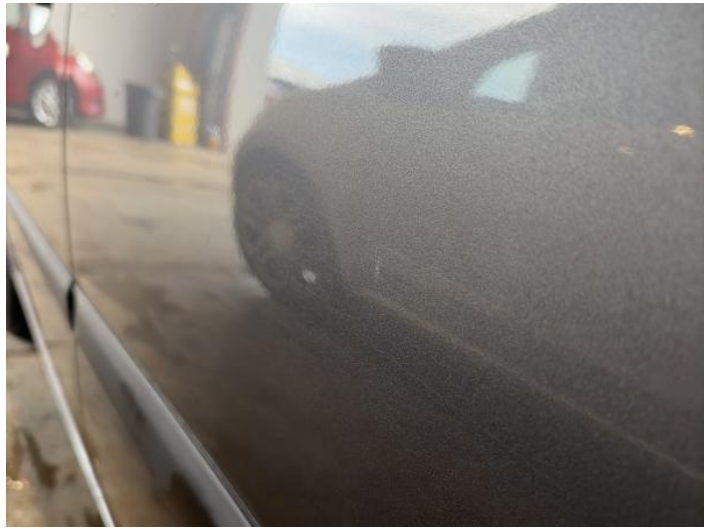
6: Door nsr
Dented
2 Or Less UpTo 10mm

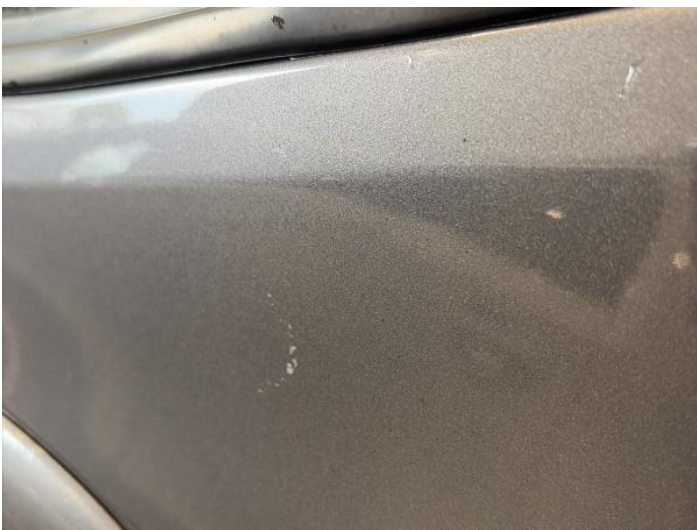
7: Door nsr
Chipped
1 To 5

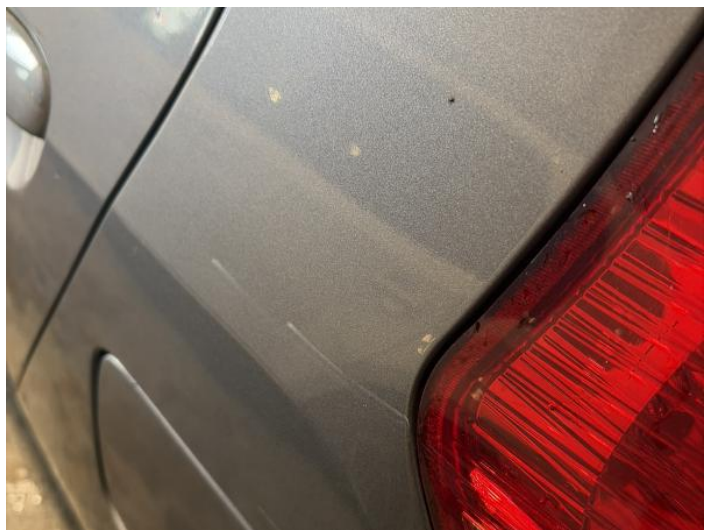
8: Qtr Panel nsr
Scratched
Over 25mm Thru Paint

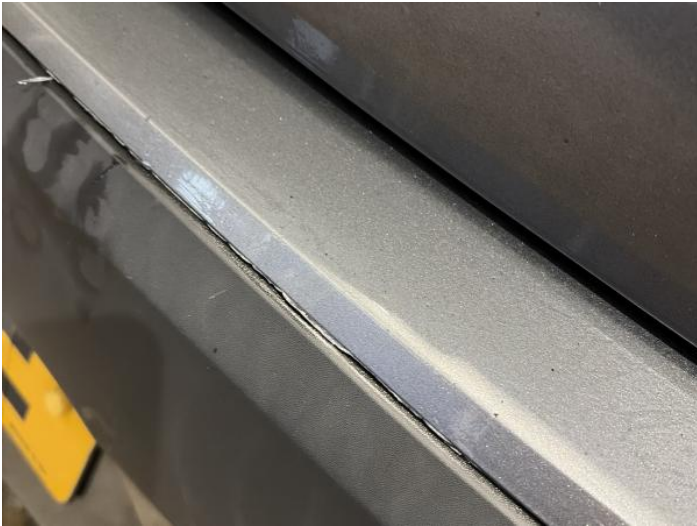
9: Bumper Rear
Poor Previous Repair
Poor Paint

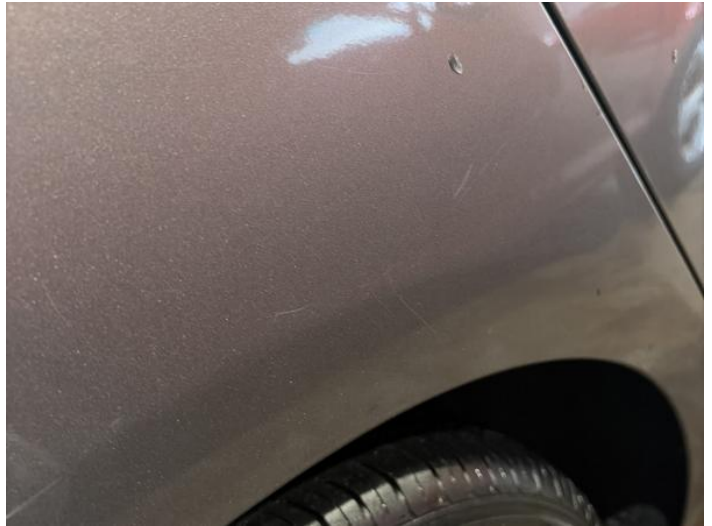
10: Qtr Panel osr
Scratched
Over 25mm Thru Paint

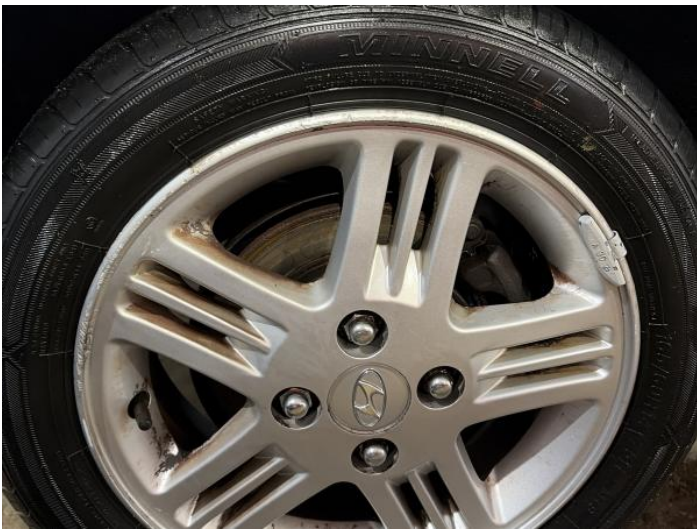
11: Wheel osr
Scratched
Over 50mm

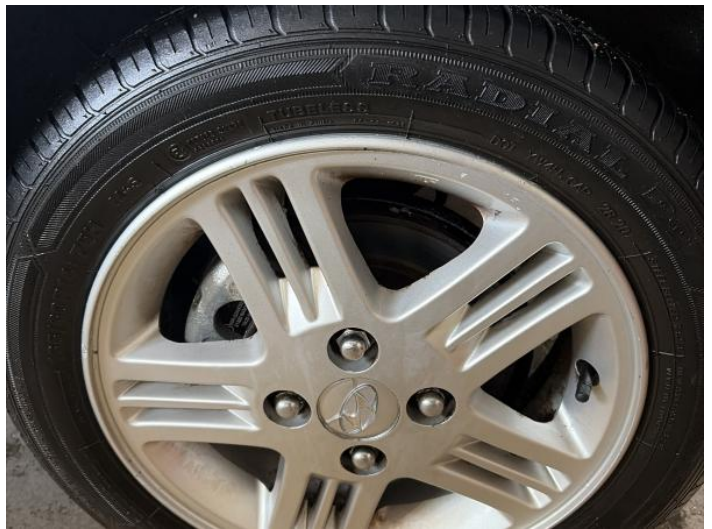
12: Wheel nsr
Scratched
Up To 50mm

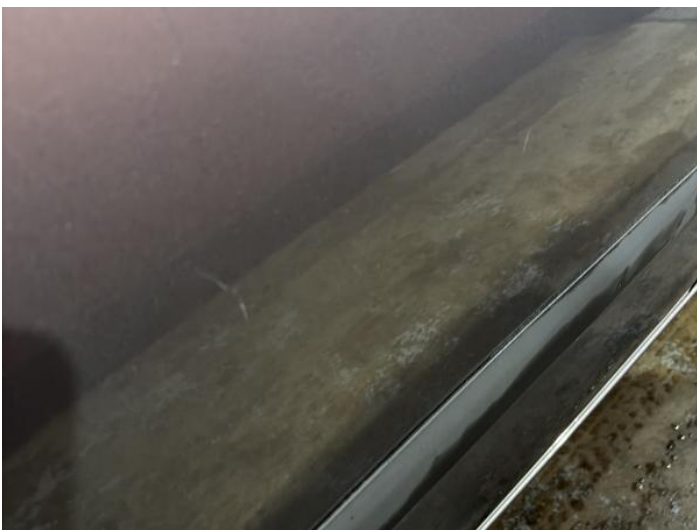
13: Door osr
Scratched
Over 25mm Thru Paint

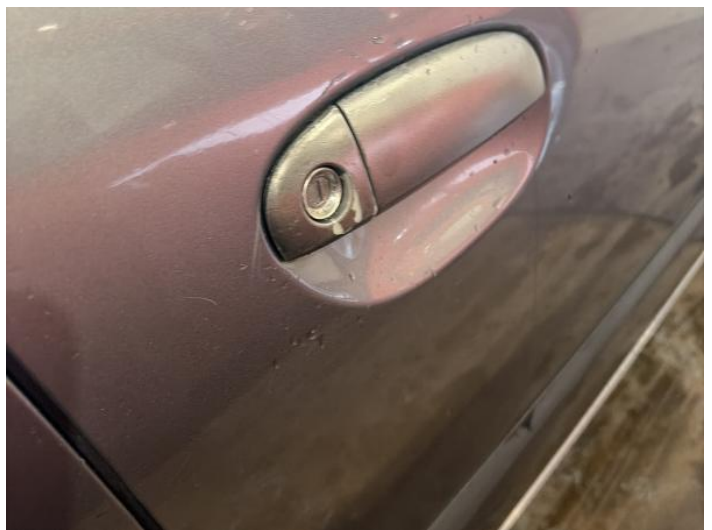
14: Door osf
Scratched
Over 25mm Thru Paint

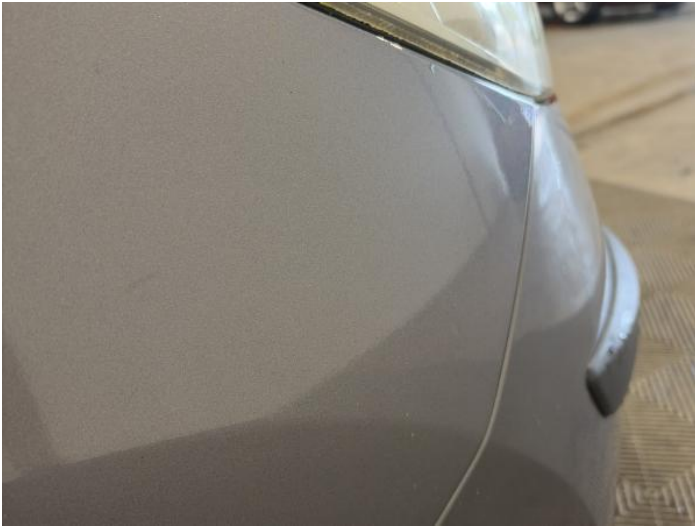
15: Wing of
Chipped
1 To 5

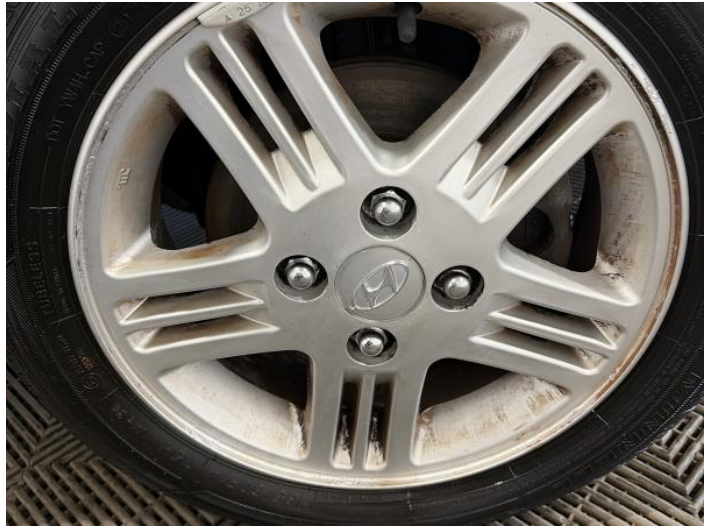
16: Wheel of
Scratched
Over 50mm

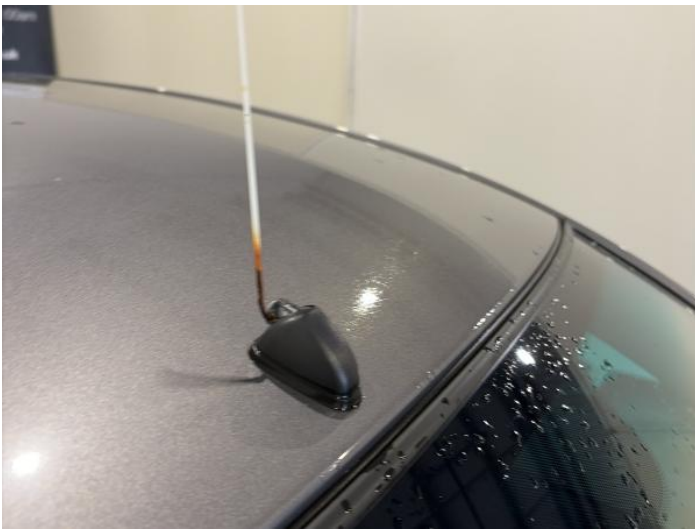
17: Aerial
Broken
Replace
