VEHICLE INSPECTION REPORT

YP08UDV

Ford Mondeo 2.3 Zetec 5dr Auto

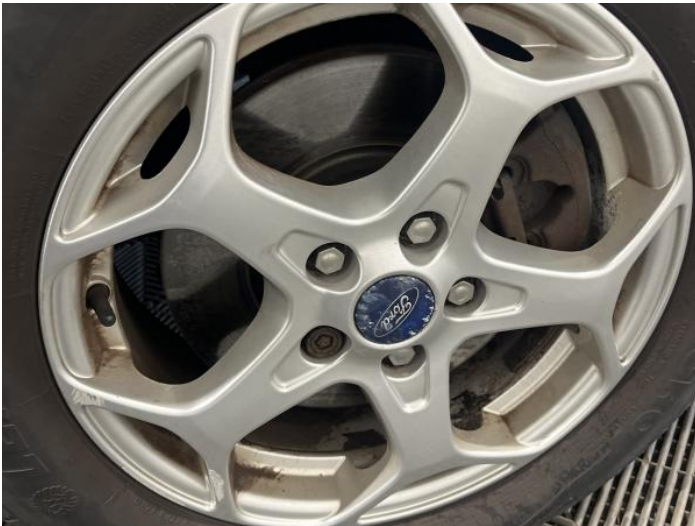
1: Wheel of
Scratched
Up To 50mm

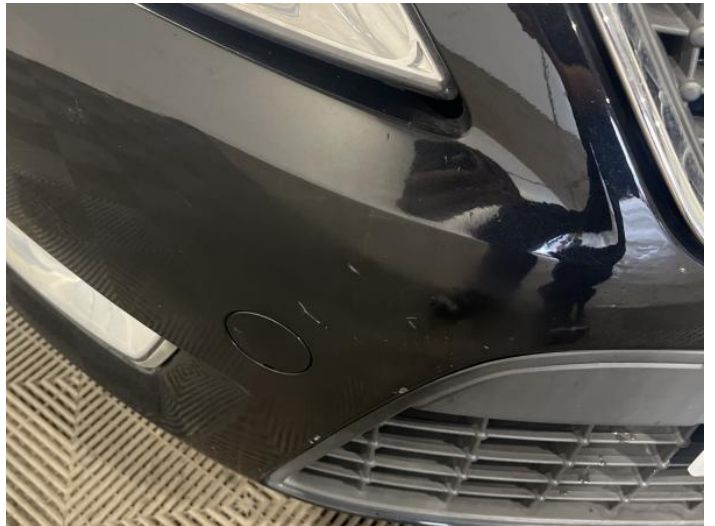
2: Bumper Front
Scratched
25 to 100mm Thru Paint

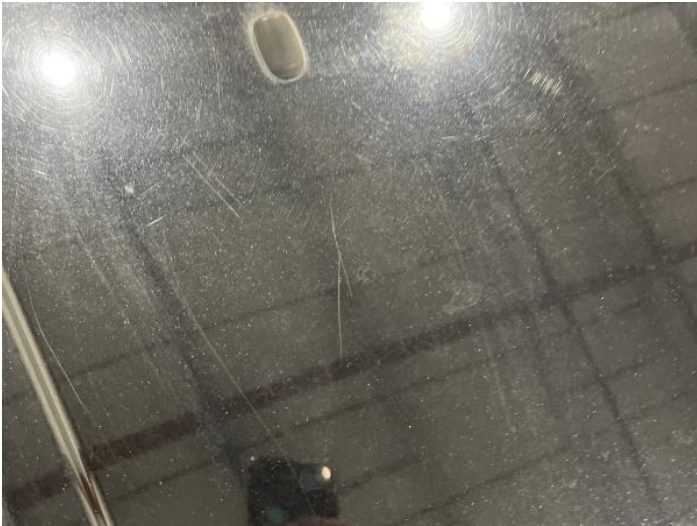
3: Bonnet
Scratched
Over 25mm Thru Paint

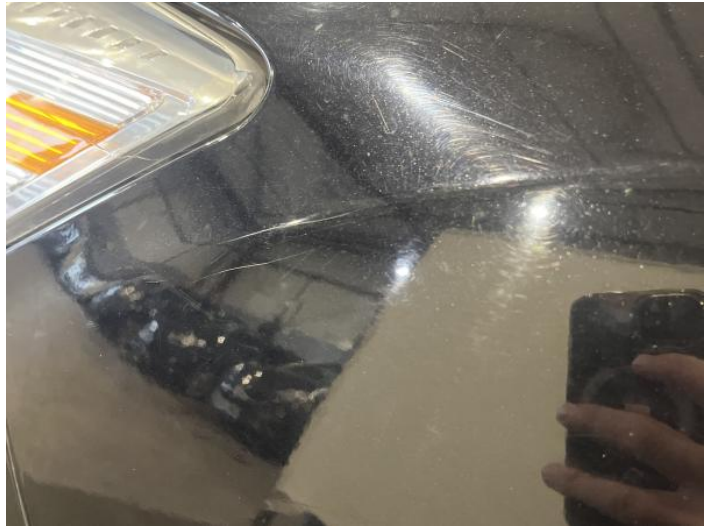
4: Wing nsf
Scratched
Over 25mm Thru Paint

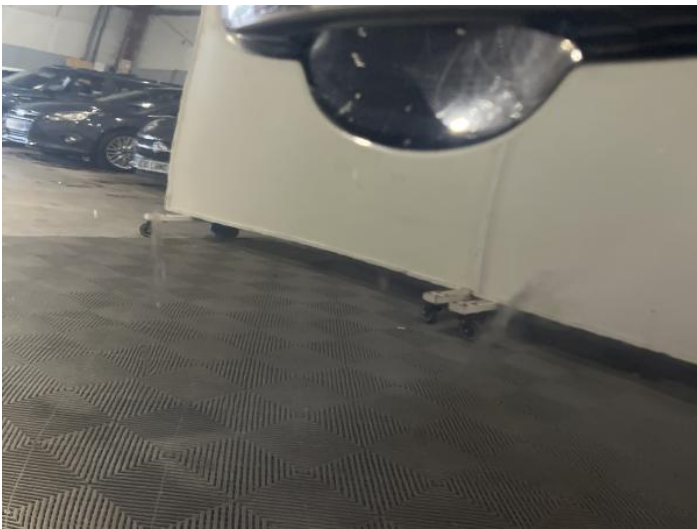
5: Door nsf
Scratched
Over 25mm Thru Paint

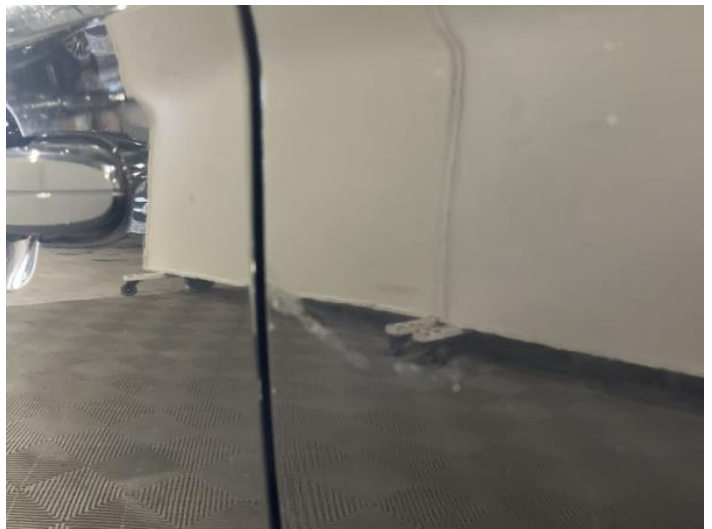
6: Door nsr
Scratched
Over 25mm Thru Paint

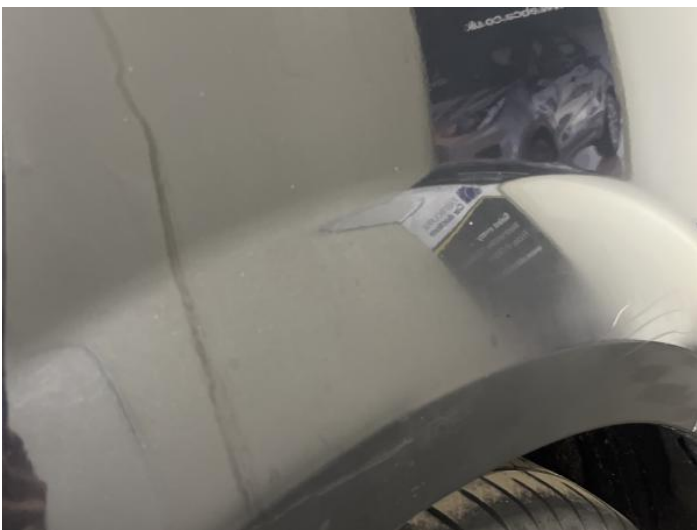
7: Qtr Panel nsr
Poor Previous Repair
Poor Paint

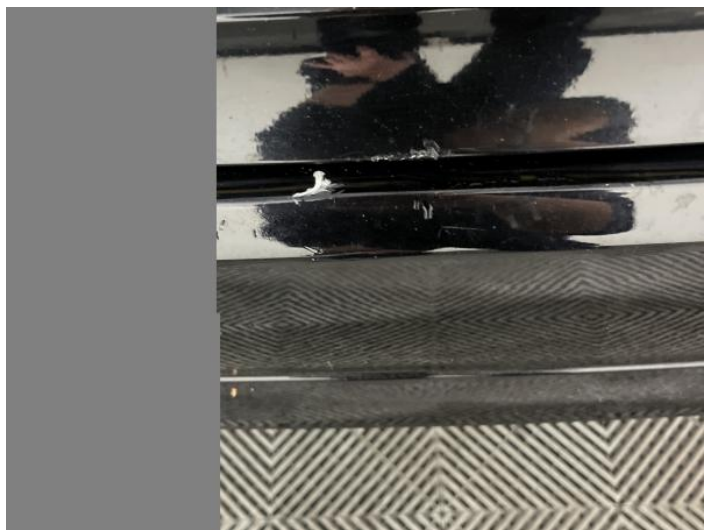
8: Bumper Rear
Scratched
25 to 100mm Thru Paint

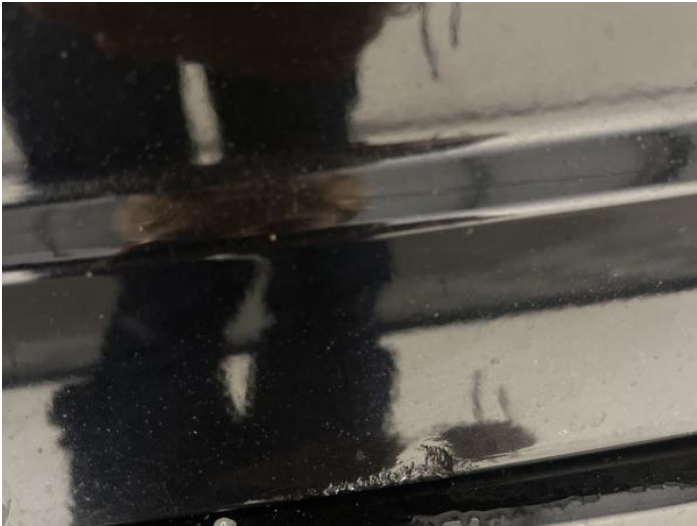
9: Tailgate
Dented
Over 30mm

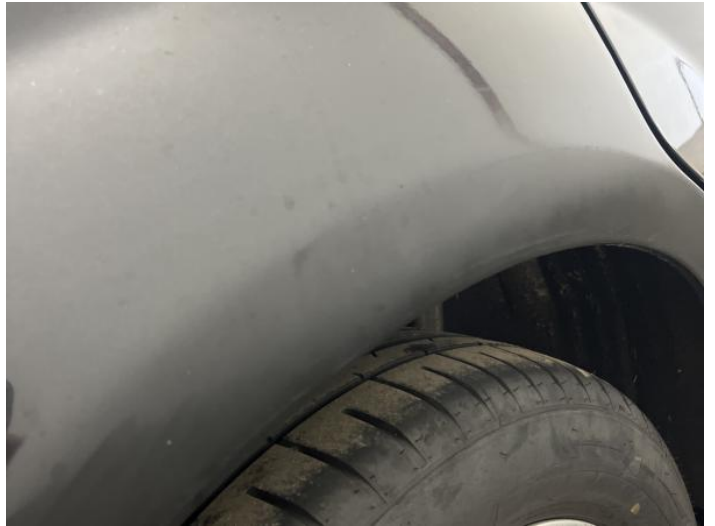
10: Qtr Panel osr
Poor Previous Repair
Poor Paint

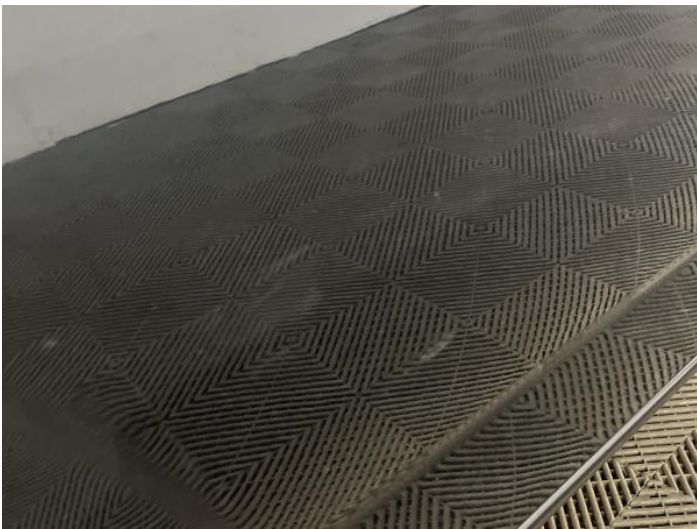
11: Door osr
Scratched
Over 25mm Thru Paint

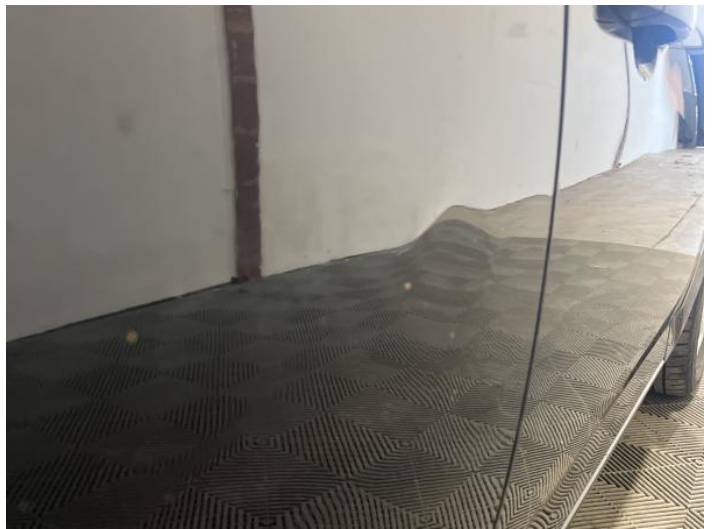
12: Door osr
Dented
Over 30mm
