# VEHICLE INSPECTION REPORT

**NU08KBJ**

## Nissan Micra 1.2 Acenta 5dr

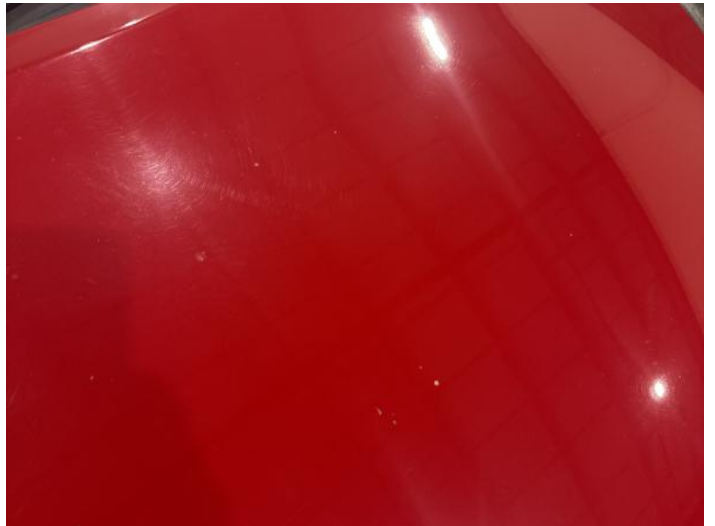
2: Bonnet  
Chipped  
Multiple Chips

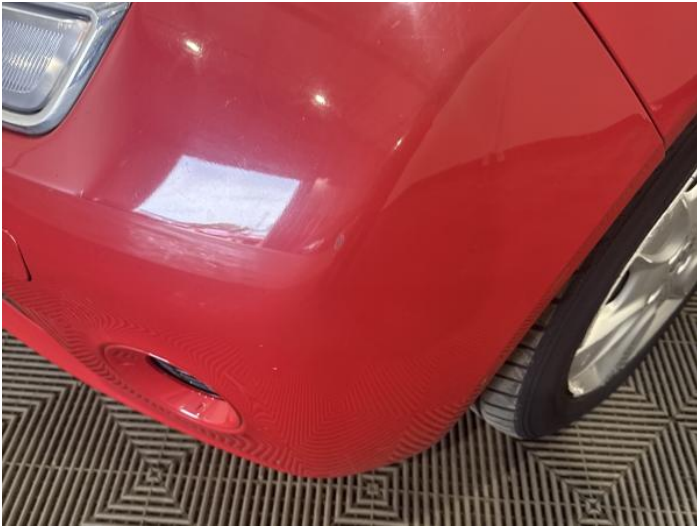
3: Bumper Front  
Scratched  
25 to 100mm Thru Paint

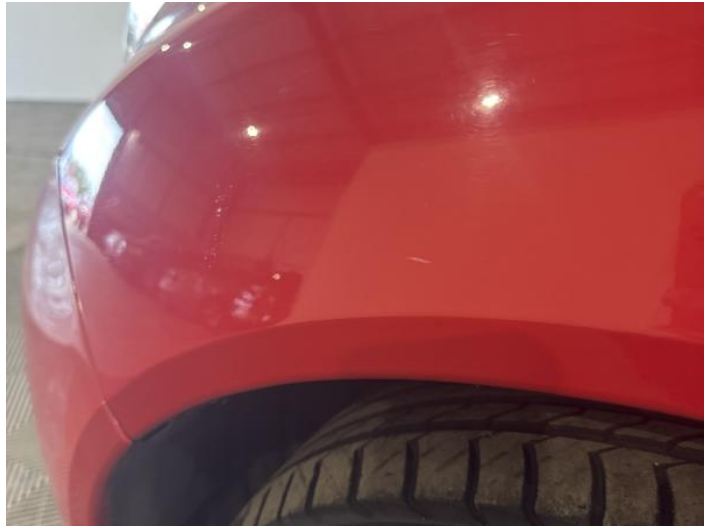
4: Wing nsf  
Scratched  
UpTo 25mm Thru Paint

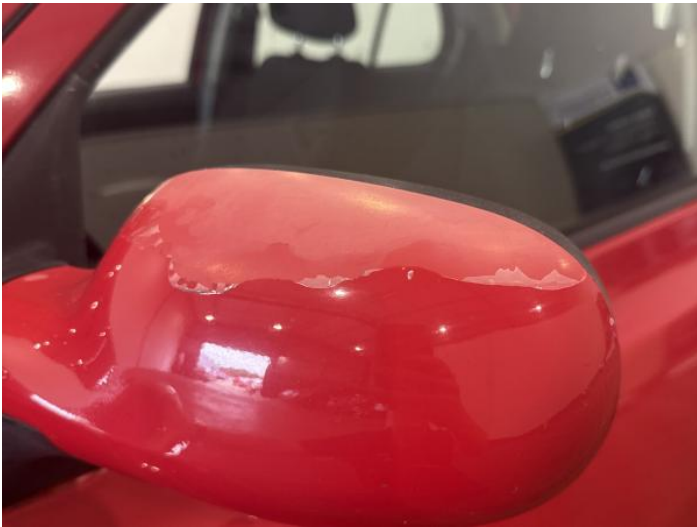
5: Door Mirror Assy nsf  
Scratched (Painted)  
Over 25mm Thru Paint

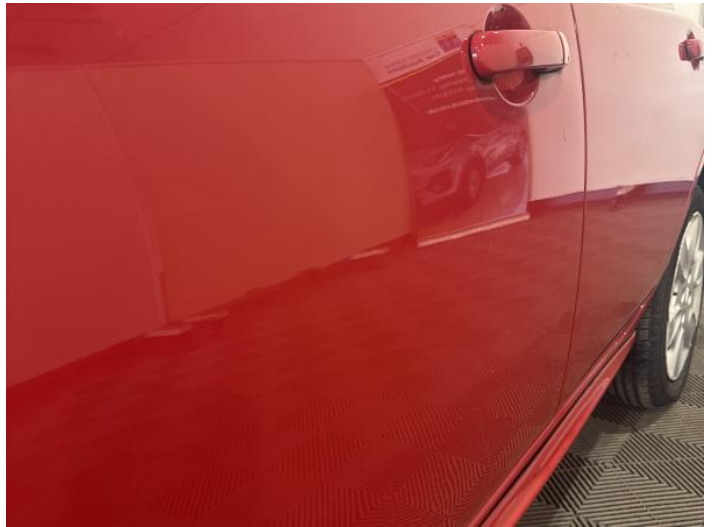
6: Door nsf  
Dented  
With Paint Damage

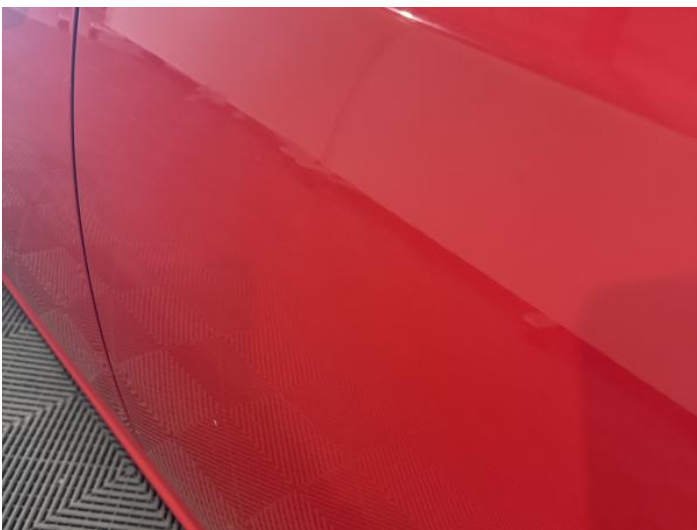
7: Door nsr  
Dented  
With Paint Damage

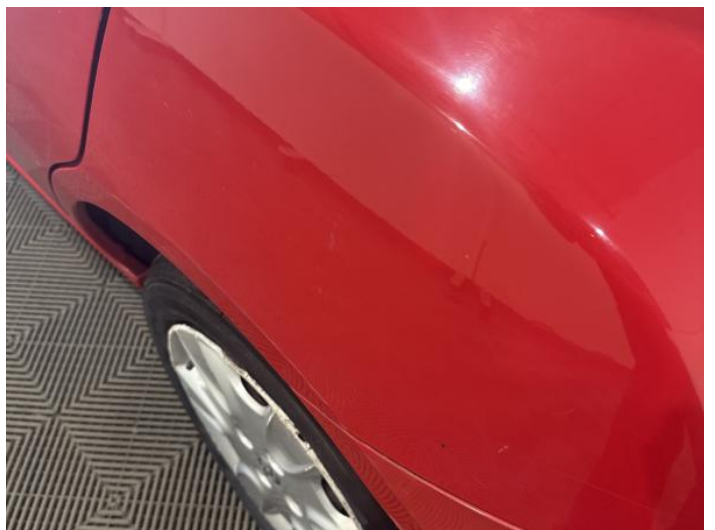
8: Qtr Panel nsr  
Dented  
With Paint Damage

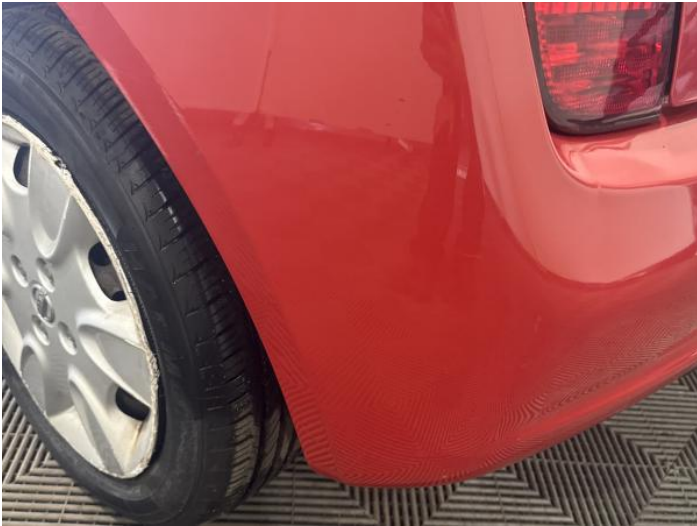
9: Bumper Rear  
Scratched  
Over 100mm Thru Paint

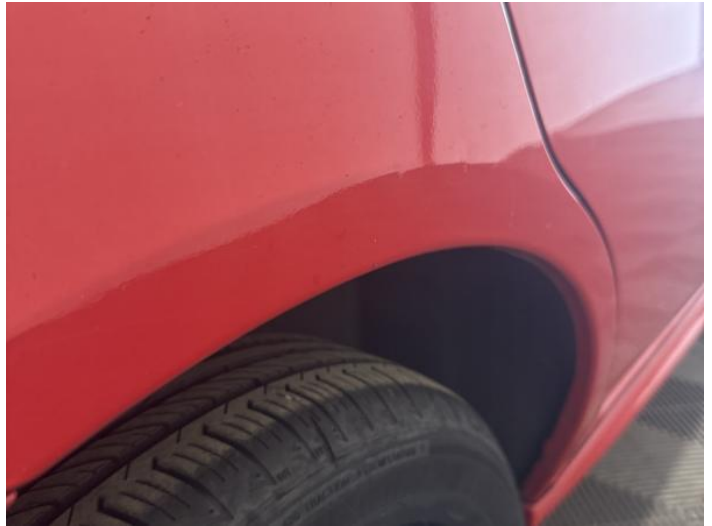
10: Qtr Panel osr  
Dented  
Over 30mm

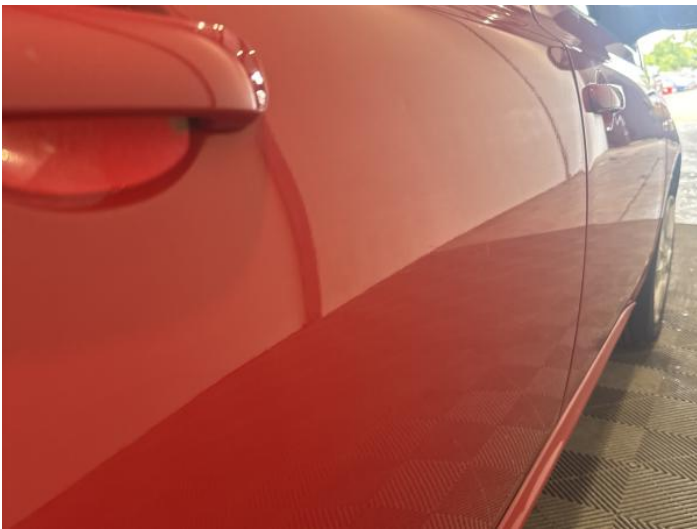
11: Door osr  
Dented  
Between 10mm + 30mm

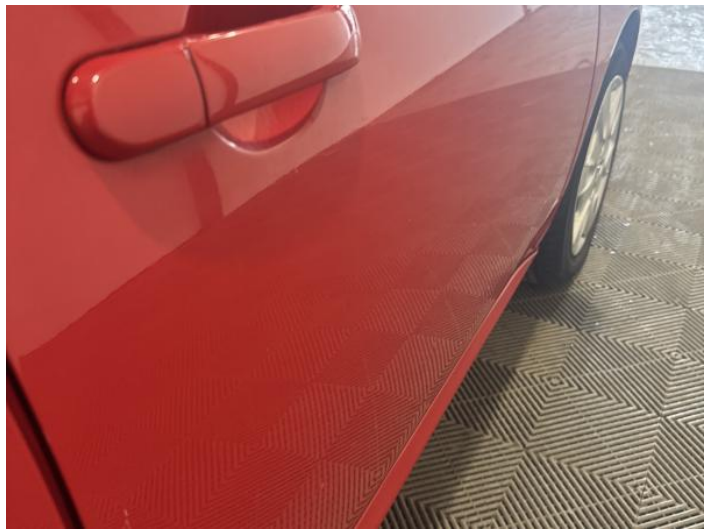
12: Door osf  
Dented  
Over 30mm

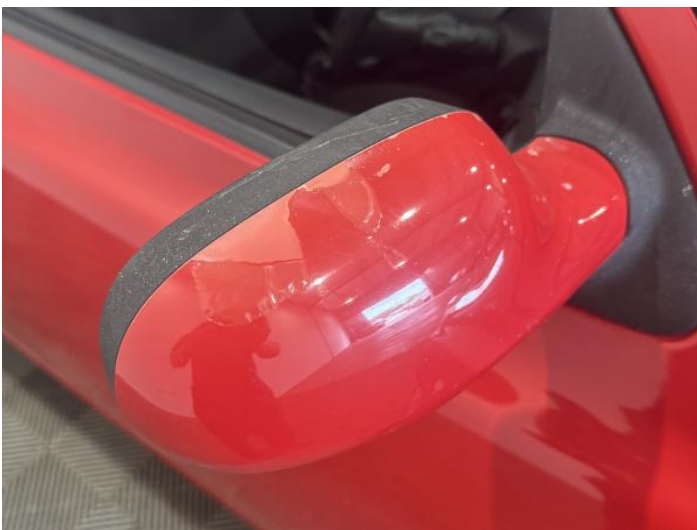
13: Door Mirror Assy osf  
Scratched (Painted)  
Over 25mm Thru Paint

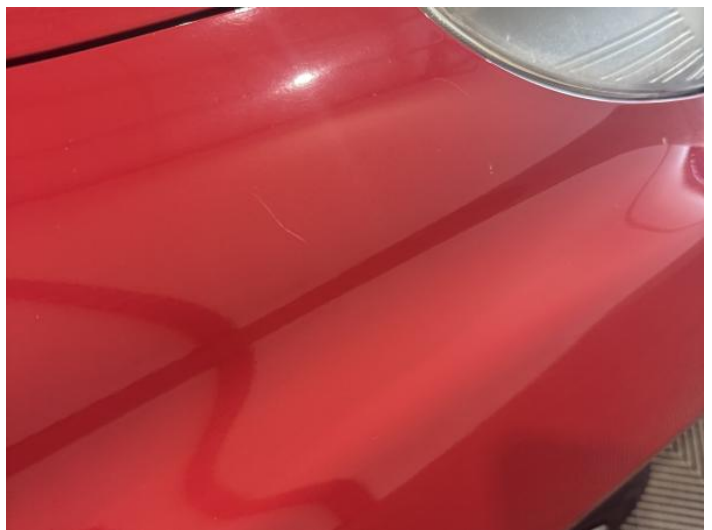
14: Wing osf  
Scratched  
Over 25mm Thru Paint

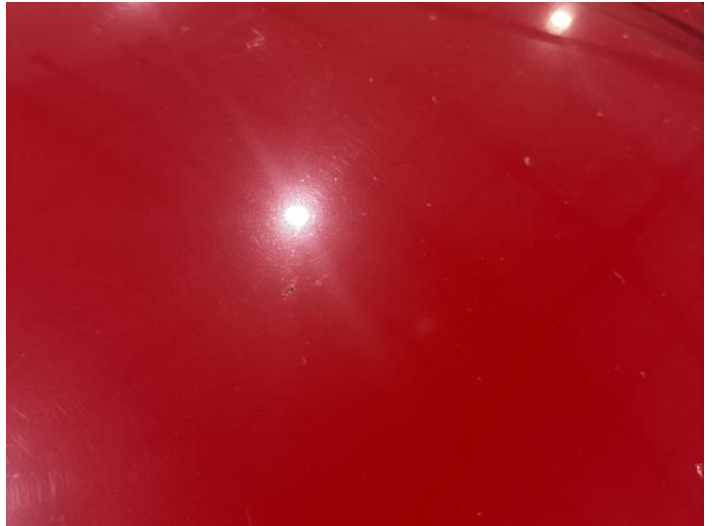
16: Roof  
Chipped  
Multiple Chips

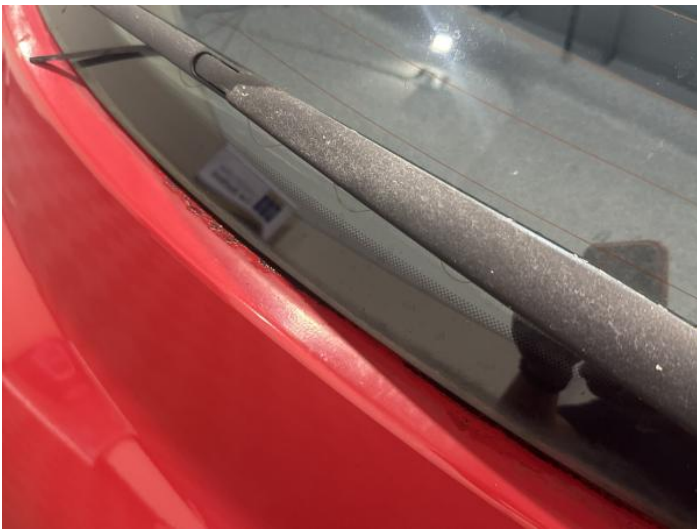
17: Wiper Rear  
Broken  
Replace

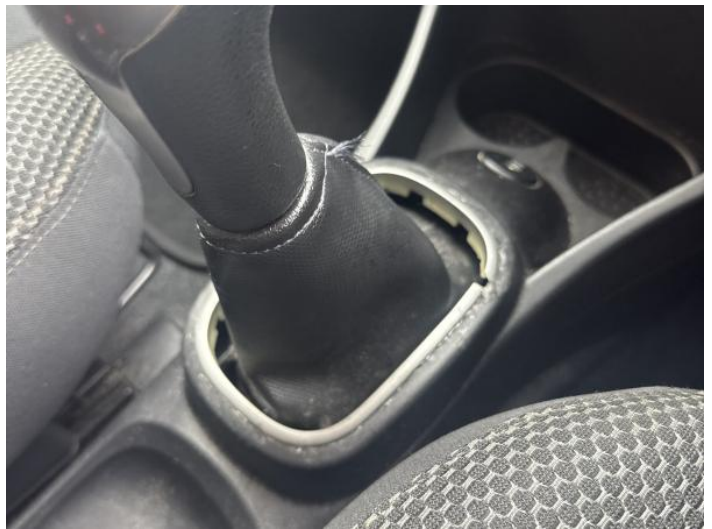
18: Switches And Controls  
Broken  
Replace
