**LH09AUC**

# VEHICLE INSPECTION REPORT

## Nissan Note 1.6 Tekna 5dr Auto

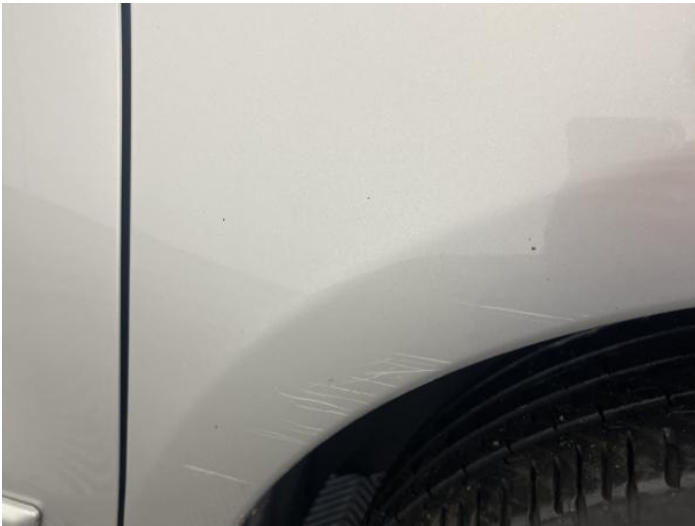
1: Wing of  
Scratched  
Over 25mm Thru Paint

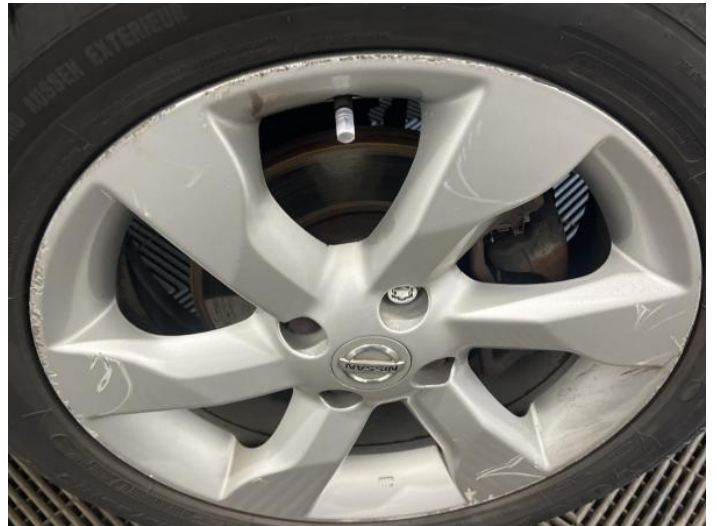
2: Wheel of  
Scratched  
Over 50mm

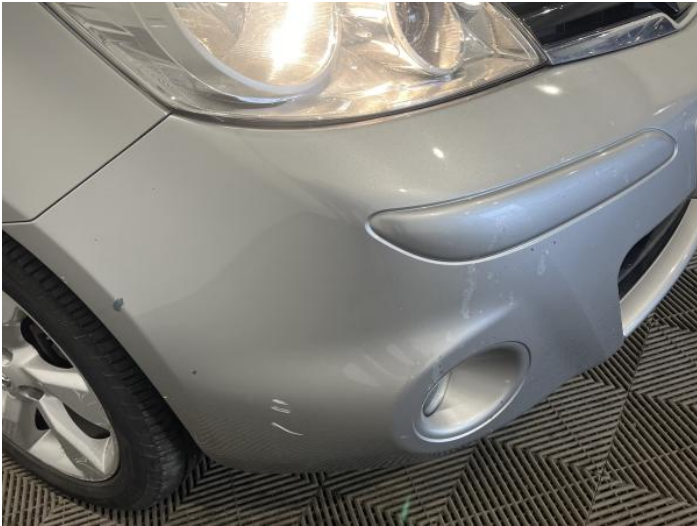
3: Bumper Front  
Scratched  
Over 100mm Thru Paint

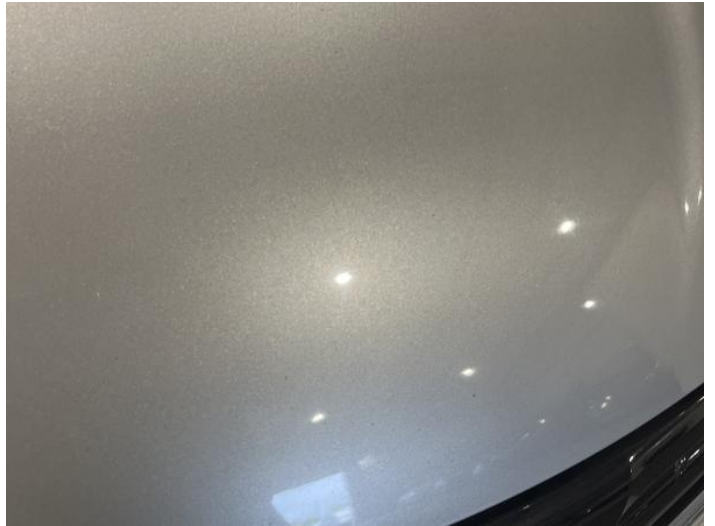
4: Bonnet  
Chipped  
Multiple Chips

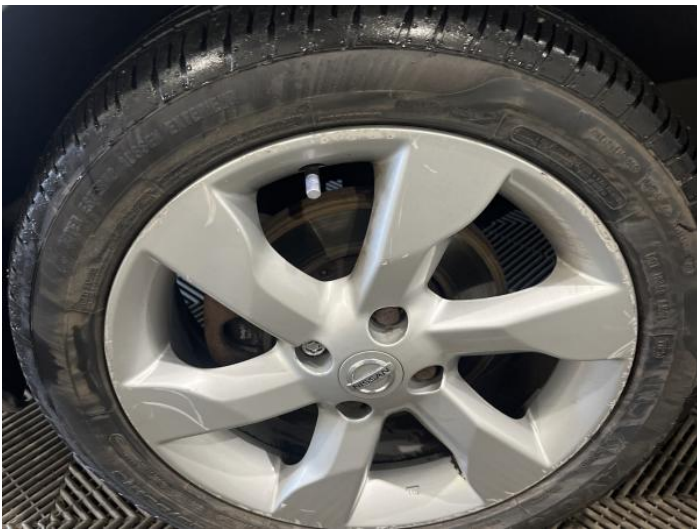
5: Wheel nsf  
Scratched  
Over 50mm

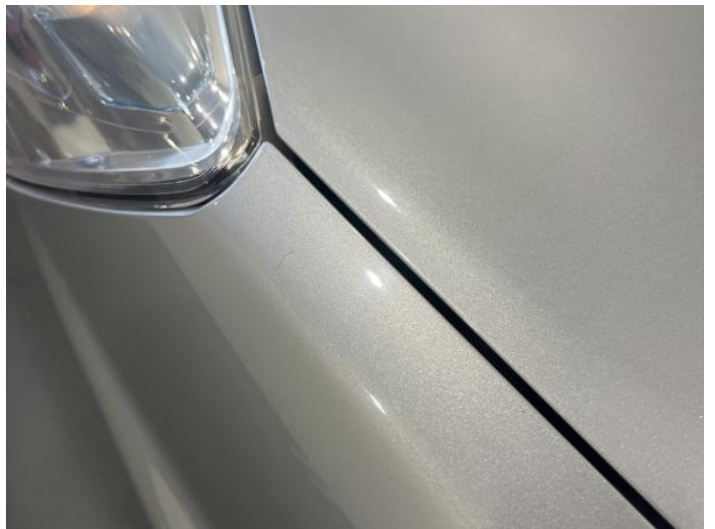
6: Wing nsf  
Scratched  
UpTo 25mm Thru Paint

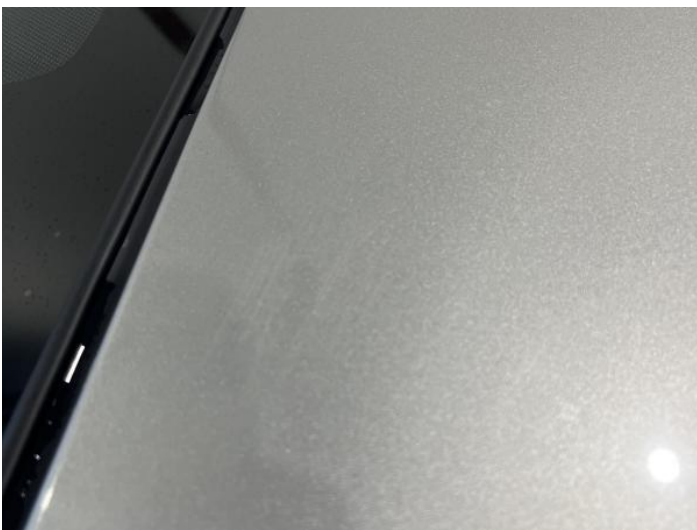
7: Roof  
Scratched  
Over 25mm Thru Paint

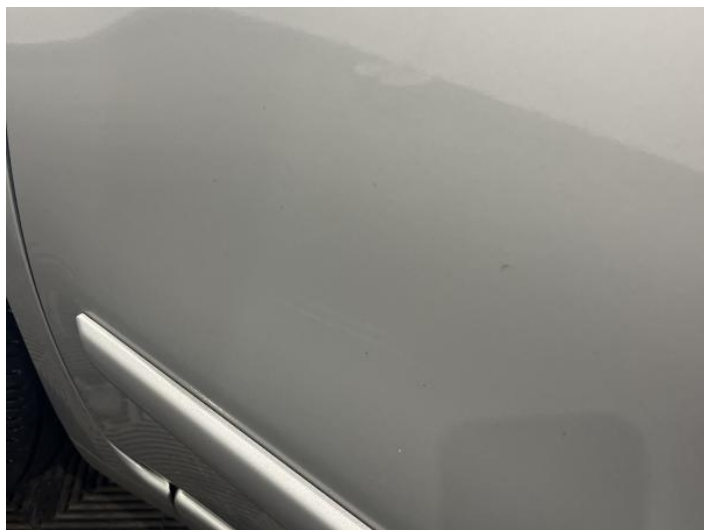
8: Door nsf  
Scratched  
Over 25mm Thru Paint

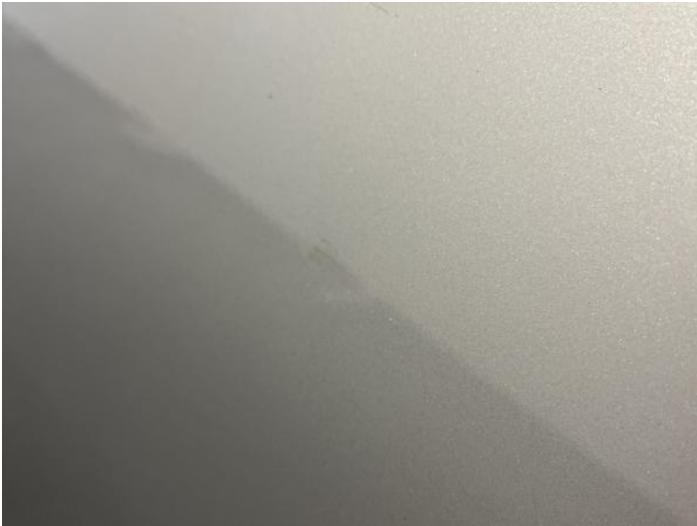
9: Door nsr  
Dented  
2 Or Less UpTo 10mm

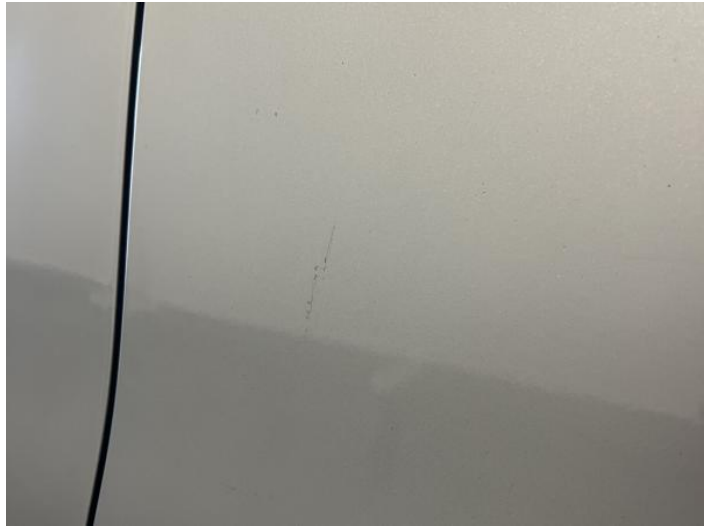
10: Door nsr  
Scratched  
Over 25mm Thru Paint

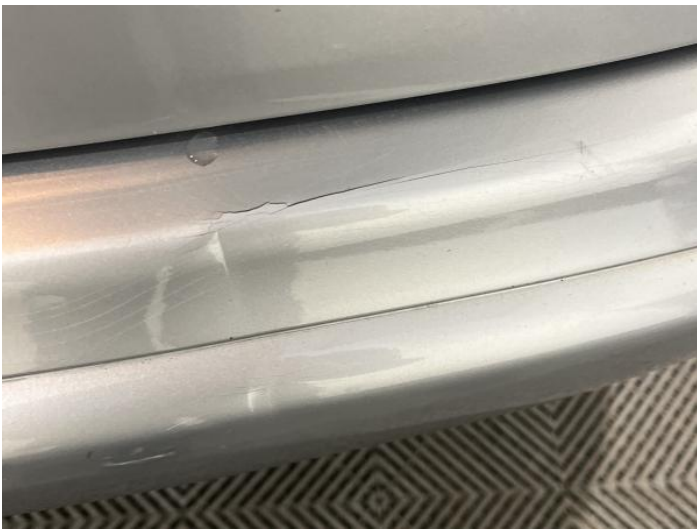
11: Bumper Rear  
Dented  
With Paint Damage

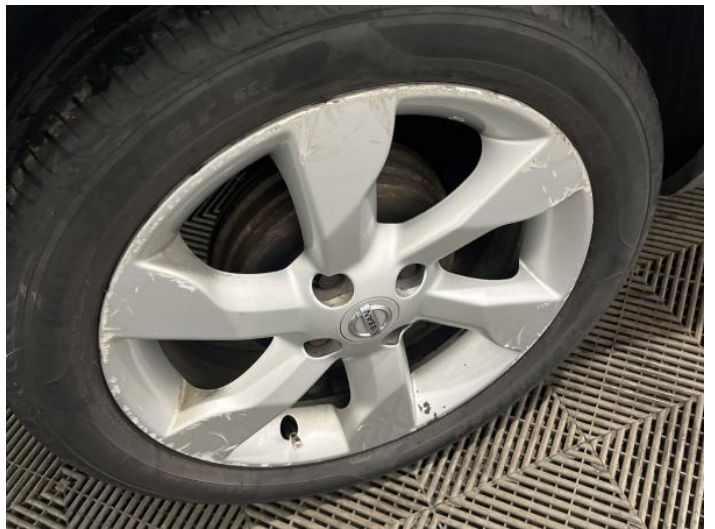
12: Wheel osr  
Scratched  
Over 50mm

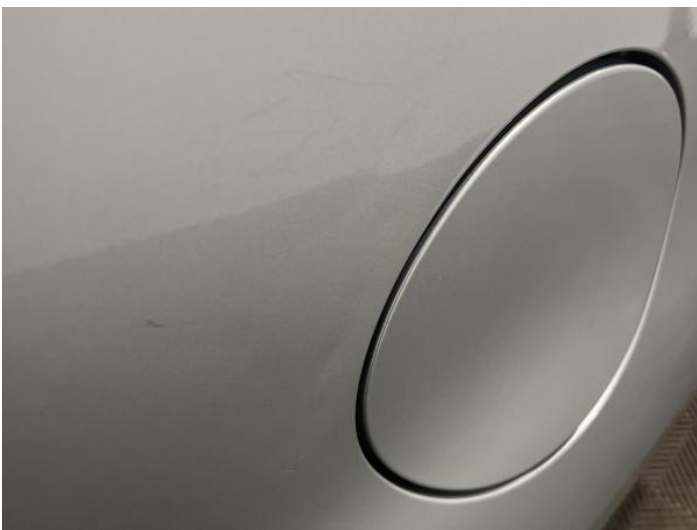
13: Qtr Panel osr  
Poor Previous Repair  
Rippled UpTo 30%

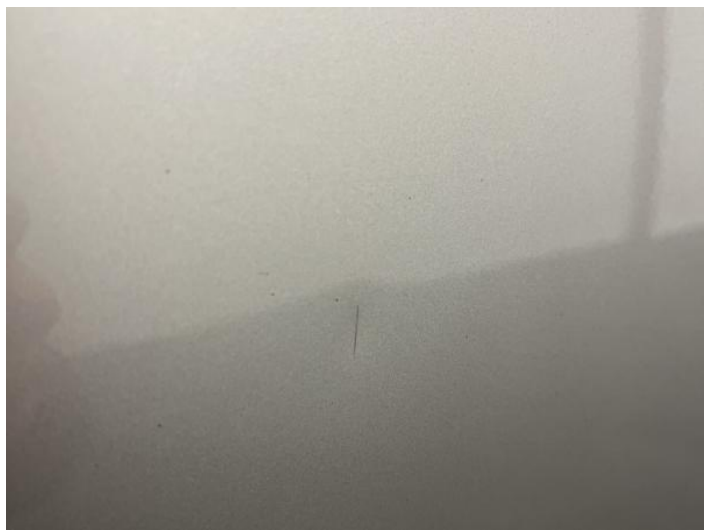
14: Door osr  
Dented  
Over 30mm

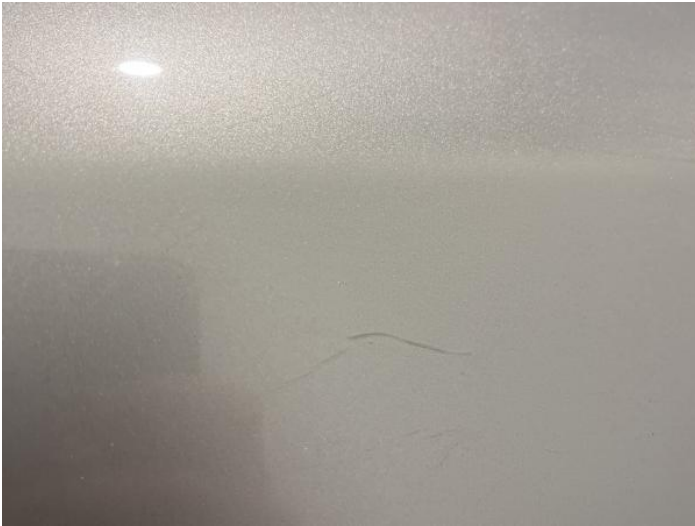
15: Door osr  
 Scratched  
 Over 25mm Thru Paint

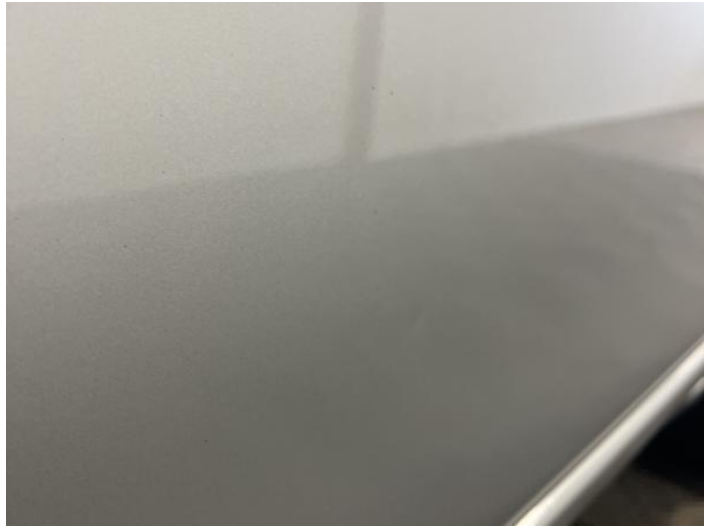
16: Door osf  
 Dented  
 Between 10mm + 30mm
