VEHICLE INSPECTION REPORT

NU16DYX

Nissan Qashqai 1.6 dCi Tekna 5dr Xtronic

Non Runner Inspection

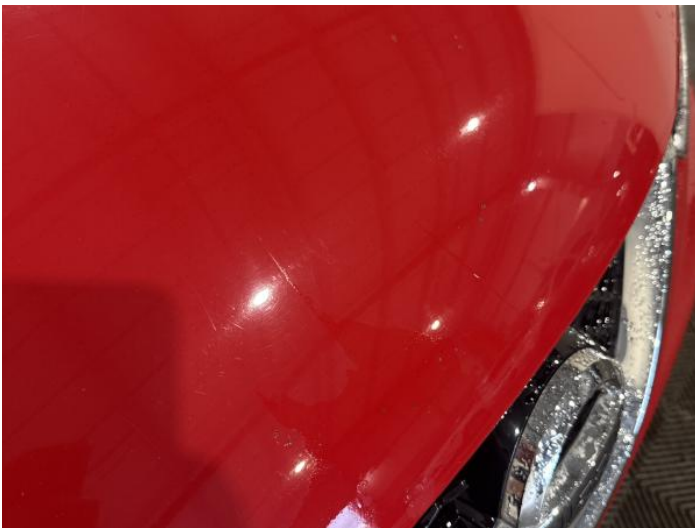
1: Bonnet
Chipped
Multiple Chips

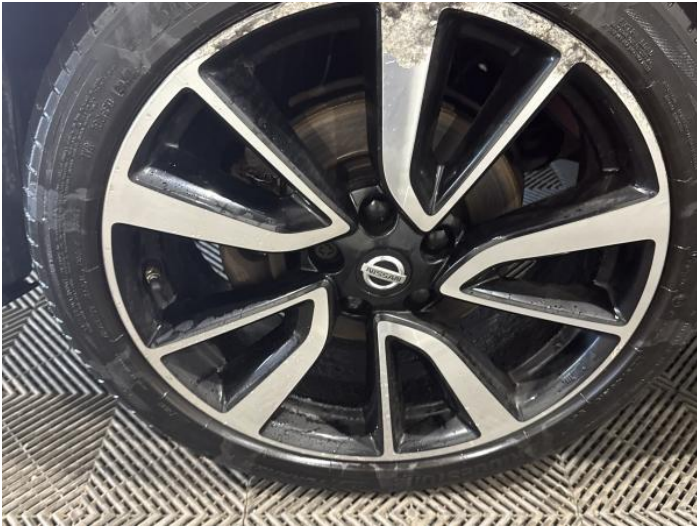
3: Wheel nsf
Scratched
Over 50mm

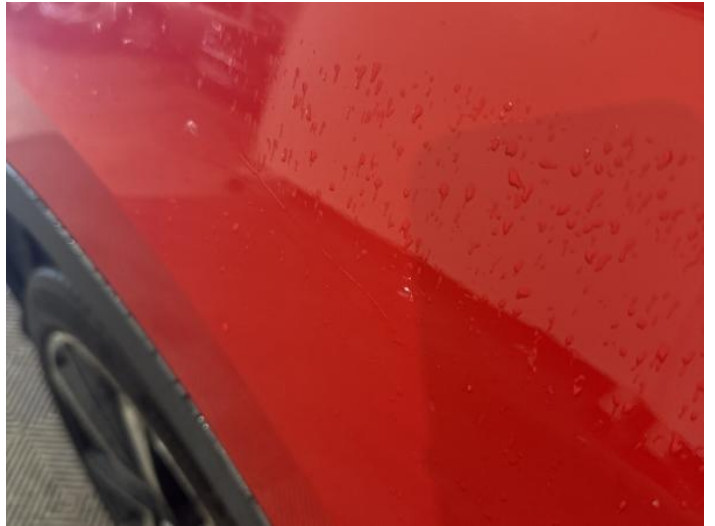
4: Wing nsf
Scratched
Over 25mm Thru Paint

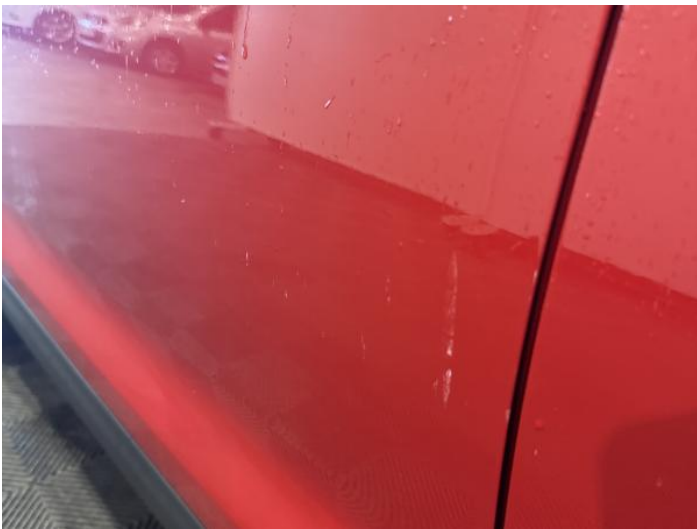
5: Door nsf
Scratched
Over 25mm Thru Paint

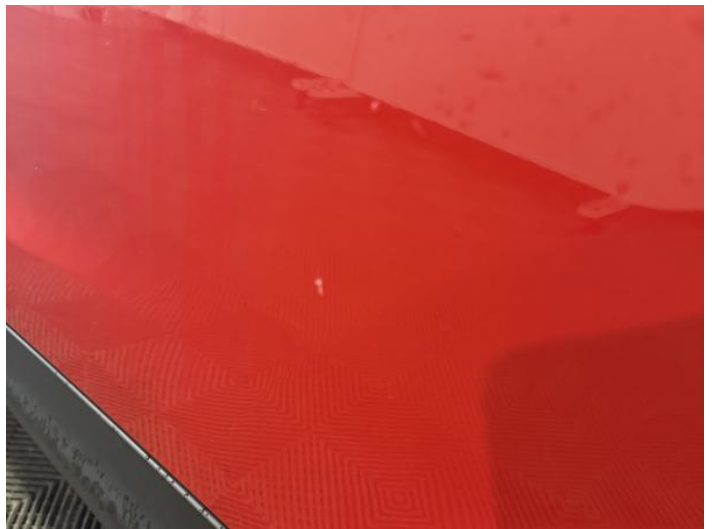
6: Door nsr
Scratched
Over 25mm Thru Paint

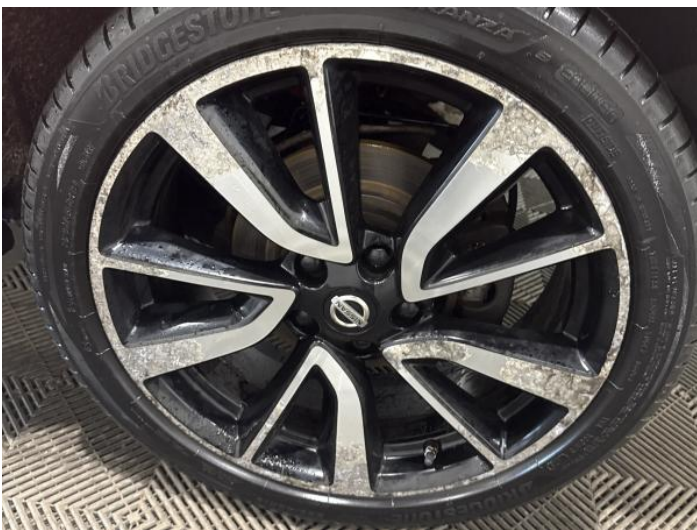
7: Wheel nsr
Scratched
Over 50mm

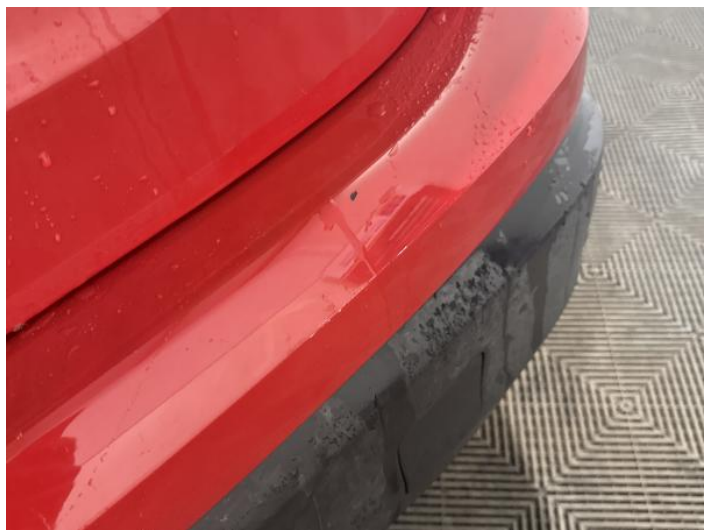
8: Bumper Rear
Scratched
25 to 100mm Thru Paint

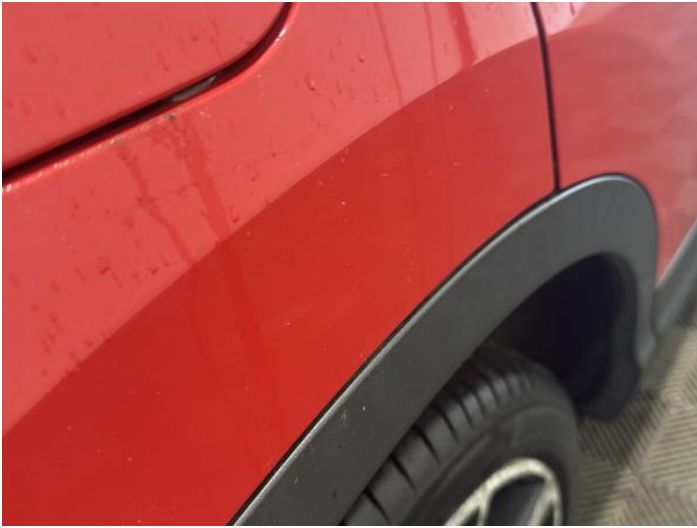
9: Qtr Panel osr
Scratched
UpTo 25mm Thru Paint

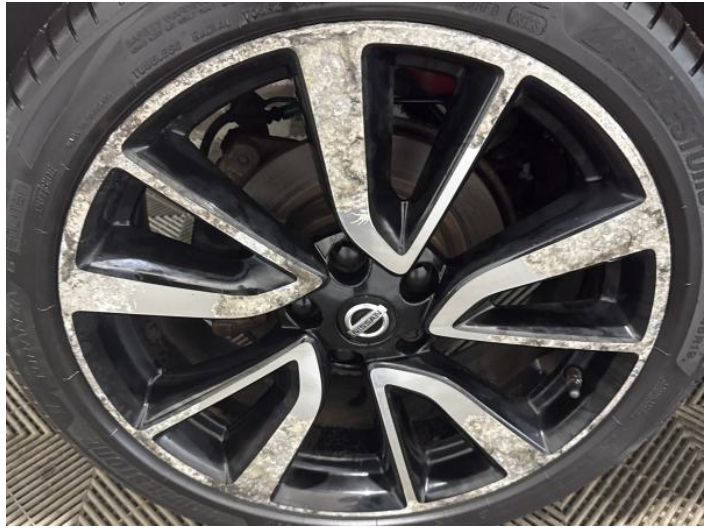
10: Wheel osr
Scratched
Over 50mm

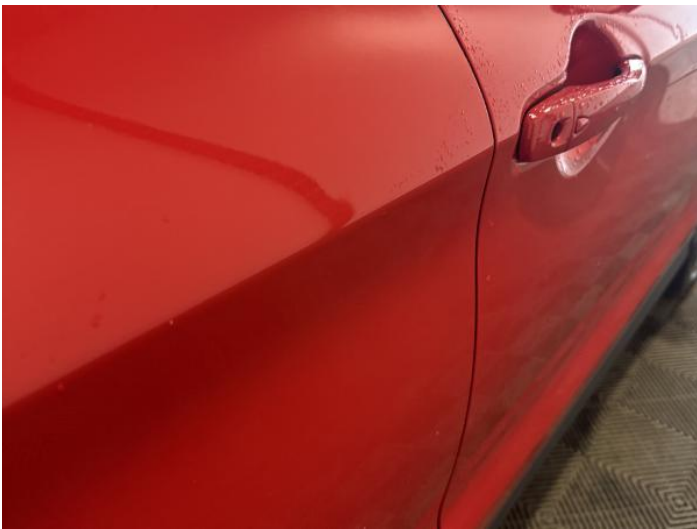
11: Door osr
Dented
Between 10mm + 30mm

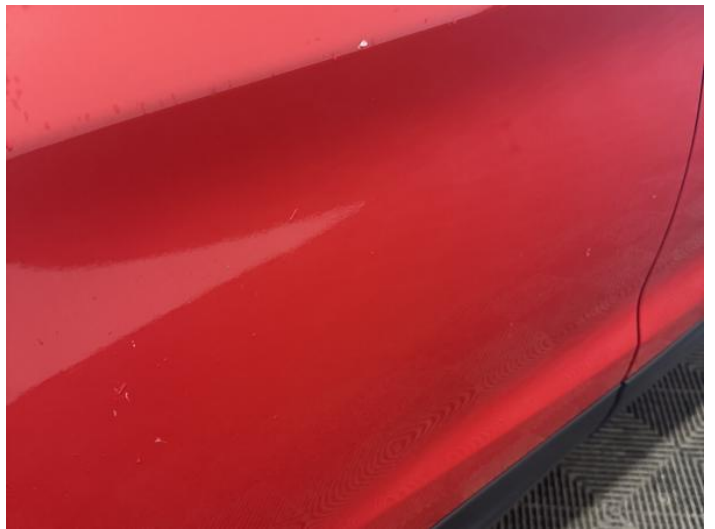
12: Door osf
Chipped
Multiple Chips

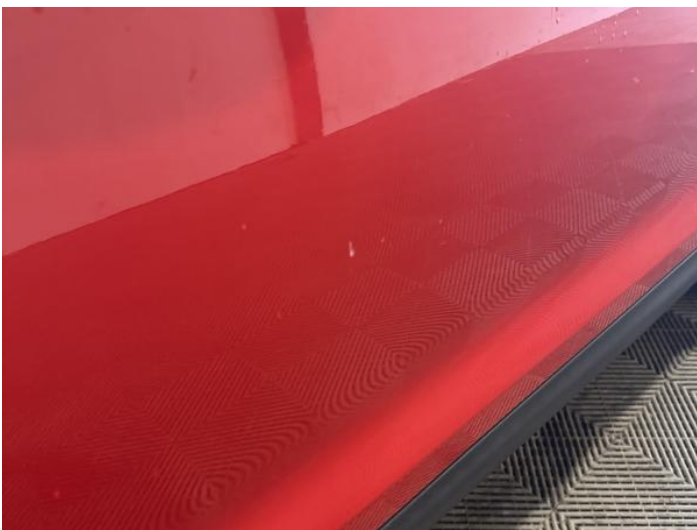
13: Door osf
Dented
Between 10mm + 30mm

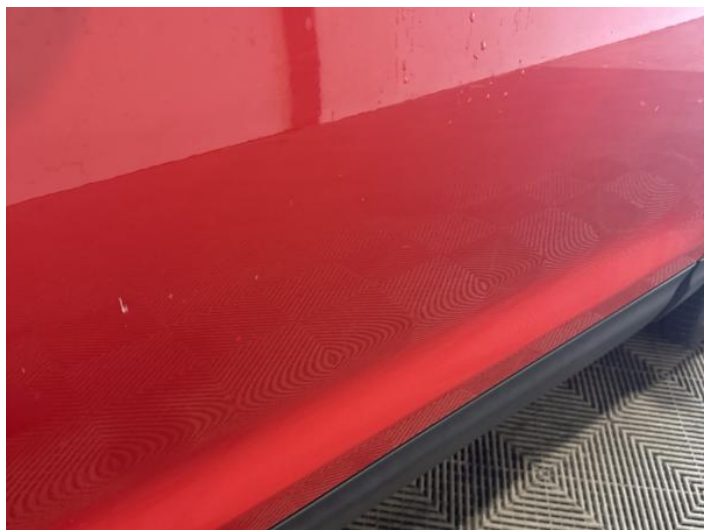
14: Door osf
Chipped
Multiple Chips

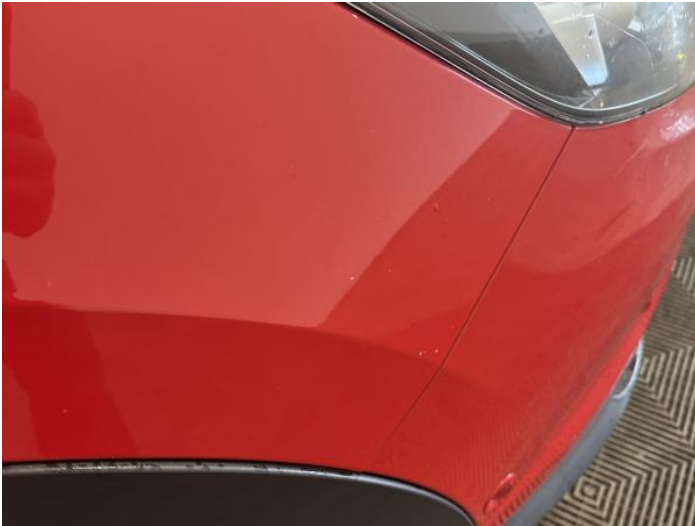
15: Wing of
Chipped
Multiple Chips

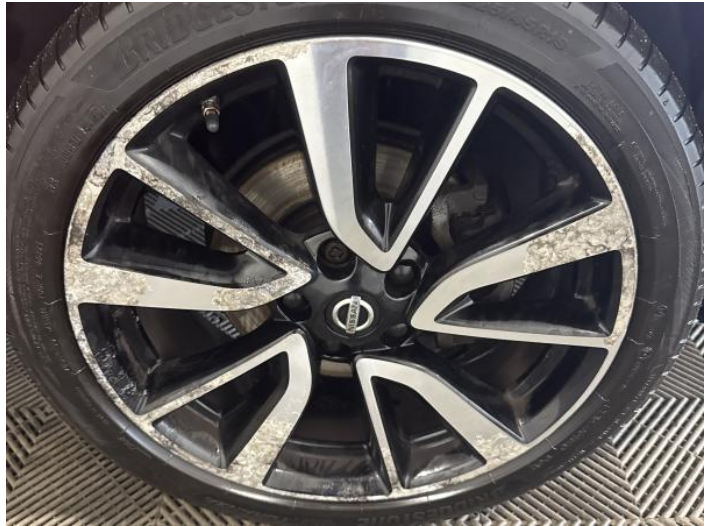
16: Wheel of
Scratched
Over 50mm
