# VEHICLE INSPECTION REPORT

**BW68NKF**

## MG Mg 3 EXCITE VTI-TECH

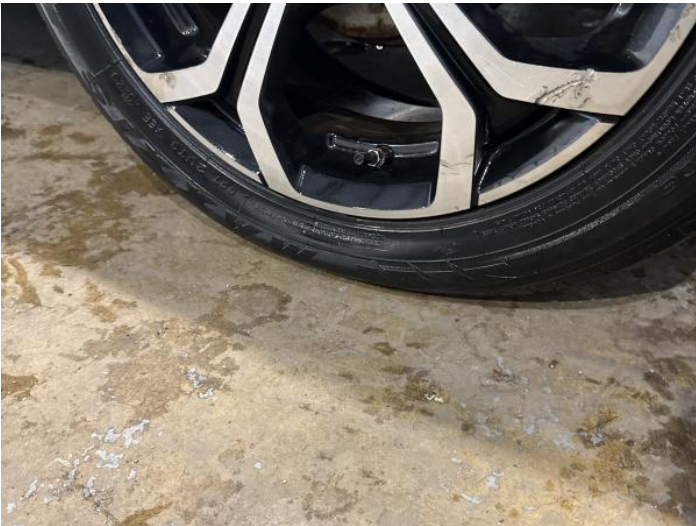
NSF	NEXEN	5.0mm
NSR	MAXXIS	Damaged
OSF	NEXEN	6.0mm
OSR	SUNNY	5.0mm
Spare

1: Tyre nsr  
Damaged  
Replace

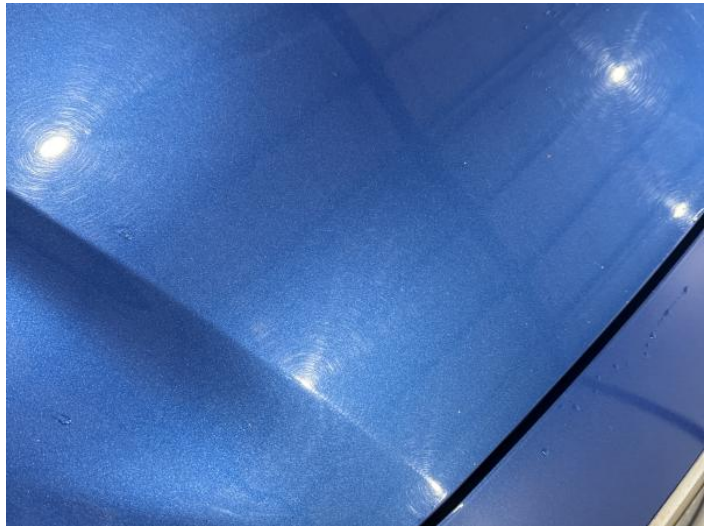
2: Bonnet  
Chipped  
Multiple Chips

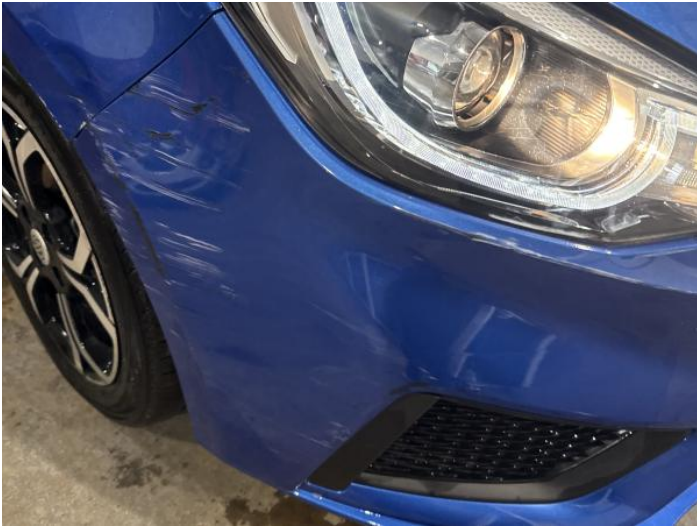
3: Bumper Front  
Scratched  
Over 100mm Thru Paint

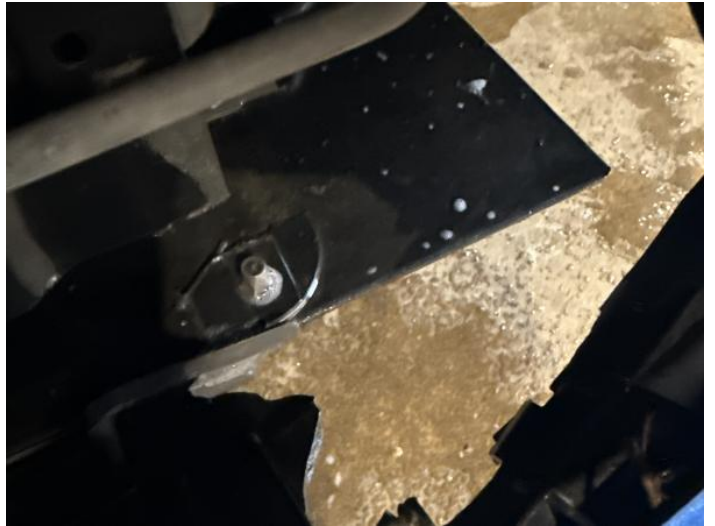
4: Bumper Front Moulding  
Broken  
Replace

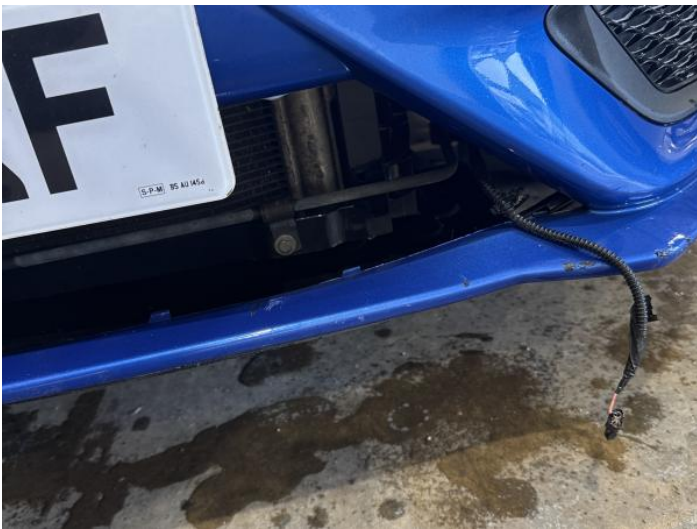
5: Bumper Front Grill  
Missing  
Replace

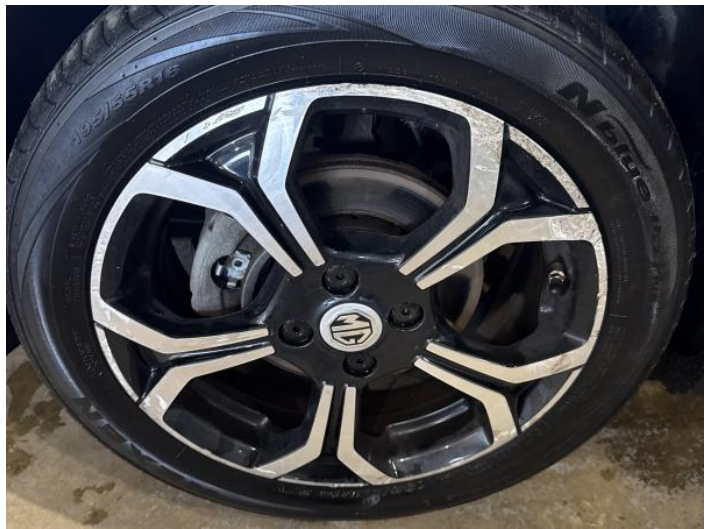
6: Wheel nsf  
Scratched  
Over 50mm

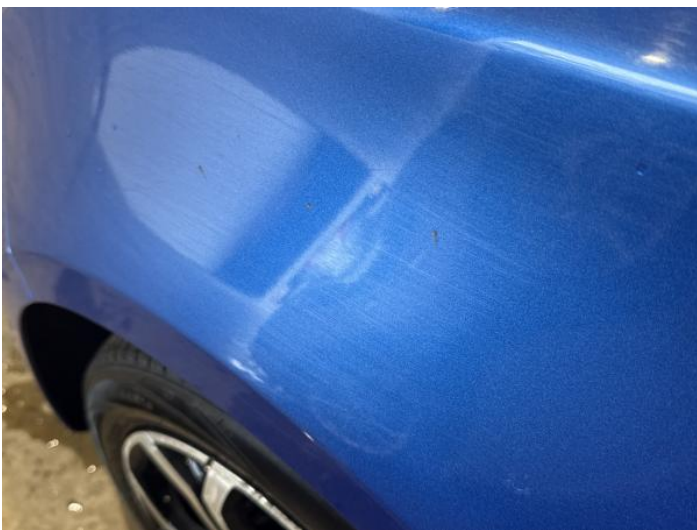
7: Wing nsf  
Chipped  
1 To 5

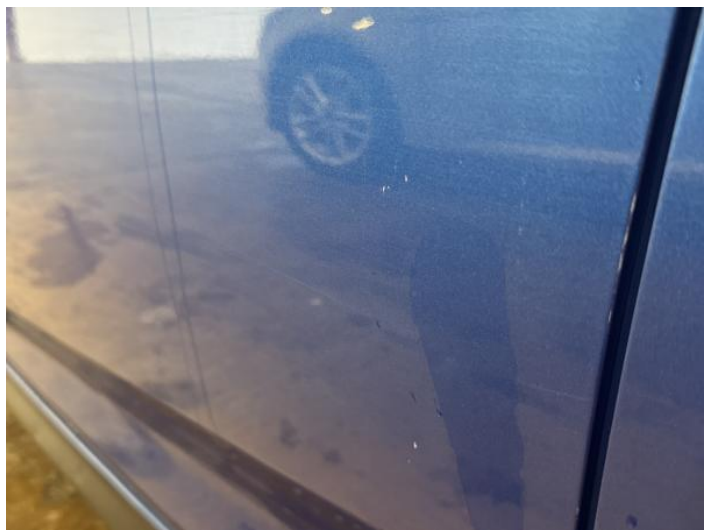
8: Door nsf  
Chipped  
1 To 5

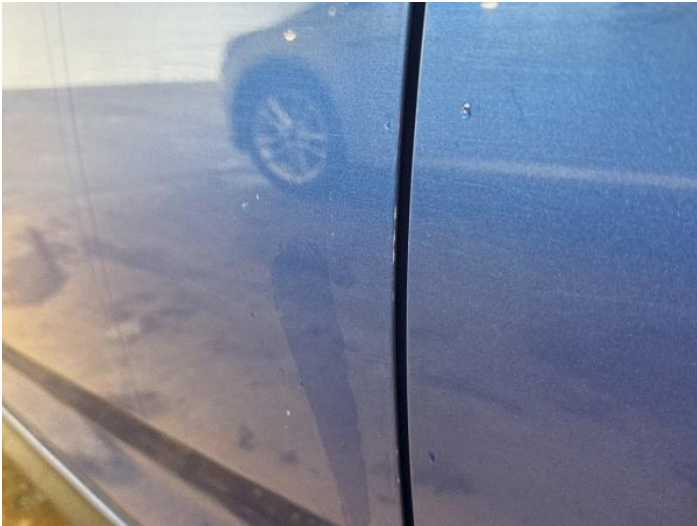
9: Door nsf  
Chipped  
Edge Chip

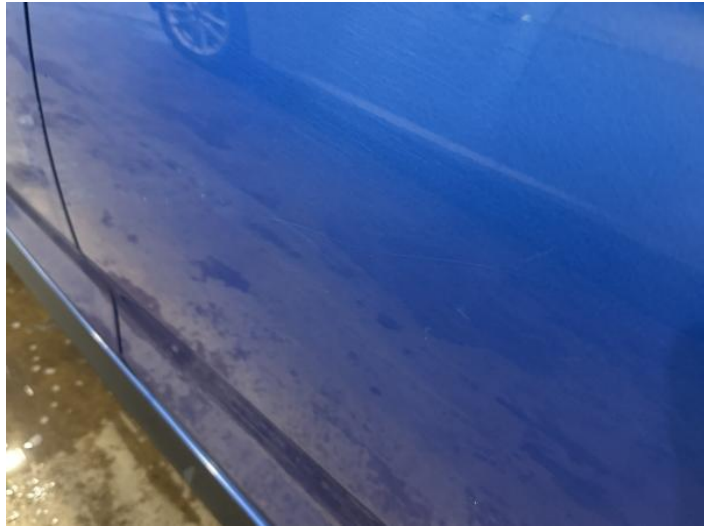
10: Door nsr  
Scratched  
Over 25mm Thru Paint

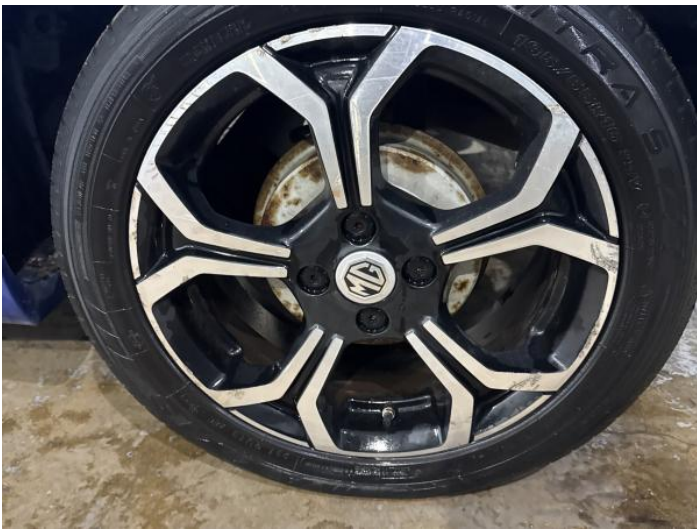
11: Wheel nsr  
Scratched  
Over 50mm

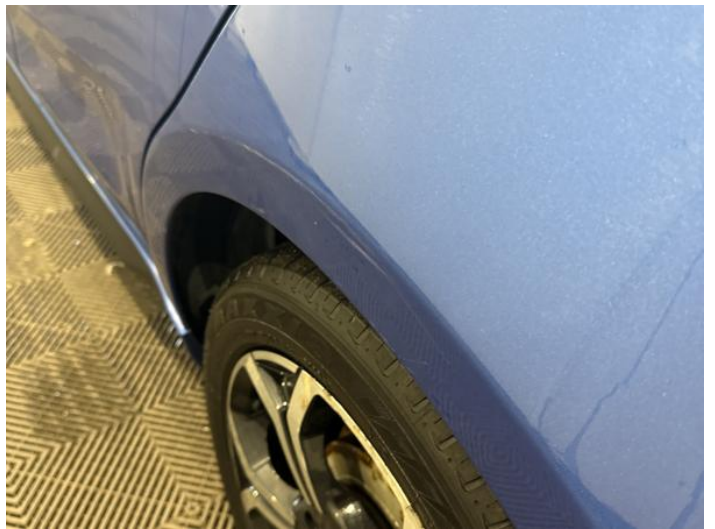
12: Qtr Panel nsr  
Scratched  
Over 25mm Thru Paint

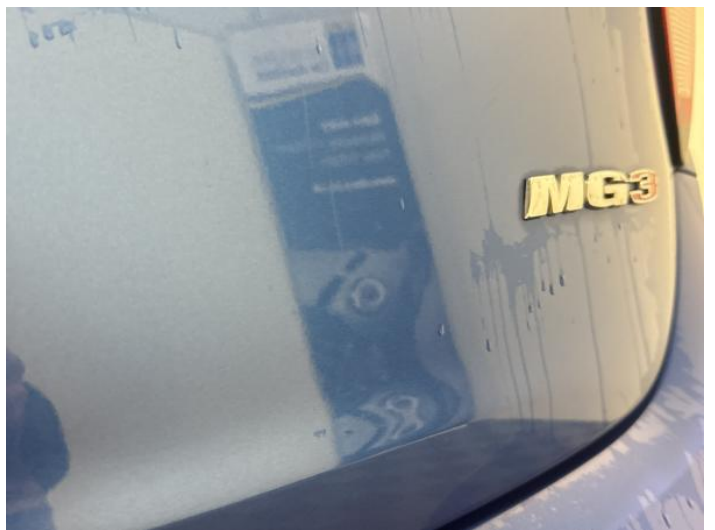
14: Tailgate  
Scratched  
Over 25mm Thru Paint

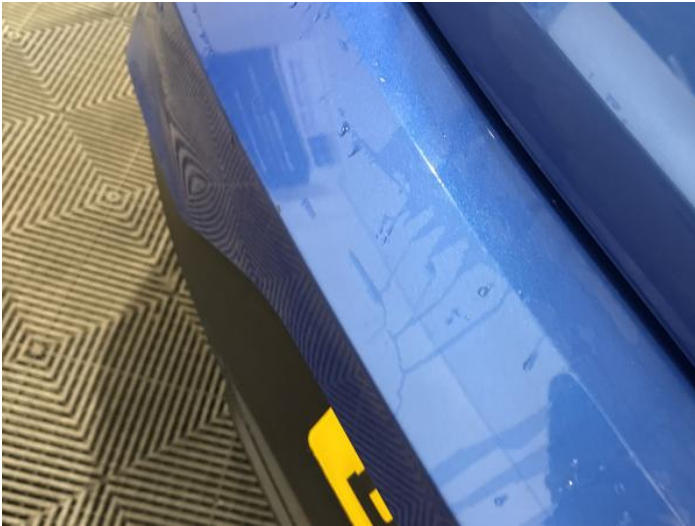
15: Bumper Rear  
Chipped  
1 To 5

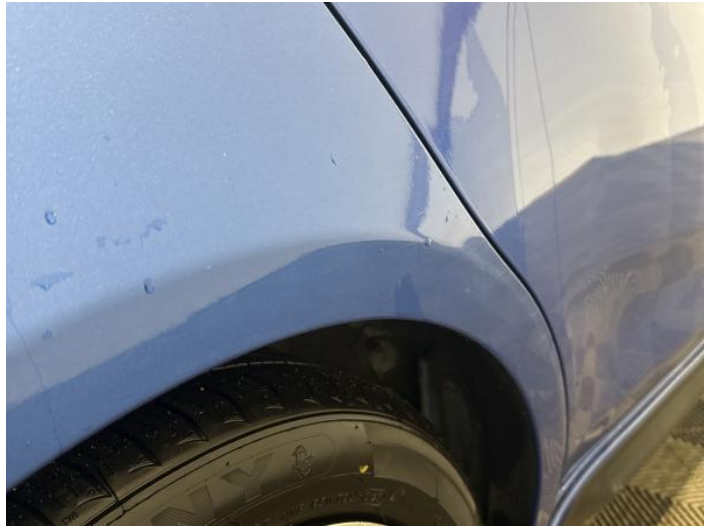
16: Qtr Panel osr  
Scratched  
Over 25mm Thru Paint

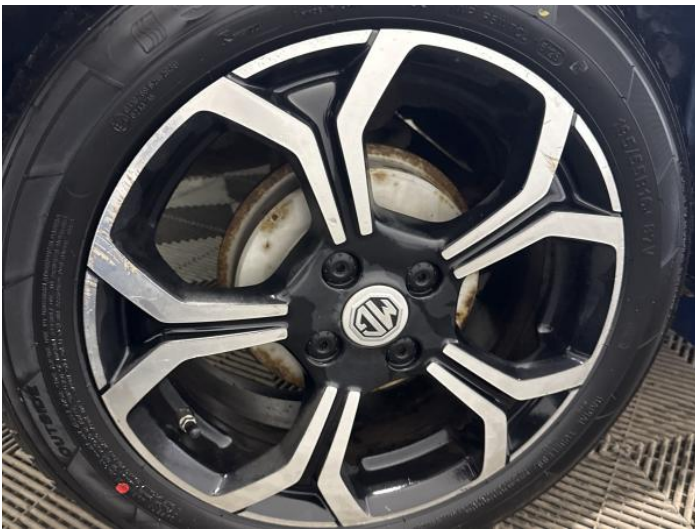
17: Wheel osr  
Scratched  
Over 50mm

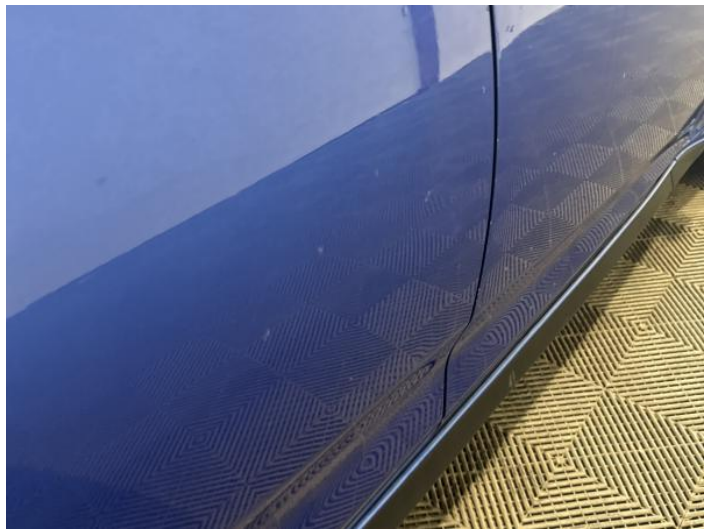
18: Door osr  
Dented  
With Paint Damage

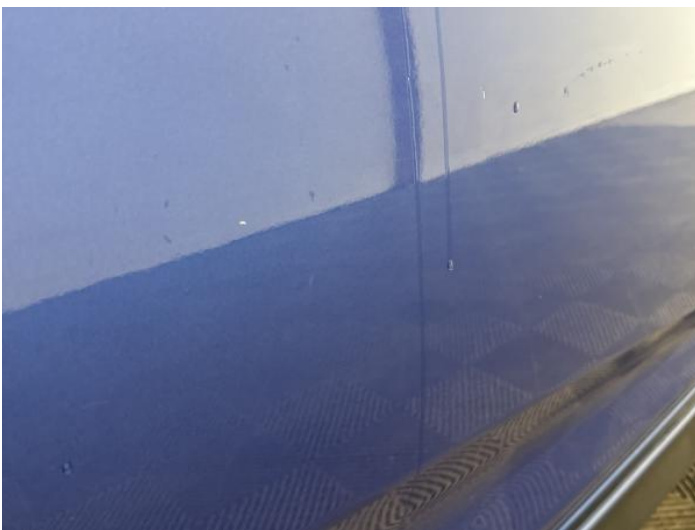
19: Door osf  
Chipped  
1 To 5

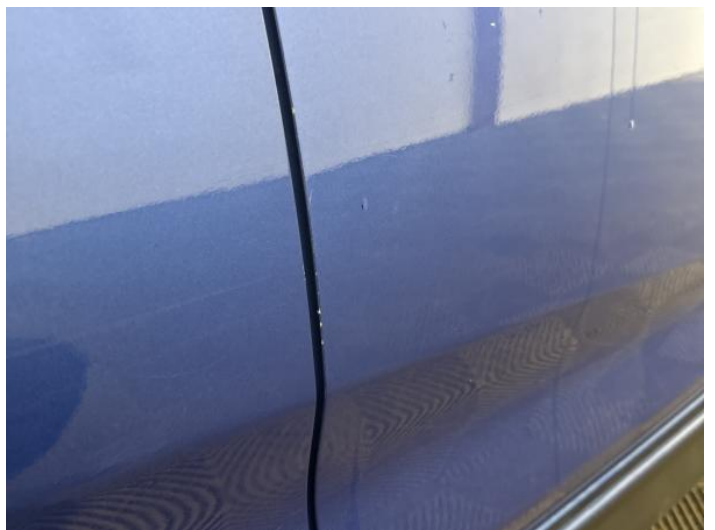
20: Door osf  
Chipped  
Edge Chip

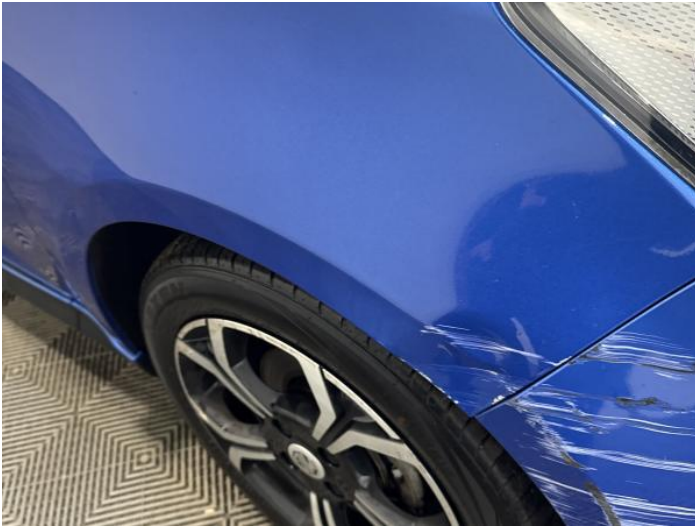
21: Wing of  
Dented  
With Paint Damage

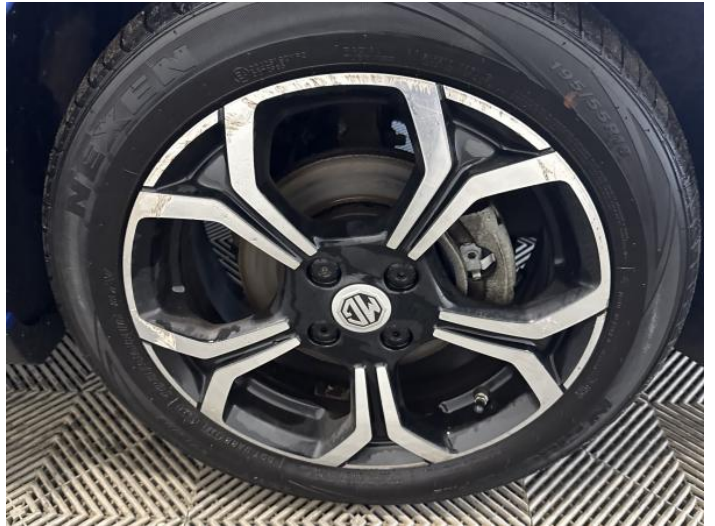
22: Wheel of  
Scratched  
Over 50mm

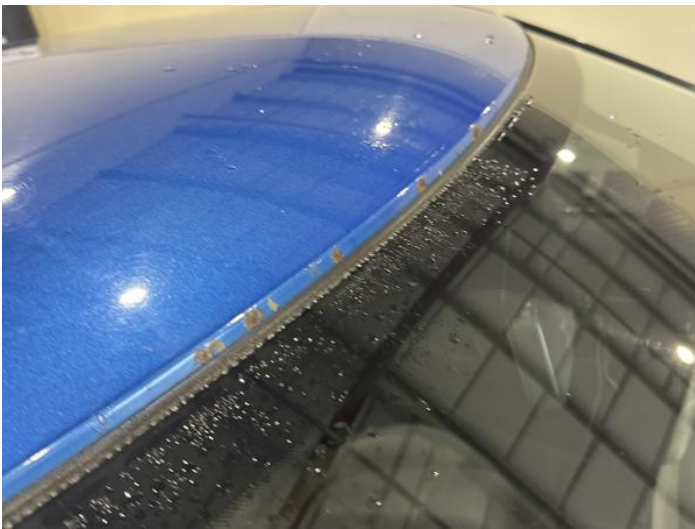
23: Roof  
Rusted  
Over 5mm
