VEHICLE INSPECTION REPORT

FL63LLM

Vauxhall Meriva 1.4T 16V Exclusiv 5dr Auto

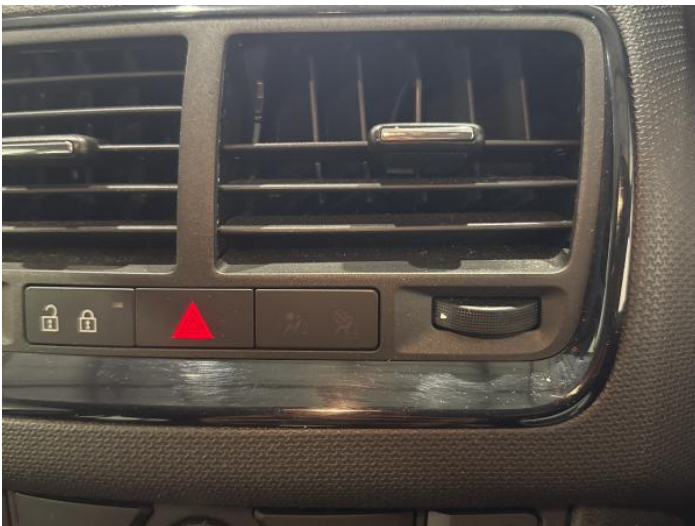
1: Air Vents osf
Damaged
Replace

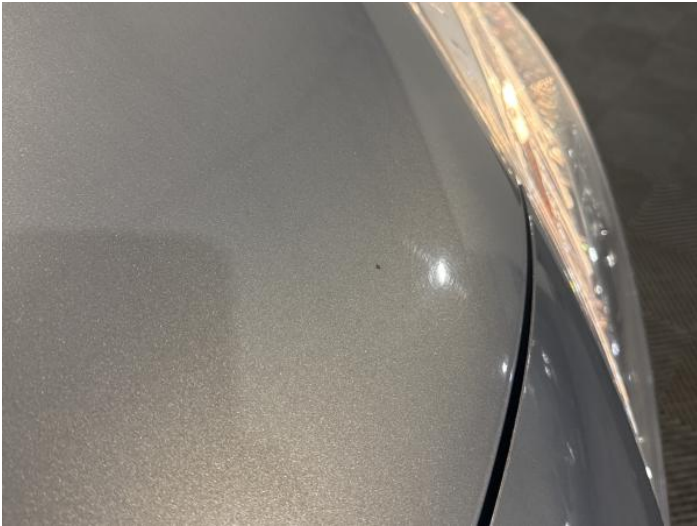
3: Bonnet
Chipped
1 To 5

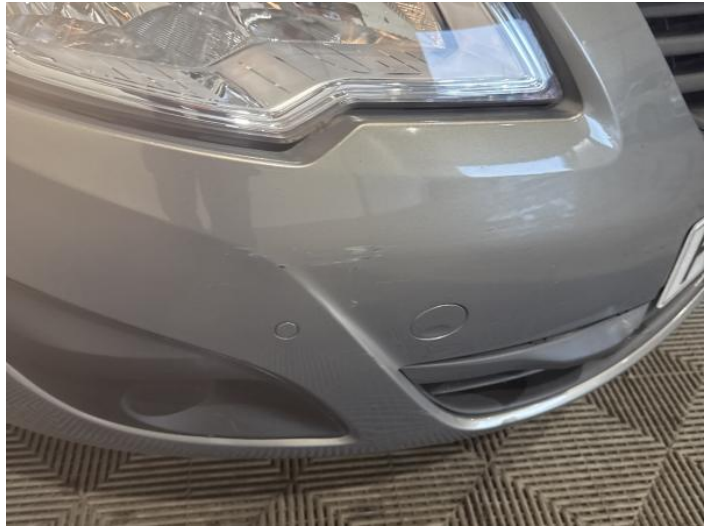
4: Bumper Front
Scratched
25 to 100mm Thru Paint

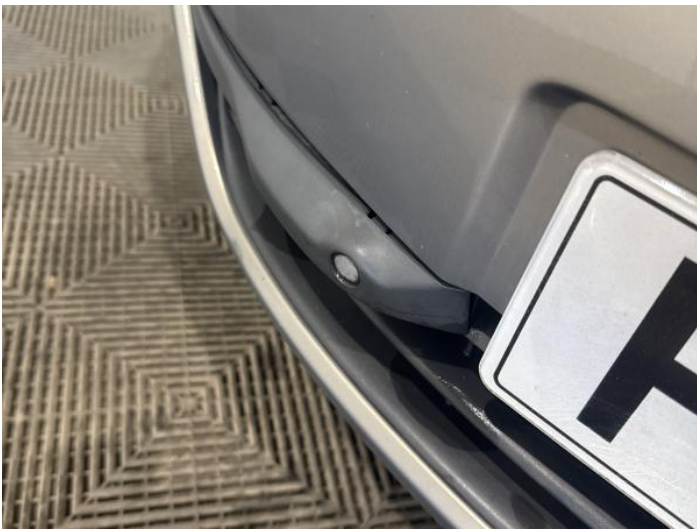
5: Bumper Front Moulding
Scuffed (Unpainted)
Over 100mm

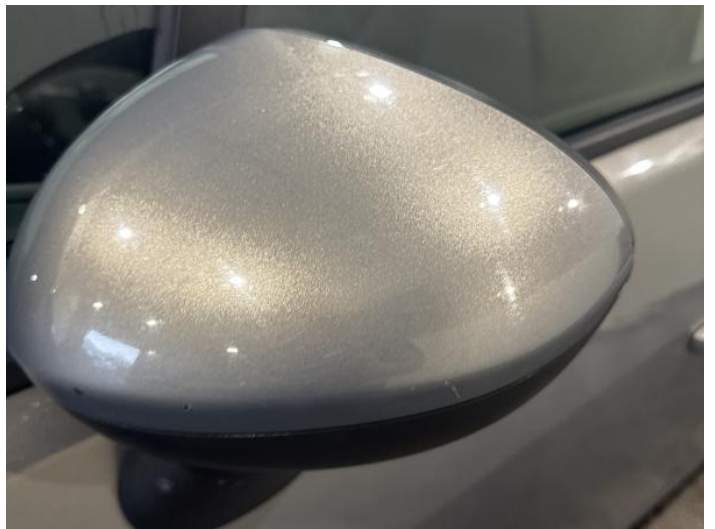
6: Door Mirror Assy nsf
Scratched (Painted)
UpTo 25mm Thru Paint

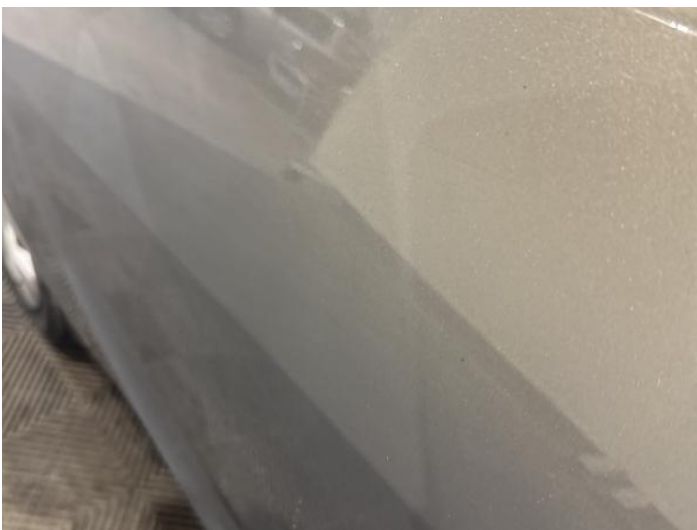
7: Door nsf
Dented
Between 10mm + 30mm

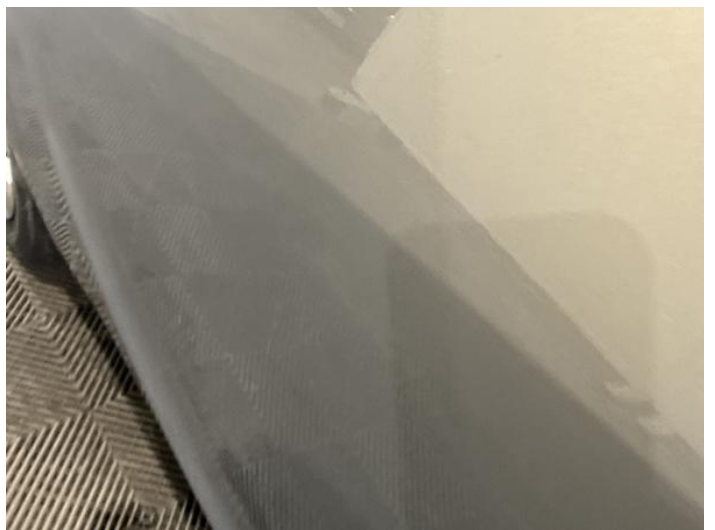
8: Door osf
Chipped
1 To 5

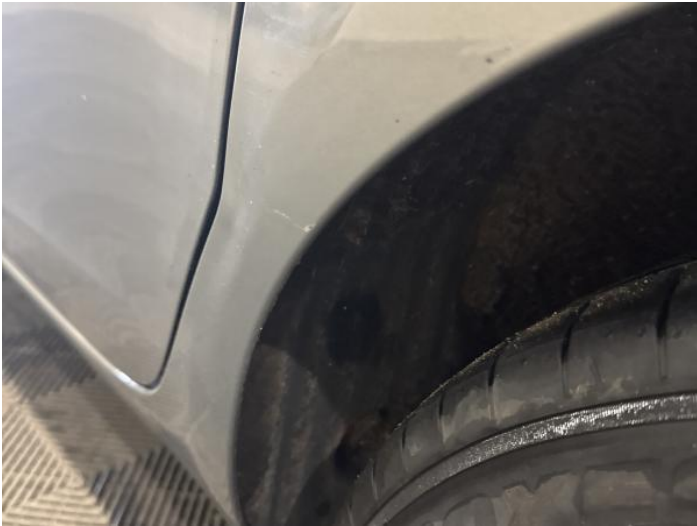
9: Qtr Panel nsr
Dented
Over 30mm

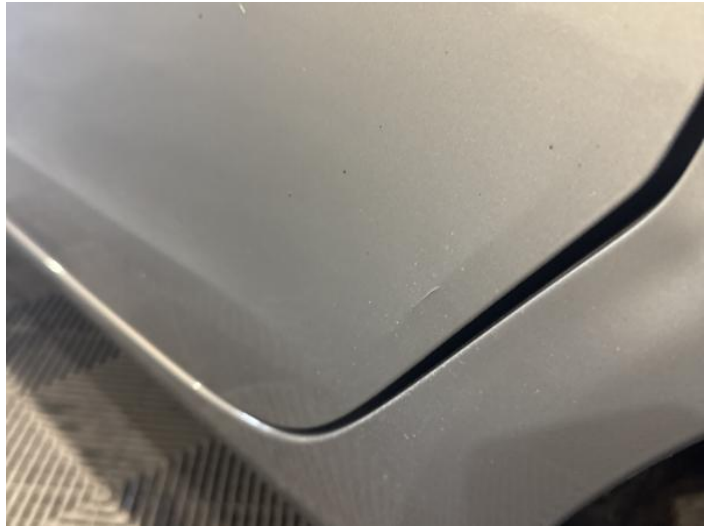
10: Door nsr
Dented
With Paint Damage

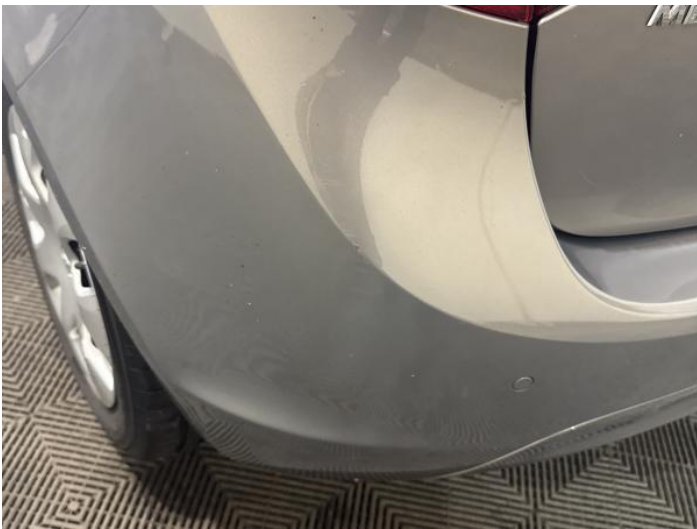
11: Bumper Rear
Scratched
25 to 100mm Thru Paint

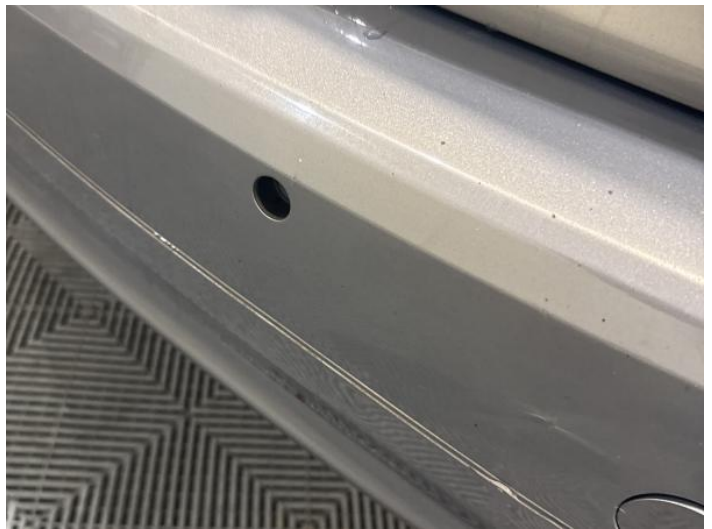
12: Parking Sensor Rear
Missing
Replace

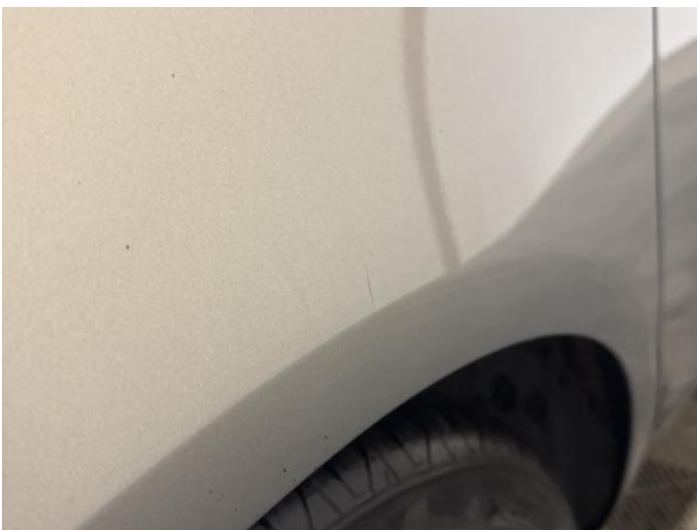
13: Qtr Panel osr
Scratched
UpTo 25mm Thru Paint

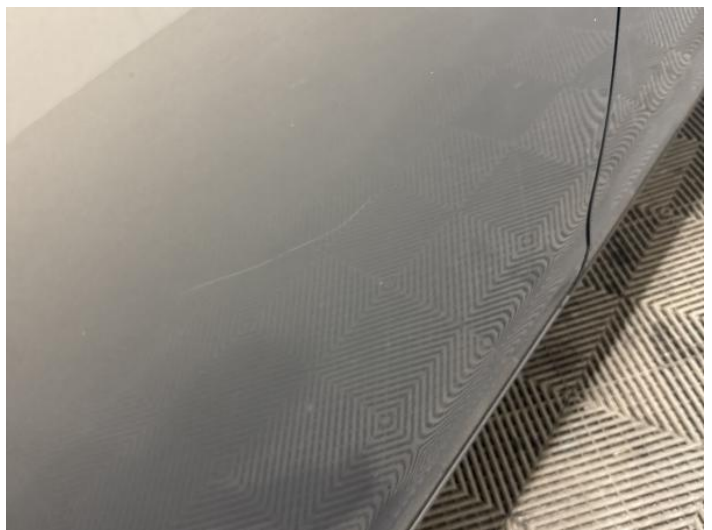
14: Door osr
Scratched
Over 25mm Thru Paint

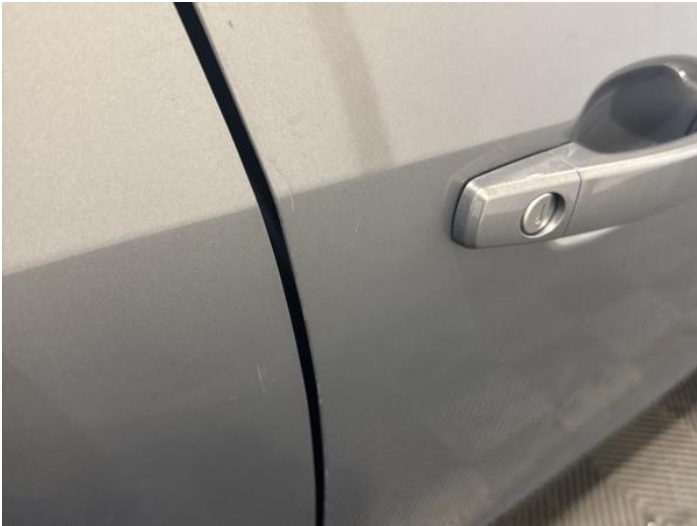
15: Door osf
Scratched
UpTo 25mm Thru Paint

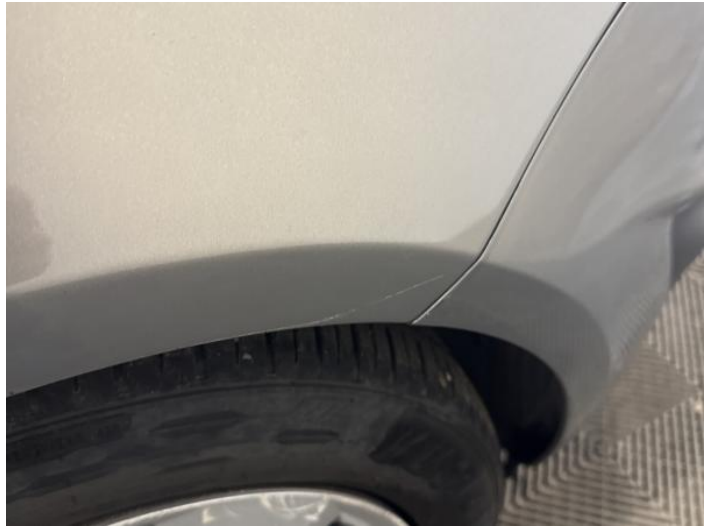
16: Wing nsf
Scratched
Over 25mm Thru Paint

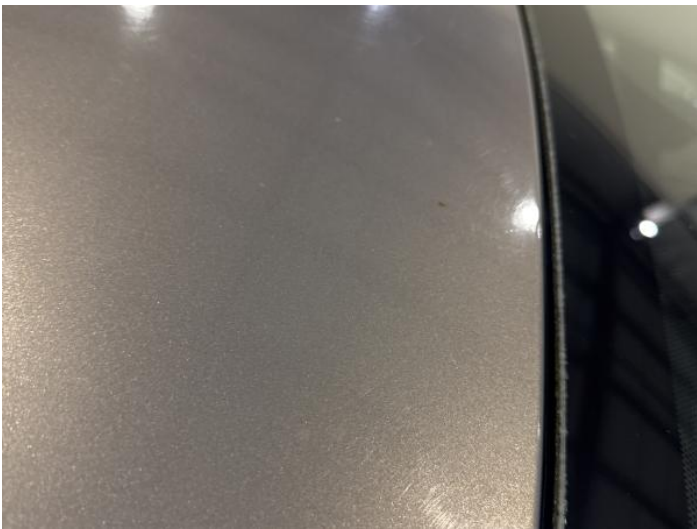
17: Roof
Chipped
1 To 5
