VEHICLE INSPECTION REPORT

GU10UPH

Ford Fiesta 1.4 Zetec 5dr

nama
 GRADE
5

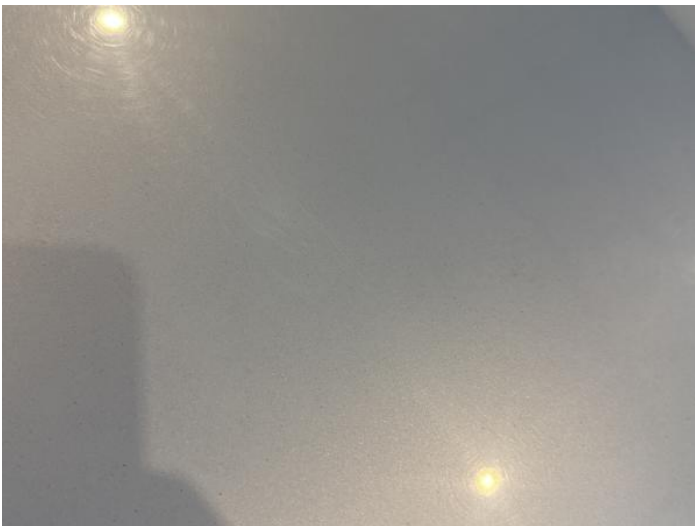
1: Bonnet
Scratched
Over 25mm Thru Paint

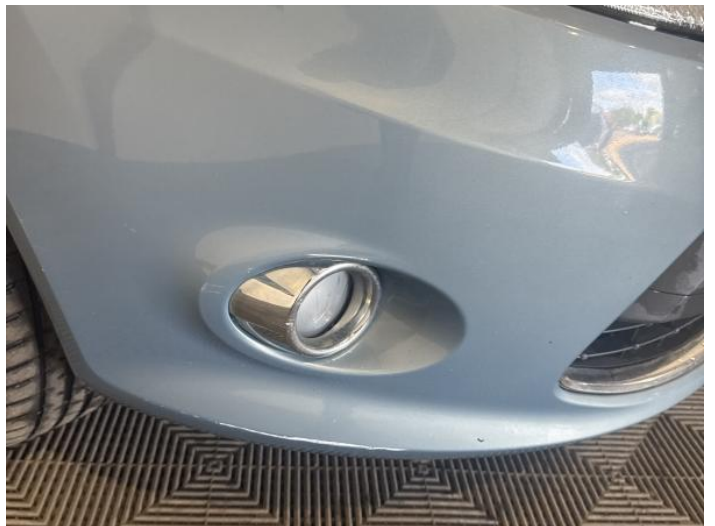
2: Bumper Front
Scratched
25 to 100mm Thru Paint

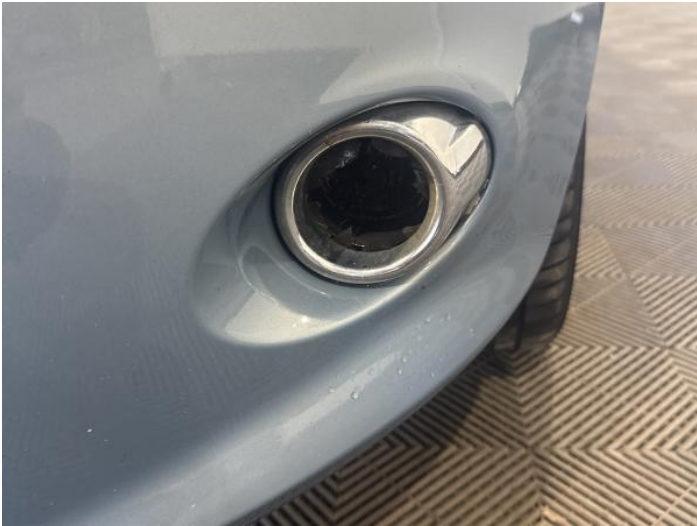
3: Fogdriving Lamp nsf
Broken
Replace

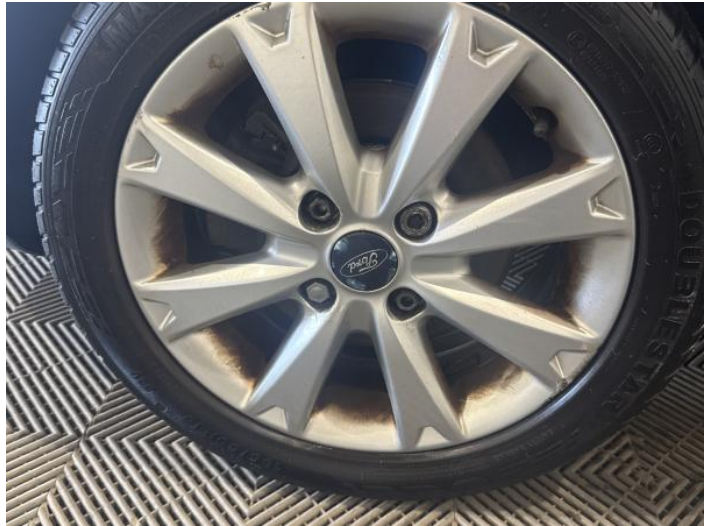
4: Wheel nsf
Scratched
Over 50mm

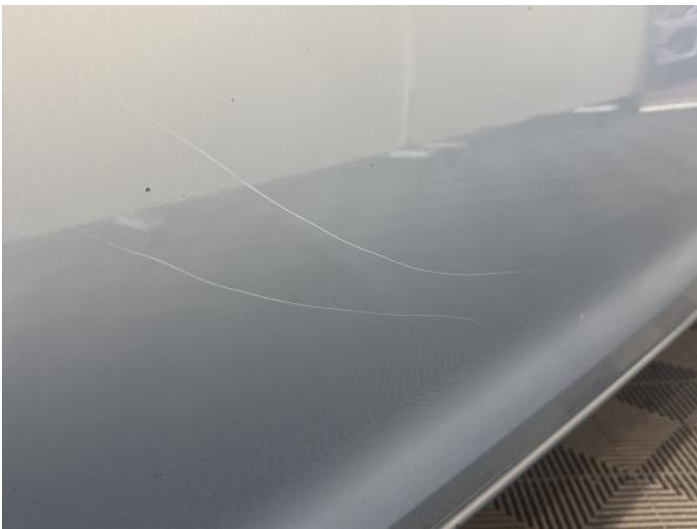
5: Door nsf
Scratched
Over 25mm Thru Paint

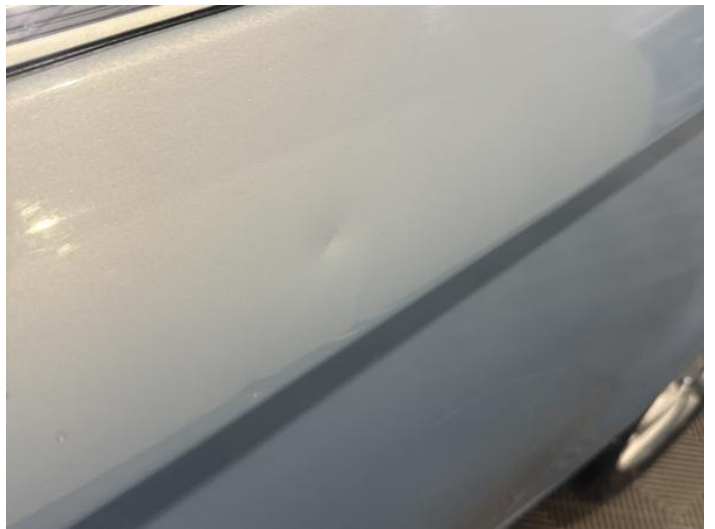
6: Door nsr
Dented
Between 10mm + 30mm

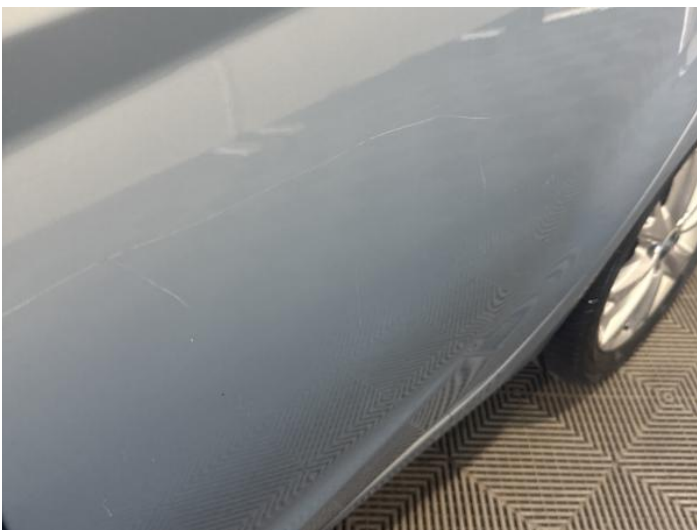
7: Door nsr
Scratched
Over 25mm Thru Paint

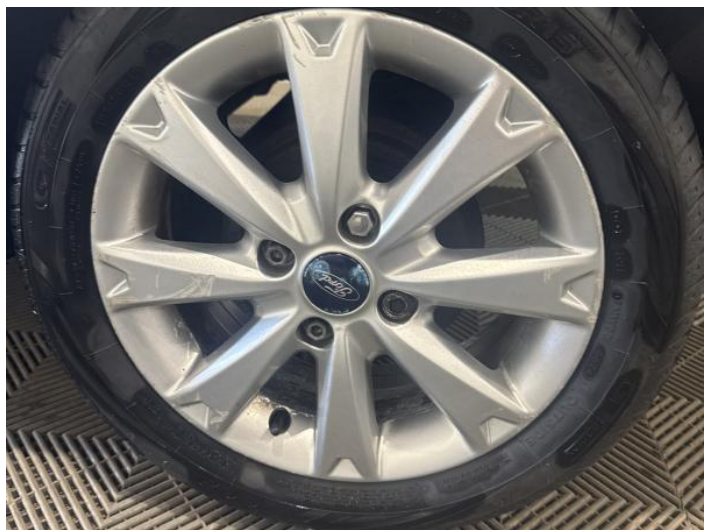
8: Wheel nsr
Scratched
Over 50mm

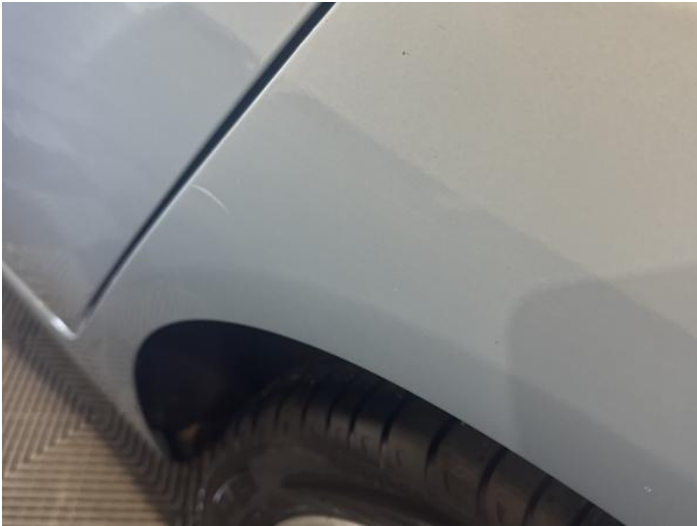
9: Qtr Panel nsr
Scratched
UpTo 25mm Thru Paint

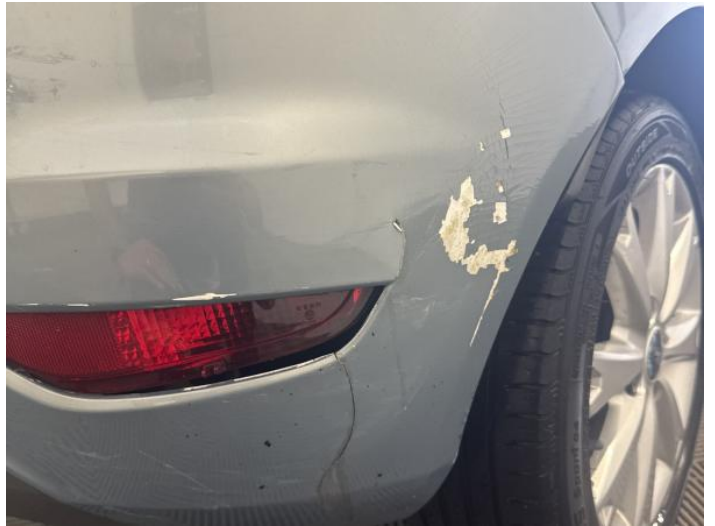
10: Bumper Rear
Cracked
Over 25mm

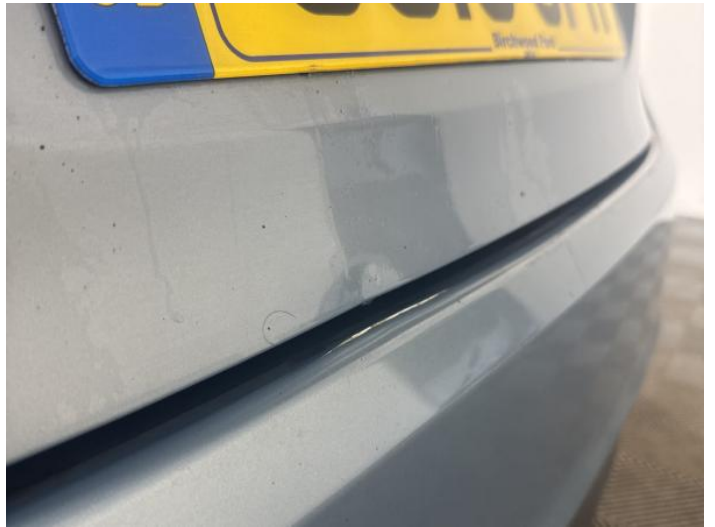
12: Tailgate
Dented
Over 30mm

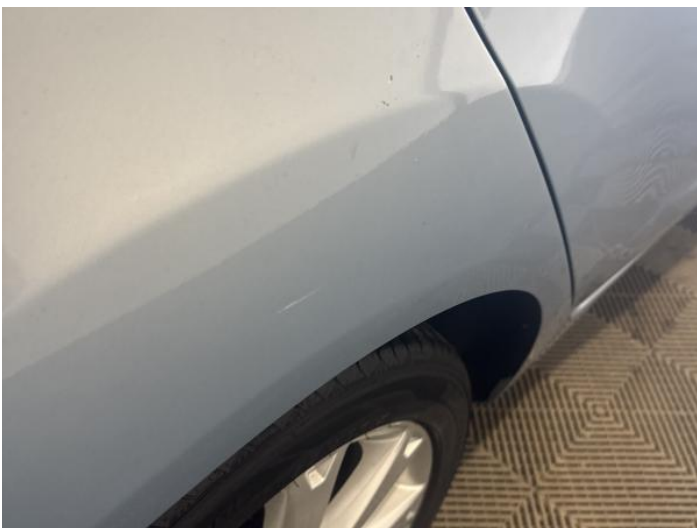
13: Qtr Panel osr
Scratched
UpTo 25mm Thru Paint

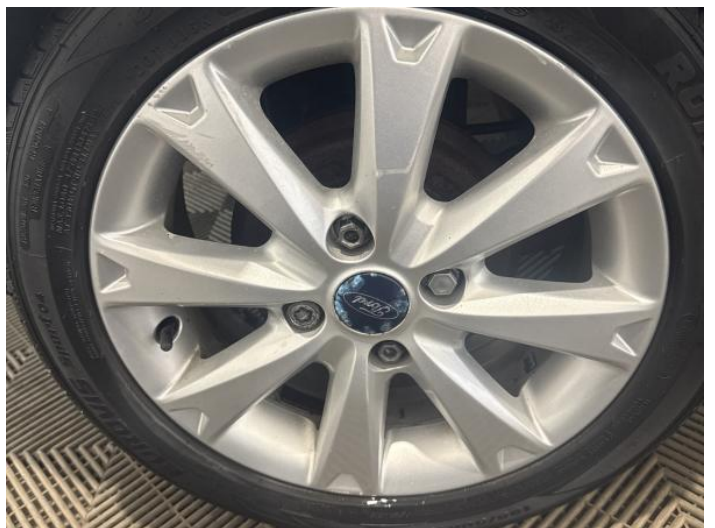
14: Wheel nsr
Scratched
Over 50mm

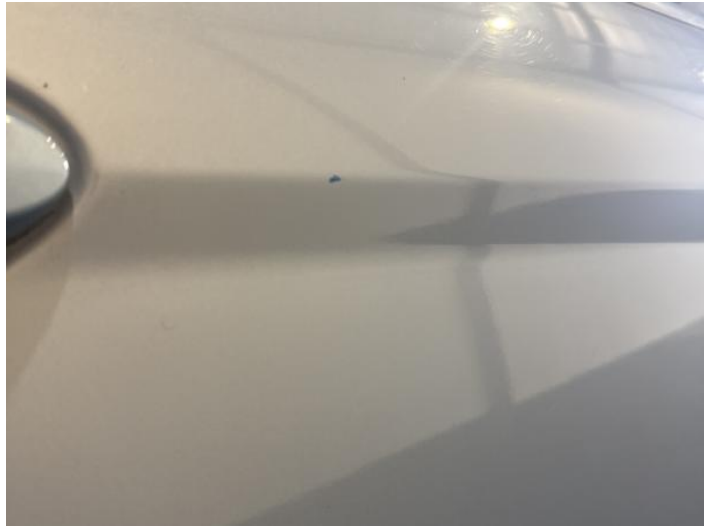
16: Door osr
Chipped
1 To 5

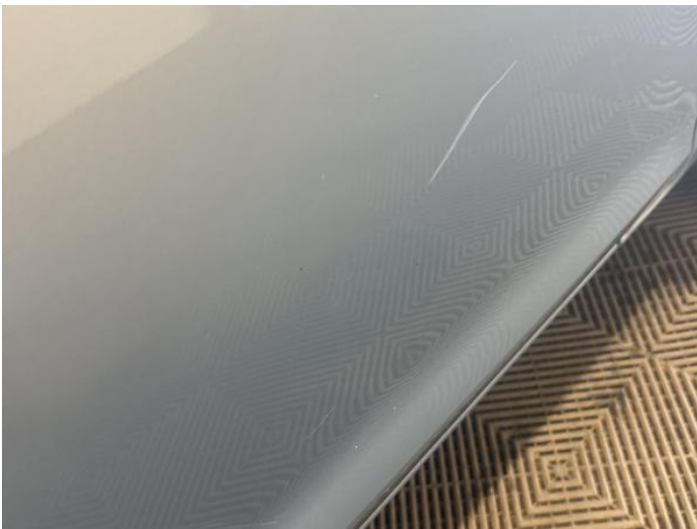
17: Door osf
Scratched
Over 25mm Thru Paint

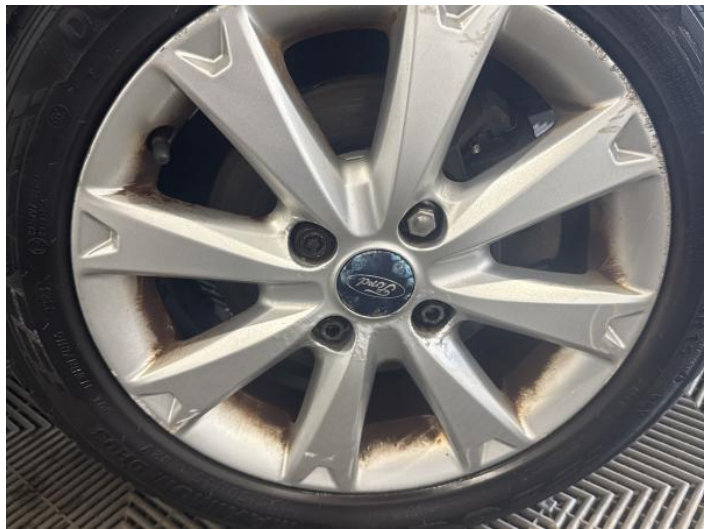
18: Wheel osf
Scratched
Over 50mm

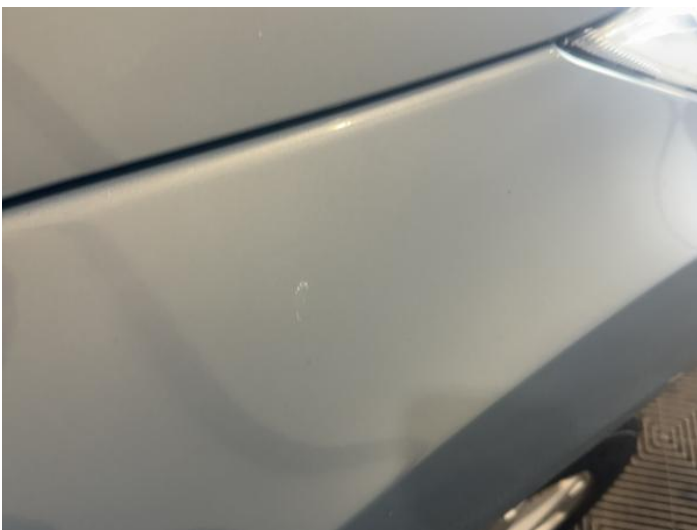
19: Wing osf
Chipped
1 To 5

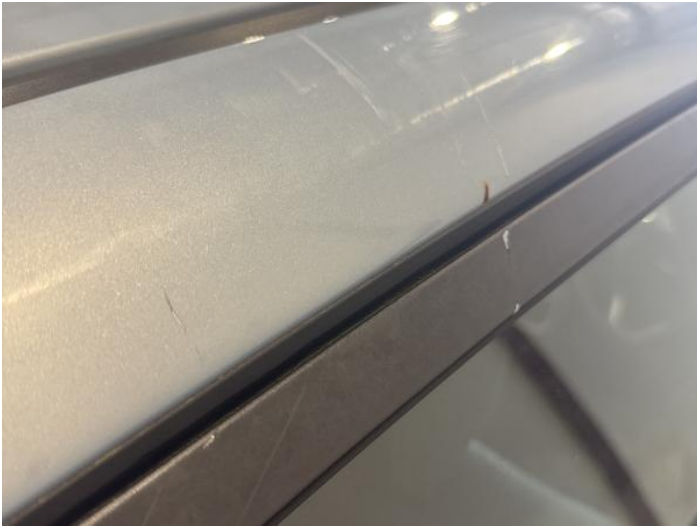
21: B Post os
 Scratched
 Rusted

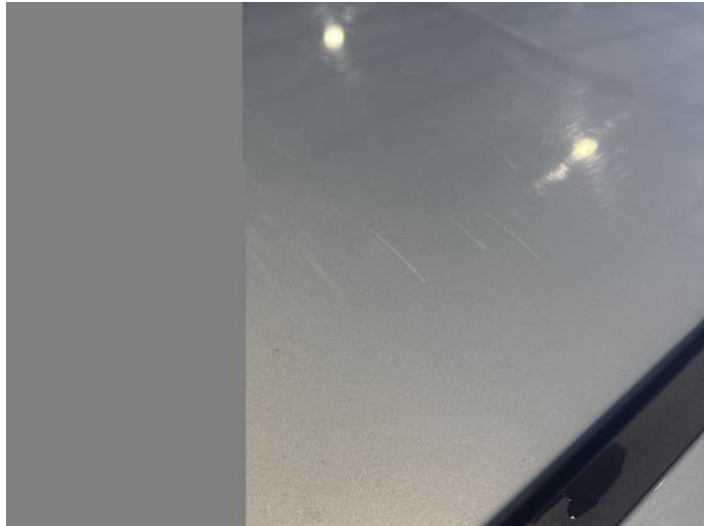
22: Roof
 Scratched
 Over 25mm Thru Paint

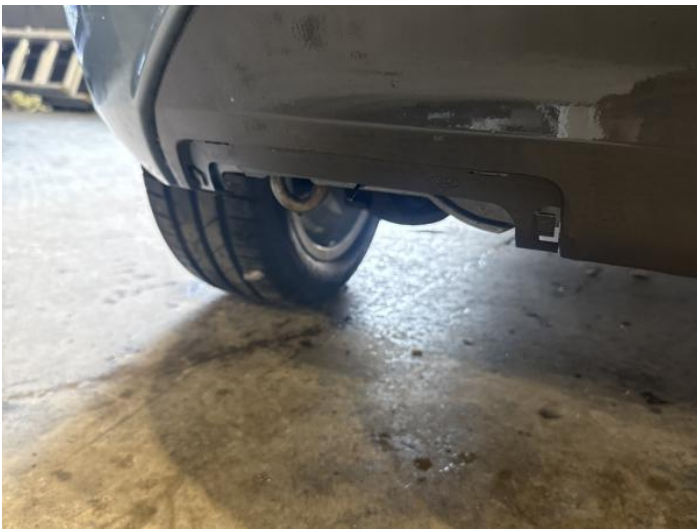
23: Rear TowEye Cvr
 Missing
 Replace
