VEHICLE INSPECTION REPORT

BX63EZM

Ford Focus 1.0 EcoBoost Zetec 5dr

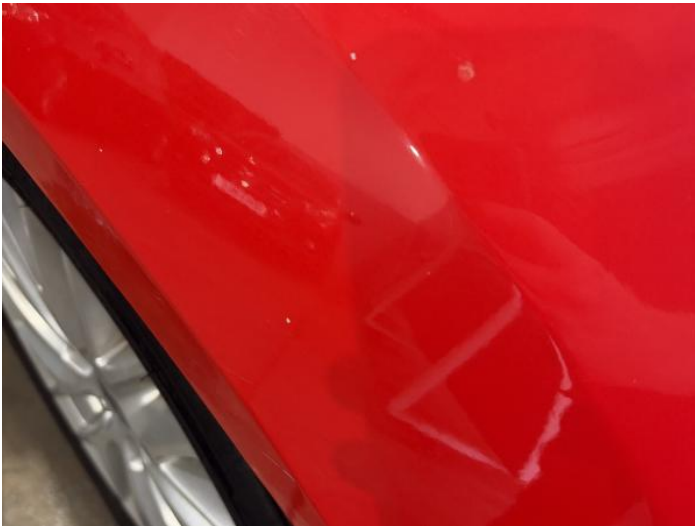
1: Wing ofsf
Chipped
1 To 5

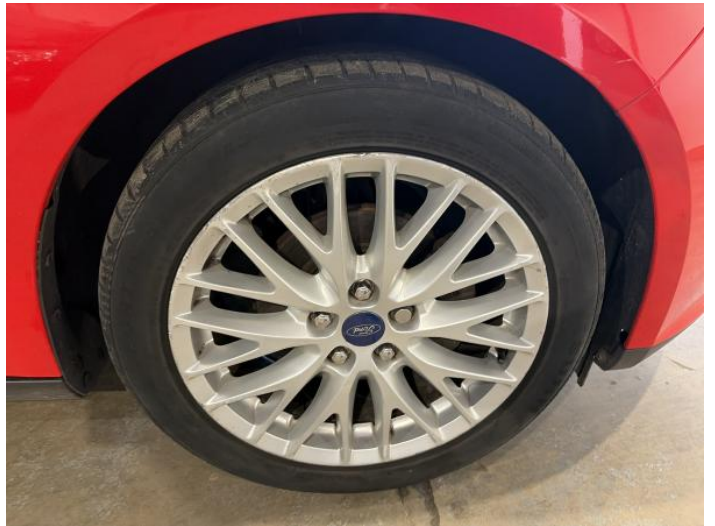
2: Wheel ofsf
Scratched
Over 50mm

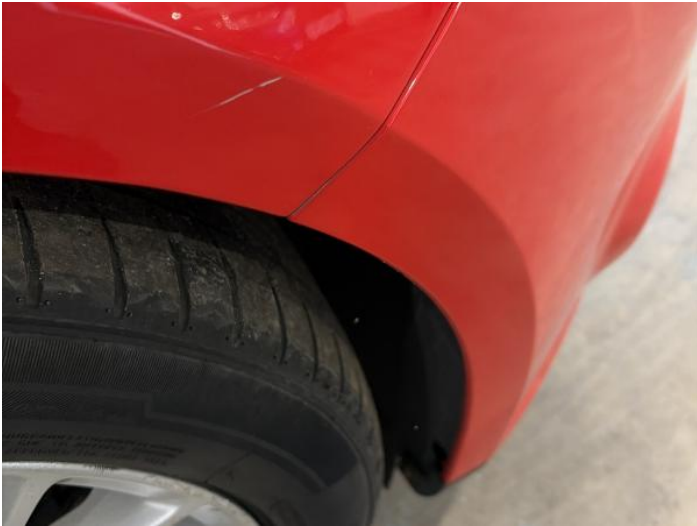
3: Wing osf
Scratched
UpTo 25mm Thru Paint

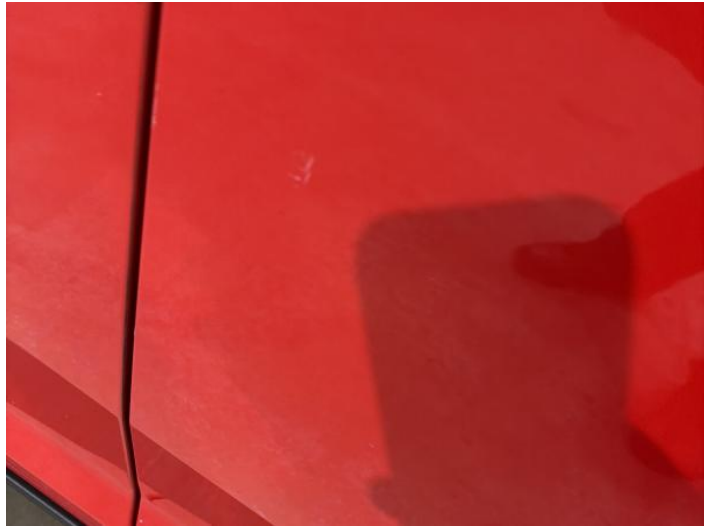
4: Door osf
Chipped
1 To 5

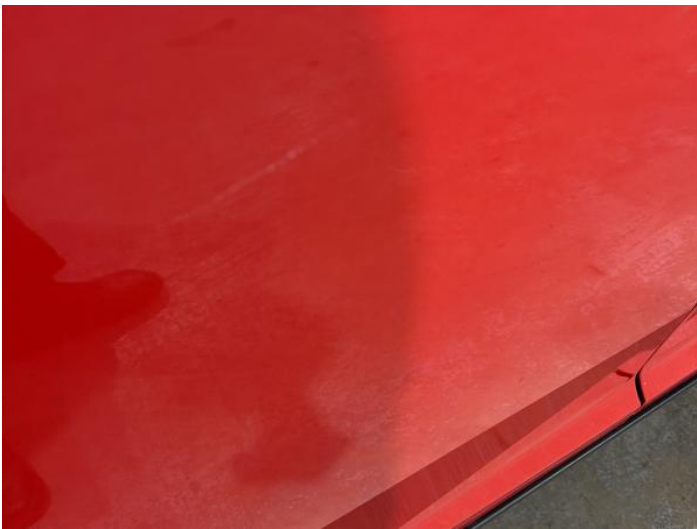
5: Door osr
Scratched
UpTo 25mm Thru Paint

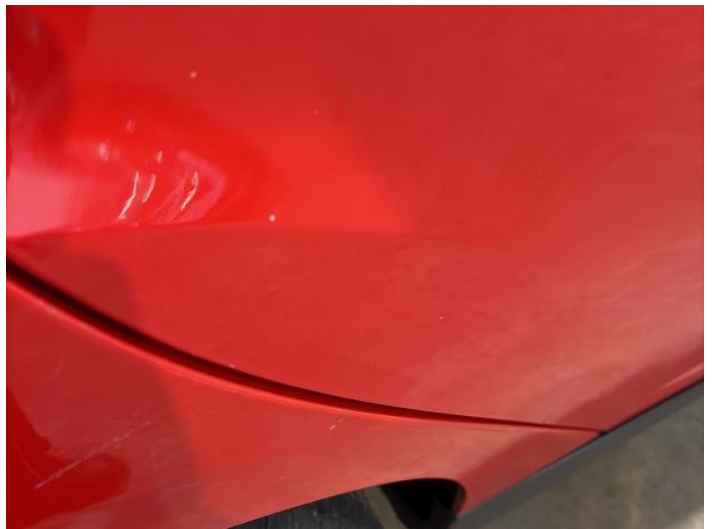
6: Door osr
Chipped
1 To 5

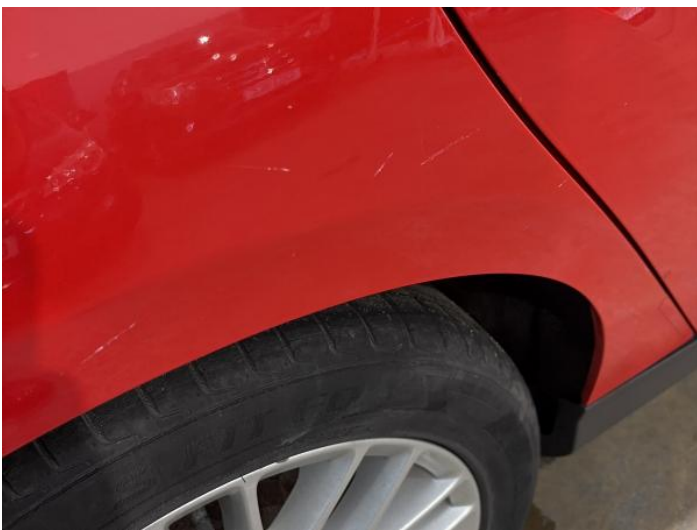
7: Qtr Panel osr
Scratched
Over 25mm Thru Paint

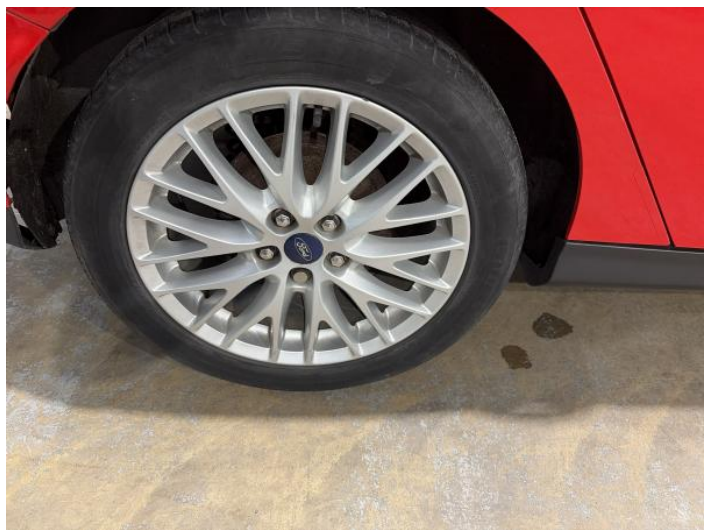
8: Wheel osr
Scratched
Up To 50mm

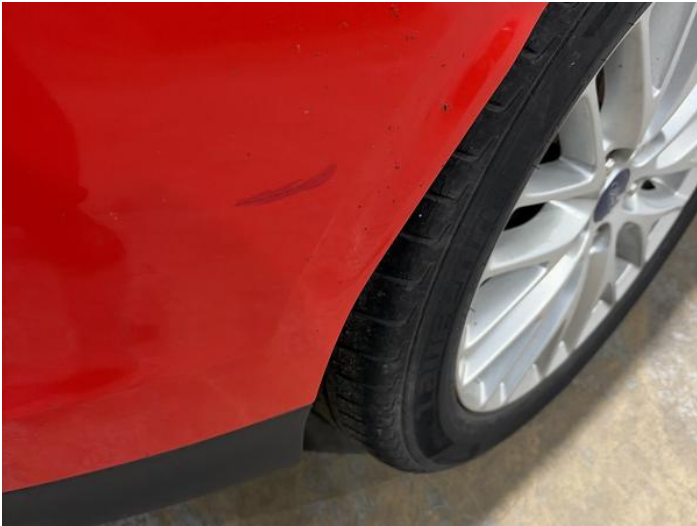
9: Bumper Rear
Scratched
Over 100mm Thru Paint

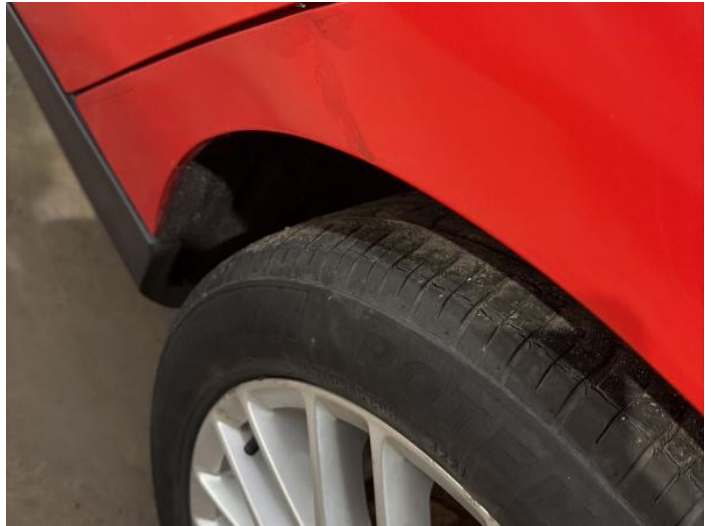
10: Qtr Panel nsr
Dented
With Paint Damage

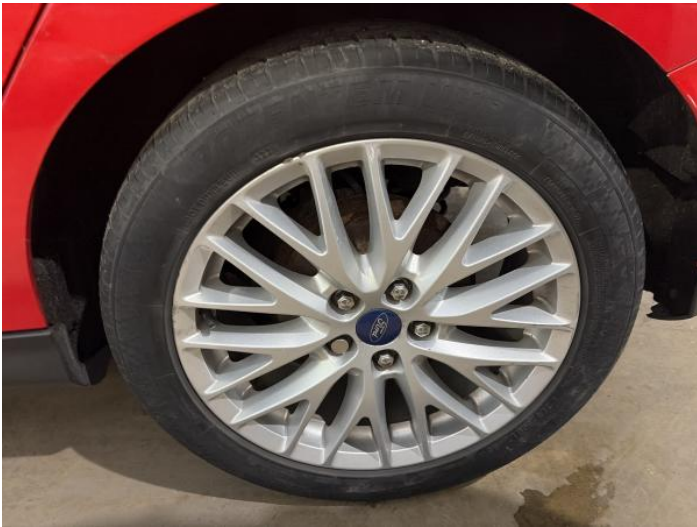
11: Wheel nsr
Scratched
Over 50mm

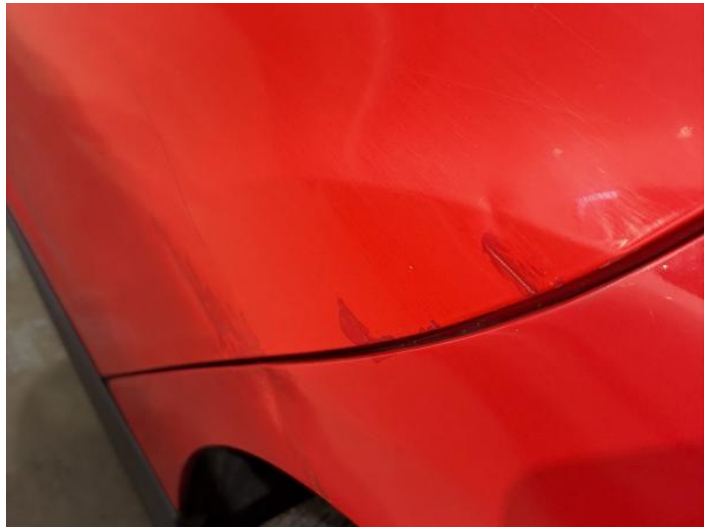
12: Door nsr
Dented
With Paint Damage

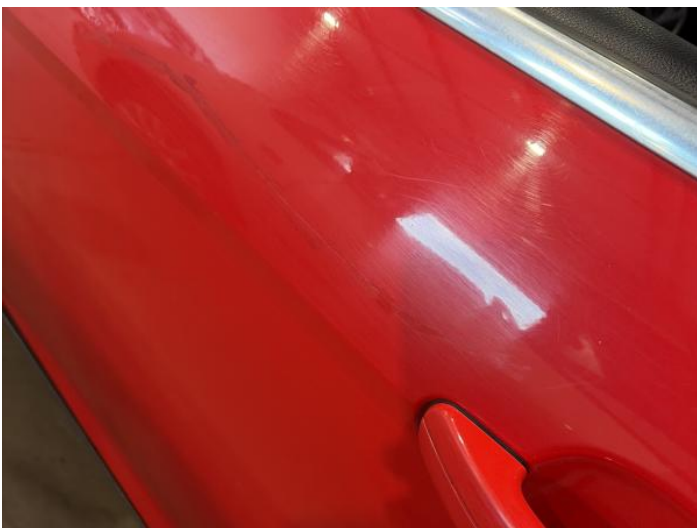
13: Door nsf
Scratched
Over 25mm Thru Paint

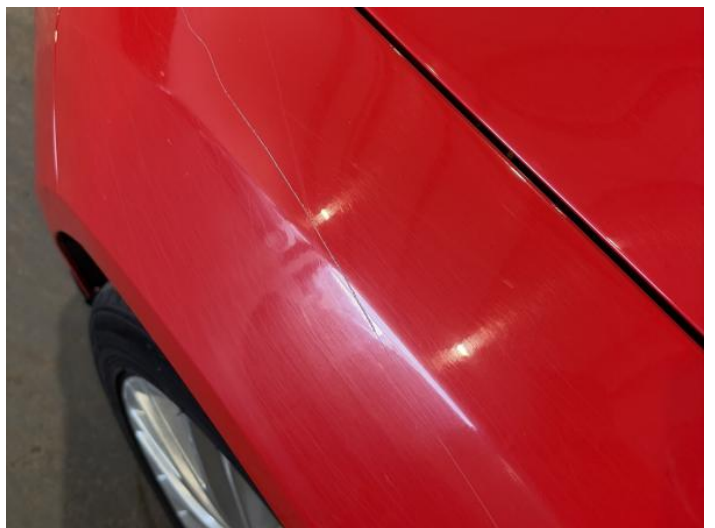
14: Wing nsf
Dented
With Paint Damage

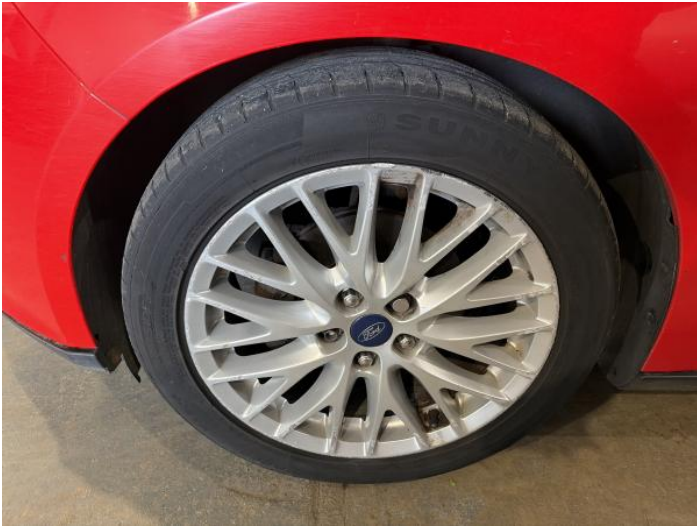
15: Wheel nsf
Scratched
Over 50mm

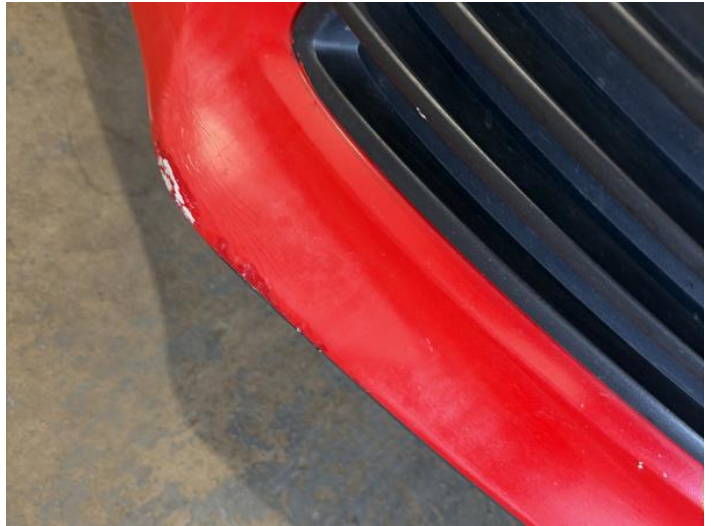
16: Bumper Front
Poor Previous Repair
Poor Paint

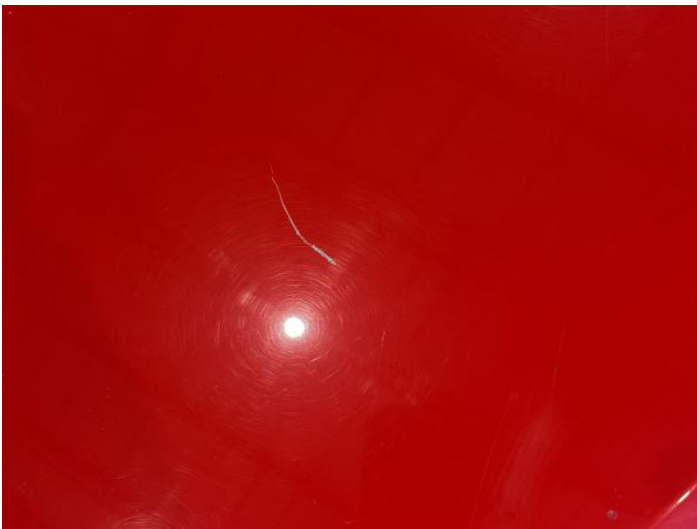
17: Bonnet
Scratched
Over 25mm Thru Paint

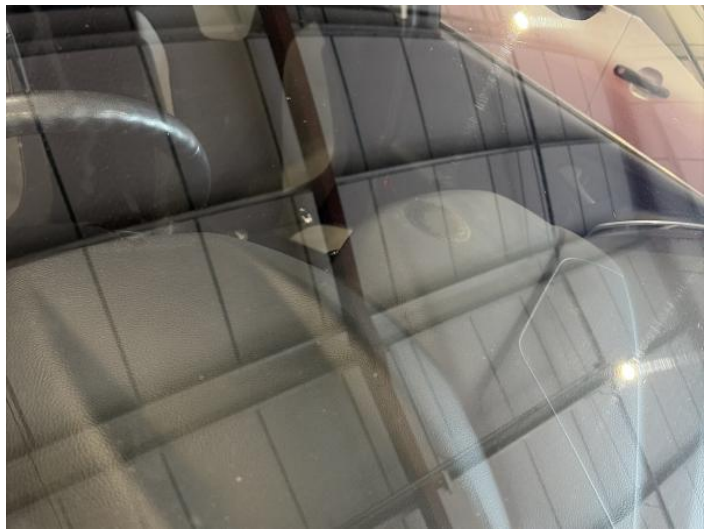
18: Screen Front
Chipped
UpTo 10mm

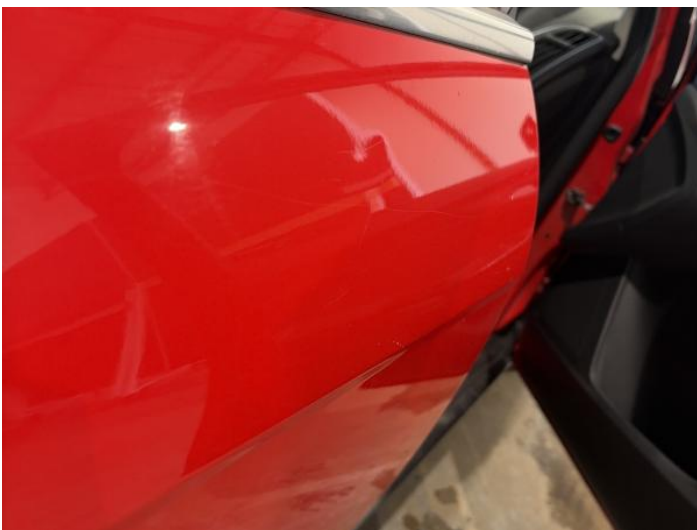
19: Door osr
Dented
Between 10mm + 30mm
