# VEHICLE INSPECTION REPORT

**VN64XMP**

## Nissan Pulsar 1.5 dCi N-Tec 5dr

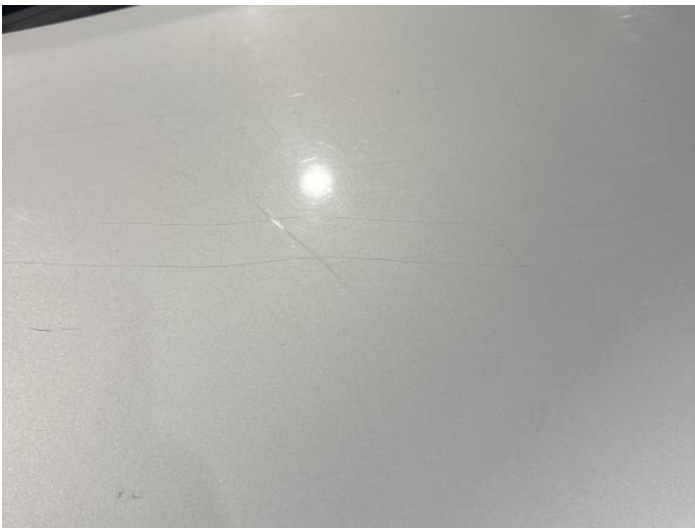
1: Bonnet  
Scratched  
Over 25mm Thru Paint

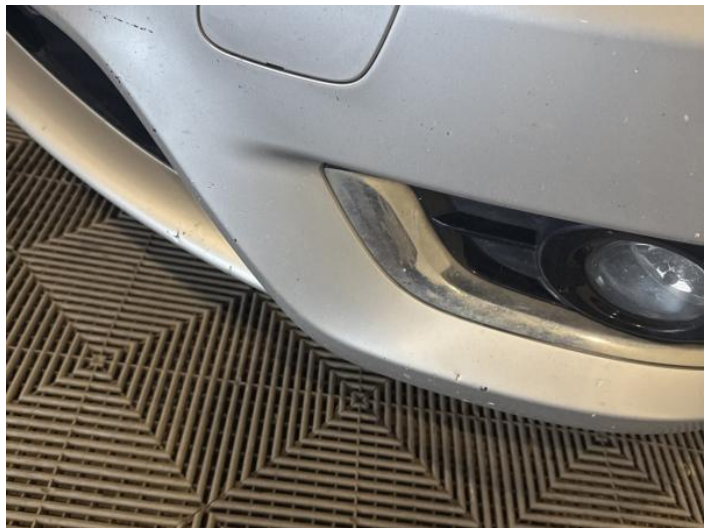
2: Bumper Front  
Dented  
With Paint Damage

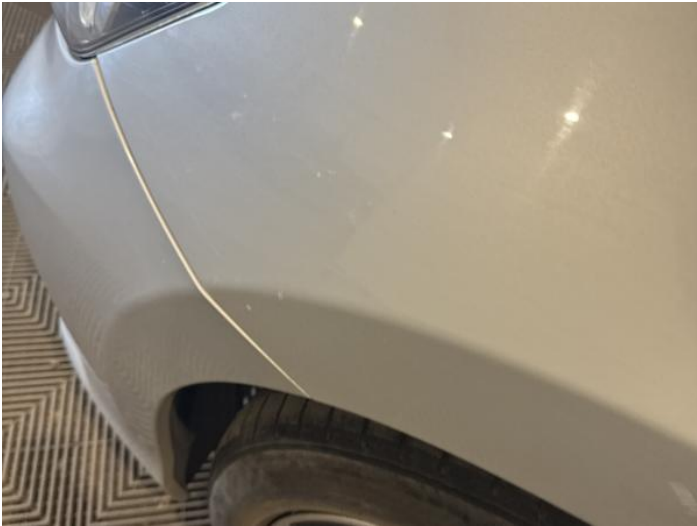
3: Wing nsf  
Chipped  
1 To 5

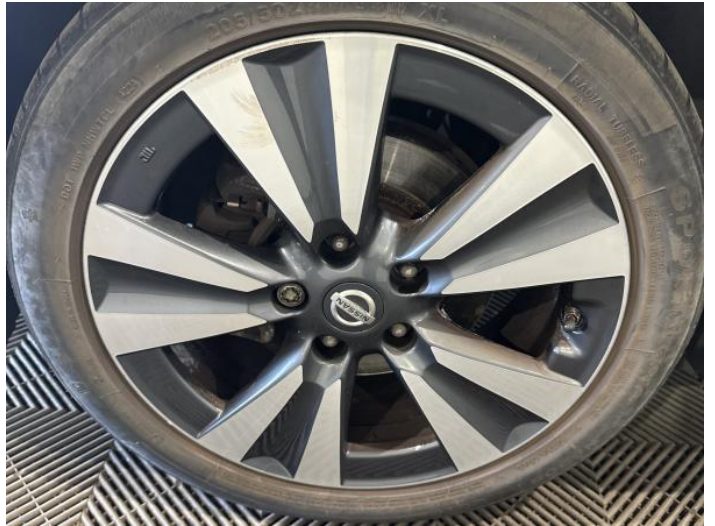
4: Wheel nsf  
Scratched  
Over 50mm

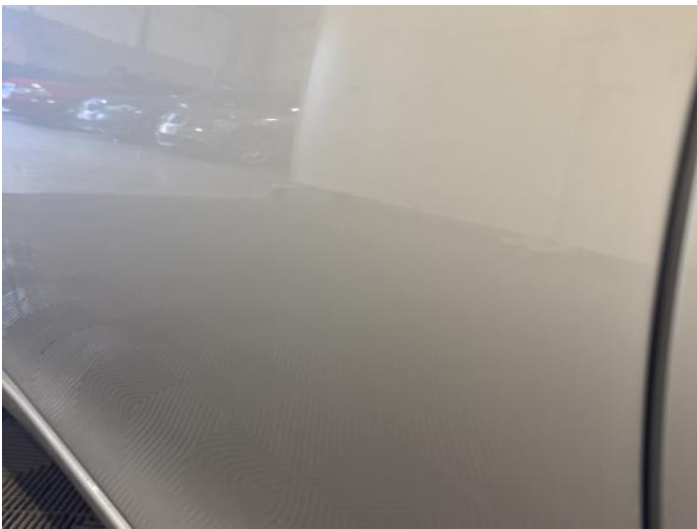
5: Door nsf  
Chipped  
1 To 5

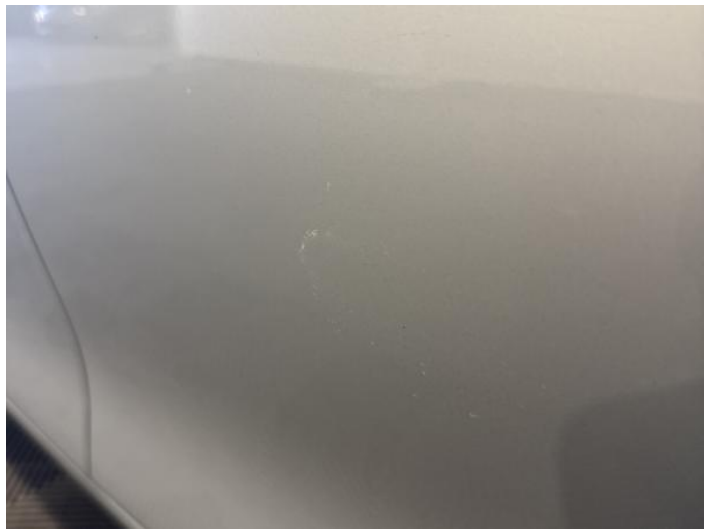
6: Door nsr  
Scratched  
Over 25mm Thru Paint

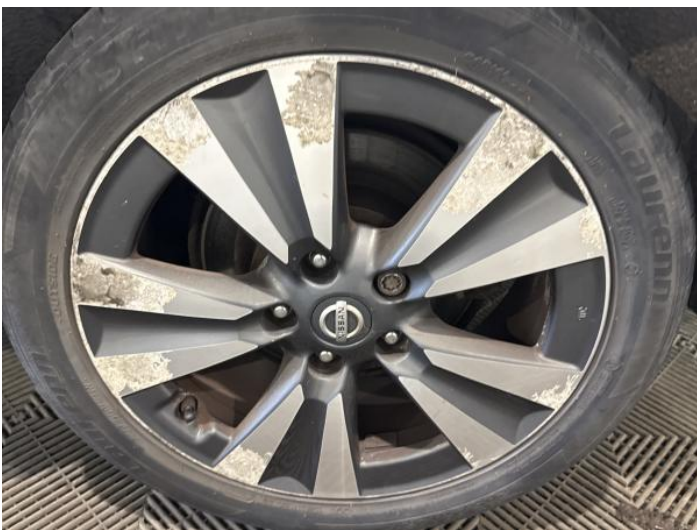
7: Wheel nsr  
Scratched  
Over 50mm

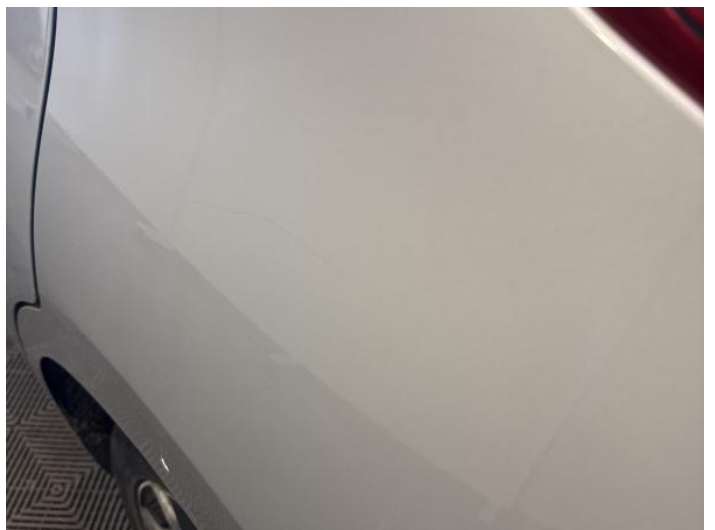
8: Qtr Panel nsr  
Scratched  
Over 25mm Thru Paint

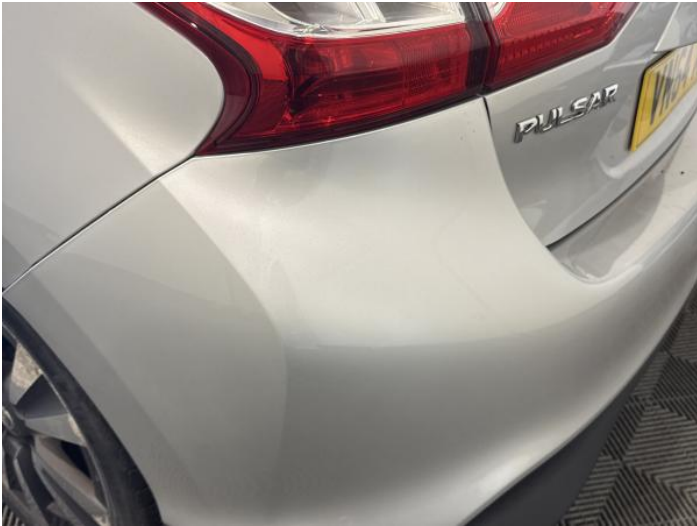
9: Bumper Rear  
Scratched  
25 to 100mm Thru Paint

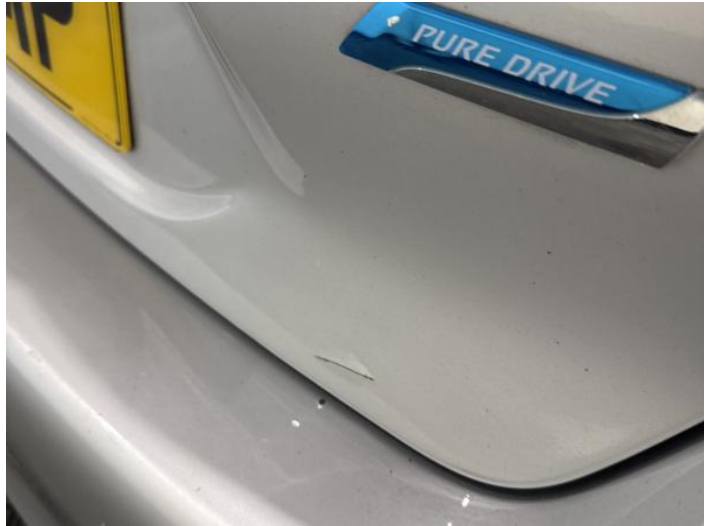
10: Tailgate  
Dented  
With Paint Damage

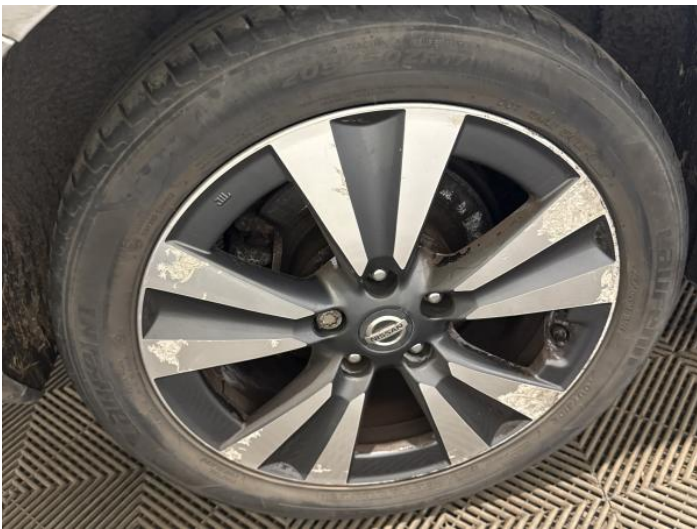
11: Wheel osr  
Scratched  
Over 50mm

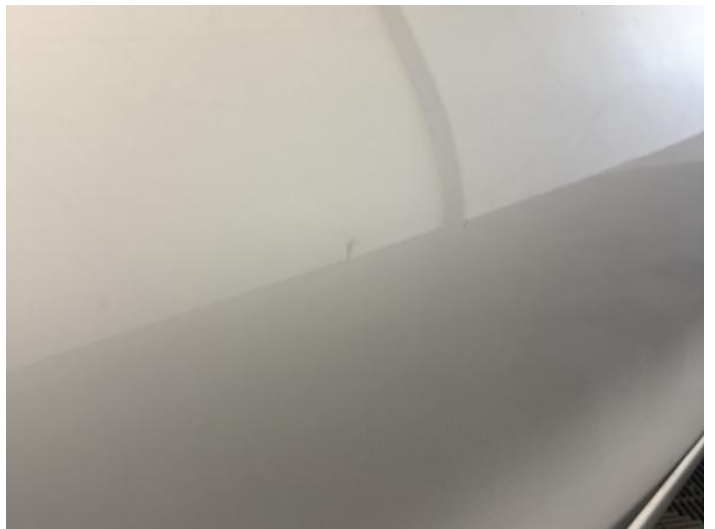
12: Door osr  
Dented  
With Paint Damage

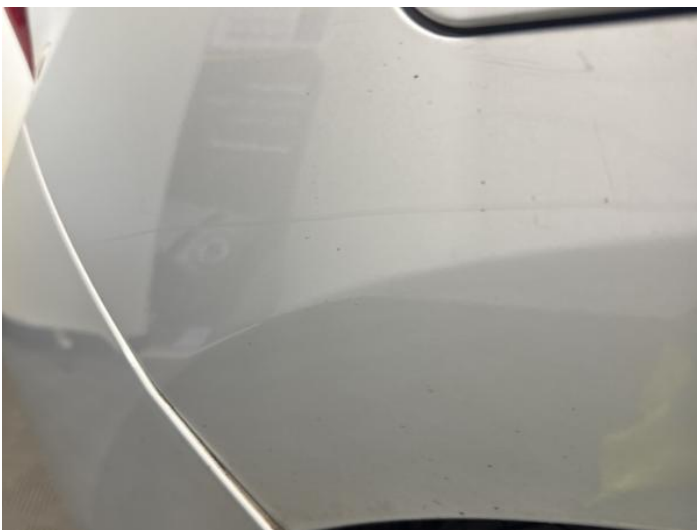
13: Qtr Panel osr  
Scratched  
Over 25mm Thru Paint

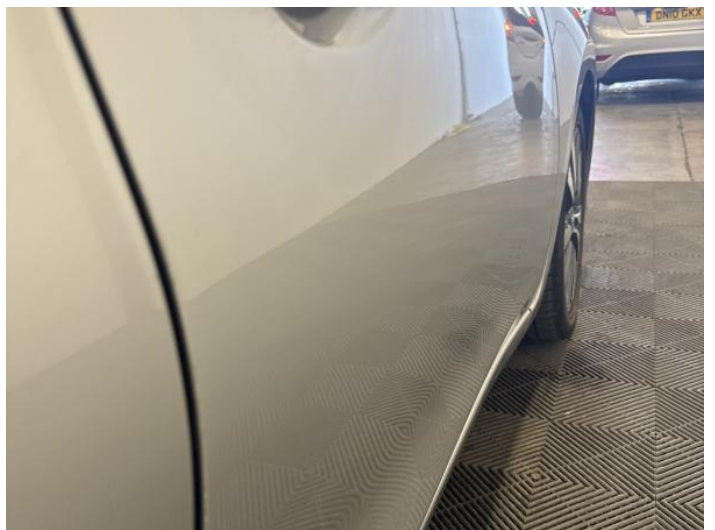
14: Door osf  
Dented  
Over 30mm

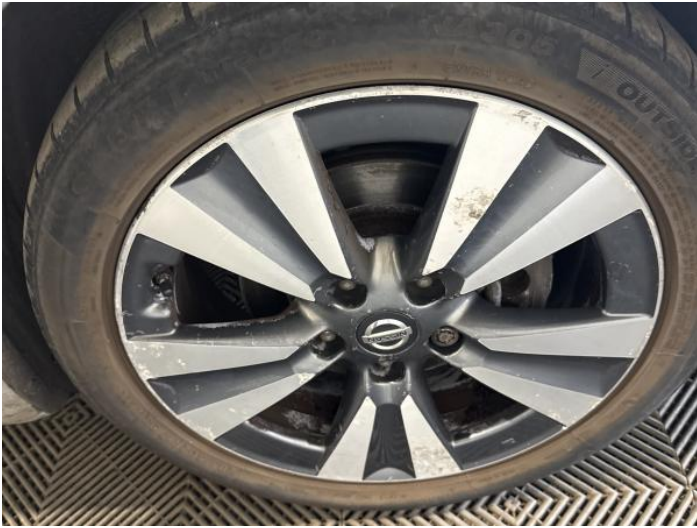
15: Wheel of  
Scratched  
Over 50mm
