VEHICLE INSPECTION REPORT

RJ16GZV

Renault Kadjar 1.5 dCi Dynamique S Nav 5dr

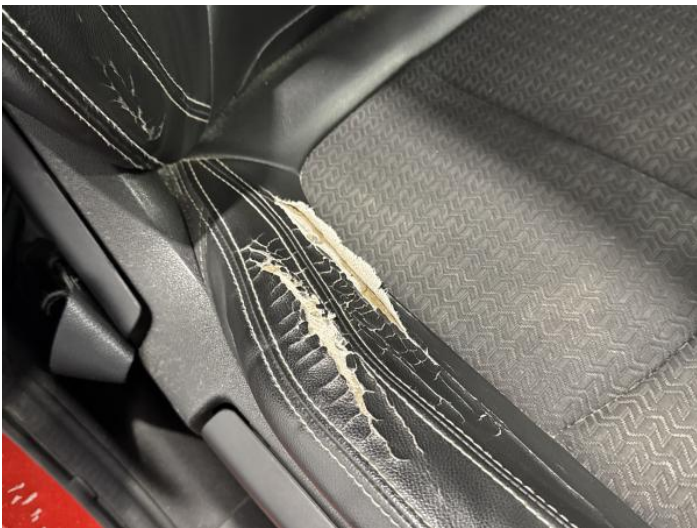
1: Seat Base Cover of
Torn
Over 3mm

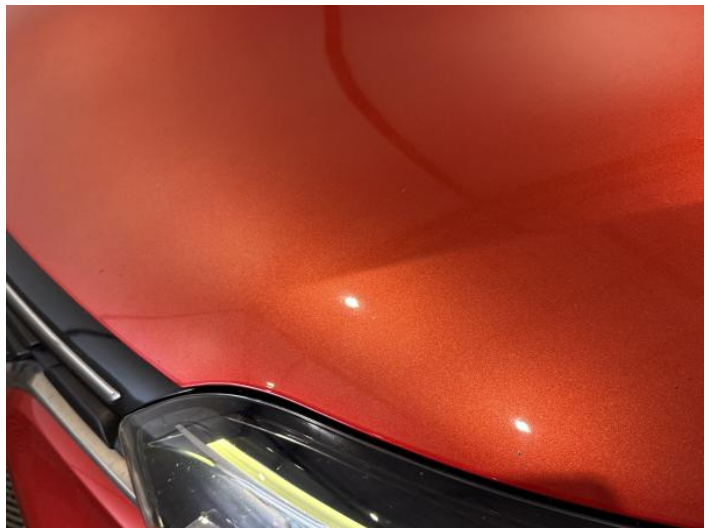
2: Bonnet
Chipped
Multiple Chips

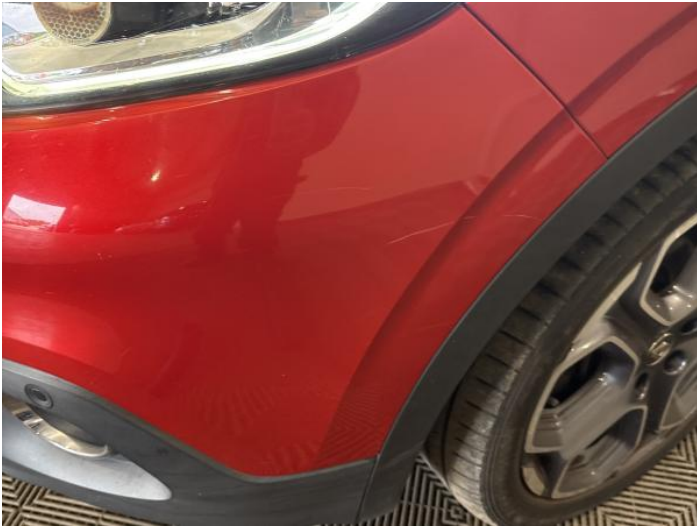
3: Bumper Front
Scratched
25 to 100mm Thru Paint

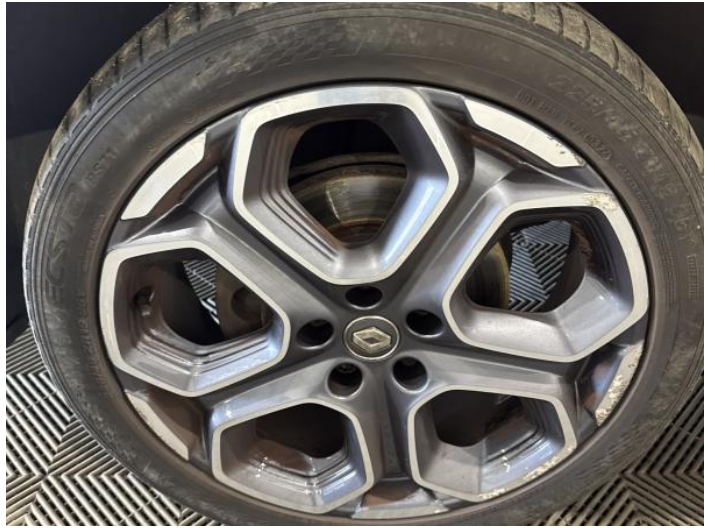
4: Wheel nsf
Scratched
Over 50mm

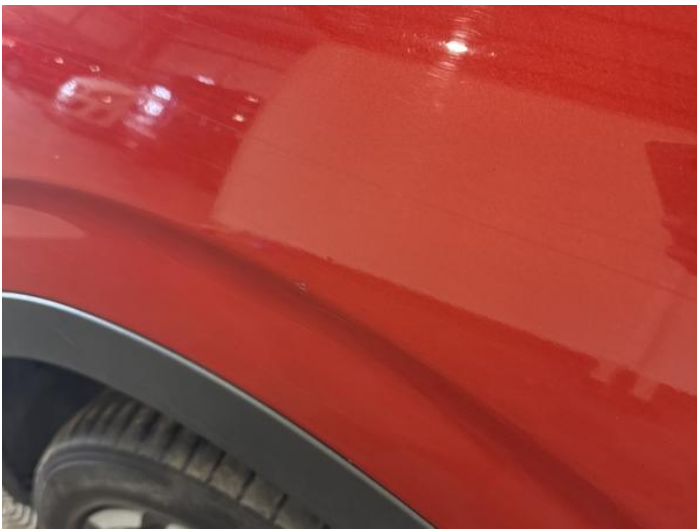
5: Wing nsf
Chipped
1 To 5

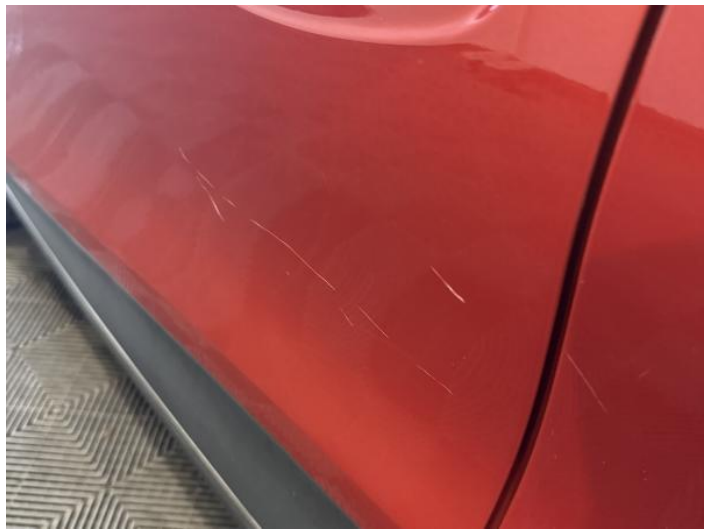
6: Door nsf
Dented
With Paint Damage

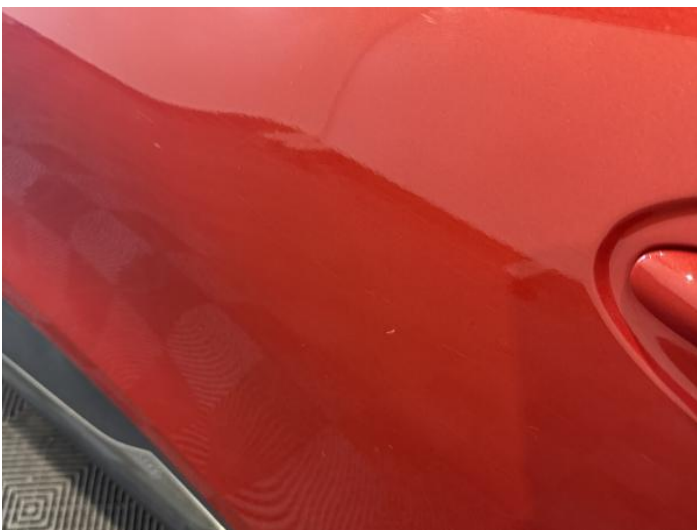
7: Door nsr
Chipped
1 To 5

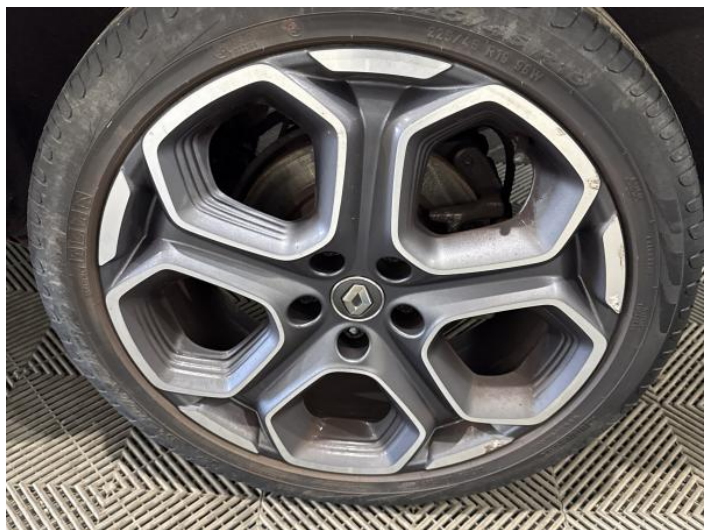
8: Wheel nsr
Scratched
Over 50mm

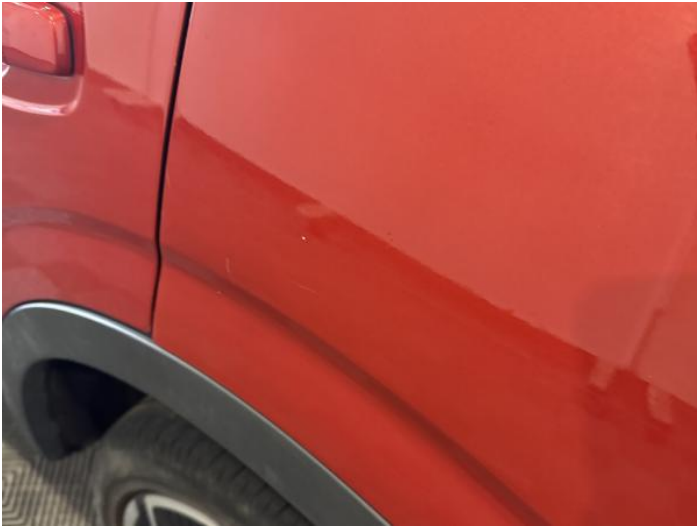
9: Qtr Panel nsr
Chipped
1 To 5

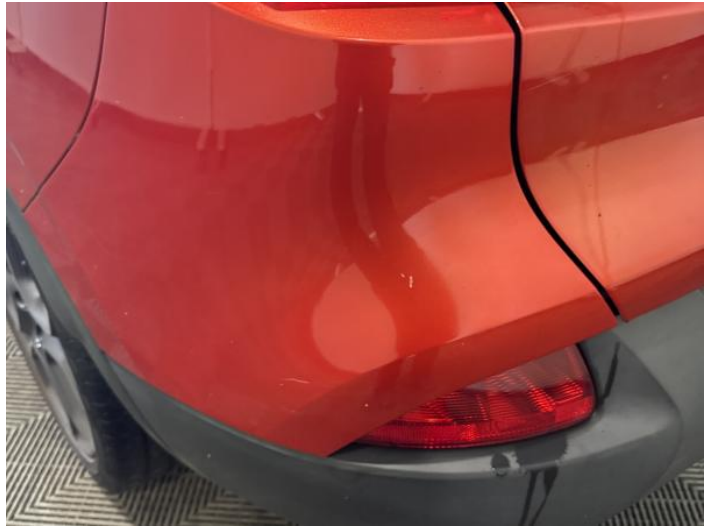
10: Bumper Rear
Scratched
Over 100mm Thru Paint

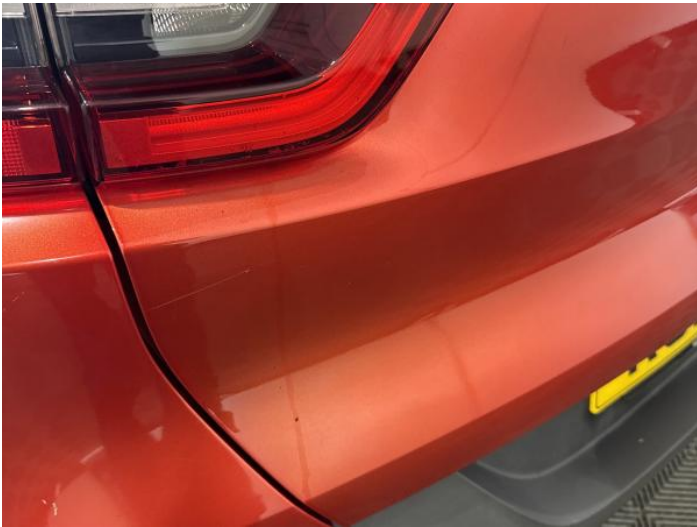
11: Tailgate
Dented
With Paint Damage

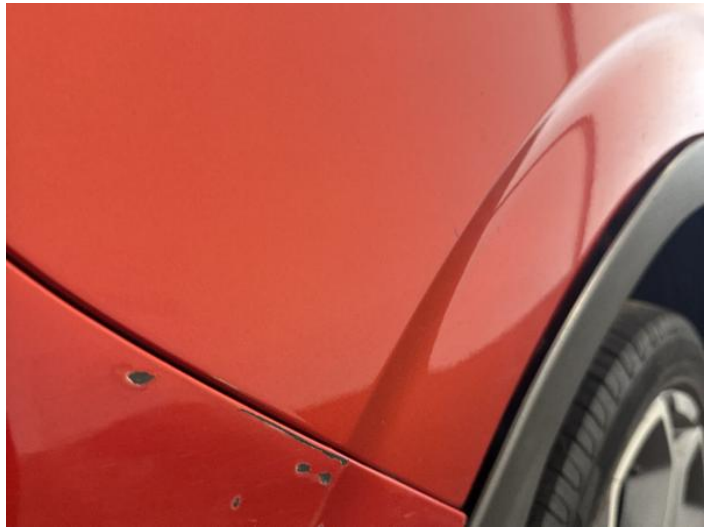
12: Qtr Panel osr
Scratched
Up To 25mm Thru Paint

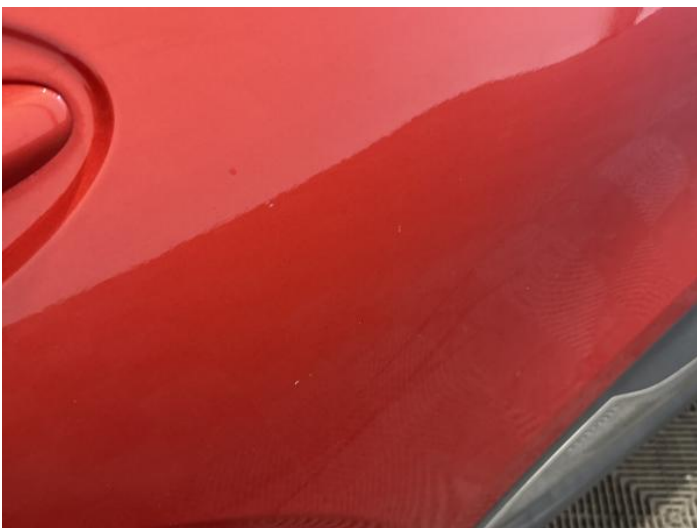
13: Door osr
Chipped
1 To 5

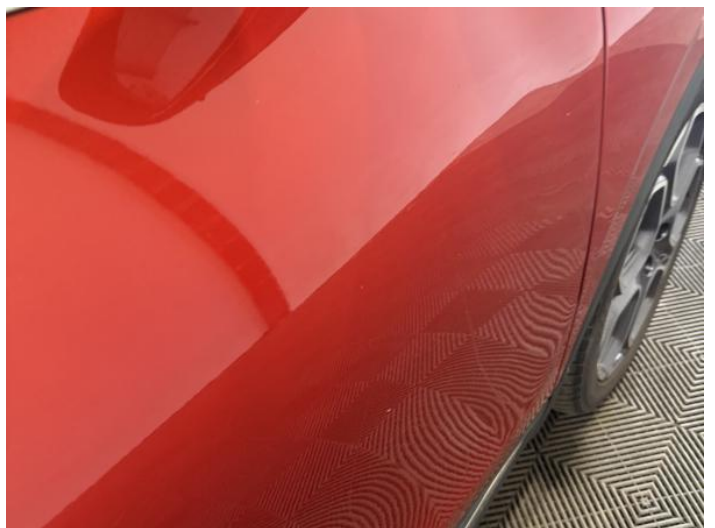
14: Door osf
Dented
Between 10mm + 30mm

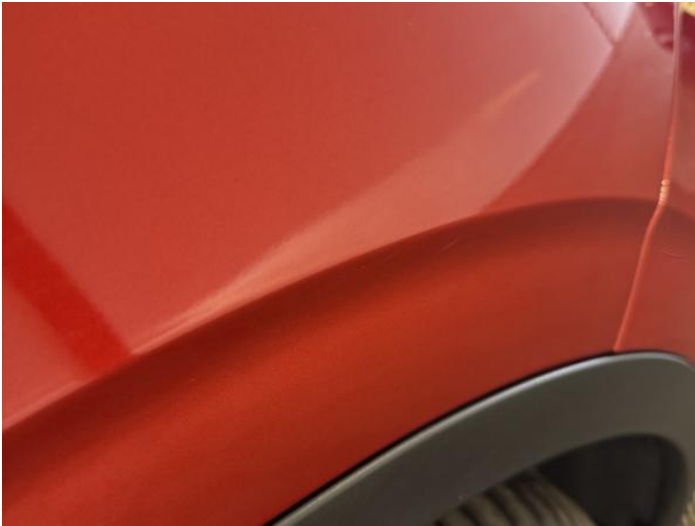
15: Wing of
Scratched
Up To 25mm Thru Paint

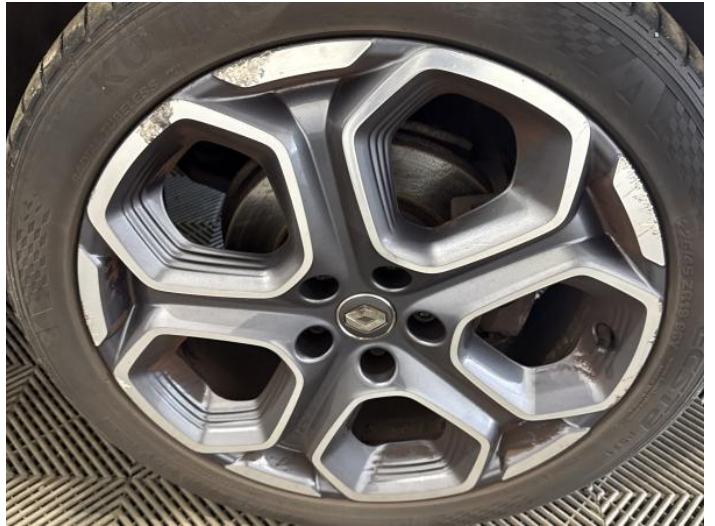
16: Wheel of
Scratched
Over 50mm

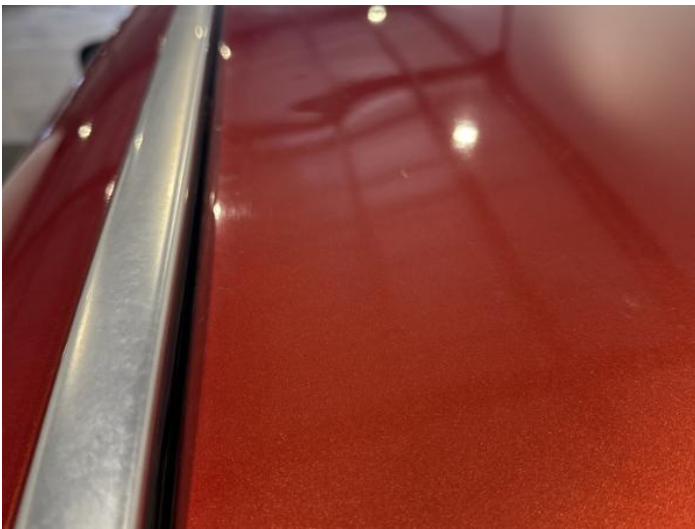
17: Roof
Dented
Over 30mm
