VEHICLE INSPECTION REPORT

LJ11AWP

Nissan Qashqai 1.6 [117] Tekna 5dr

nama
GRADE
4

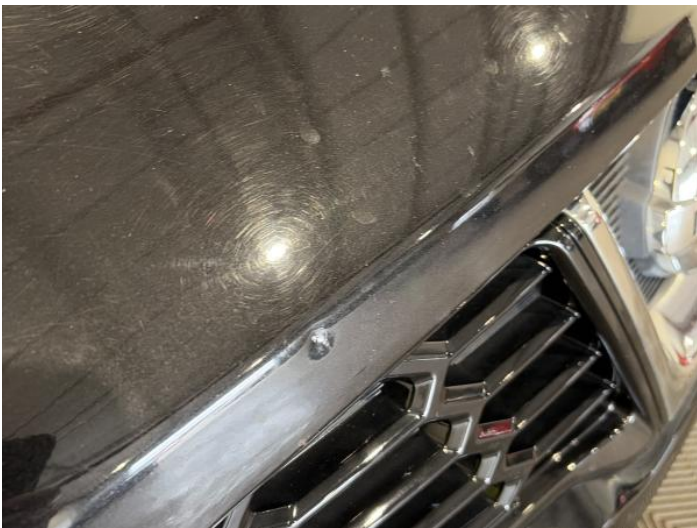
1: Bonnet
Dented
Between 10mm + 30mm

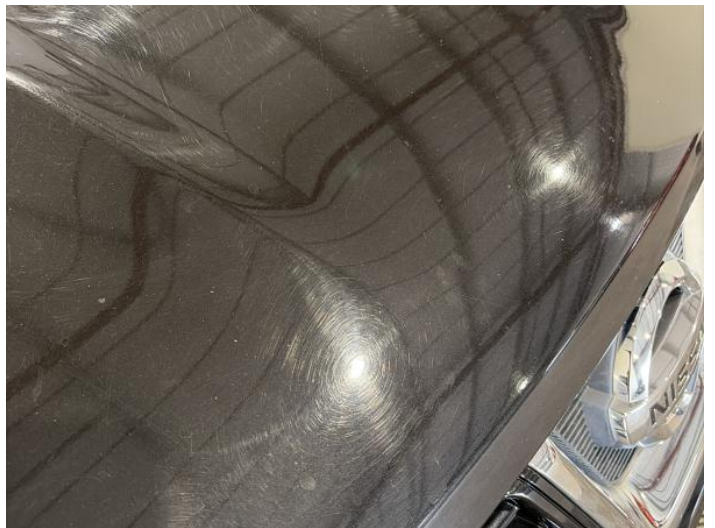
2: Bonnet
Chipped
Multiple Chips

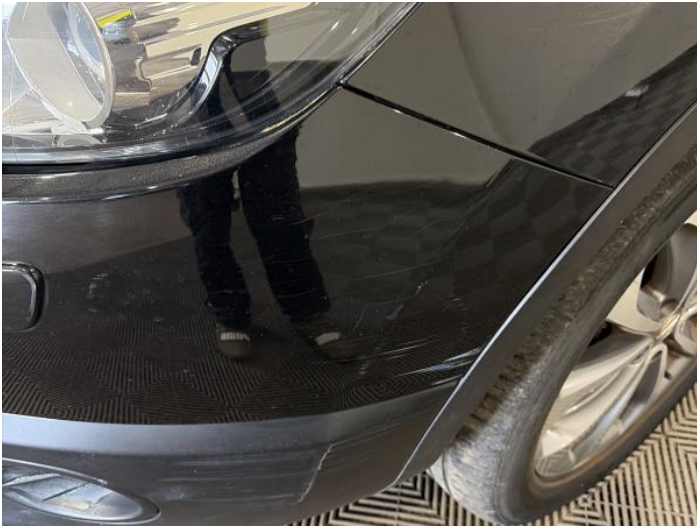
3: Bumper Front
Scratched
25 to 100mm Thru Paint

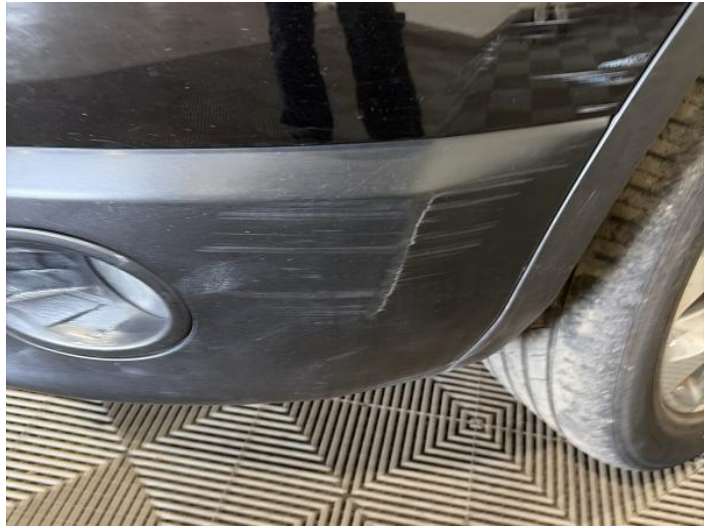
4: Bumper Front Moulding
Scuffed (Unpainted)
Over 100mm

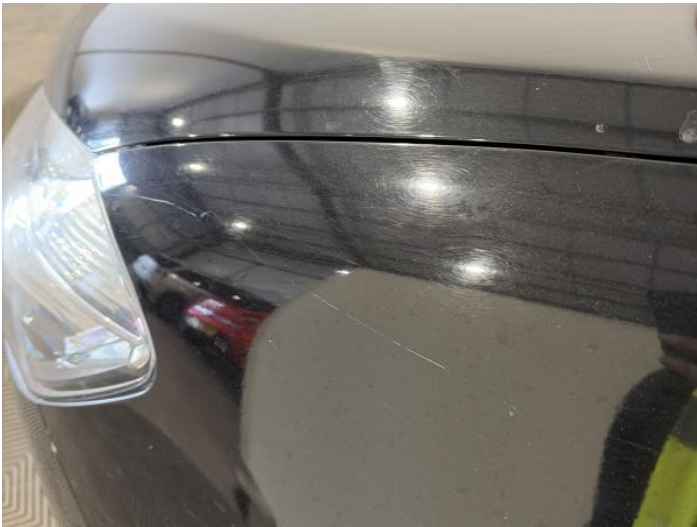
5: Wing nsf
Scratched
Over 25mm Thru Paint

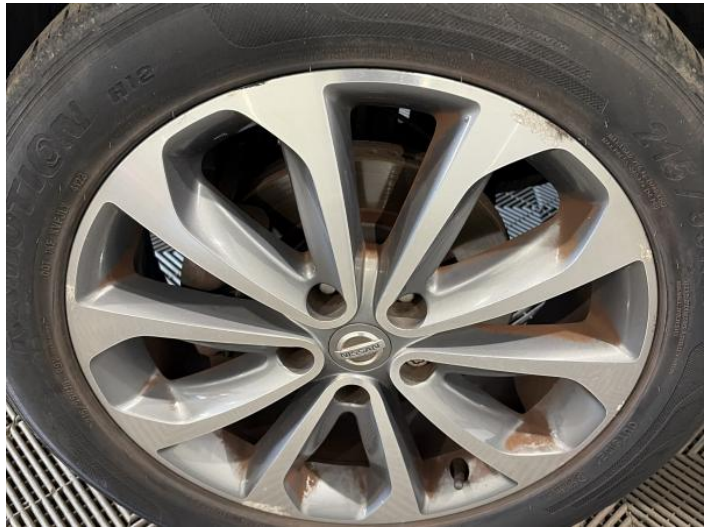
6: Wheel nsf
Scratched
Over 50mm

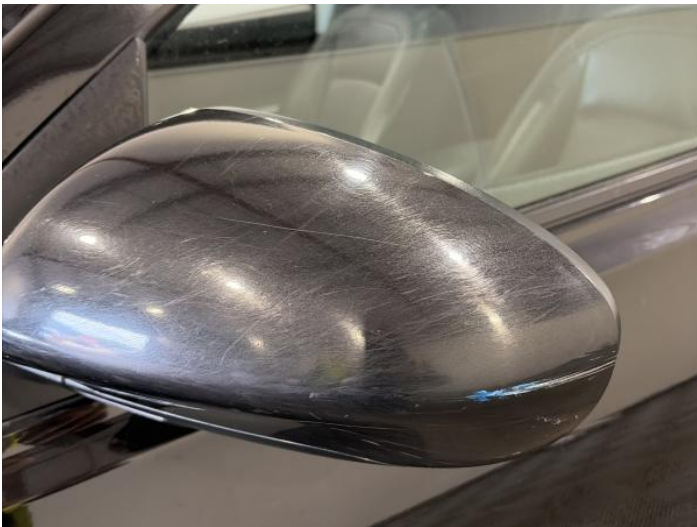
7: Door Mirror Assy nsf
Scratched (Painted)
Over 25mm Thru Paint

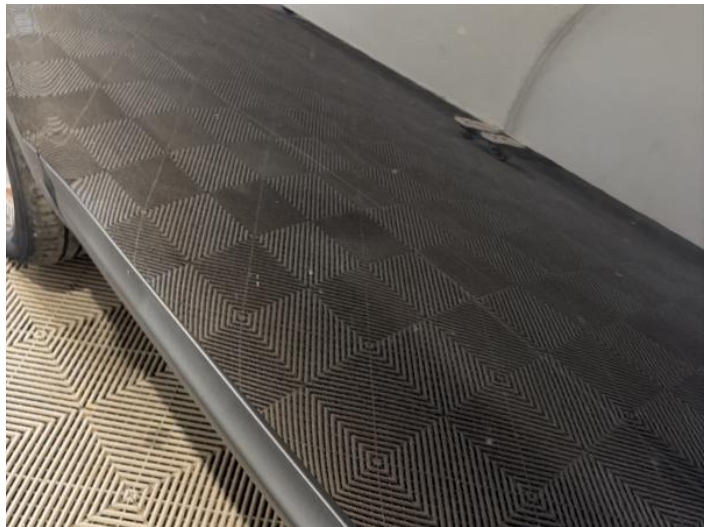
8: Door nsf
Scratched
Over 25mm Thru Paint

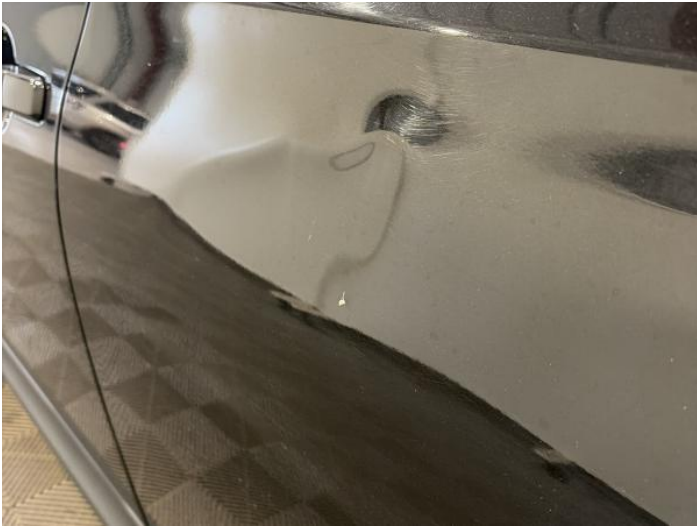
9: Door nsr
Dented
With Paint Damage

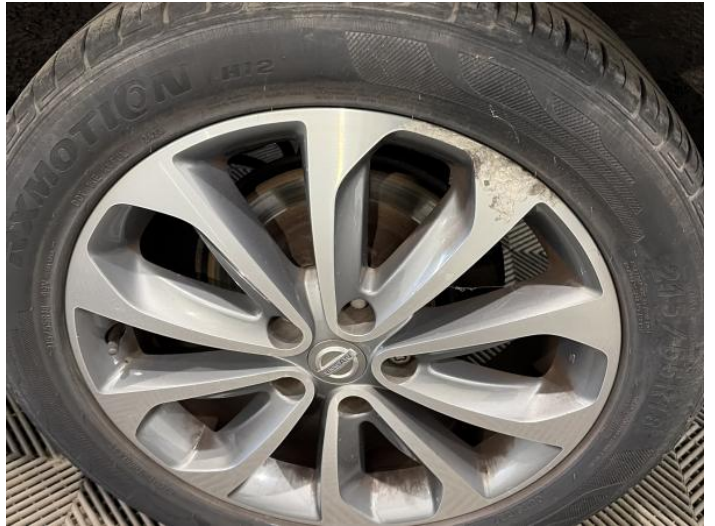
10: Wheel nsr
Corroded
Light

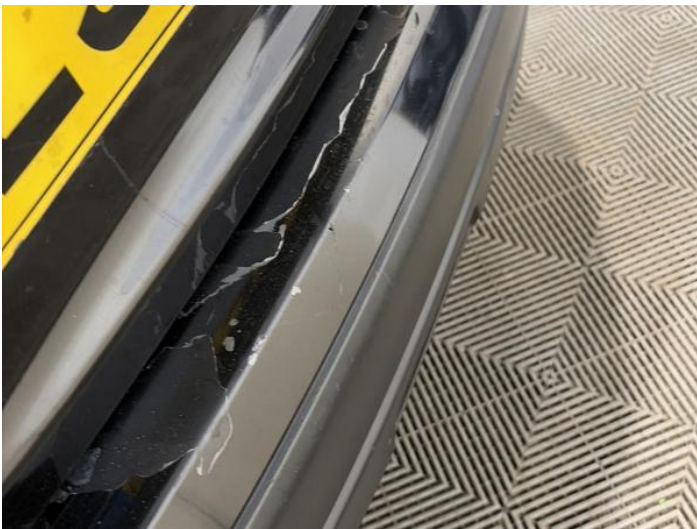
11: Bumper Rear
Poor Previous Repair
Paint Flake

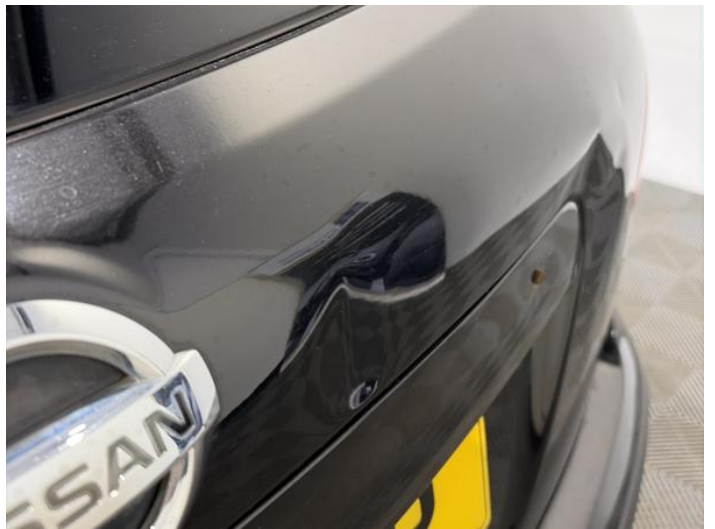
12: Tailgate
Dented
Over 30mm

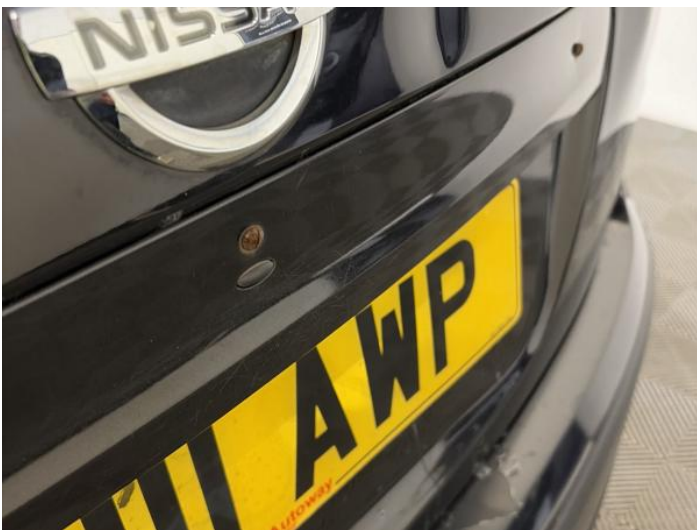
13: Tailgate Trim Panel
Broken
Replace

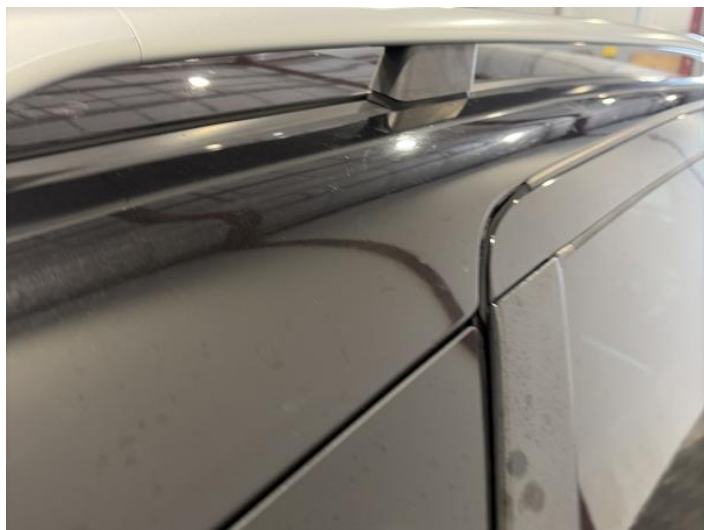
14: C Post os
Dented
Between 10mm + 30mm

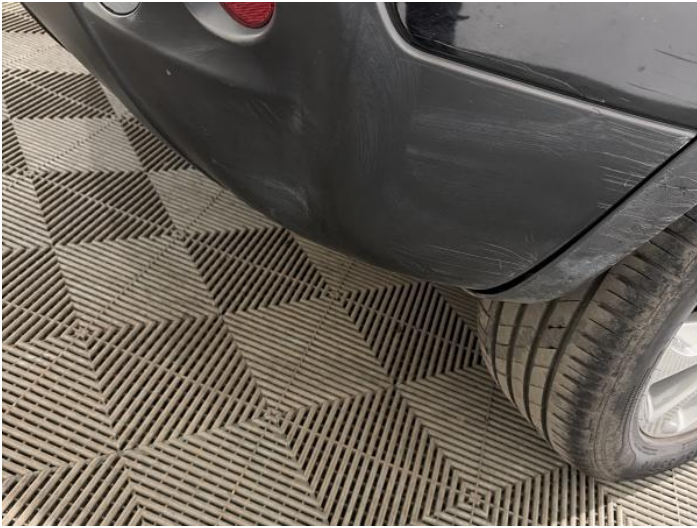
15: Bumper Rear Moulding
Scuffed (Unpainted)
Over 100mm

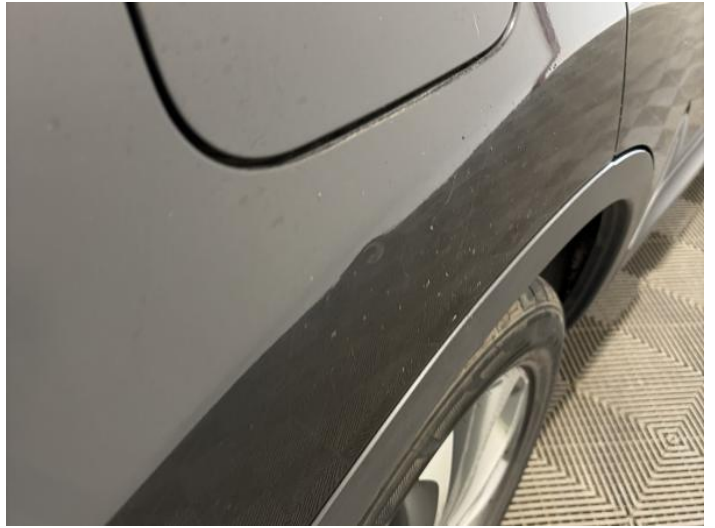
16: Qtr Panel osr
Dented
Between 10mm + 30mm

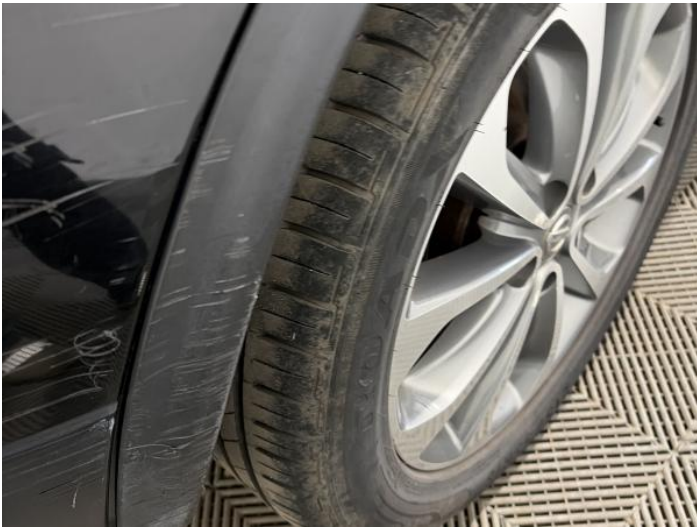
17: Qtr Panel Arch Extension os
Scuffed (Unpainted)
Over 100mm

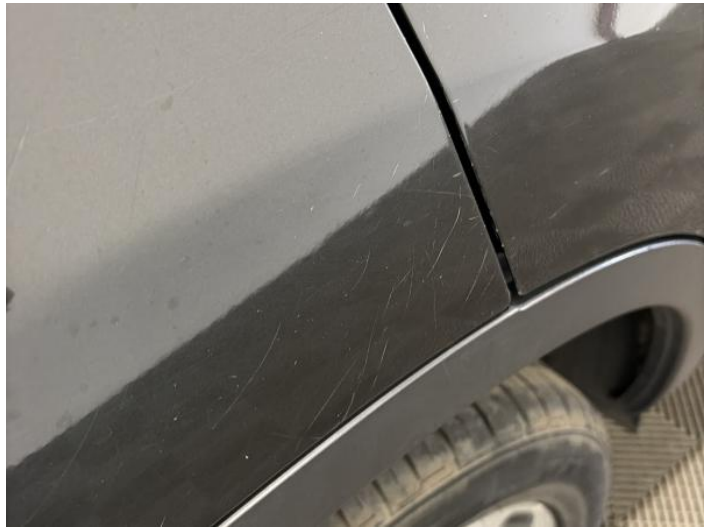
18: Qtr Panel osr
Scratched
Over 25mm Thru Paint

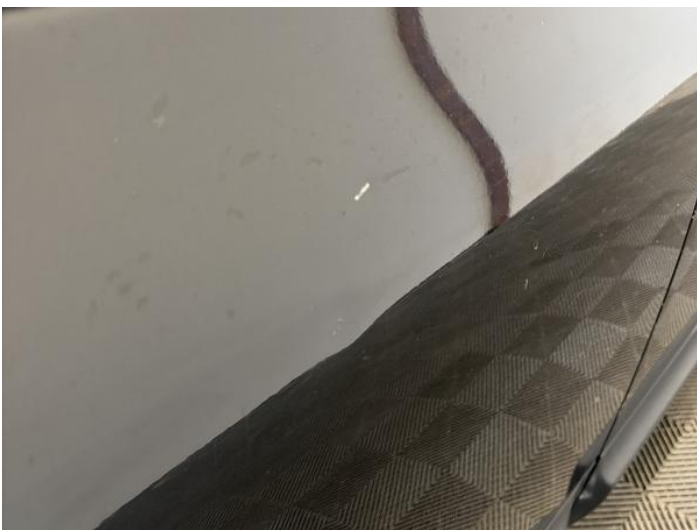
19: Door osr
Dented
Between 10mm + 30mm

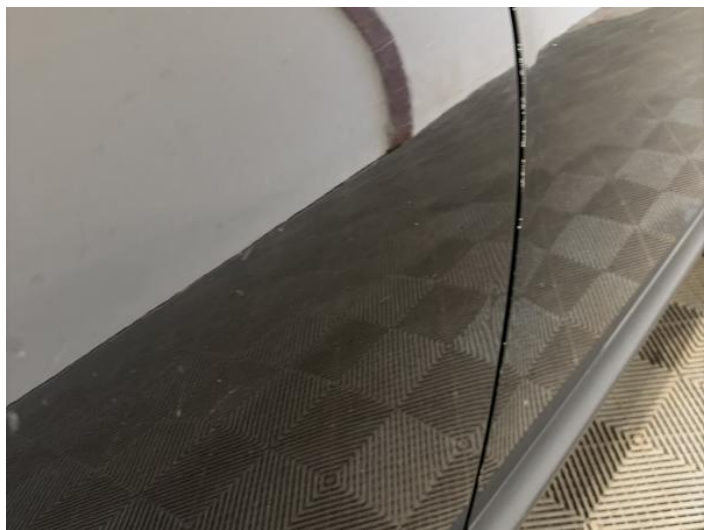
20: Door osr
Scratched
Over 25mm Thru Paint

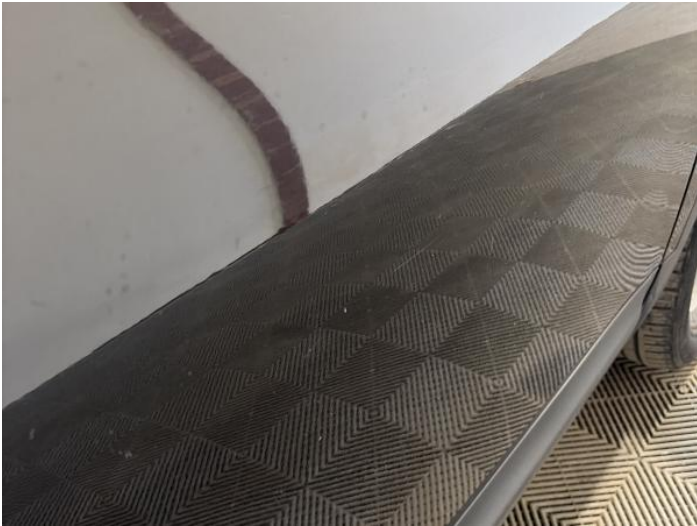
21: Door osf
 Scratched
 Over 25mm Thru Paint

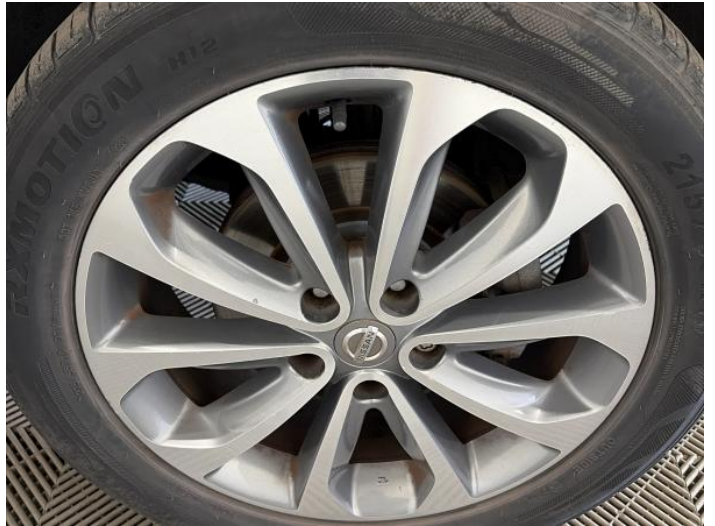
22: Wheel osf
 Scratched
 Up To 50mm

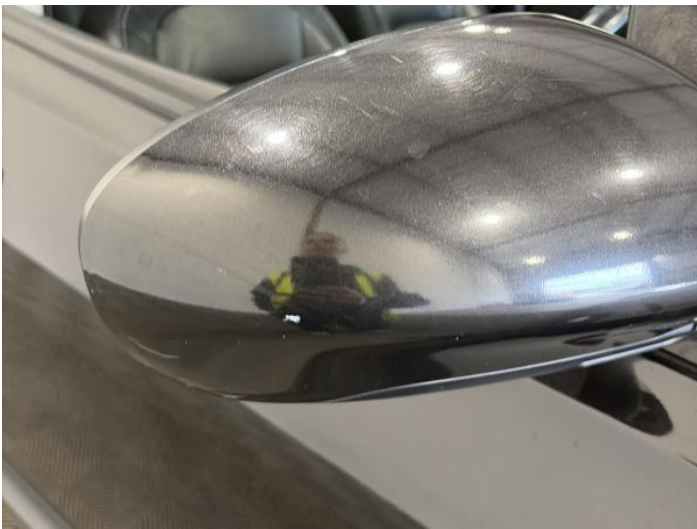
23: Door Mirror Assy osf
 Scratched (Painted)
 UpTo 25mm Thru Paint
