# VEHICLE INSPECTION REPORT

**WD66XEP**

## Renault Captur 1.5 dCi 90 Dynamique Nav 5dr

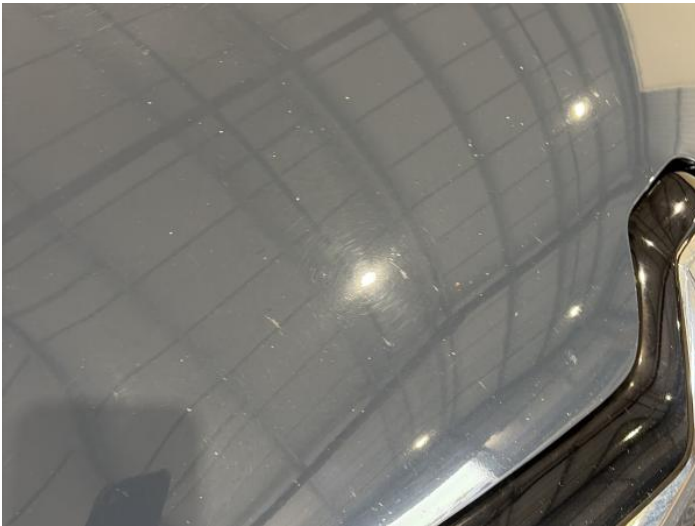
1: Bonnet  
Chipped  
Multiple Chips

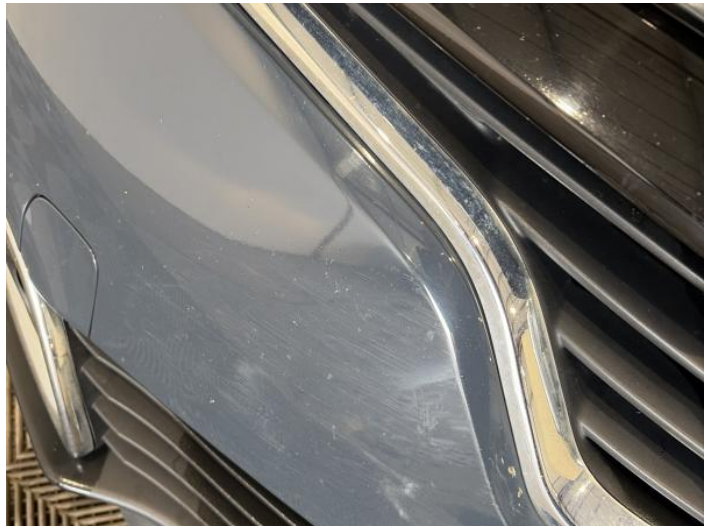
2: Bumper Front  
Scratched  
25 to 100mm Thru Paint

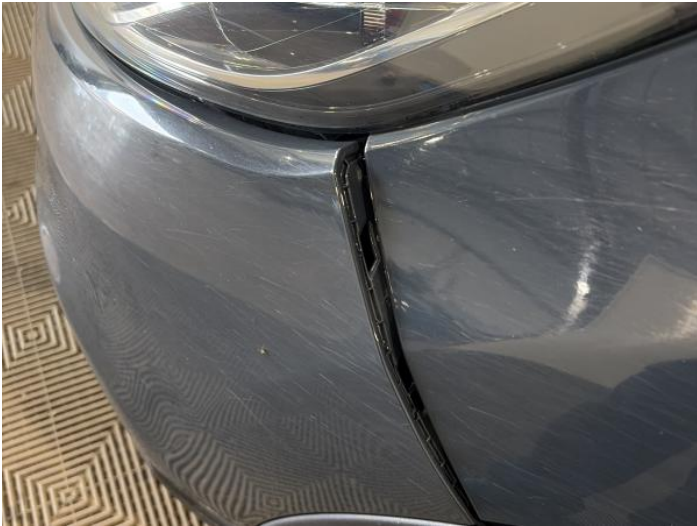
3: Bumper Front  
Insecure  
Action Required

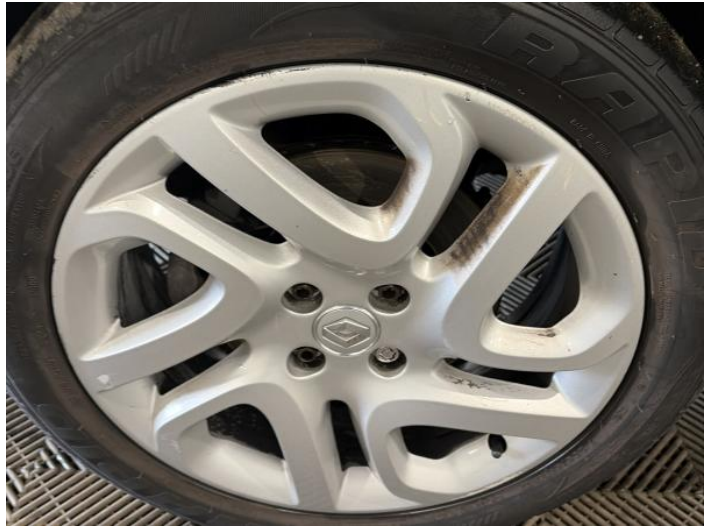
4: Wheel nsf  
Scratched  
Over 50mm

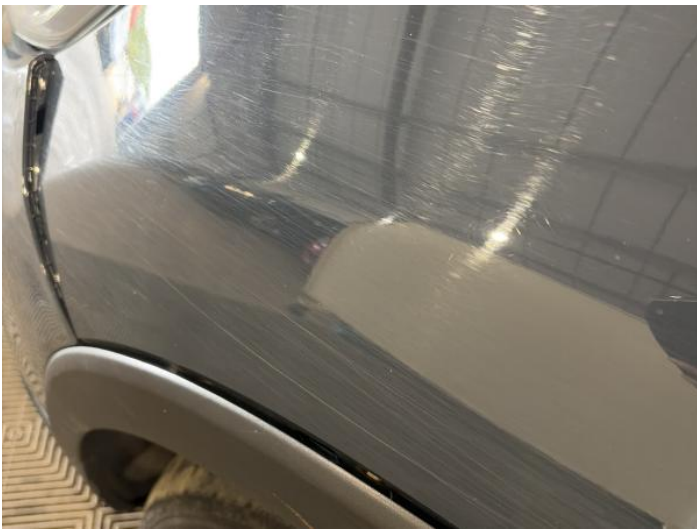
5: Wing nsf  
Scratched  
Over 25mm Thru Paint

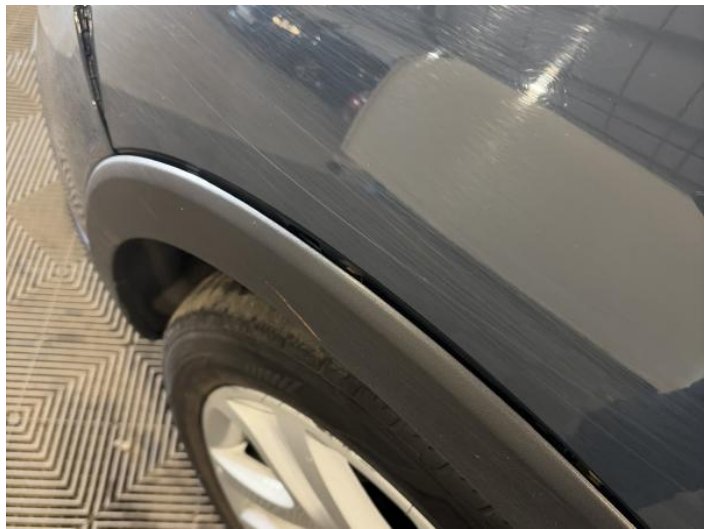
6: Wing Front Arch Extension ns  
Scuffed (Unpainted)  
Over 100mm

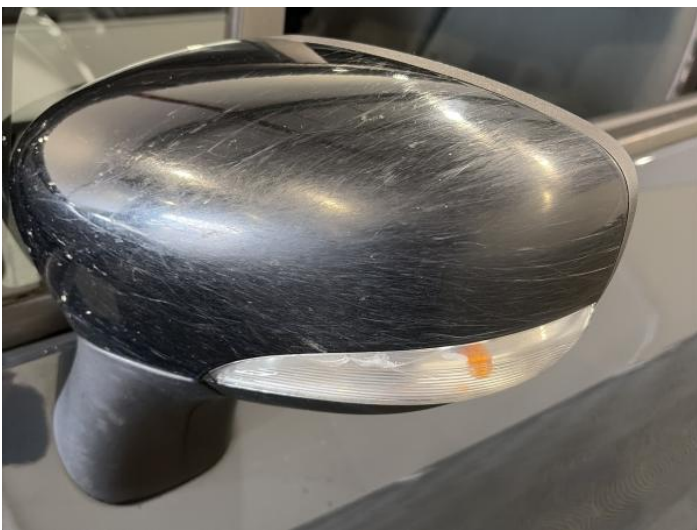
7: Flasher Side Repeater ns  
Broken  
Replace

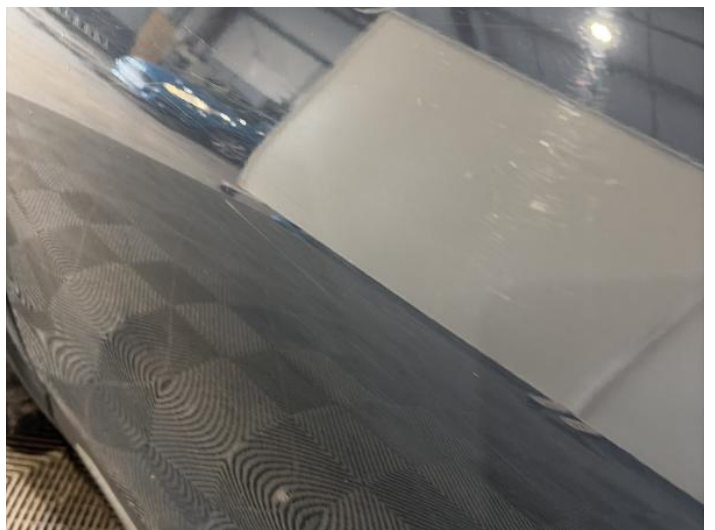
8: Door nsf  
Dented  
Between 10mm + 30mm

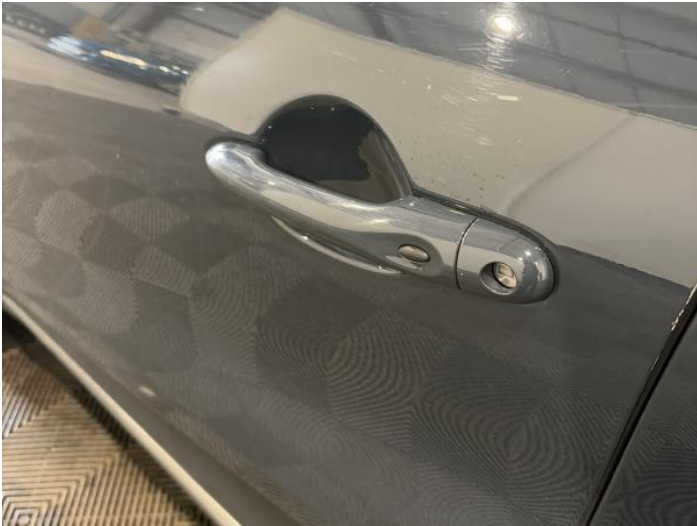
9: Door nsf  
Chipped  
Multiple Chips

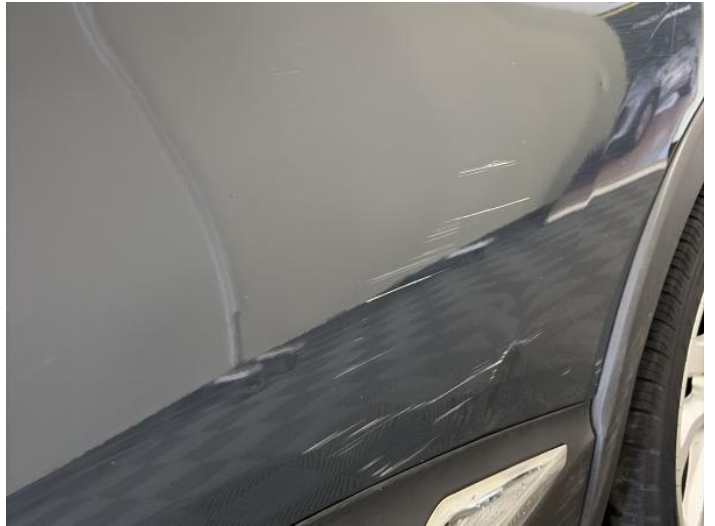
10: Door nsr  
Dented  
With Paint Damage

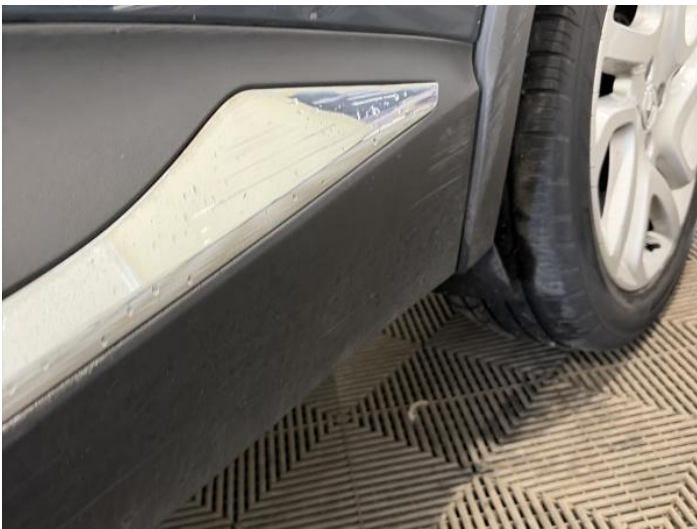
11: Door Moulding nsr  
Scuffed (Unpainted)  
Over 100mm

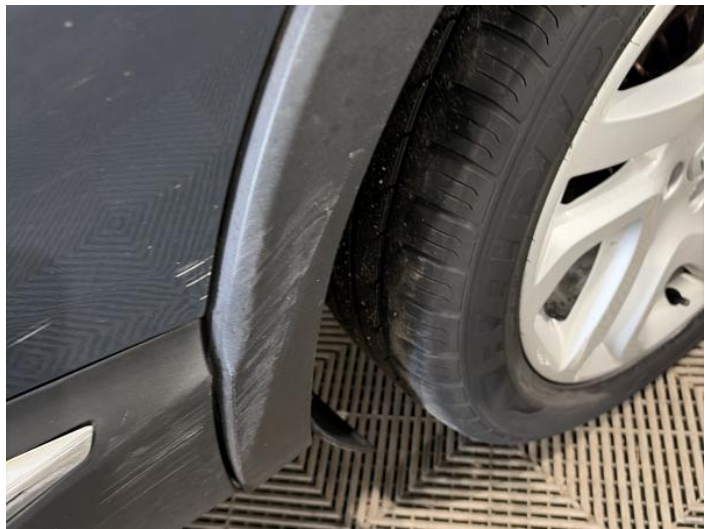
12: Qtr Panel Arch Extension ns  
Scuffed (Unpainted)  
Over 100mm

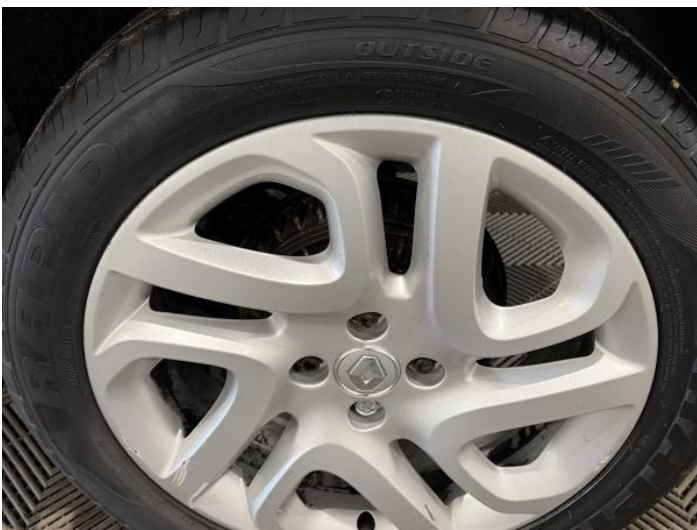
13: Wheel nsr  
Scratched  
Over 50mm

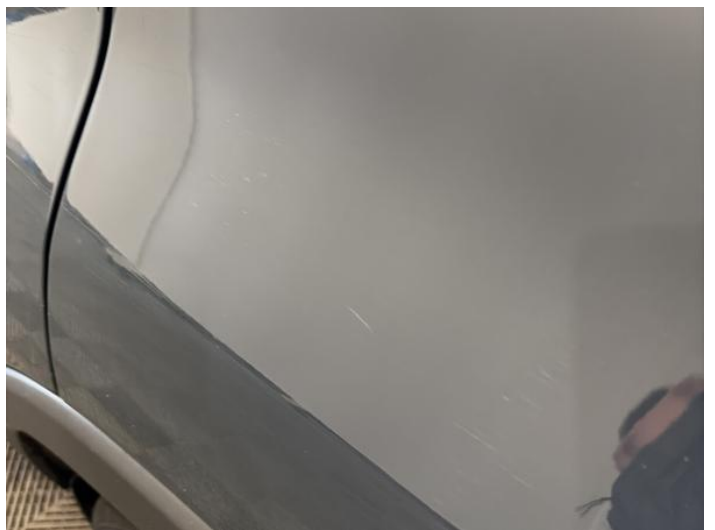
14: Qtr Panel nsr  
Scratched  
UpTo 25mm Thru Paint

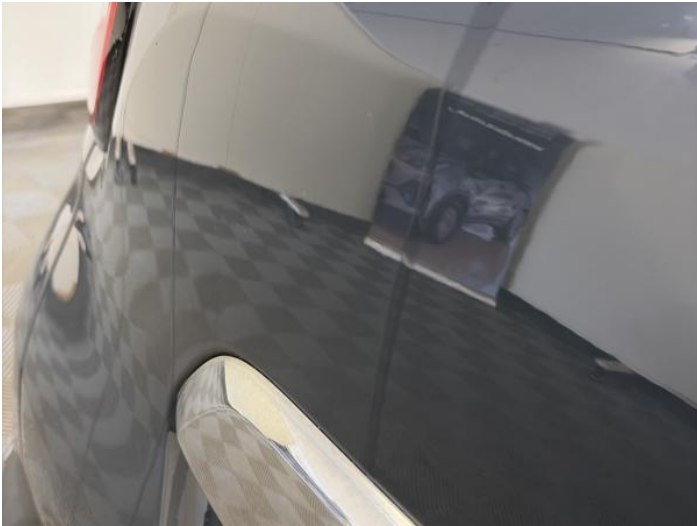
15: Tailgate  
Dented  
Between 10mm + 30mm

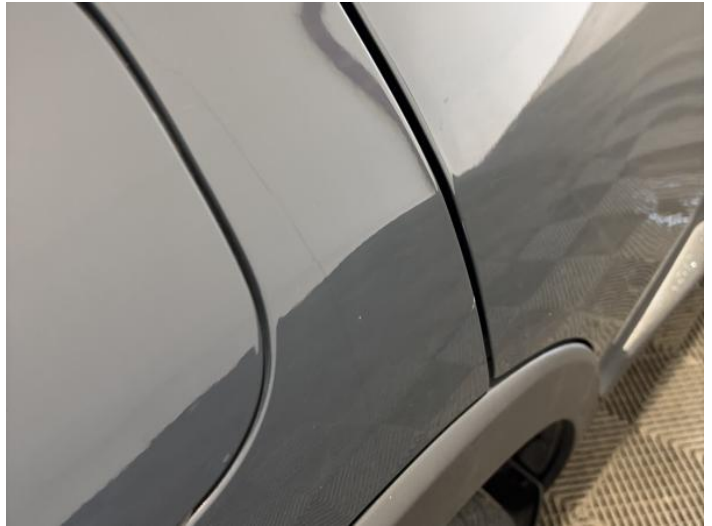
16: Qtr Panel osr  
Dented  
Between 10mm + 30mm

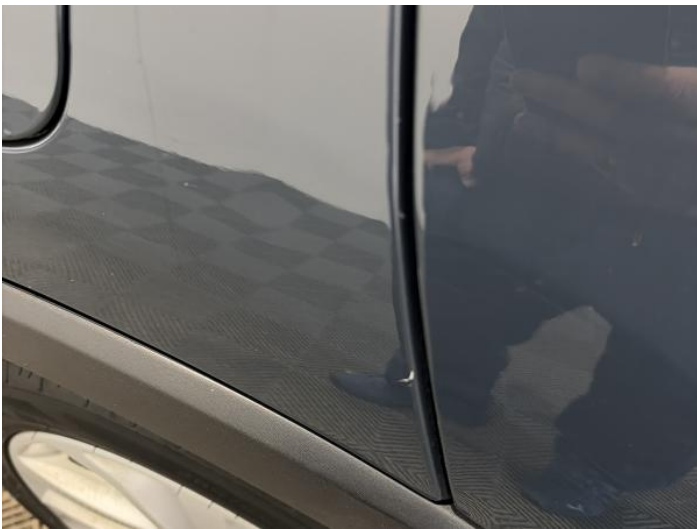
17: Qtr Panel osr  
Scratched  
UpTo 25mm Thru Paint

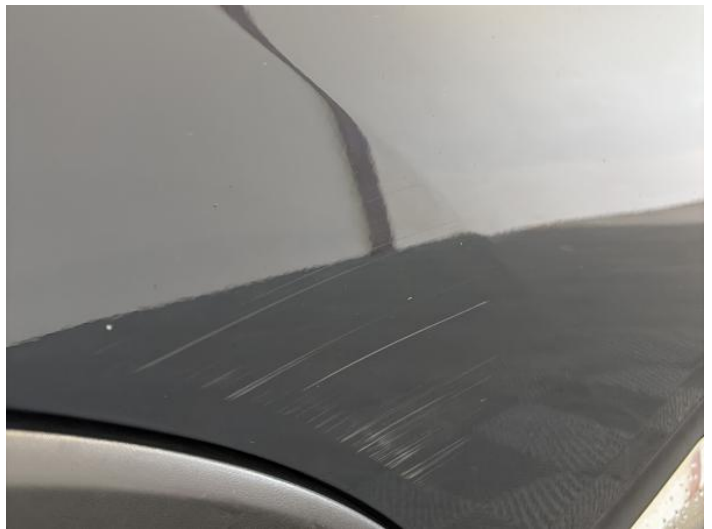
18: Door osr  
Scratched  
Over 25mm Thru Paint

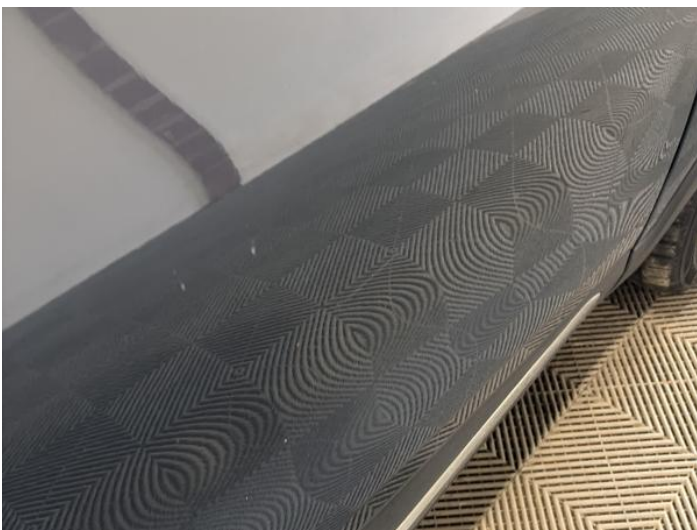
19: Door osf  
Scratched  
Over 25mm Thru Paint

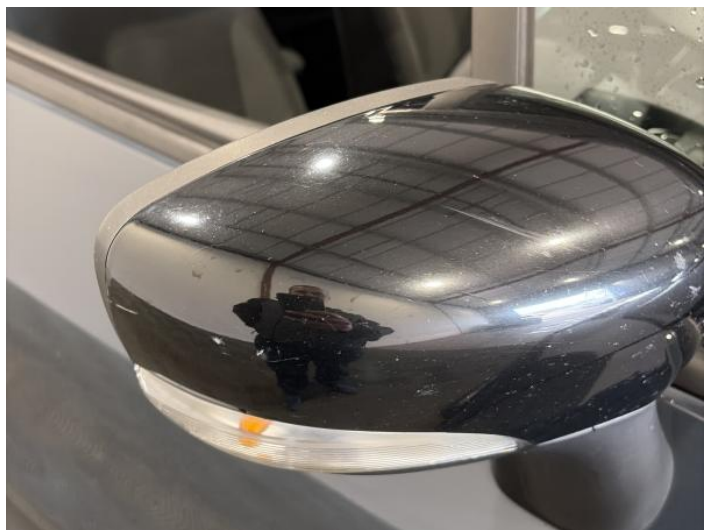
20: Door Mirror Assy osf  
Scratched (Painted)  
UpTo 25mm Thru Paint

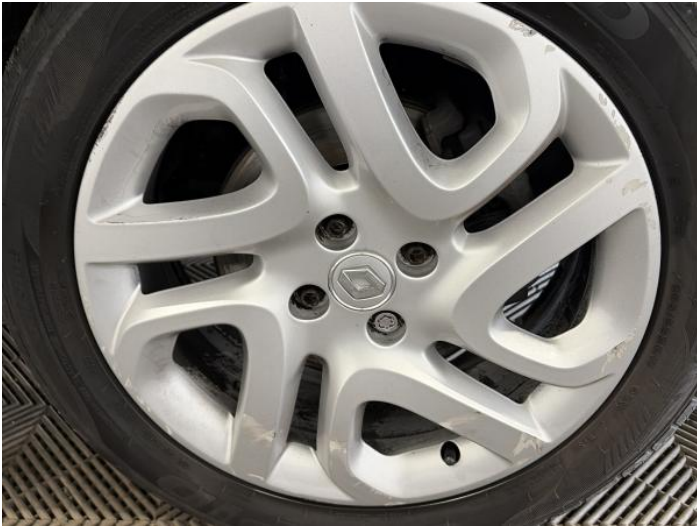
21: Wheel osf  
Scratched  
Over 50mm

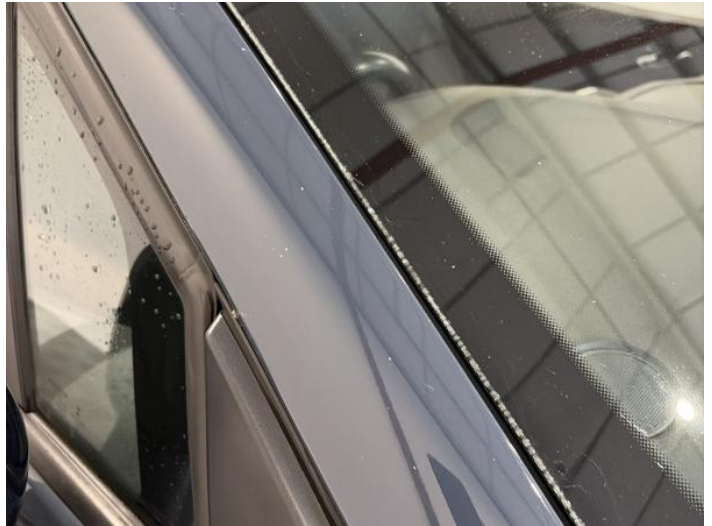
22: A Post os  
Chipped  
1 To 5

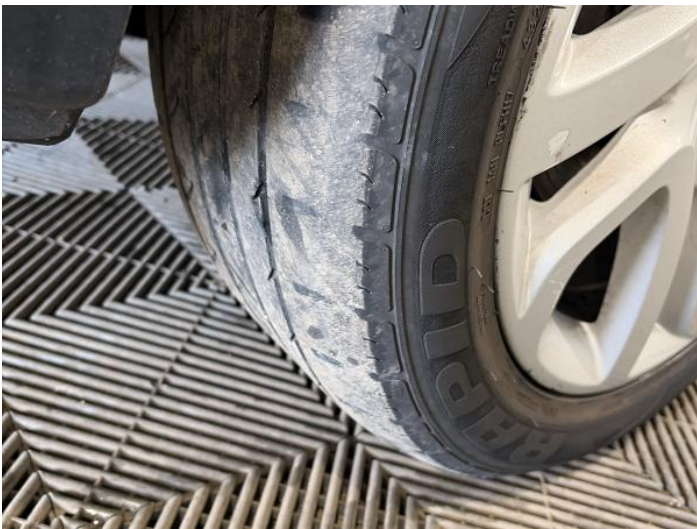
23: Tyre nsf  
Damaged  
Replace
